MINERALS PROGRAM INSPECTION REPORT
PHONE: (303) 866-3567

MINE NAME: Walstrum Mine	MINE/PROSPECTING ID#: M-1983-033	MINERAL: Granite, granite gneiss	COUNTY: Clear Creek
INSPECTION TYPE: Monitoring	INSPECTOR(S): Timothy Cazier	INSP. DATE: November 21, 2019	INSP. TIME: 09:30
OPERATOR: Albert Frei & Sons Inc.	OPERATOR REPRESENTATIVE: Al Frei, Jr.	TYPE OF OPERATION: 112c - Construction Regular Operation	
REASON FOR INSPECTION: Normal I&E Program	BOND CALCULATION TYPE: None	BOND AMOUNT: \$742,000.00	
DATE OF COMPLAINT: NA	POST INSP. CONTACTS: None	JOINT INSP. AGENCY: None	
WEATHER: Foggy	INSPECTOR'S SIGNATURE:

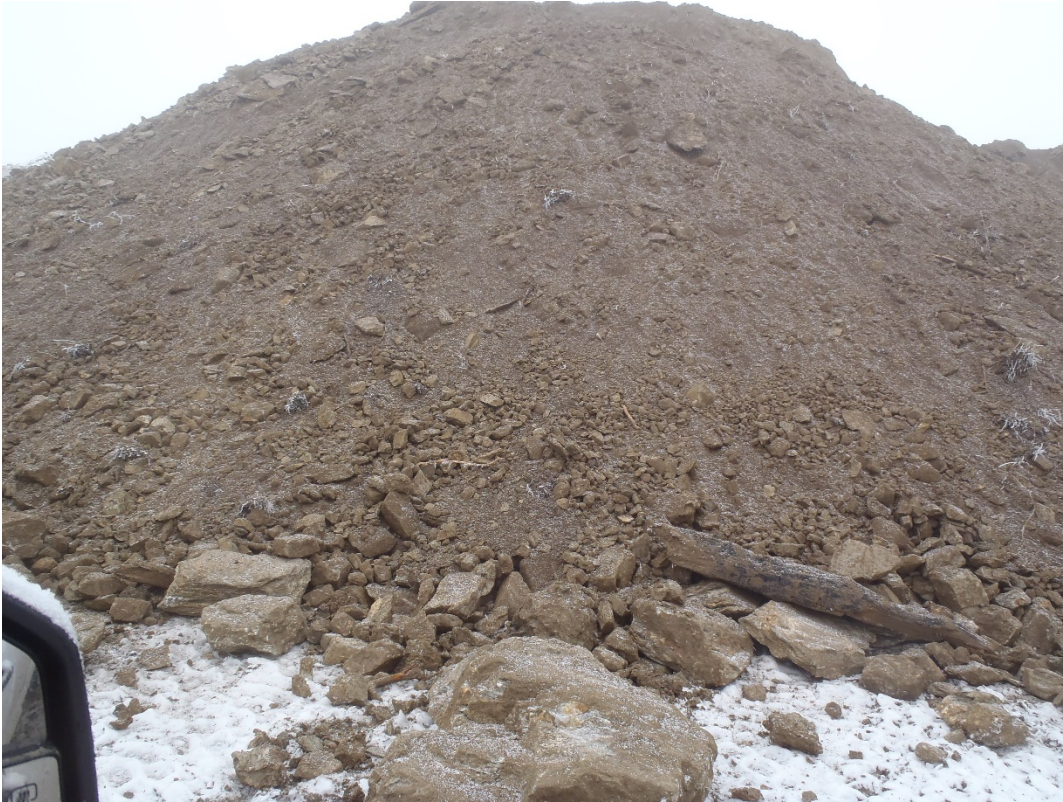
Excess Spoil and Dev. Waste: Mr. Frei indicated they do not distinguish between overburden and topsoil when stripping this material in advance of mining. The stripped material is stockpiled (see **Photo 1**) and reserved for reclamation.

Photo 1. Stockpile of stripped overburden/topsoil for reclamation.

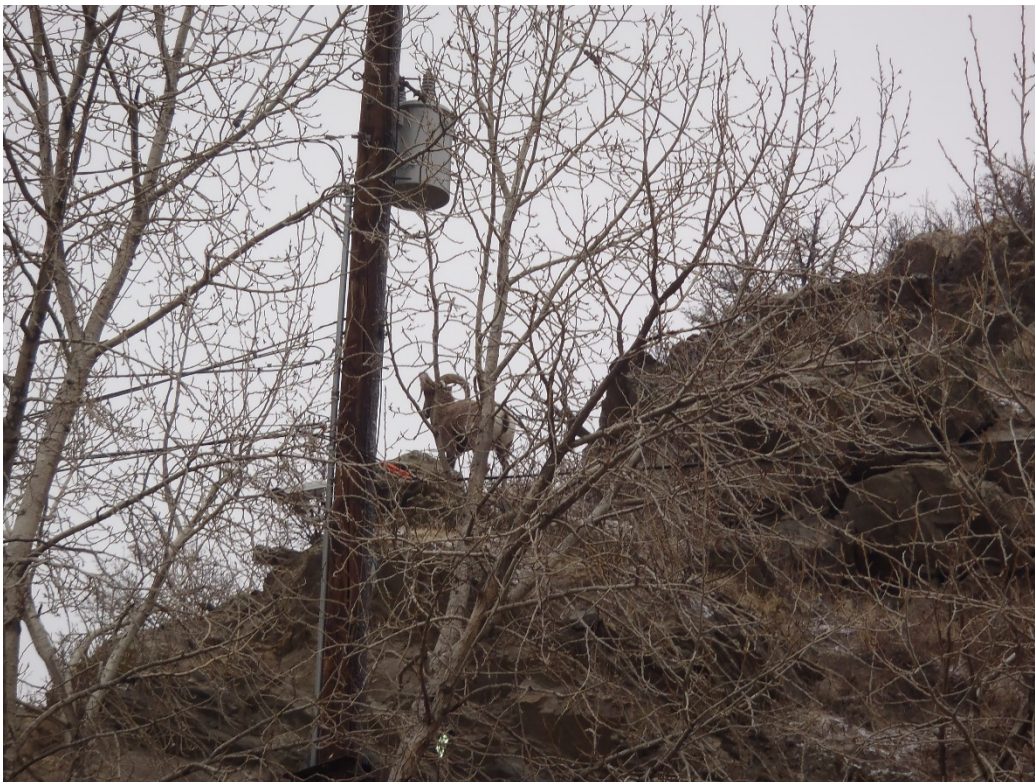
Fish and Wildlife: No impact to wildlife was observed. A bighorn sheep was observed on the west side at the beginning of the inspection (see **Photo 2**).

Photo 2. Bighorn sheep observed above mine entrance.

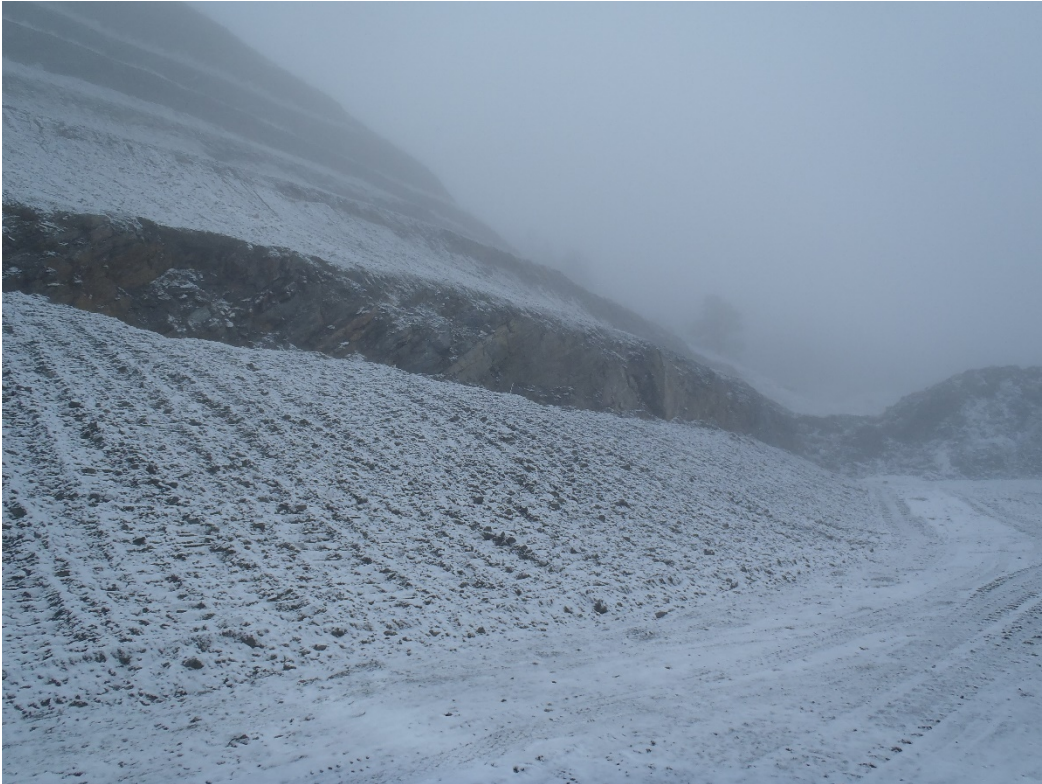
AFS undertake this action and provide results to the DRMS prior to the next DRMS inspection. Highwalls were estimated to be 40 feet in height and appeared stable (see **Photo 3**).

Photo 3. Typical highwall undergoing reclamation (east side, looking south).

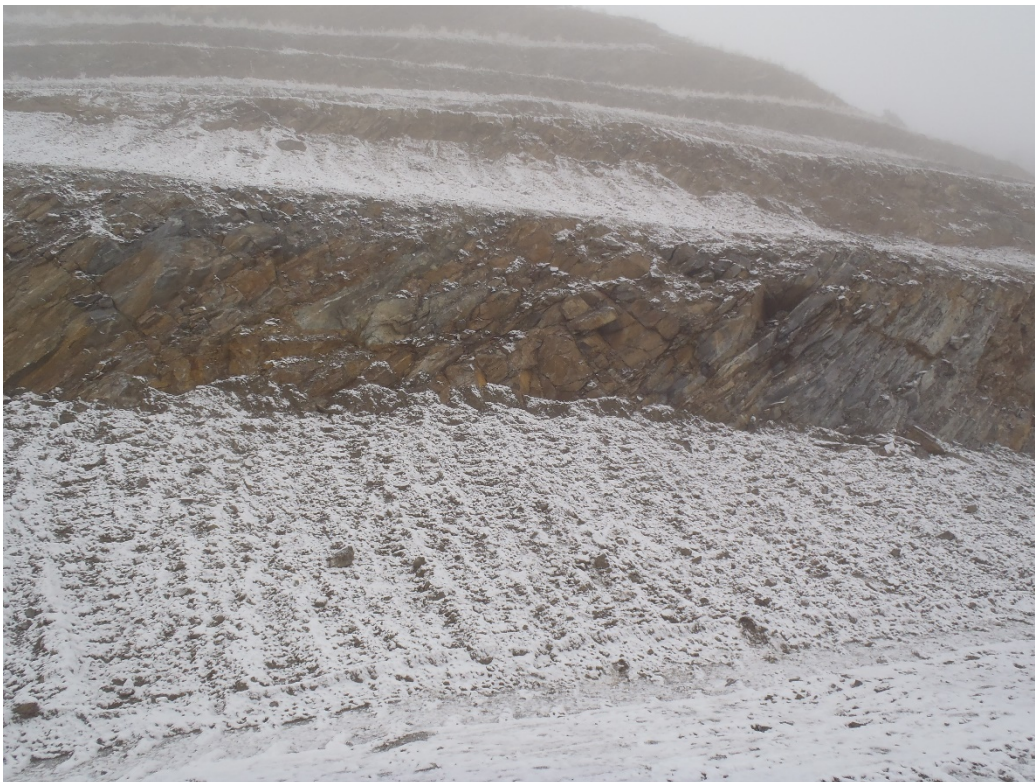
Reclamation Success: Several of the upper east highwall benches have been widened, backfilled (see **Photo 3**), topsoiled and seeded (see **Photo 4**). The two noncontiguous areas of the permit are not being mined and are commercial/industrial. [The DRMS recommends AFS request release of the two areas from the permit.](#)

Photo 4. Typical bench backfill, topsoiled and seeded (east highwall).

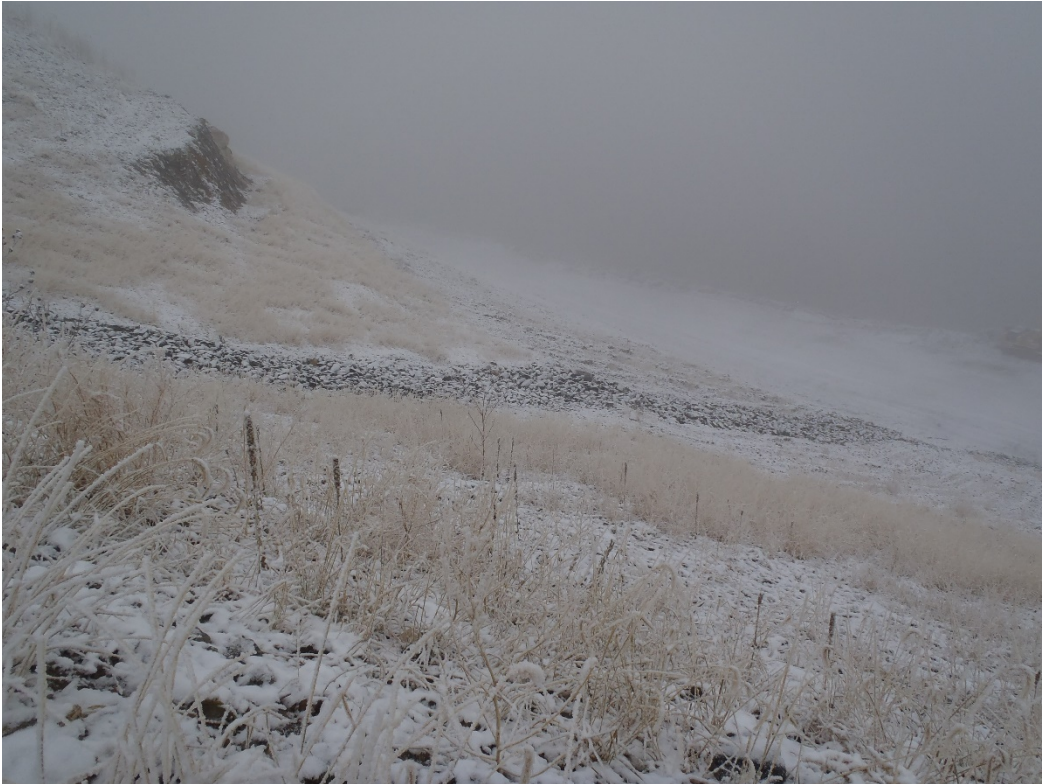
Revegetation: The top four to five benches in the southeast corner of the mine have reached final configuration and the Permittee has initiated concurrent reclamation with upper most of these benches having three growing seasons (see **Photos 5 & 6**) that appear to have well established vegetation (see **Photo 7**). Plugs of grass and shrubs (see **Photos 8 & 9**) are planted prior to broadcast seeding and hydromulching the backfilled benches. Benches below that have up to two growing seasons and Mr. Frei stated seeding was scheduled for the day of the inspection for the first bench visited, but the inclement weather postponed the effort. The vegetation growth observed was remarkable in that these slopes dry out easily as they are west facing slopes and buffeted by the common high winds following the Clear Creek canyon.

Photo 5. Revegetated bench with three growing seasons (near crest of east highwall).

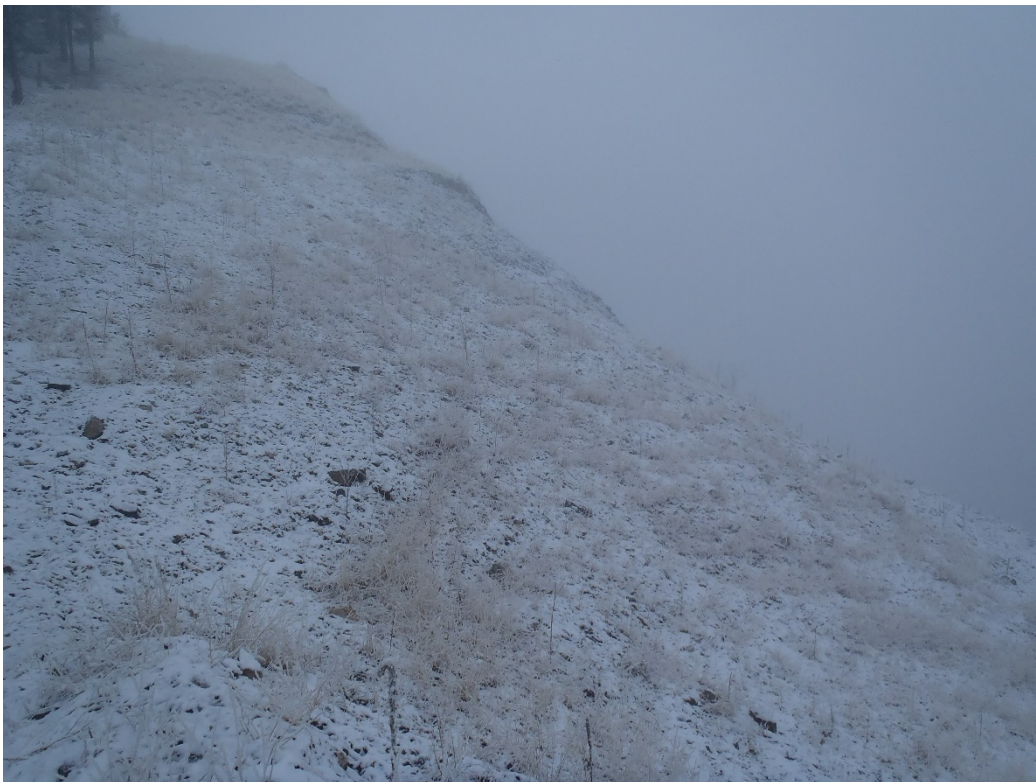
Photo 6. Revegetated bench with three growing seasons (looking at crest of east highwall).

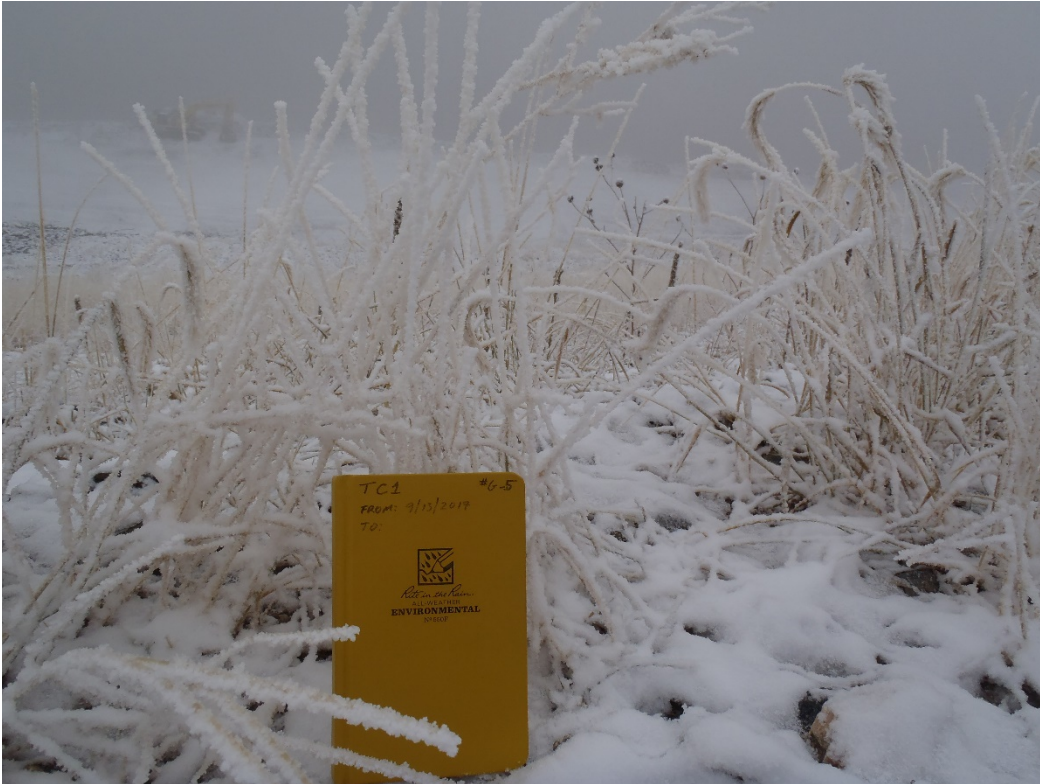
Photo 7. Close-up of established vegetation (field book for scale).

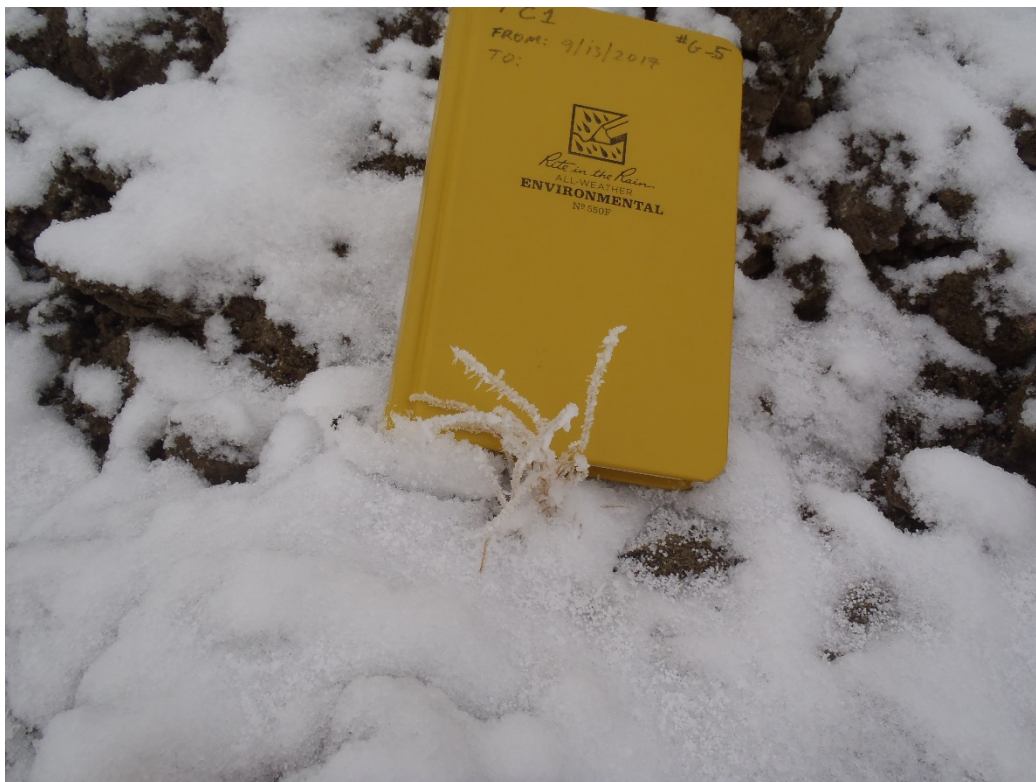
Photo 8. Grass plug – enhanced reclamation (field book for scale).

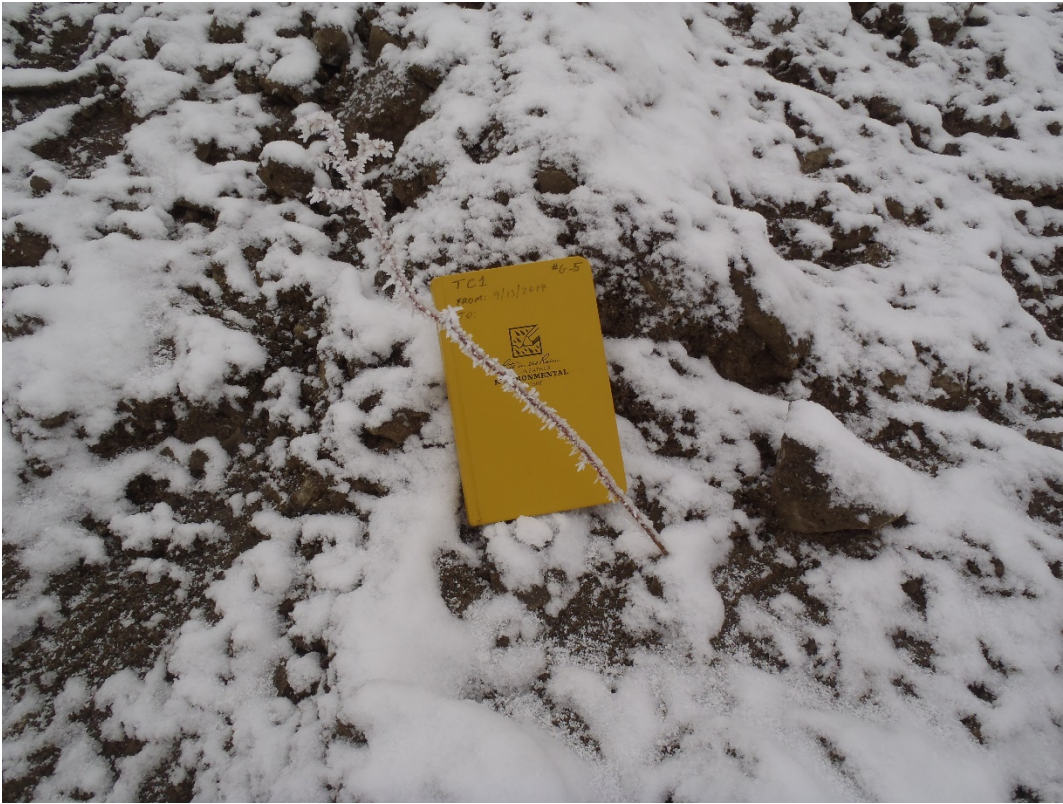
Photo 9. Shrub plug – enhanced reclamation (field book for scale).

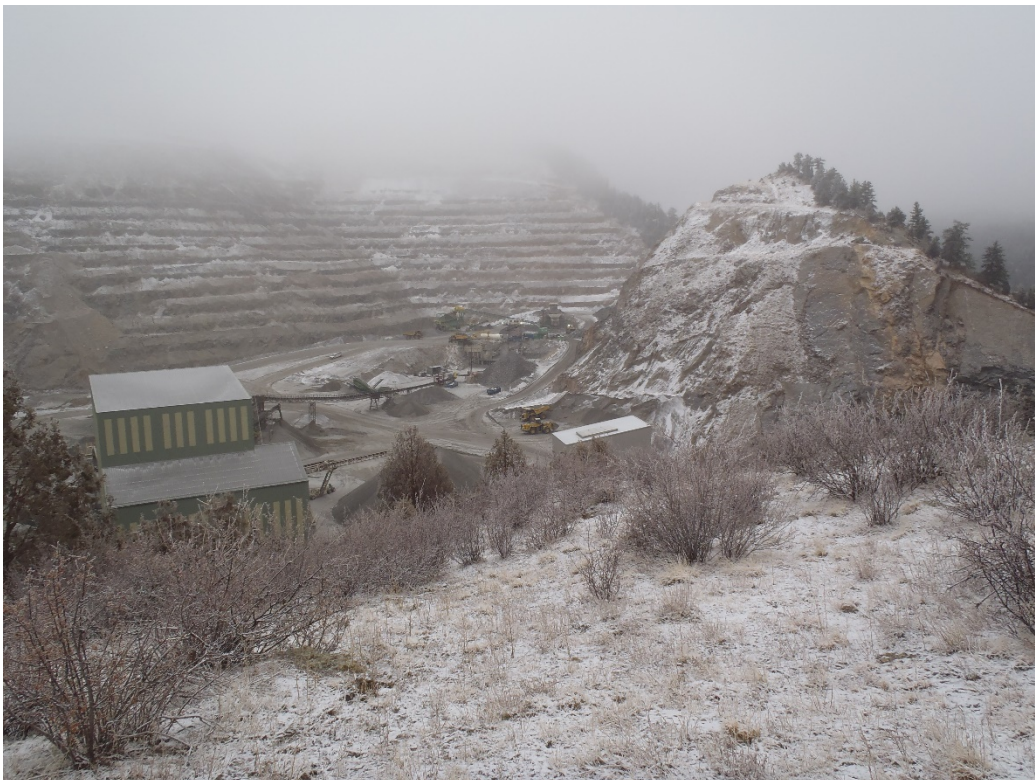
Support Facilities On-site: Several screen plants, enclosed crushers, loaders, and haul trucks were observed (see **Photo 10**).

Photo 10. Support Facilities – screen plants, enclosed crushers, loaders, & haul trucks (looking SE).

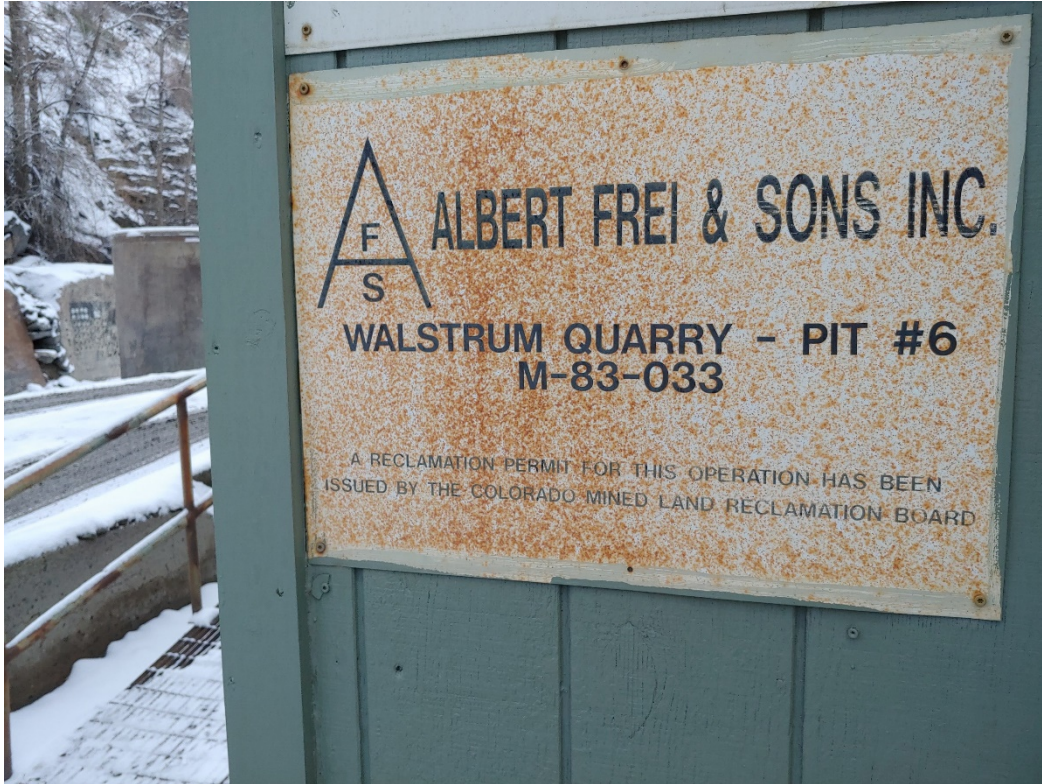
Signs and Markers: The permit sign was properly posted (see **Photo 11**) and boundary markers were observed to delineate the permit boundary (see **Photos 12, 13 and 14**).

Photo 11. Permit sign (at entrance).

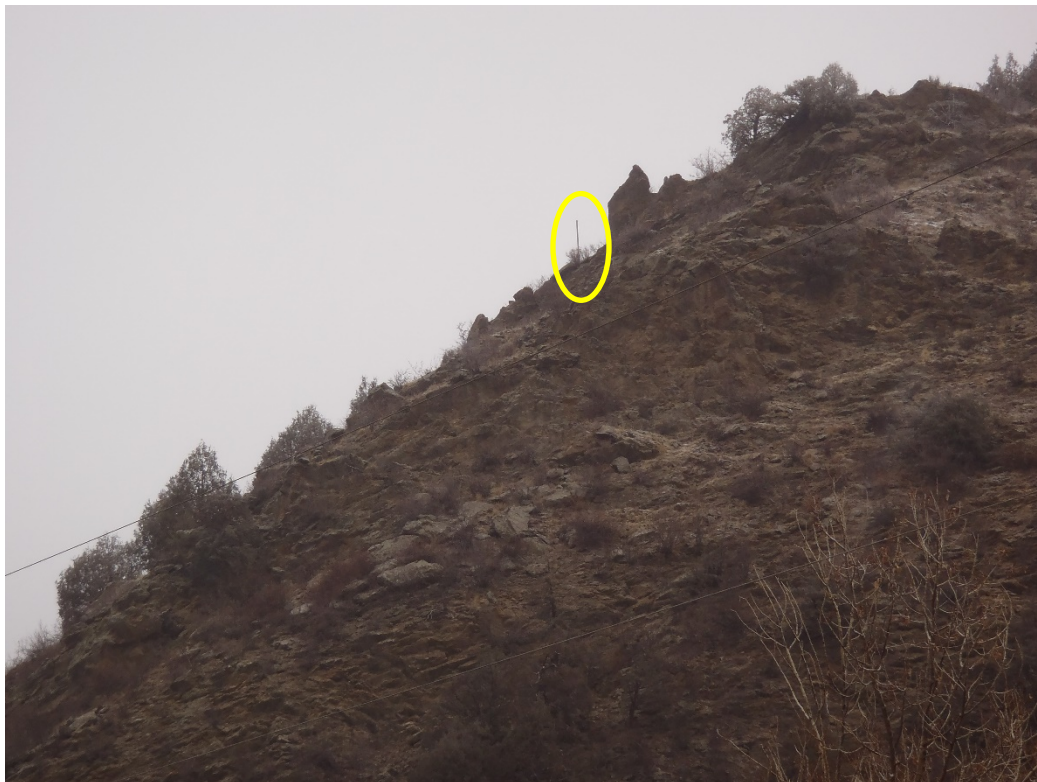
Photo 12. Boundary marker on cliff above mine entrance.

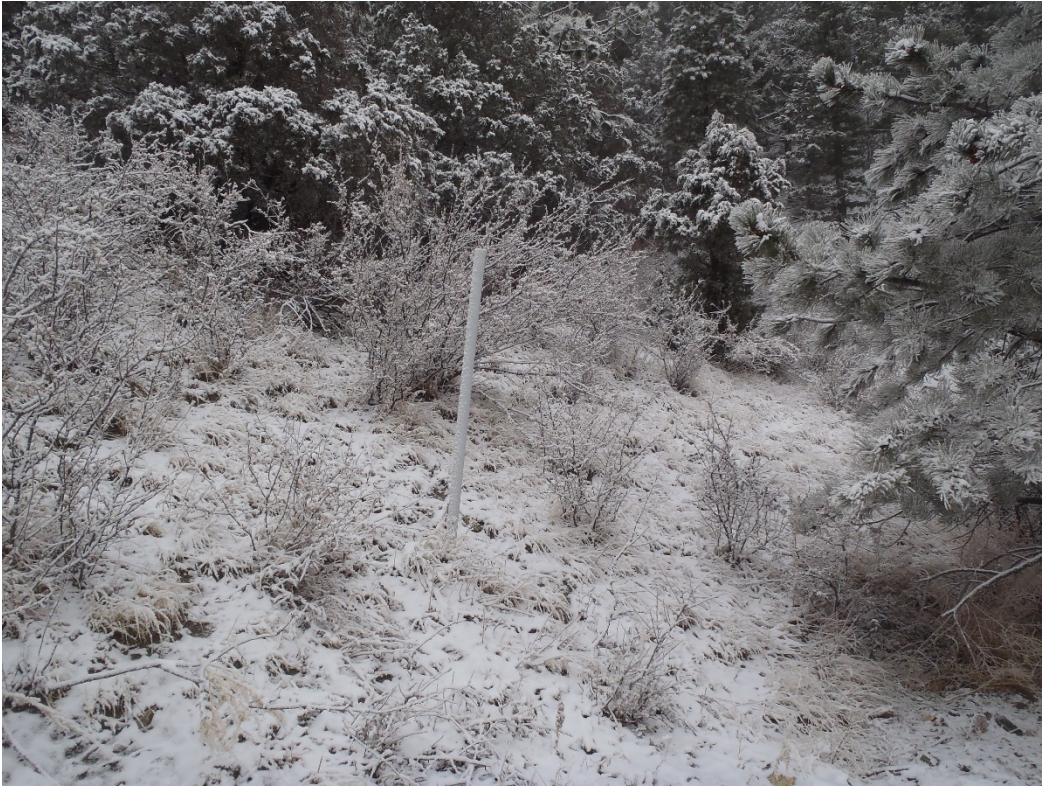
Photo 13. Typical boundary marker above east highwall.

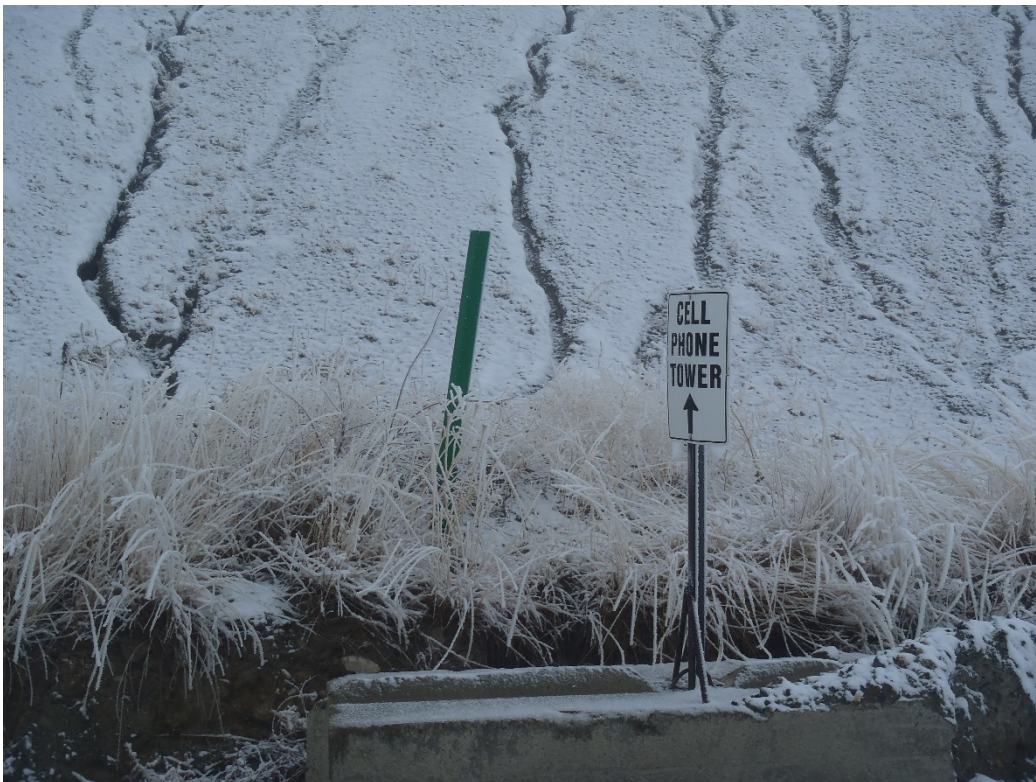
Photo 14. Boundary marker between permitted area and Gilpin County permitted area.
