QUARTERLY SEDIMENTATION POND INSPECTION REPORT

CDMR Rule 4.05.9(17)

Mine: New Elk

QUARTERLY SEDIMENTATION POND INSPECTION REPORT
New Elk Mine- June 19, 2019

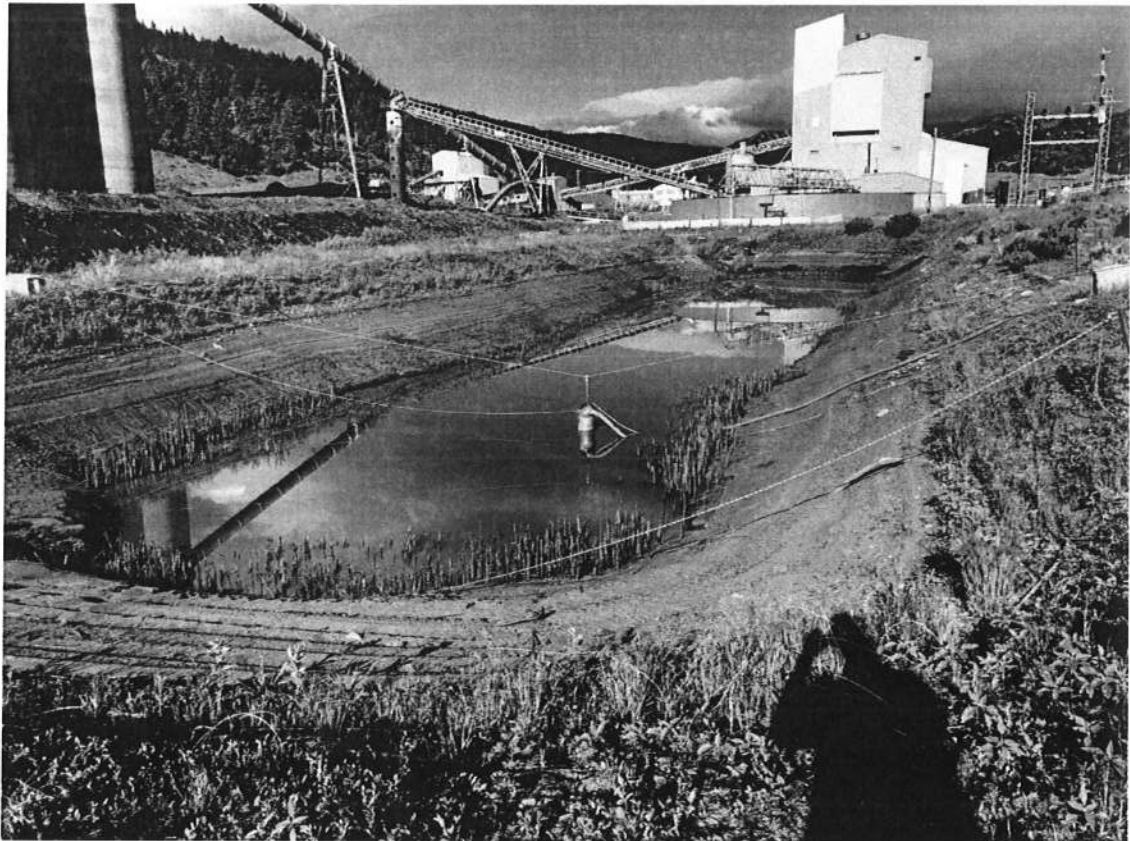
Pond 6

Water level is very low.

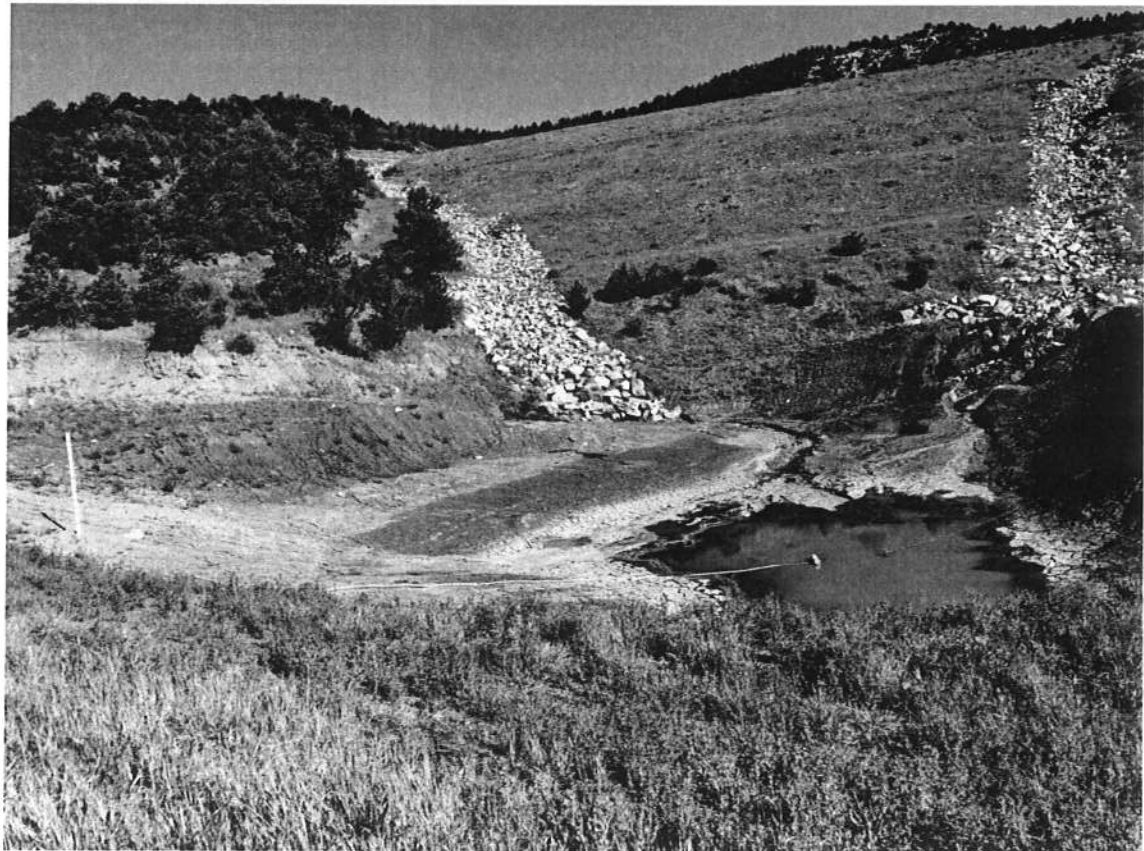
Pond 8

Holding little water, nearly dry. No increase in sediment deposits this quarter.

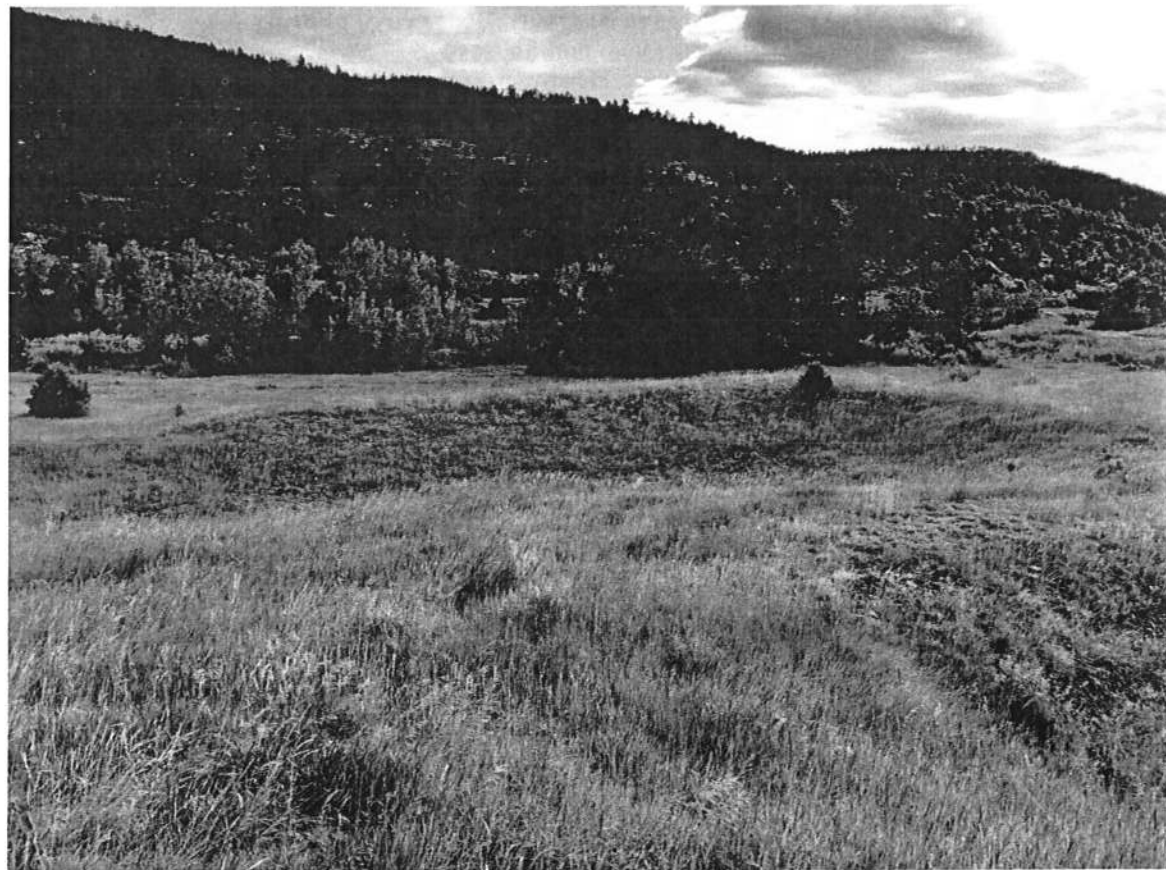
Containment Area #1

Containment area empty at time of inspection.

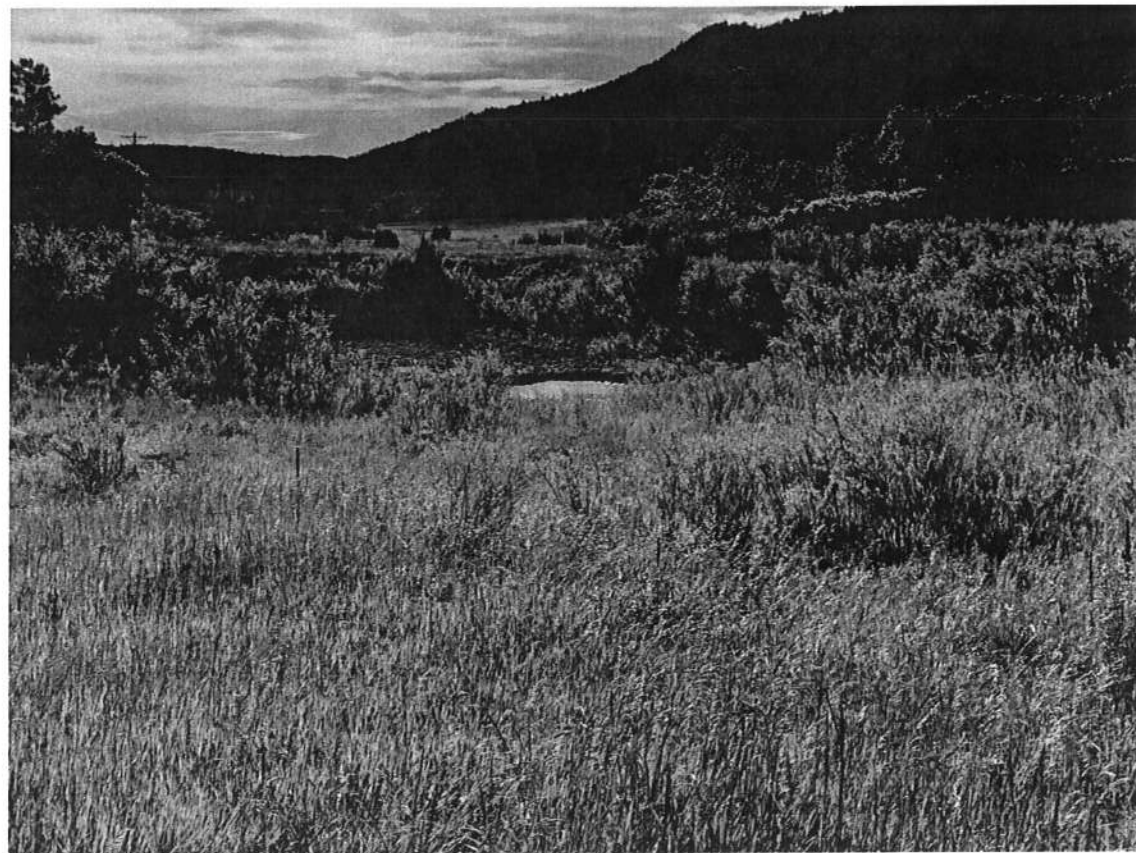
Containment Area #2

Cleaned last year, small amount of water.

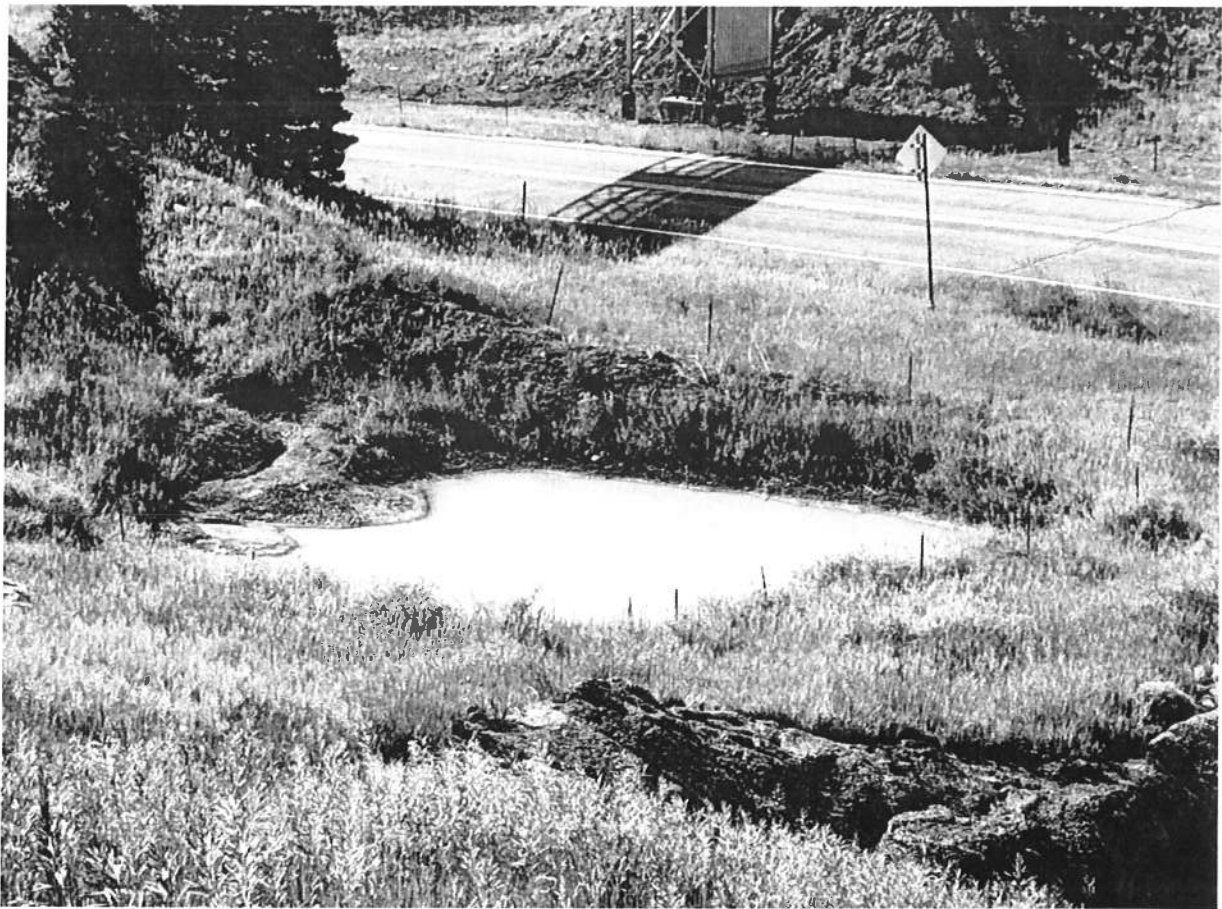
Containment Area RDA North

Containment Area is holding water. Sediment can be removed if conditions allow.

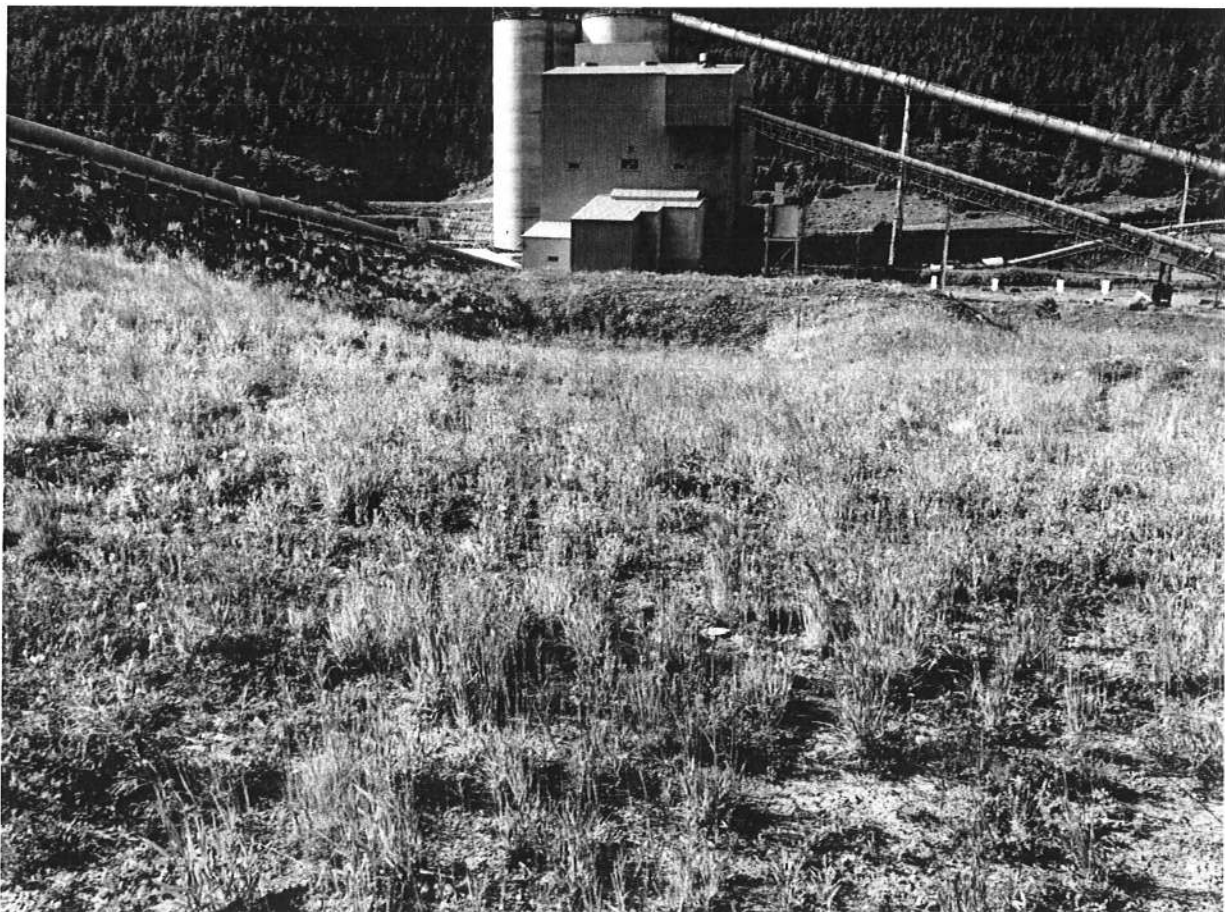
Containment Area RDA SW

Containment Area is empty.
