QUARTERLY SEDIMENTATION POND INSPECTION REPORT

Mine: New Elk

Inspection Period: Third Quarter 2019

QUARTERLY SEDIMENTATION POND INSPECTION REPORT  
New Elk Mine- September 19, 2019

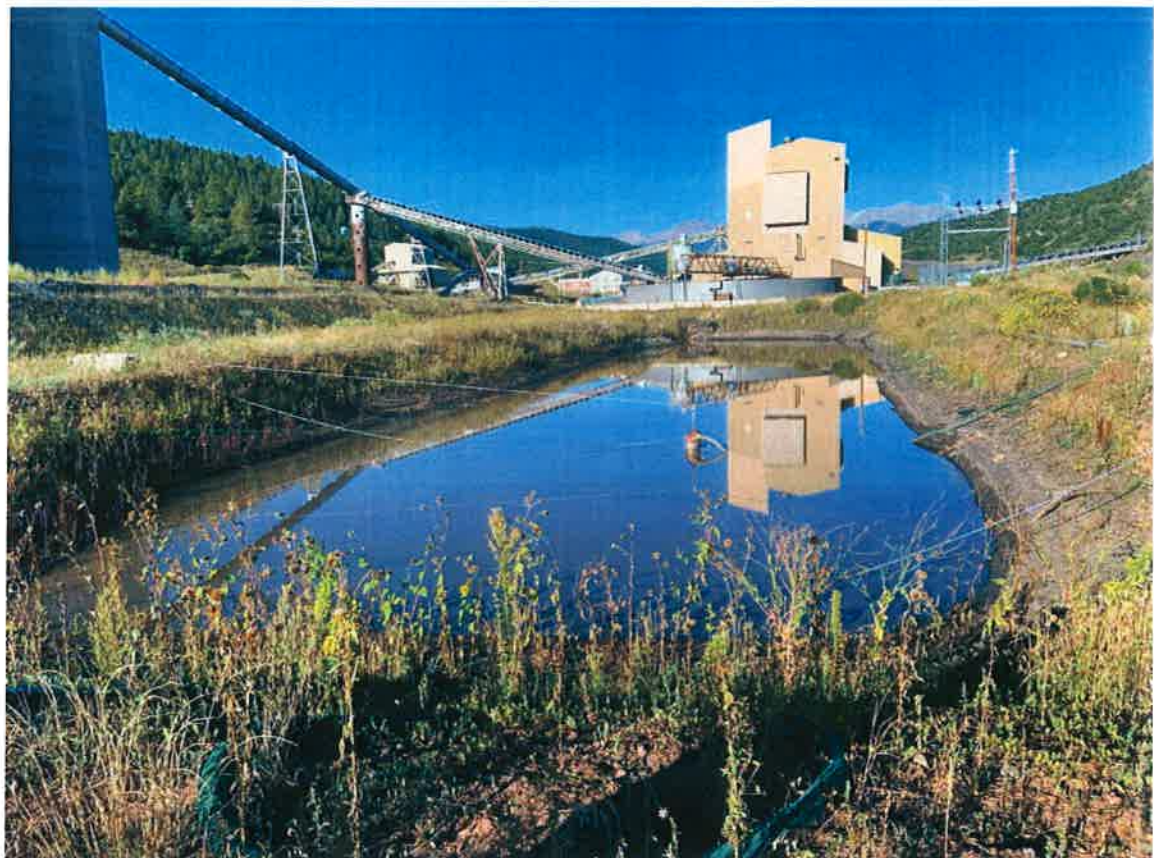
Pond 6

Water level is low, not close to full.

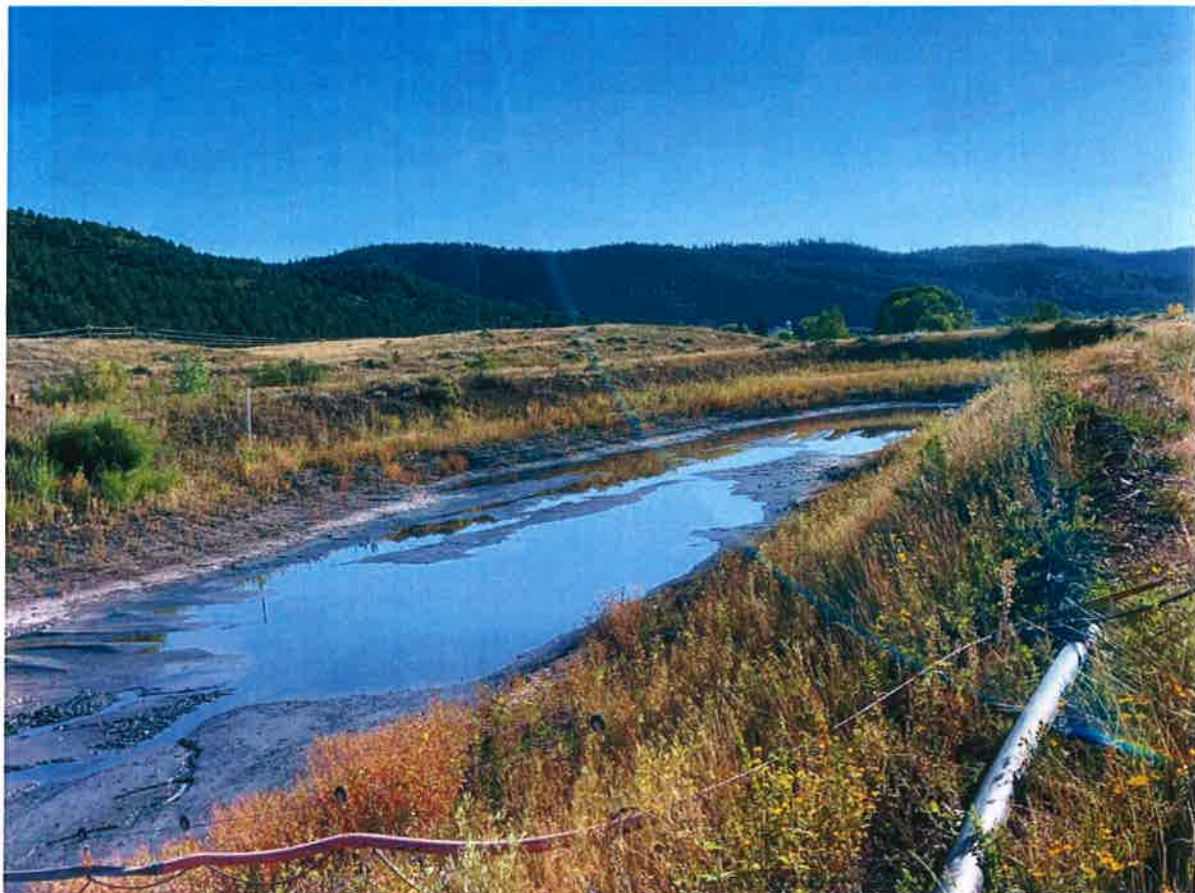
Pond 7

Pond is holding a small amount of water, almost dry.

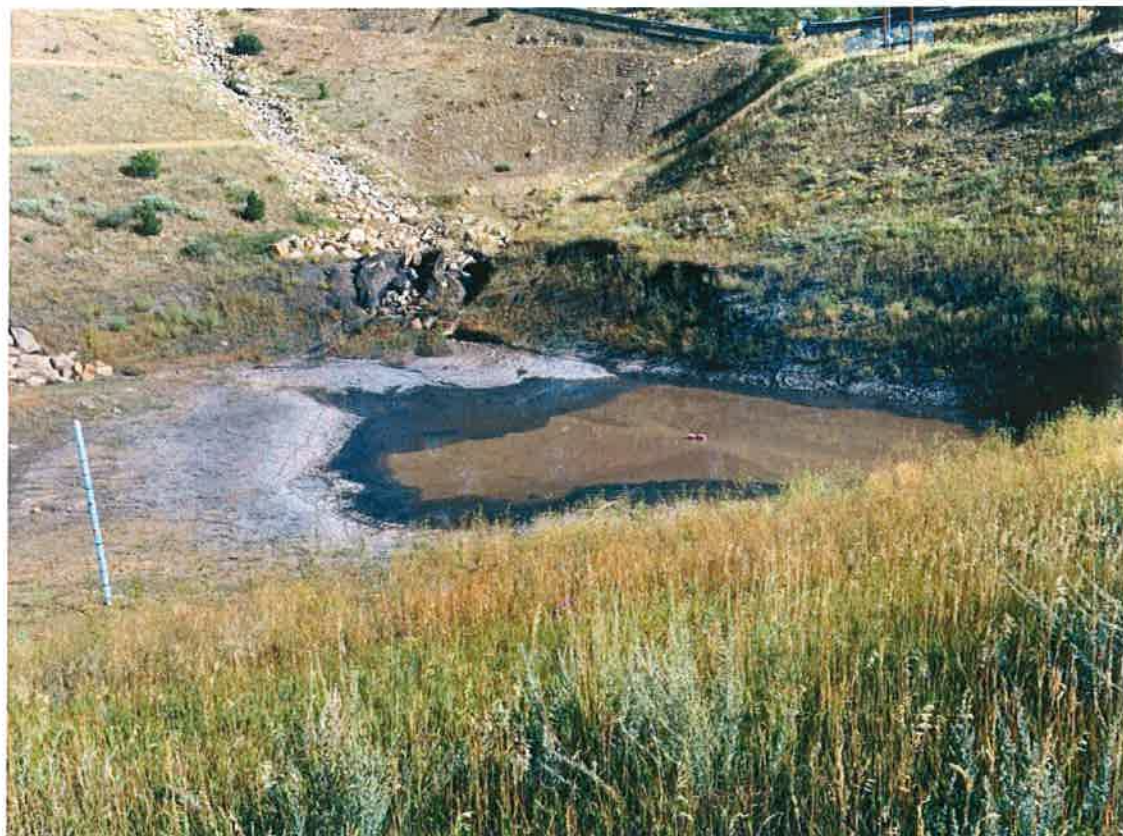
Pond 8

Pond is holding little water. Sediment currently in pond is leftover sediment from recent cleaning.

No new sediment has been deposited.

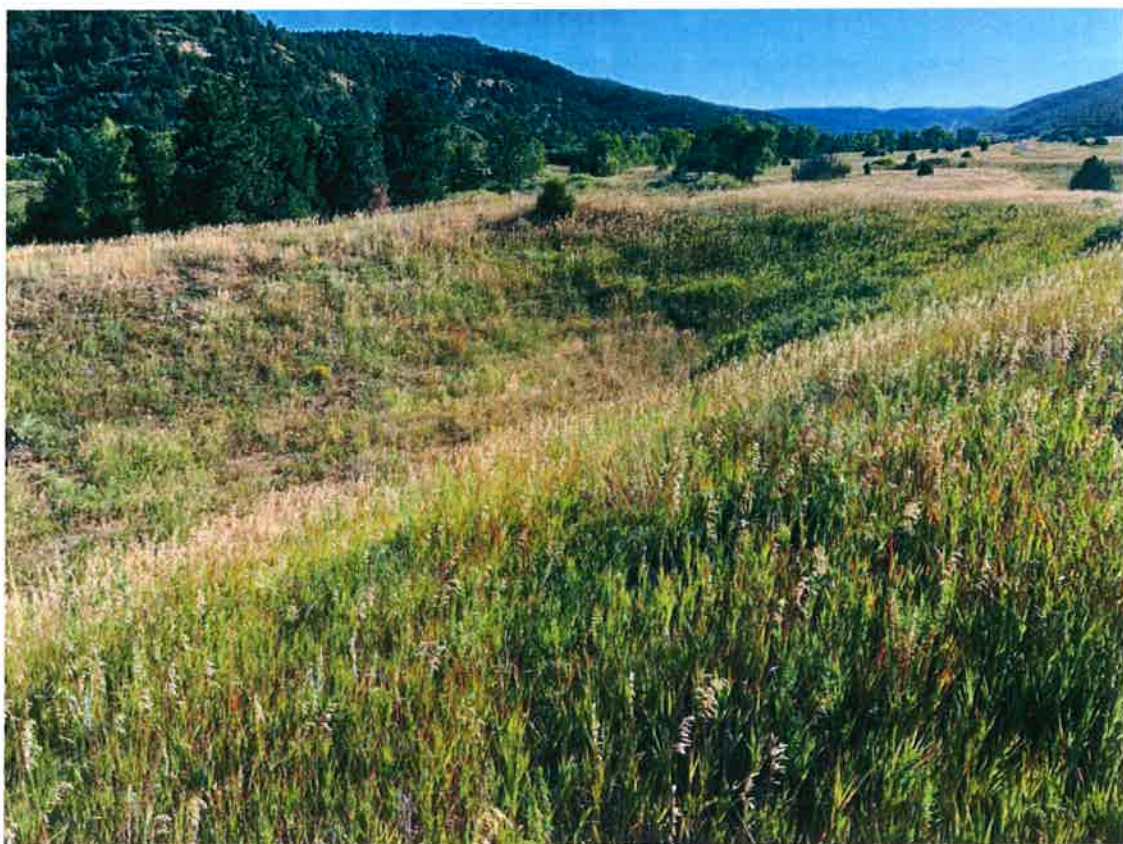
Containment Area #1

Containment area empty with no sediment at time of inspection.

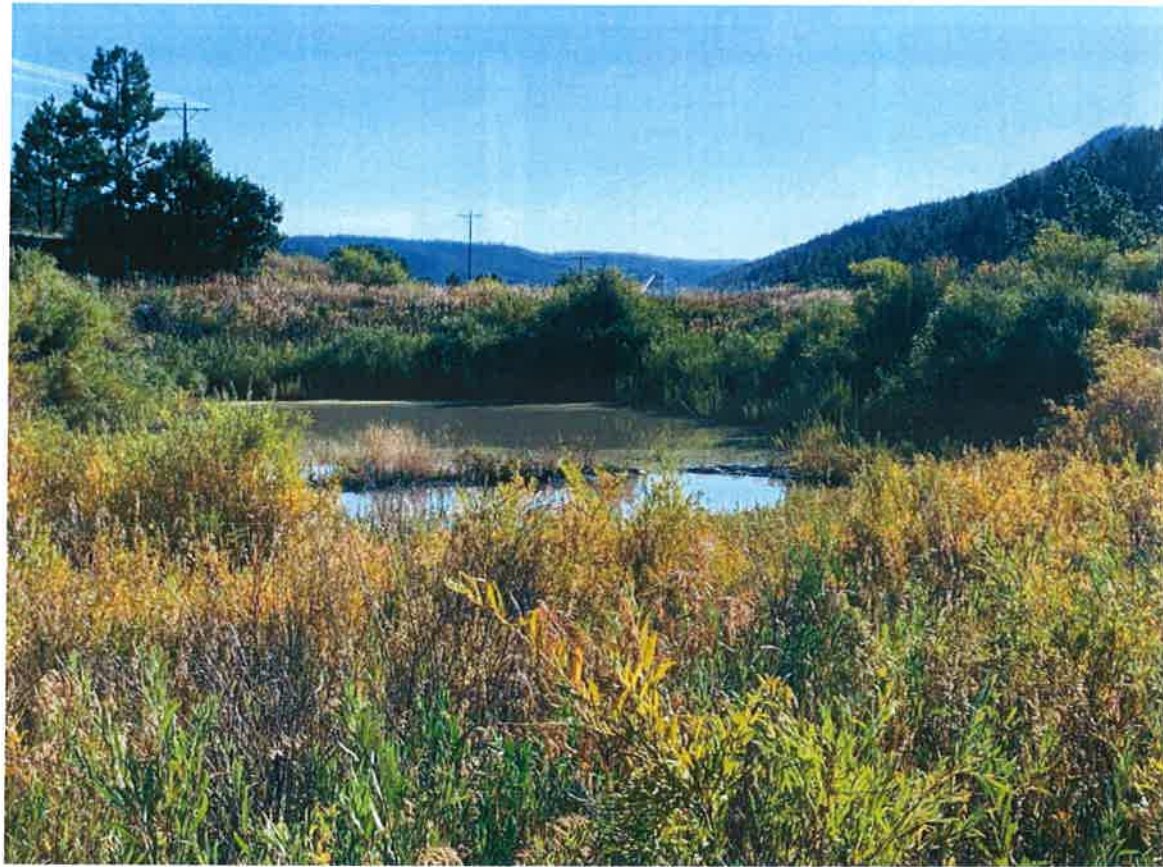
Containment Area #2

Cleaned last year, small amount of water in containment.

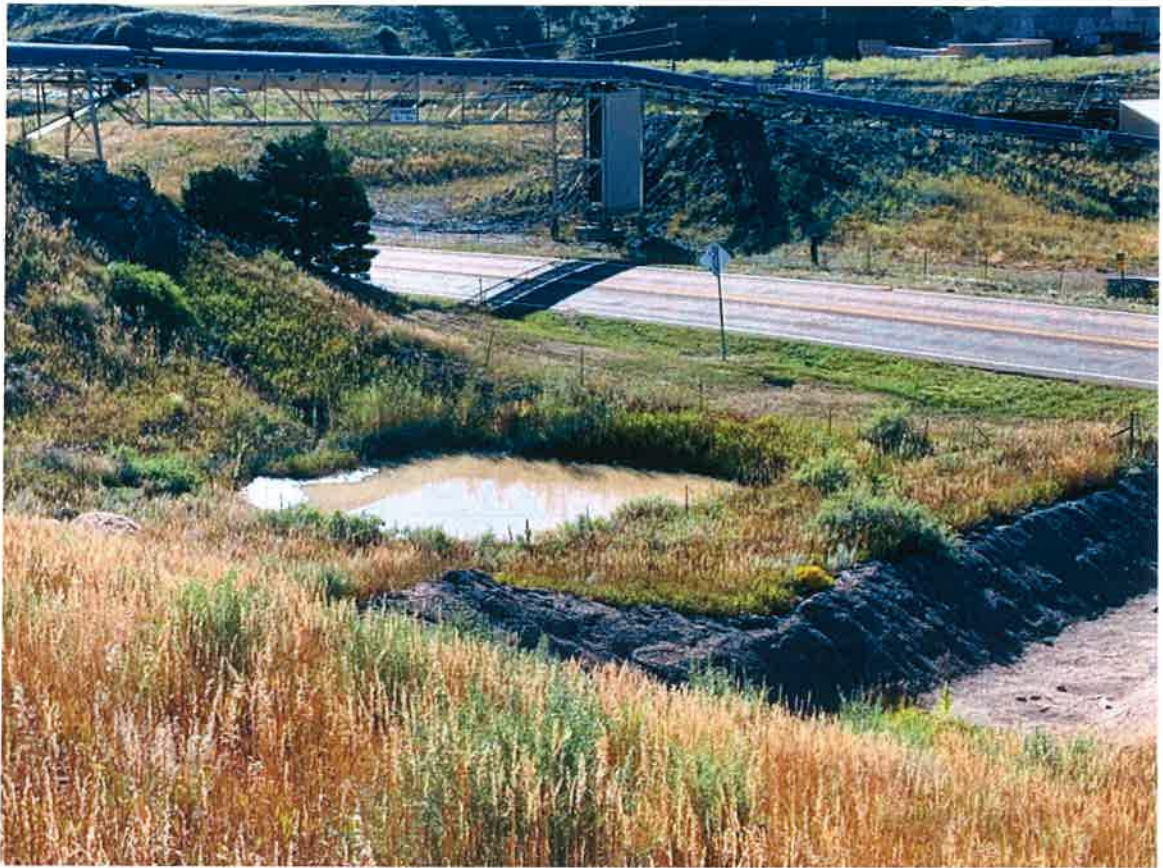
Containment Area RDA North

Containment Area is holding water. Sediment will be cleaned from pond within 6 months.

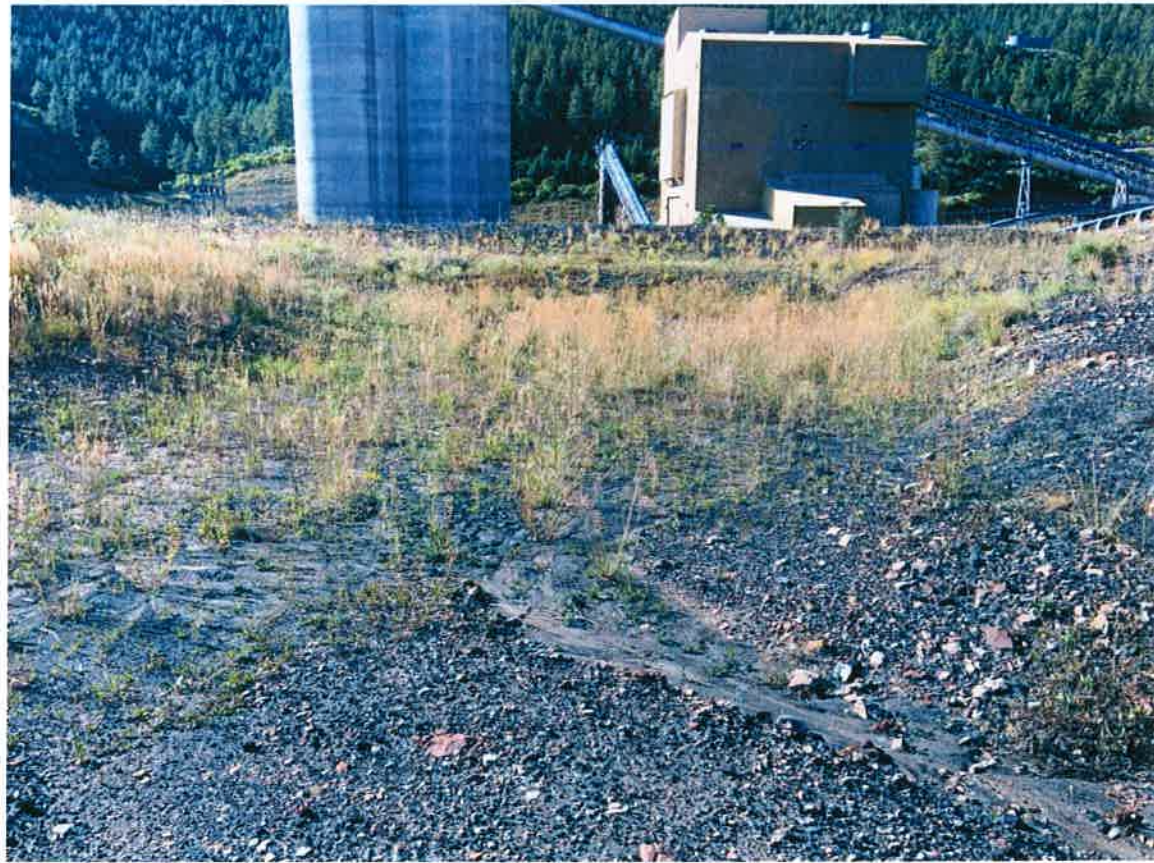
Pond RDA Southeast

Containment Area is dry.

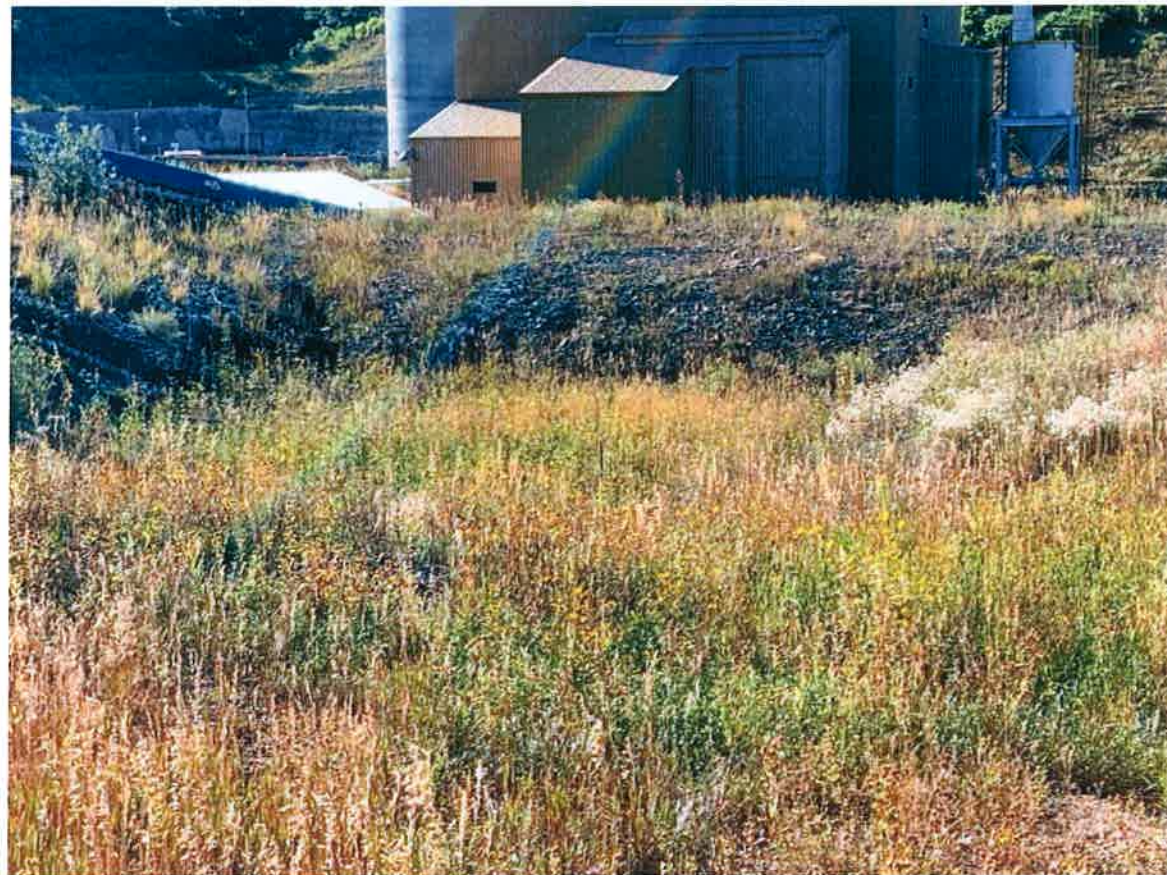
Containment Area RDA Southwest

Containment Area is dry.
