QUARTERLY SEDIMENTATION POND INSPECTION REPORT

Mine: New Elk

Inspection Period: Fourth Quarter 2019

QUARTERLY SEDIMENTATION POND INSPECTION REPORT
New Elk Mine- November 26, 2019

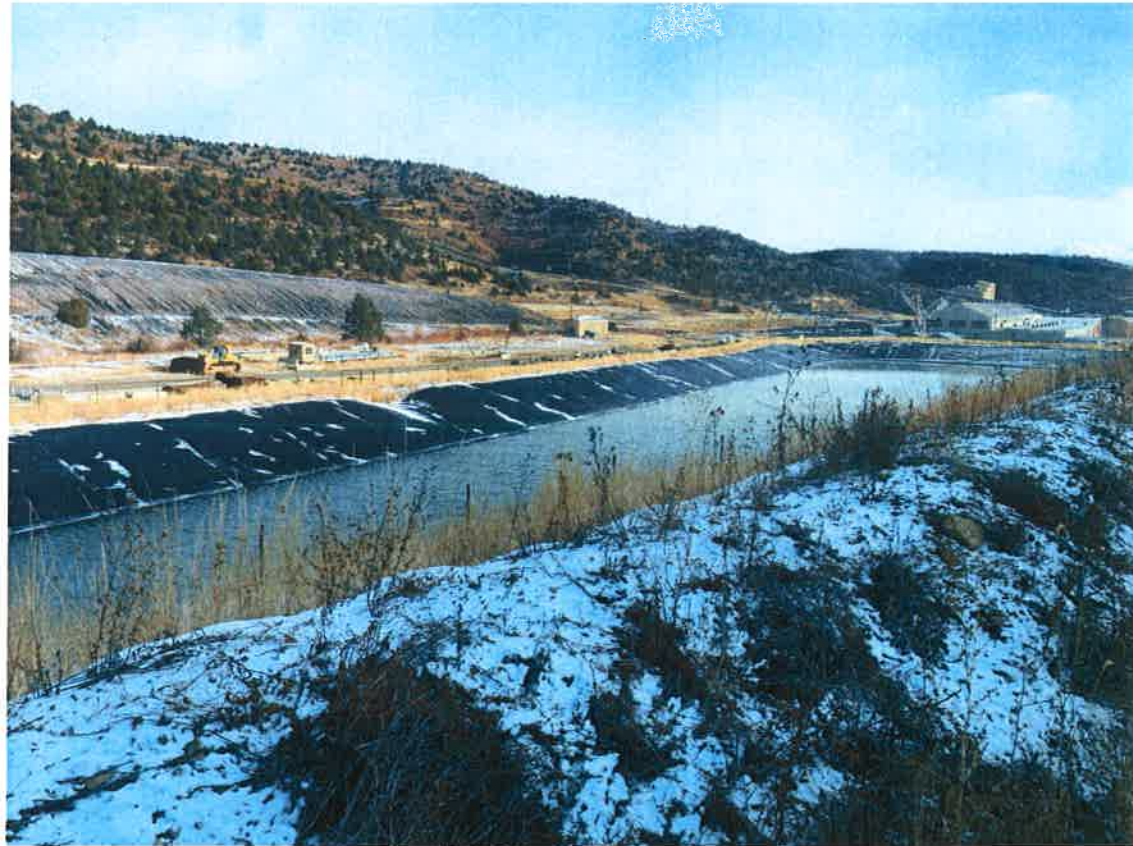
Pond 1 – Looking East

Pond liner is in good working condition at time of inspection.

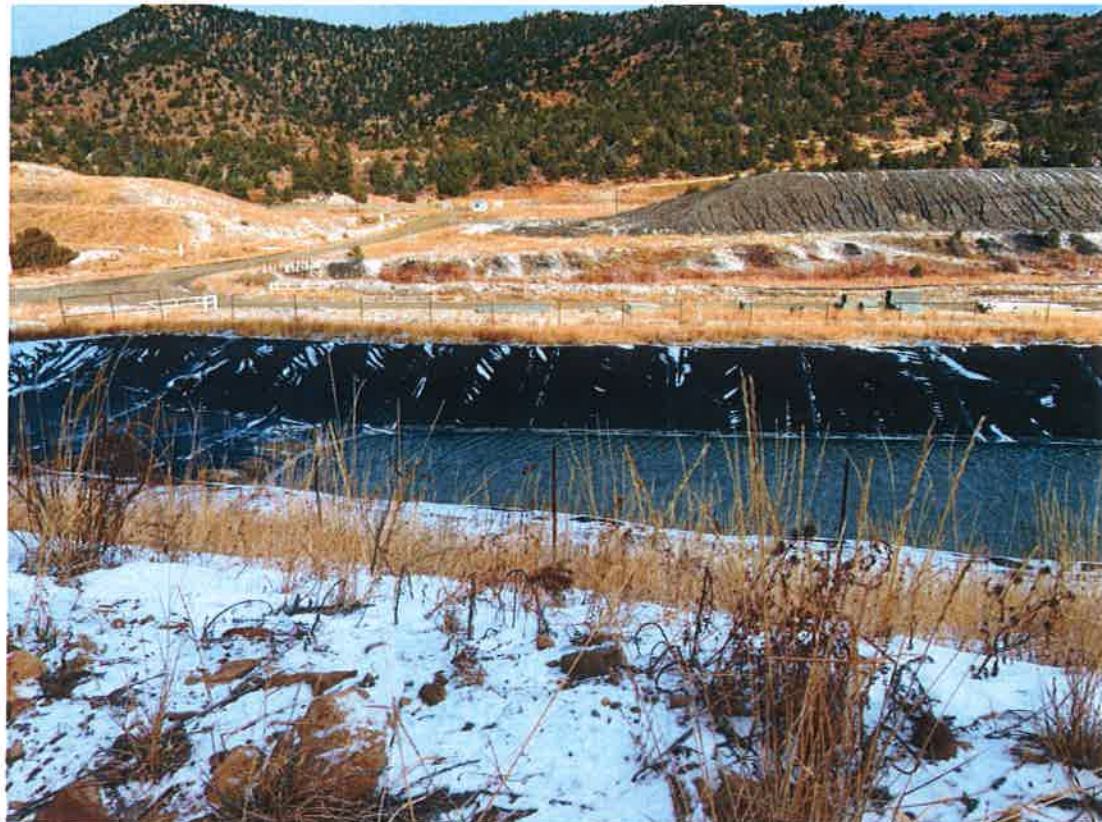
Pond 1 – Looking North at Discharge

1. Is the principal spillway system in working order?	Yes	<div>X</div>	No	
2. Is the inlet free of debris and restrictive material?	Yes	<div>X</div>	No	
3. Is the discharge outlet free of restrictive material?	Yes	<div>X</div>	No	
4. Is erosion occurring at the discharge outlet?	Yes		No	<div>X</div>
Evaluate the severity:	Extensive	Moderate	Just Starting	<div>None</div>

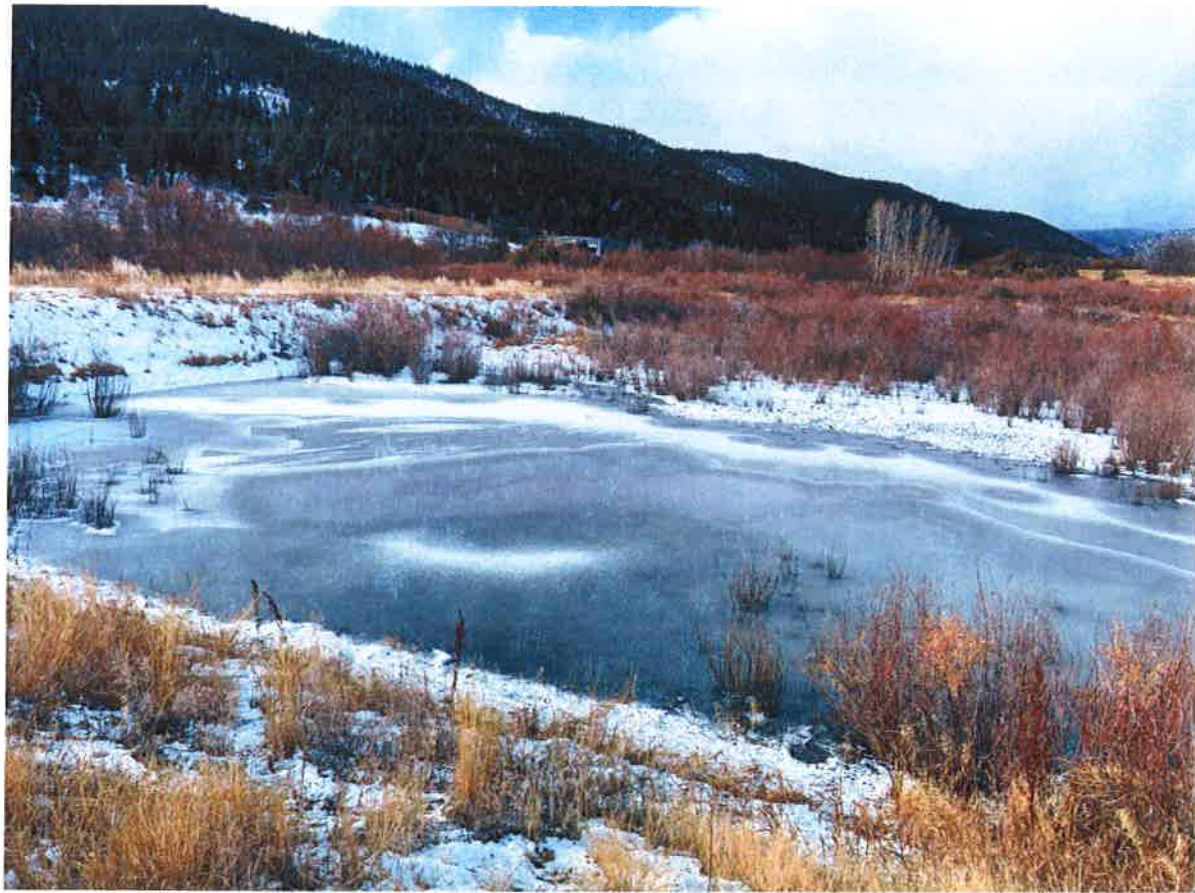
Pond 4

Pond is holding water but is not close to discharging.

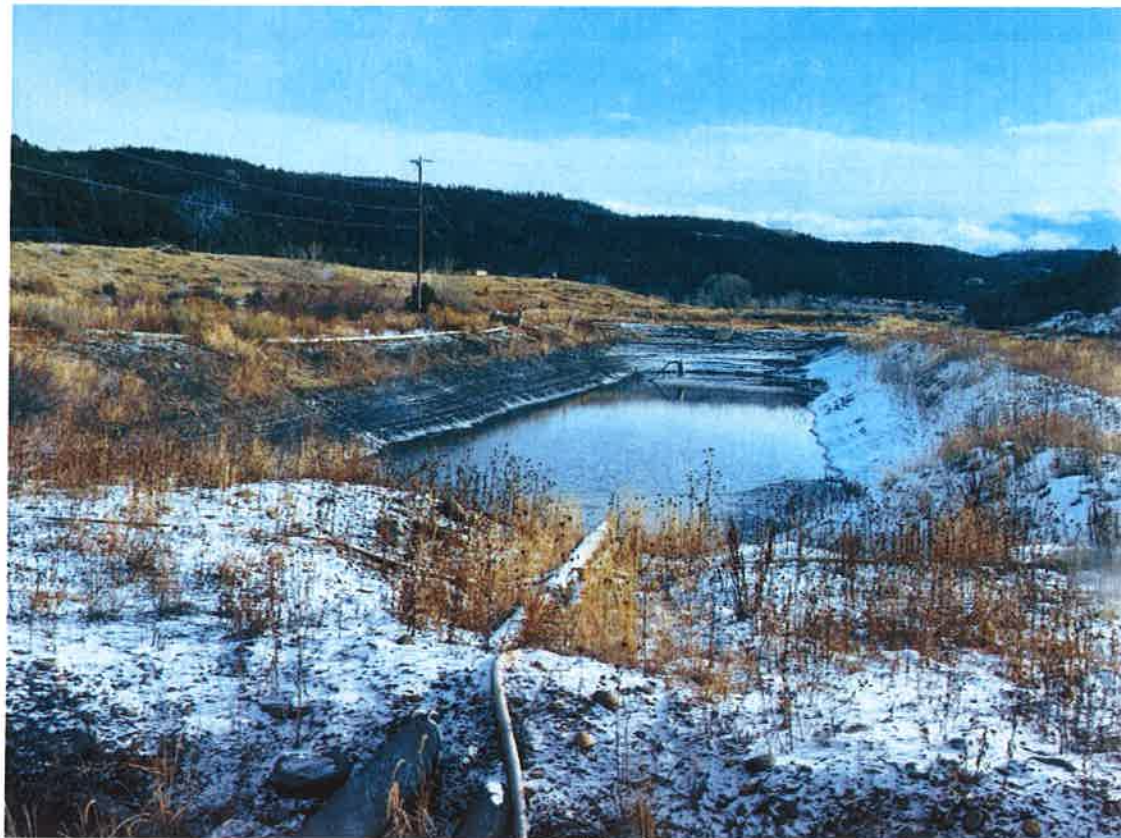
Pond 6

Water level is low, not close to full.

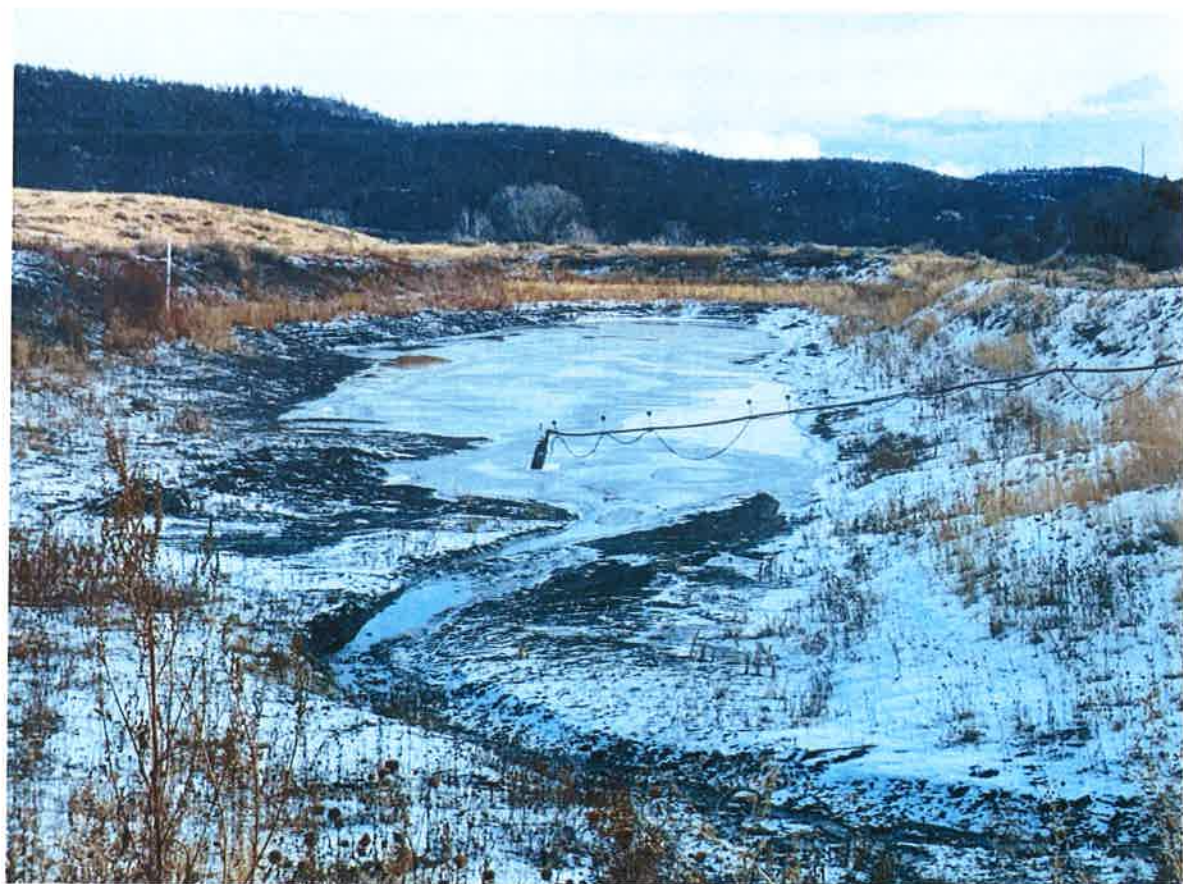
Pond 7

Pond is holding a foot of water, not near the max water level.

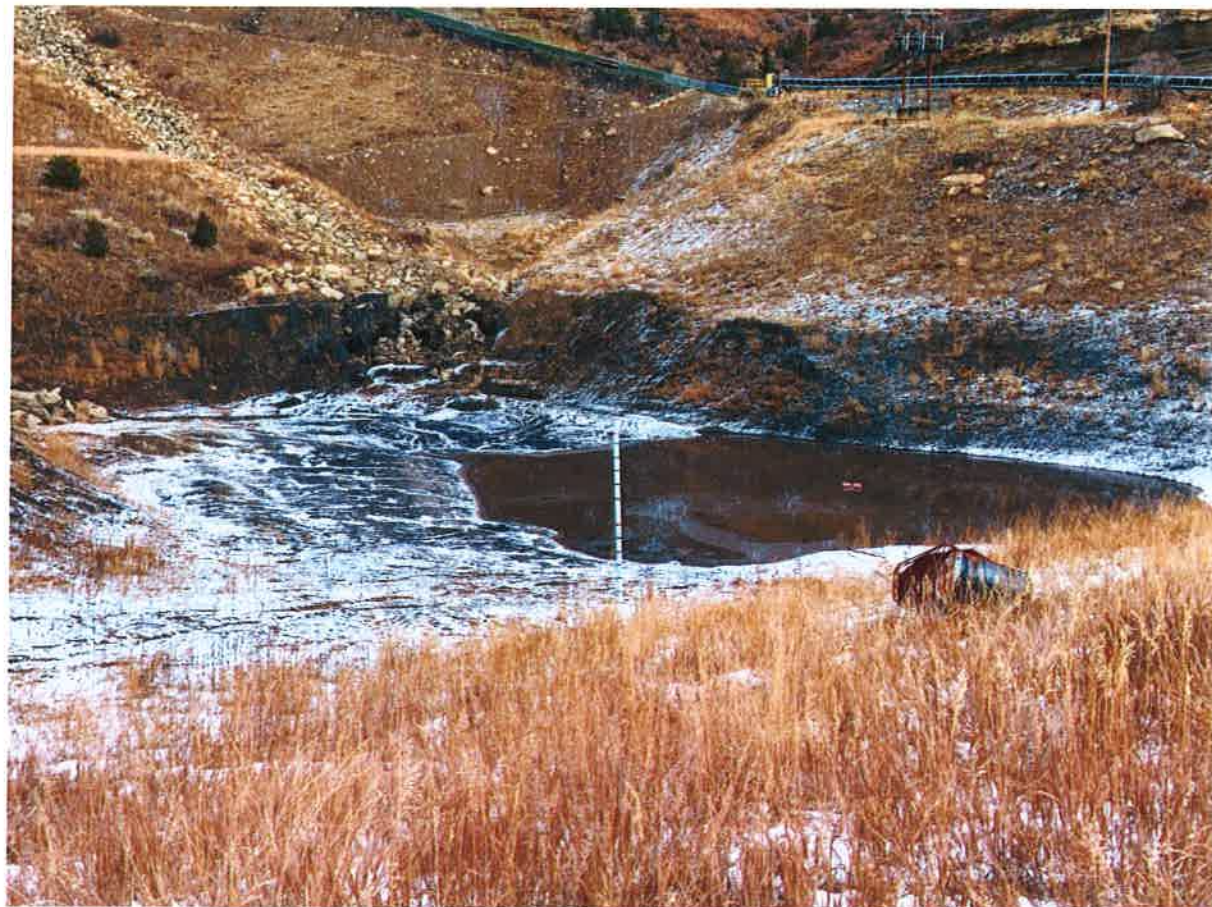
Pond 8

Pond is holding water, not near the decant level. No new sediment has been deposited.

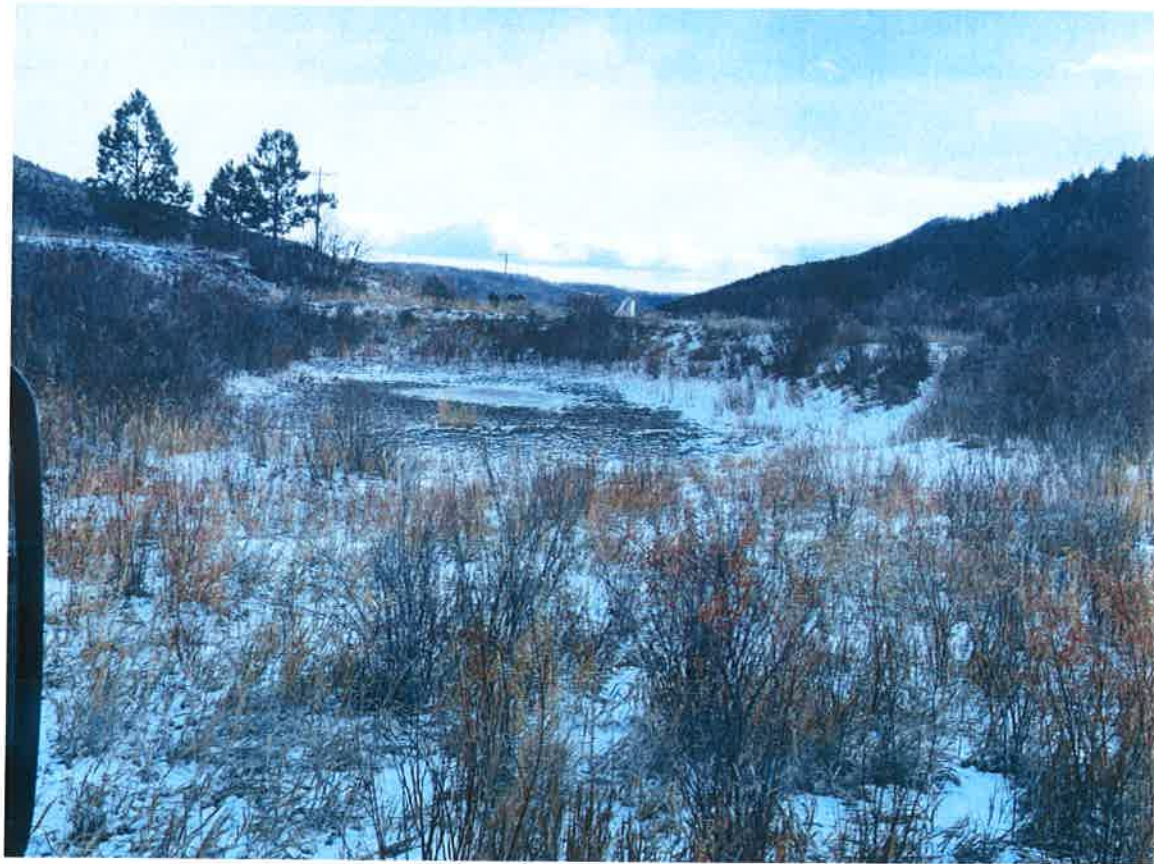
Containment Area #2

Cleaned last year, no water in containment.

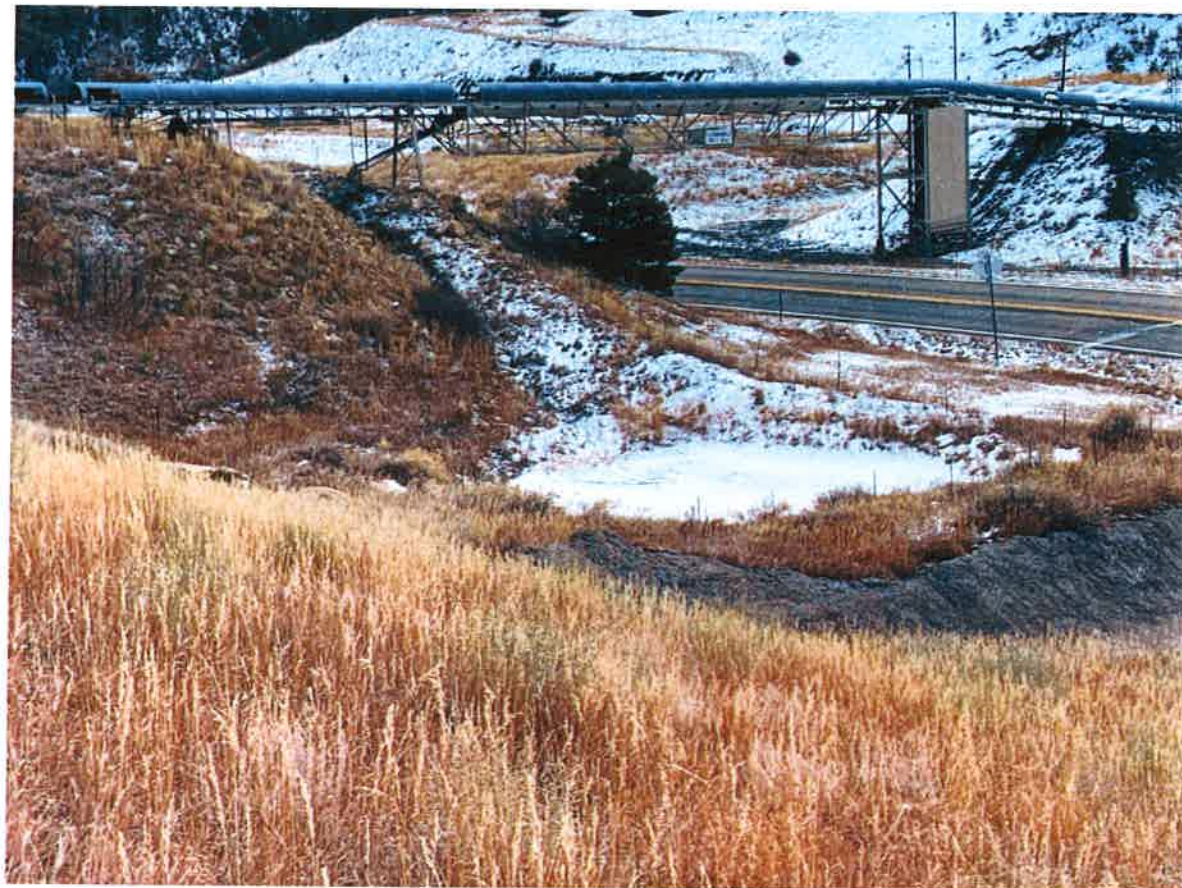
Containment Area RDA North

Containment Area is empty. Sediment will be cleaned from containment within 6 months.

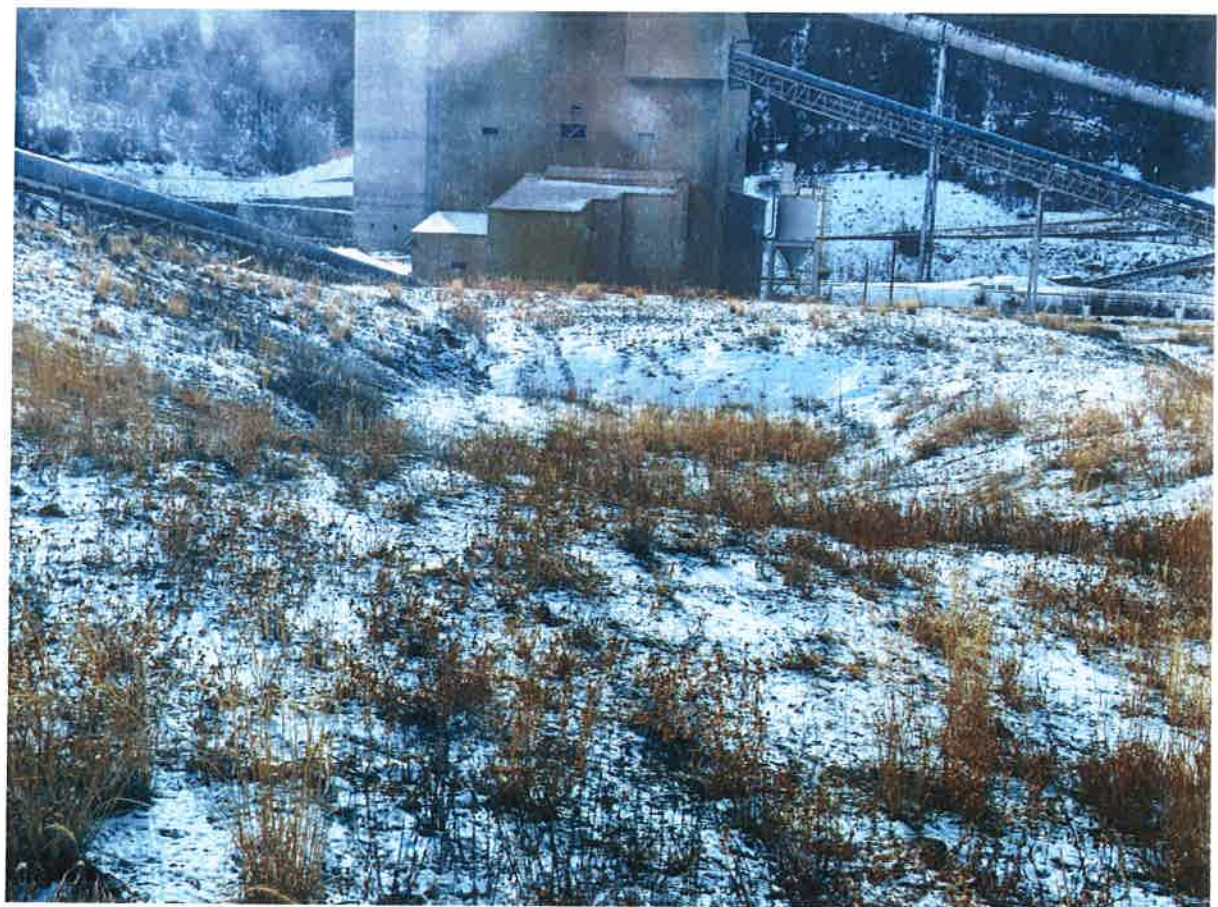
Containment Area RDA Southwest

Containment Area is dry.
