**LORENCITO CANYON MINE**  
**Permit No. C-1996-084**

**INSPECTION OF EXCESS SPOIL-FILLS 7, 8, & 9**  
**June 12, 2018**

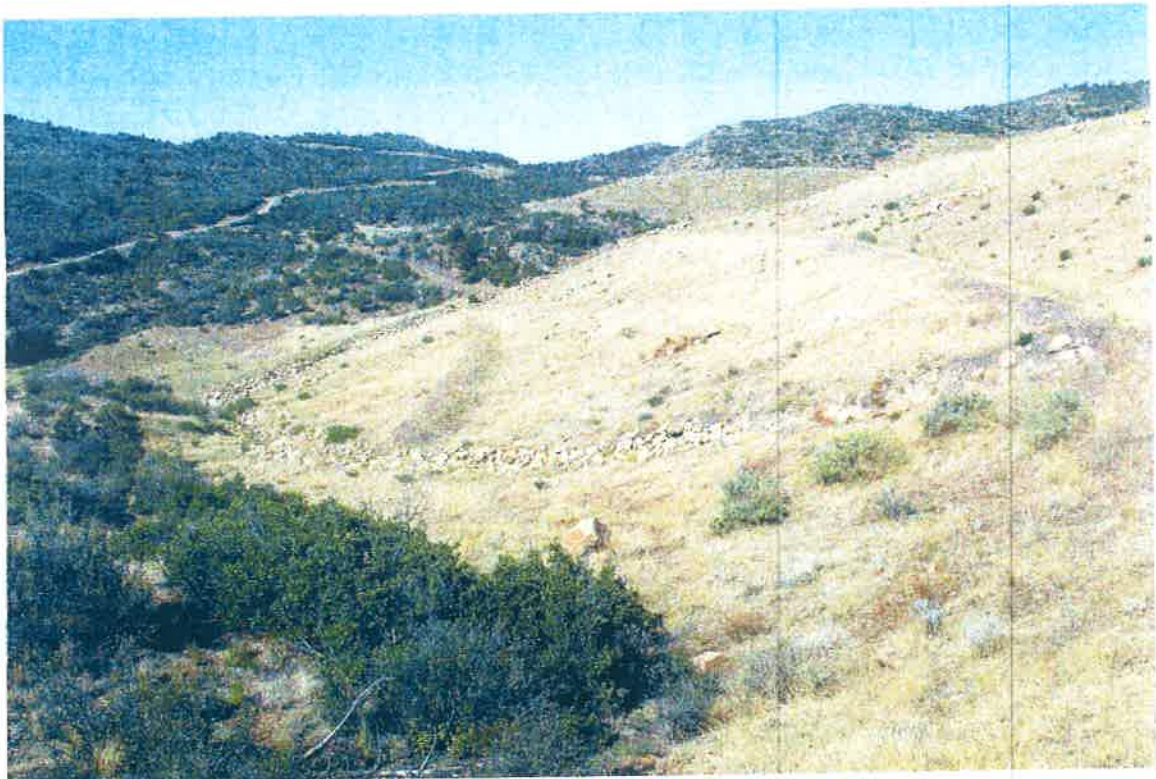
The entire excess spoil fill facility was examined for signs of failure and instability such as tension cracks, ground movement, springs and seeps, and standing water. No indication of potential instability was observed.

Dry late spring conditions prevail. Overall the site remains in good condition

1 LCM Fill 7 Lower Benches Looking West

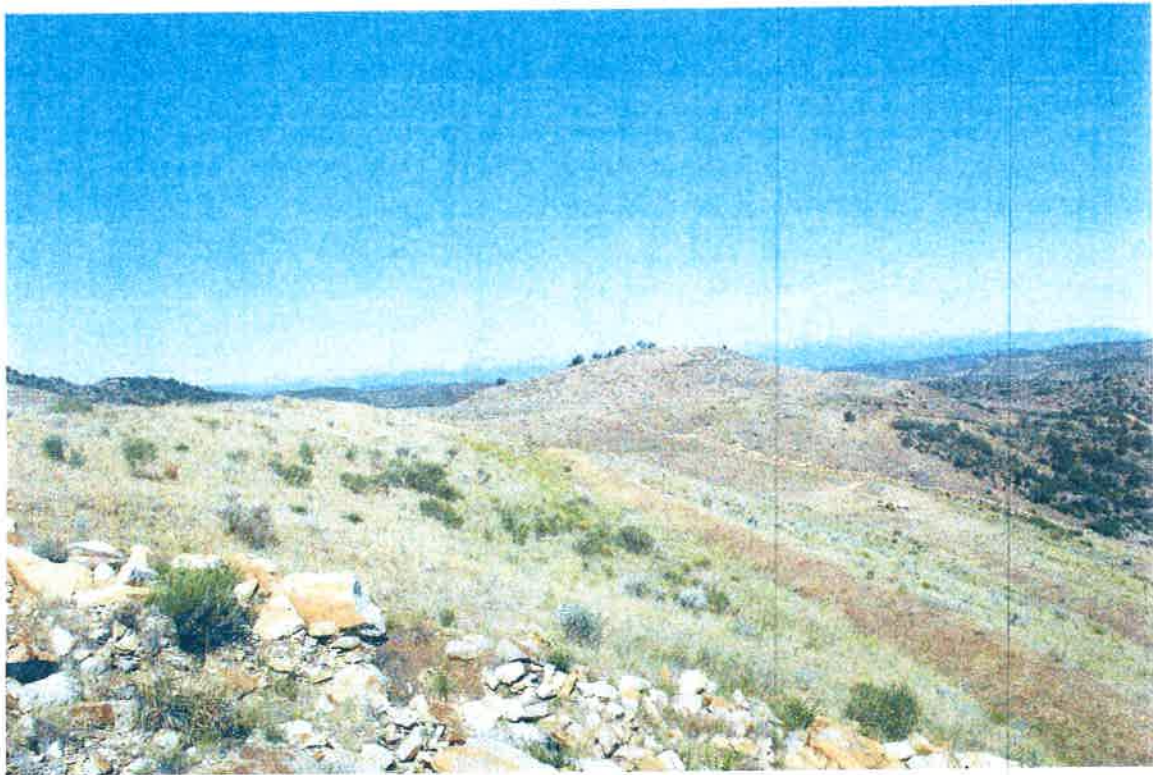
The excess spoil fill facility was examined for signs of failure and instability such as tension cracks, ground movement, springs and seeps, and standing water. No indications of potential instability or adverse conditions were observed during this inspection.

Overall, the site is in good condition with some minor rills found on the reclaimed slopes. Late spring conditions still prevail. With hot dry conditions over the past 7-10 days, soil condition was dry. Cool season grasses remain green due to the northern aspect of the site.

2 LCM Fill 8 Upper Bench Viewing West

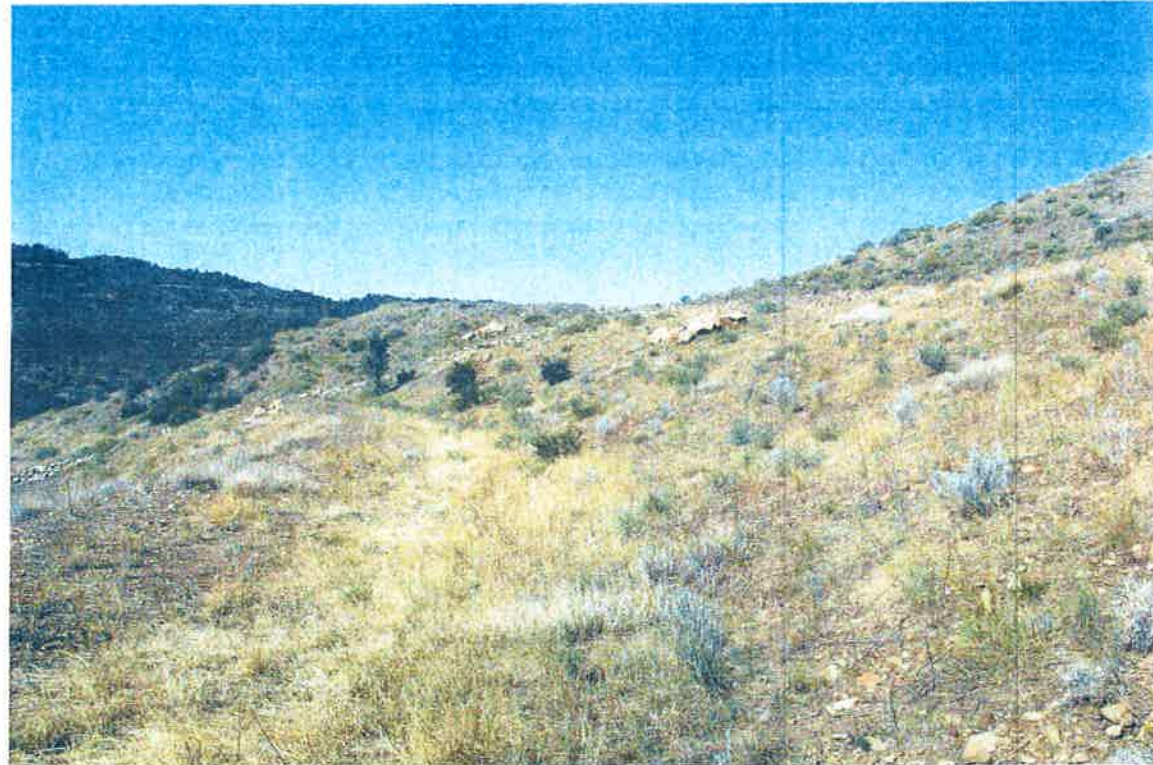
The entire excess spoil fill facility was examined for signs of failure and instability such as tension cracks, ground movement, springs and seeps, and standing water. No indication of potential instability was observed during this inspection.

Late spring conditions prevail with cool season grasses returning to dormancy due to extreme dry conditions, and warm season grasses remain dormant. Overall, site is in good condition.

3 LCM Fill 9 Upper Benches Viewing West
