LORENCITO CANYON MINE
Permit No. C-1996-084

INSPECTION OF EXCESS SPOIL-FILLS 7, 8, & 9
March 29, 2019

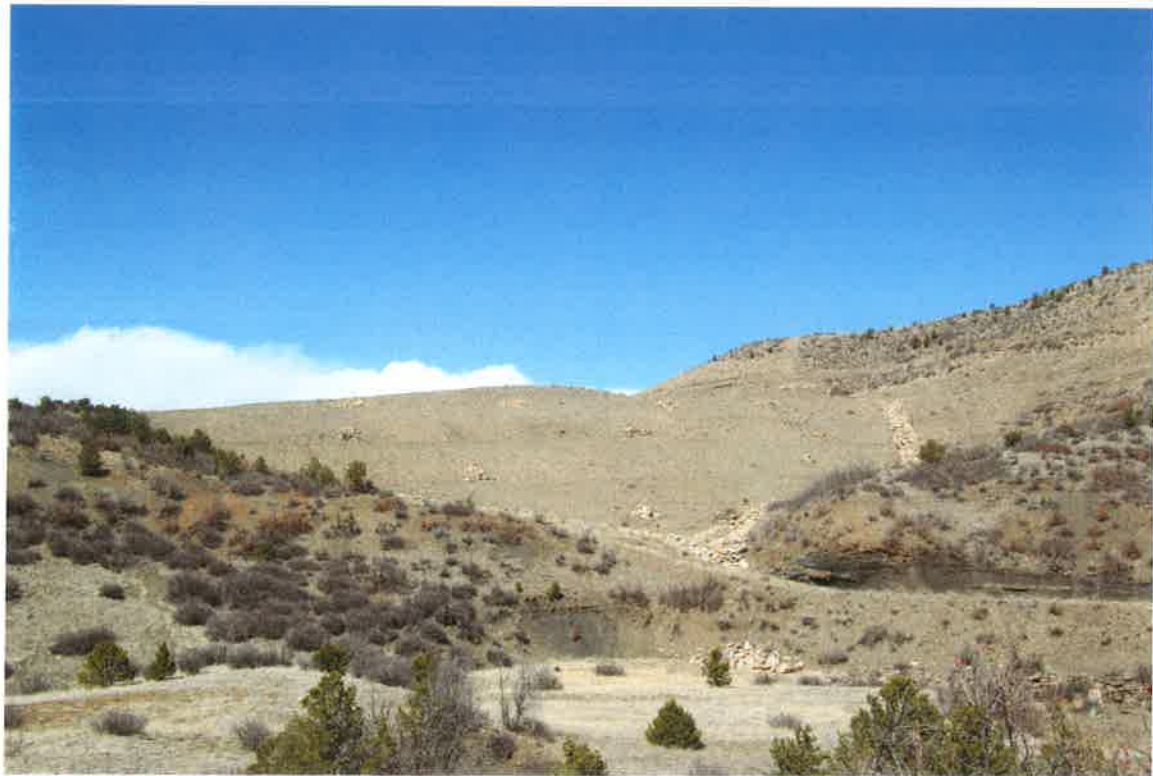
The entire excess spoil fill facility was examined for signs of failure and instability such as tension cracks, ground movement, springs and seeps, and standing water. No indication of potential instability was observed.

Fill #7 – South Facing Embankments with East Armored Down Drain Visible

Early spring conditions prevail with most areas dry but with good soil moisture. Overall the site is in good condition

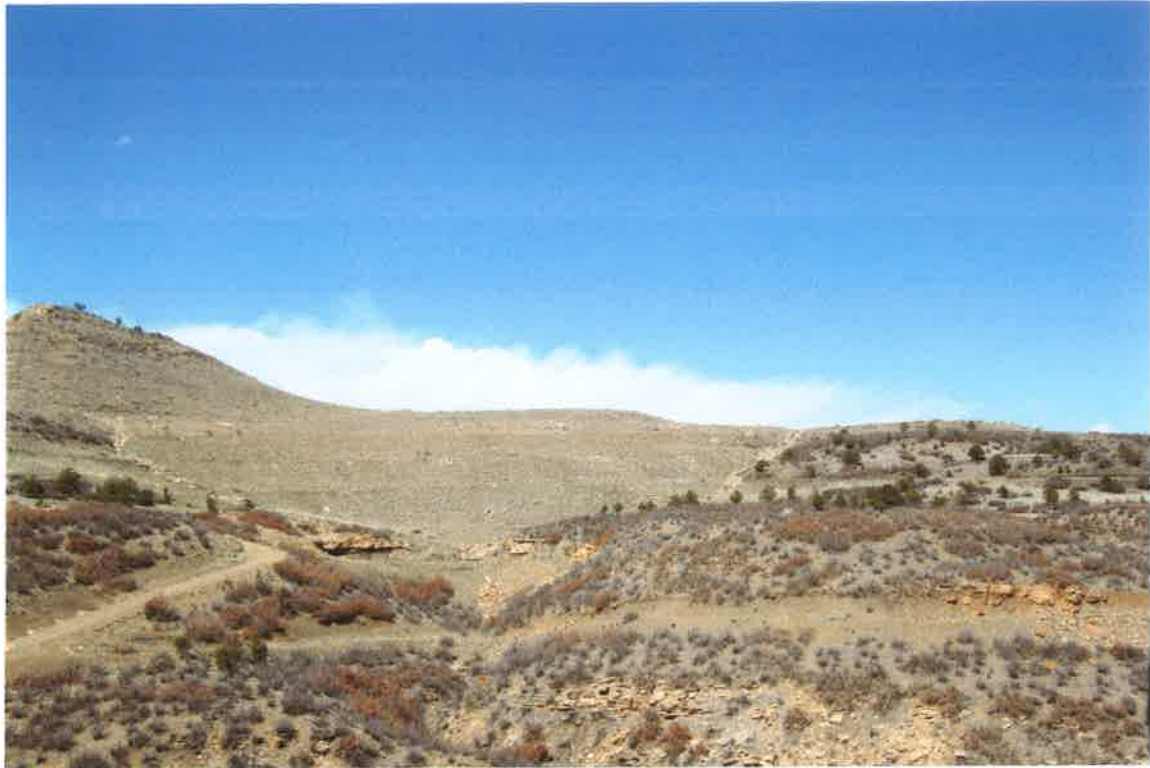
The entire excess spoil fill facility was examined for signs of failure and instability such as tension cracks, ground movement, springs and seeps, and standing water. No indication of potential instability was observed during this inspection.

Fill 9 South Facing -Taken from Adjacent Ranch Road

Early spring conditions prevail with vegetation still dormant. Overall, site is in good condition.
