**LORENCITO CANYON MINE**  
**Permit No. C-1996-084**

**INSPECTION OF EXCESS SPOIL-FILLS 7, 8, & 9**  
**June 19, 2019**

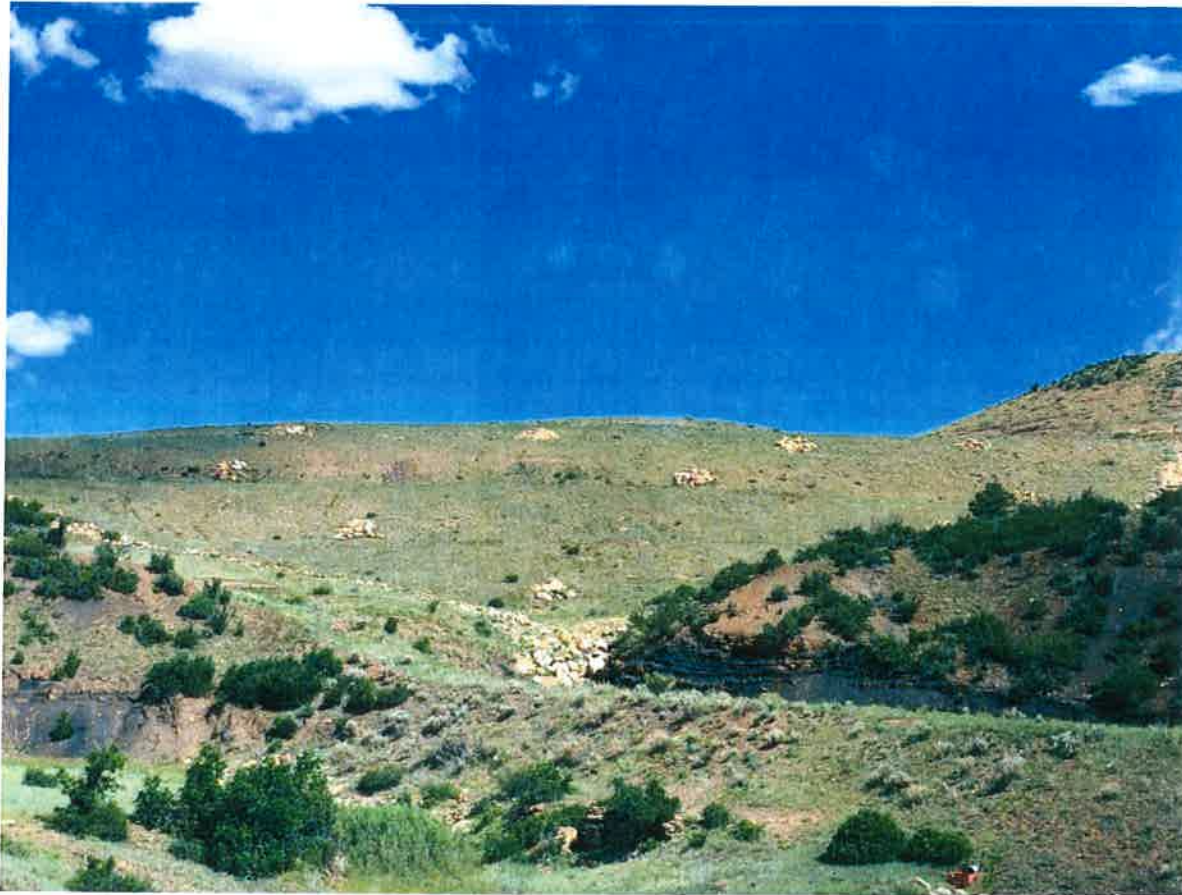
The entire excess spoil fill facility was examined for signs of failure and instability such as tension cracks, ground movement, springs and seeps, and standing water. There was no indication of potential instability at time of inspection.

Summer conditions are evident with an abundant of green vegetation and seem to be doing very well do to the spring moisture. Overall the site is in good condition.

**Fill #7- South Facing Embankments**

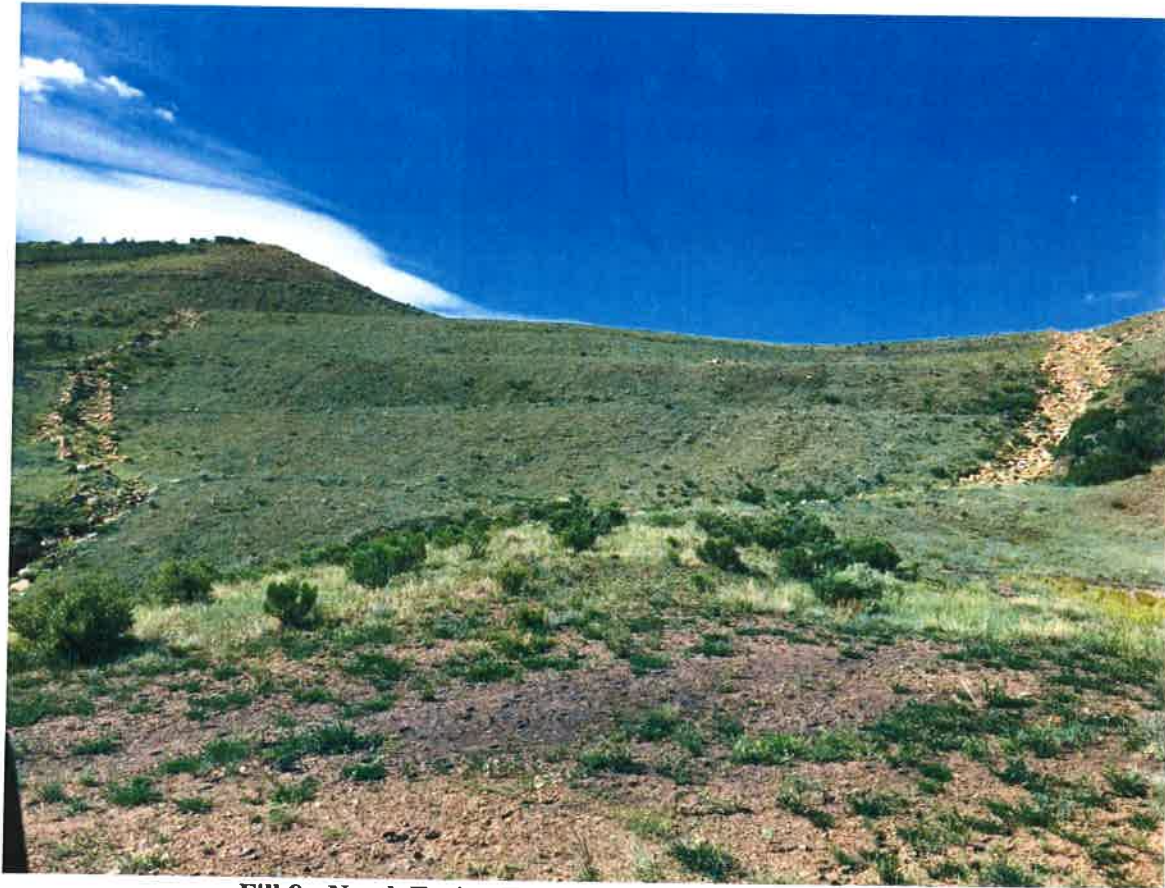
The entire excess spoil fill facility was examined for signs of failure and instability such as tension cracks, ground movement, springs and seeps, and standing water. There was no indication of potential instability at time of inspection.

Summer conditions are evident with an abundant of green vegetation and seem to be doing very well do to the spring moisture. Overall the site is in good condition.

**Fill 8 - North Facing Embankments with Down Drains Visible**

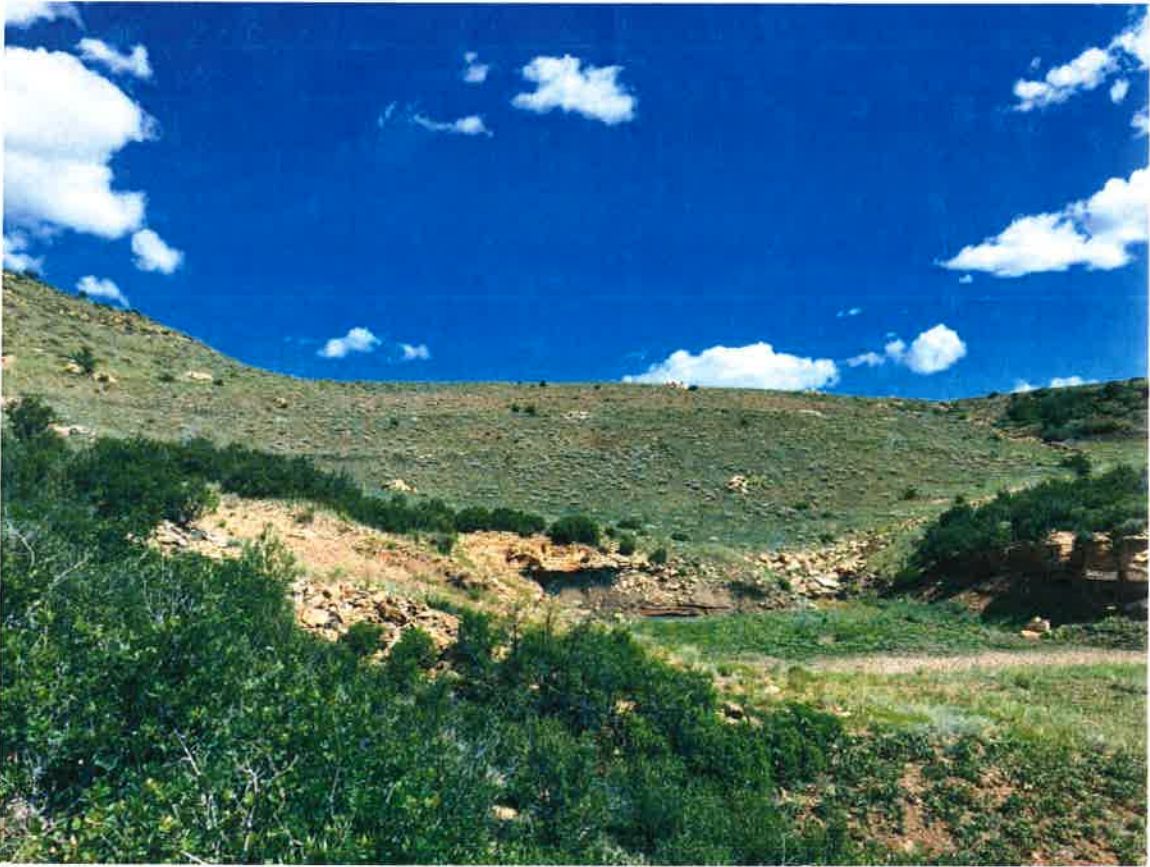
The entire excess spoil fill facility was examined for signs of failure and instability such as tension cracks, ground movement, springs and seeps, and standing water. There was no indication of potential instability at time of inspection.

Summer conditions are evident with an abundant of green vegetation and seem to be doing very well do to the spring moisture. Overall the site is in good condition.

Fill 9 – South Facing Embankments
