**LORENCITO CANYON MINE**  
**Permit No. C-1996-084**

**INSPECTION OF EXCESS SPOIL-FILLS 7, 8, & 9**  
**September 19, 2019**

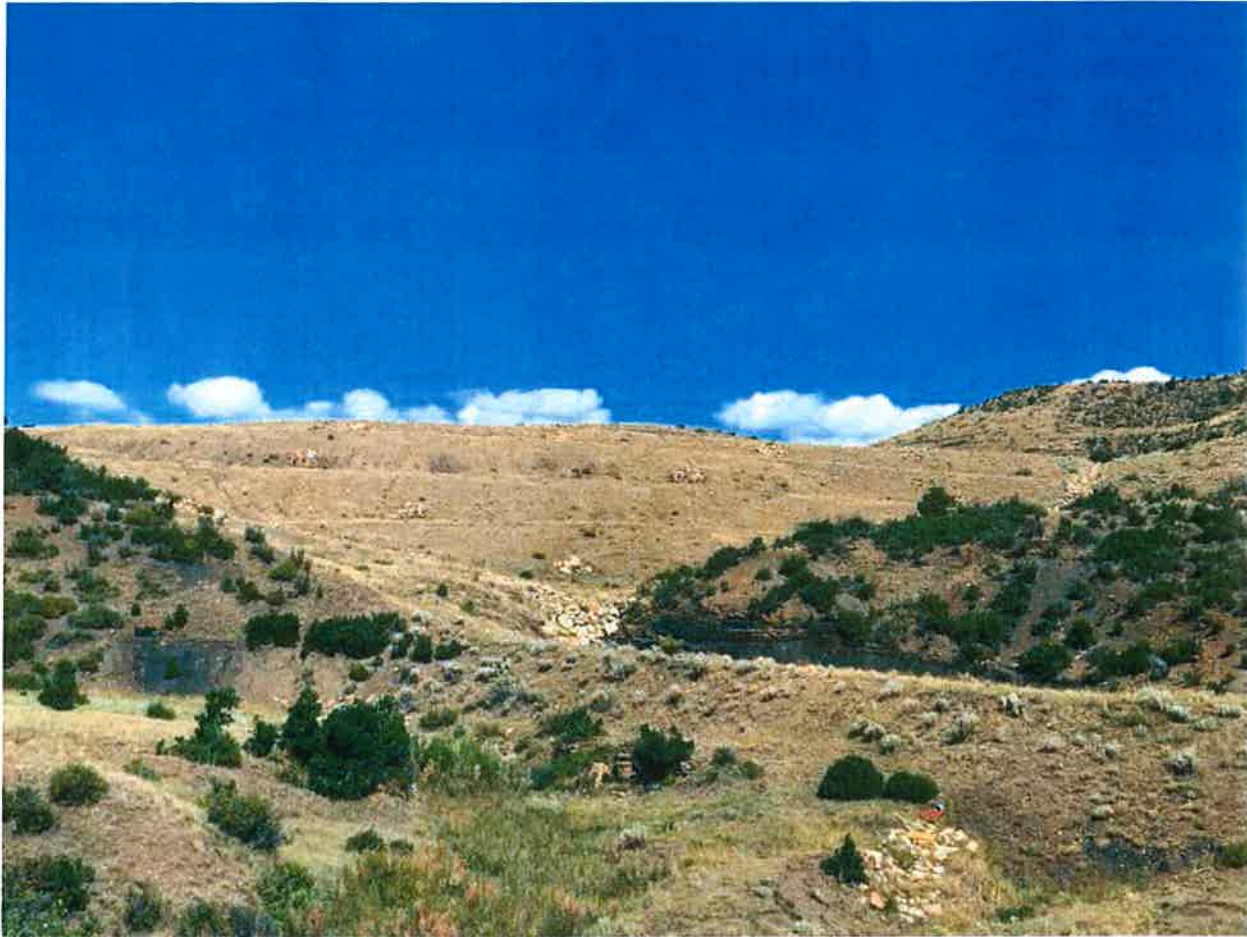
The entire excess spoil fill facility was examined for signs of failure and instability such as tension cracks, ground movement, springs and seeps, and standing water. There was no indication of potential instability at time of inspection.

Overall the site is in good condition. The vegetation on the fill is encouraging.

**Fill #7- South Facing Embankments**

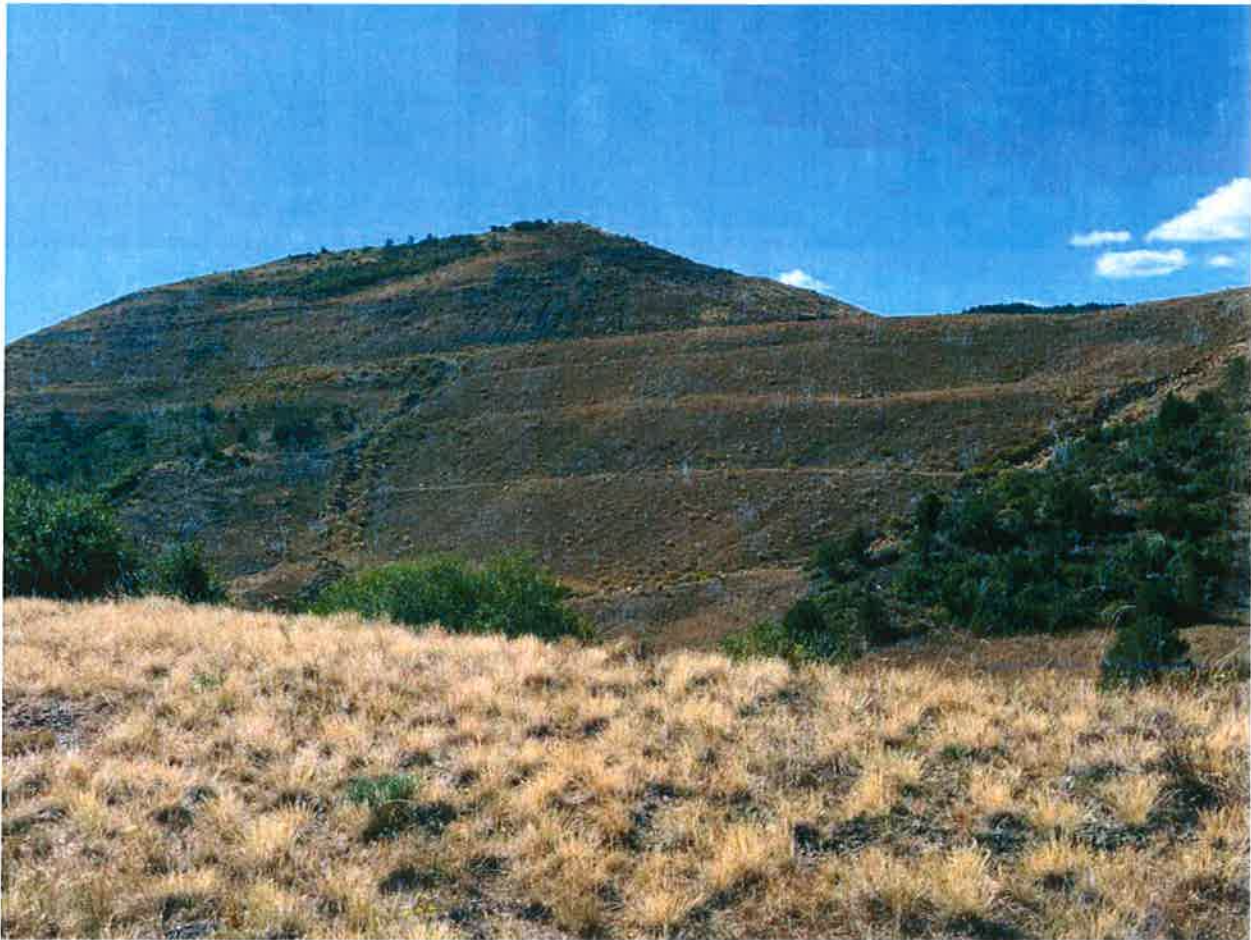
The entire excess spoil fill facility was examined for signs of failure and instability such as tension cracks, ground movement, springs and seeps, and standing water. There was no indication of potential instability at time of inspection.

Overall the site is in good condition. Vegetation is very good on the fill.

**Fill 8 - North Facing Embankments with Down Drains Visible**

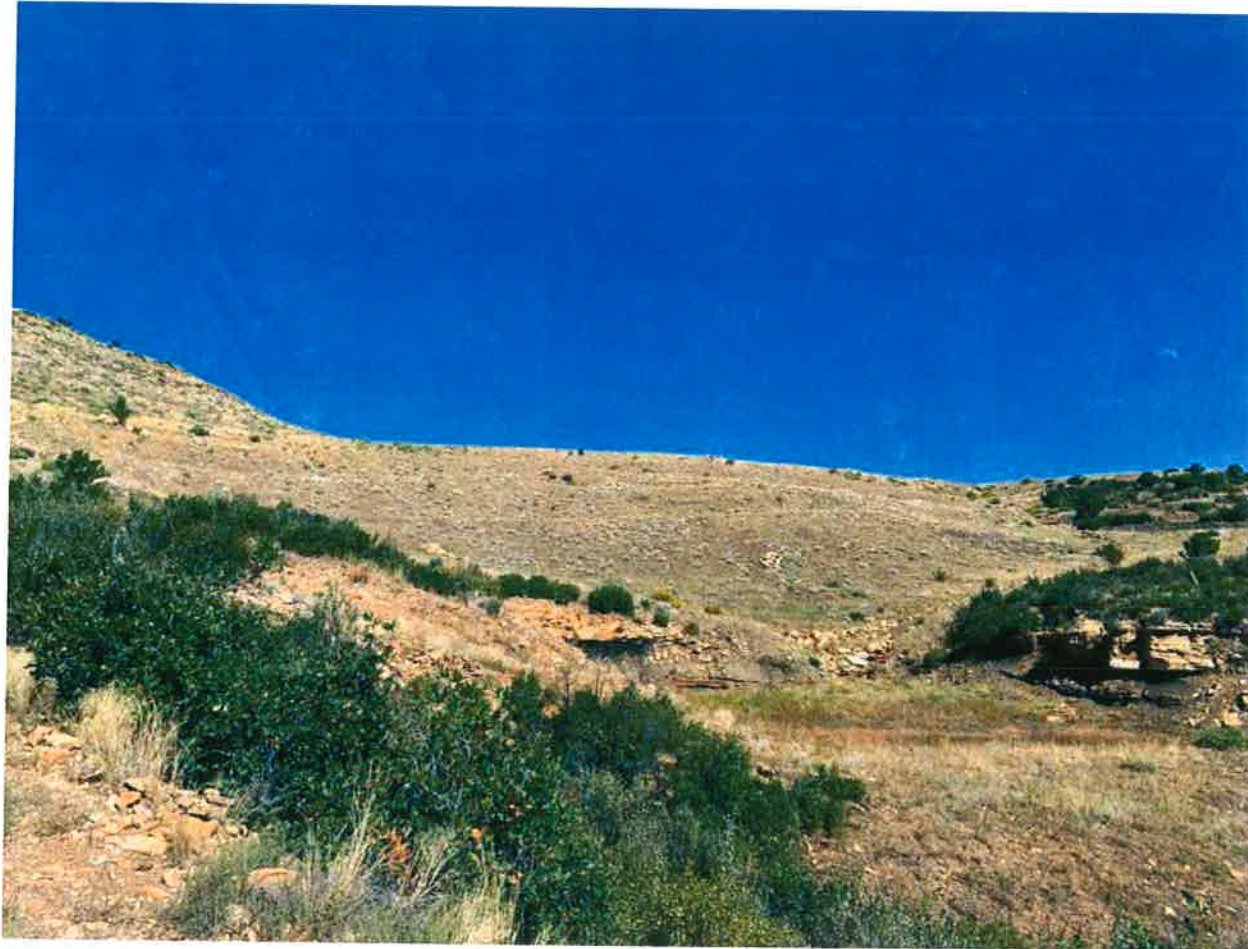
The entire excess spoil fill facility was examined for signs of failure and instability such as tension cracks, ground movement, springs and seeps, and standing water. There was no indication of potential instability at time of inspection.

Overall the site is in good condition.

**Fill 9 – South Facing Embankments**
