**LORENCITO CANYON MINE**  
**Permit No. C-1996-084**

**INSPECTION OF EXCESS SPOIL-FILLS 7, 8, & 9**  
**November 26, 2019**

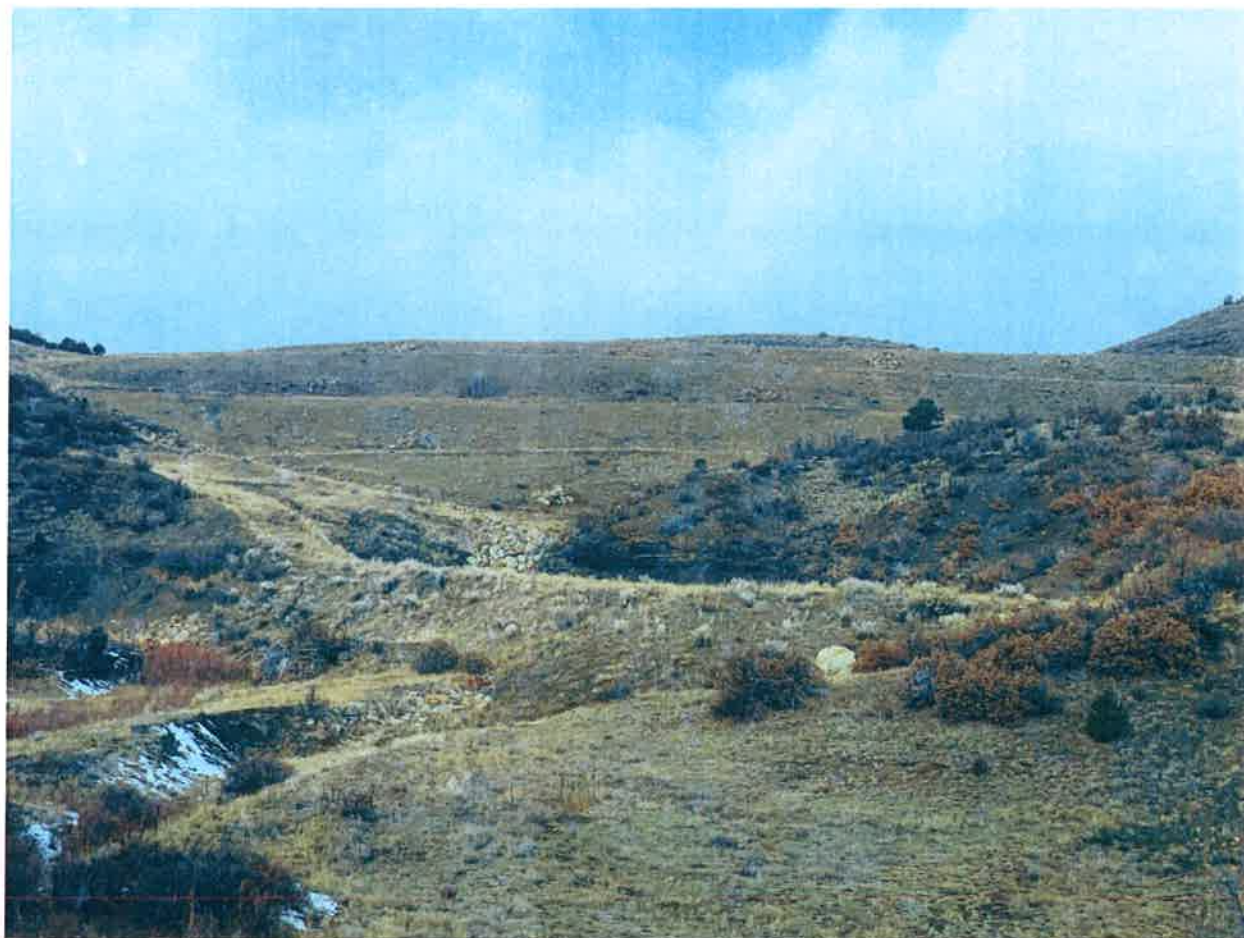
The entire excess spoil fill facility was examined for signs of failure and instability such as tension cracks, ground movement, springs and seeps, and standing water. There was no indication of potential instability at time of inspection.

Overall the site is in good condition. The vegetation on the fill is encouraging.

**Fill #7- South Facing Embankments**

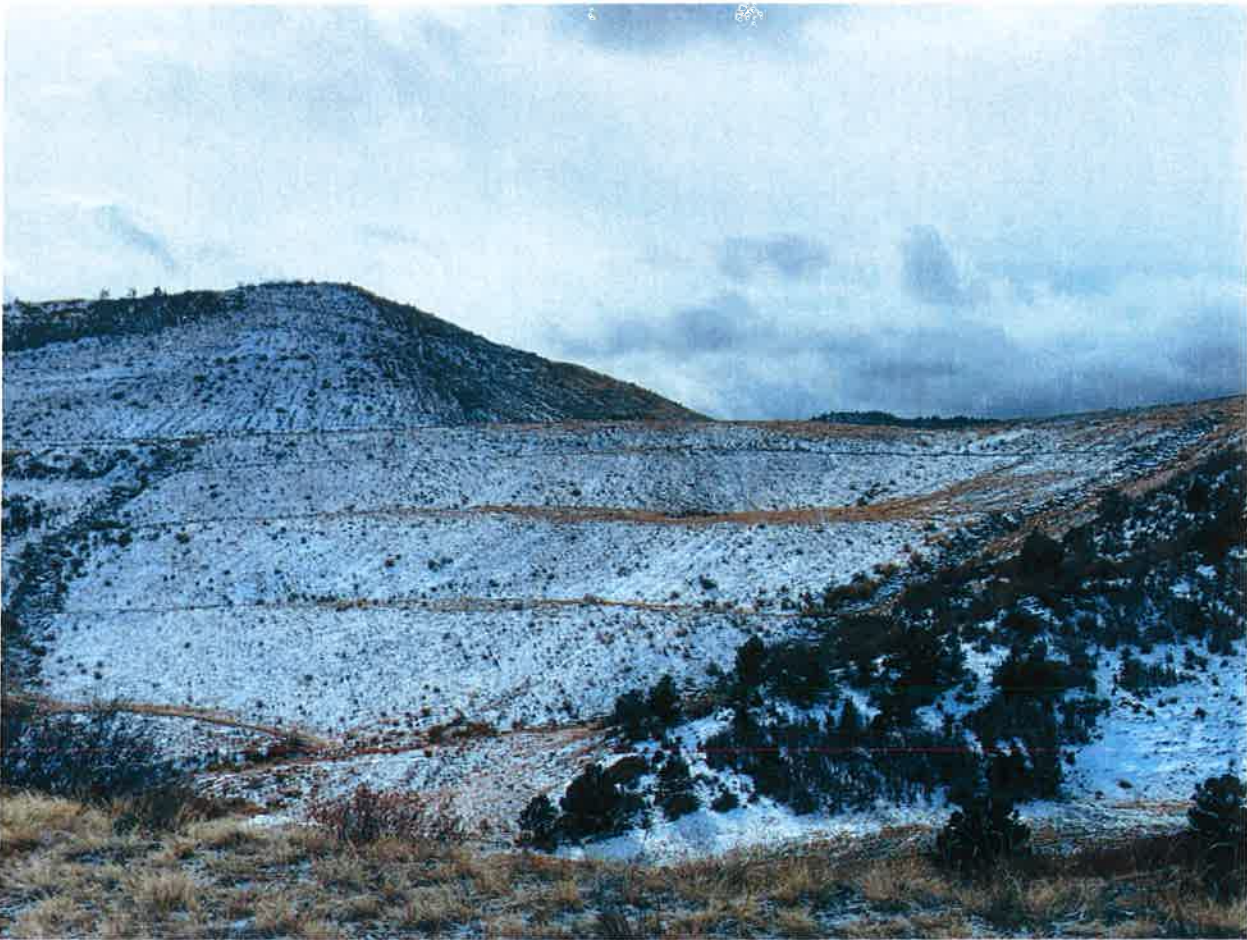
The entire excess spoil fill facility was examined for signs of failure and instability such as tension cracks, ground movement, springs and seeps, and standing water. There was no indication of potential instability at time of inspection.

Overall the site is in good condition. Vegetation is very good on the fill.

**Fill 8 - North Facing Embankments**

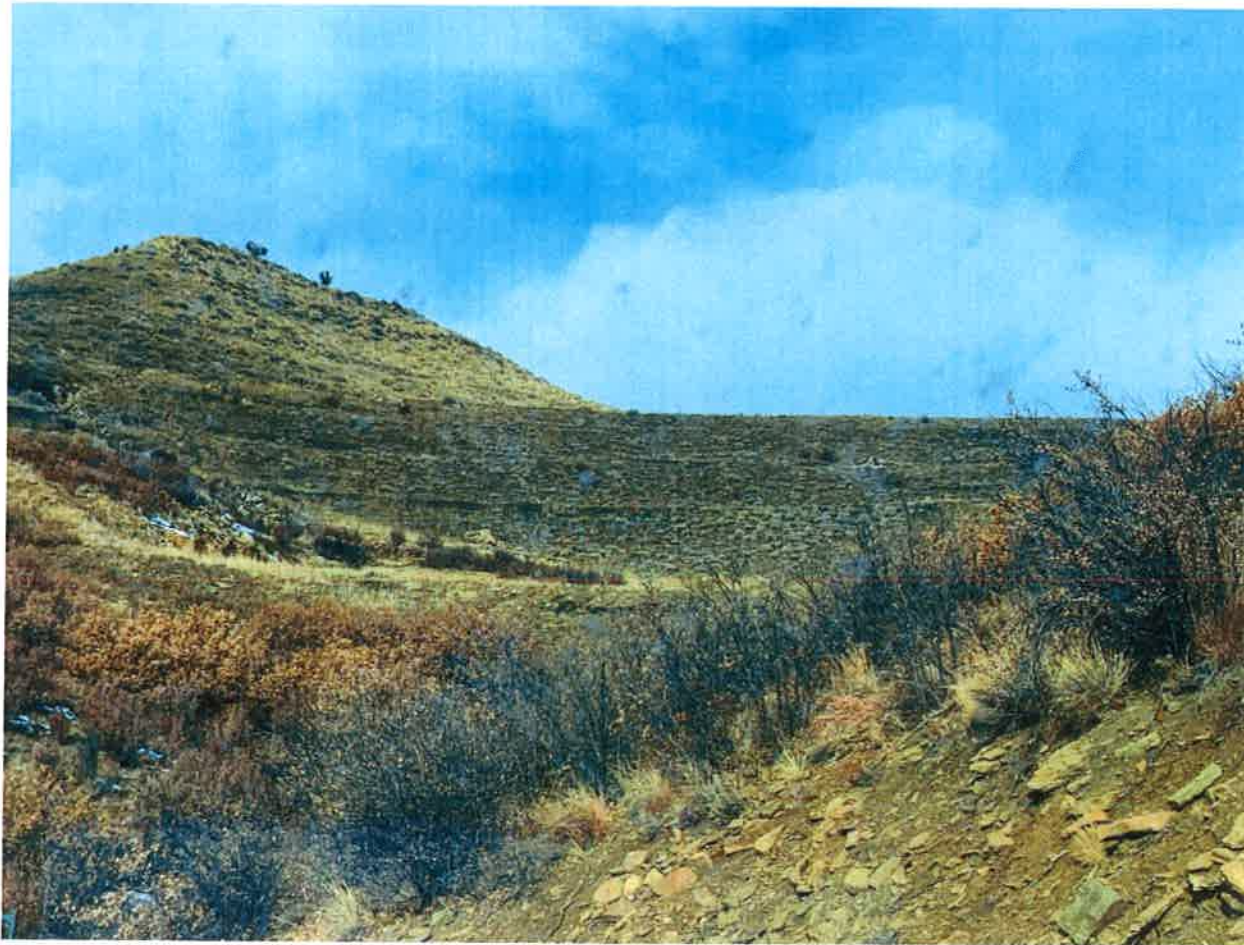
The entire excess spoil fill facility was examined for signs of failure and instability such as tension cracks, ground movement, springs and seeps, and standing water. There was no indication of potential instability at time of inspection.

Overall the site is in good condition.

**Fill 9 – South Facing Embankments**
