QUARTERLY SEDIMENTATION POND INSPECTION REPORT

CDMR Rule 4.05.9(17)

Mine: Lorencito
NPDES ID. No.: Pond #9 (North)
Inspection Period: First Quarter 2019
Inspection Date: 3/29/2019 12:15 - 64°

QUARTERLY SEDIMENT POND INSPECTION REPORT
Lorencito Canyon Mine – March 29, 2019

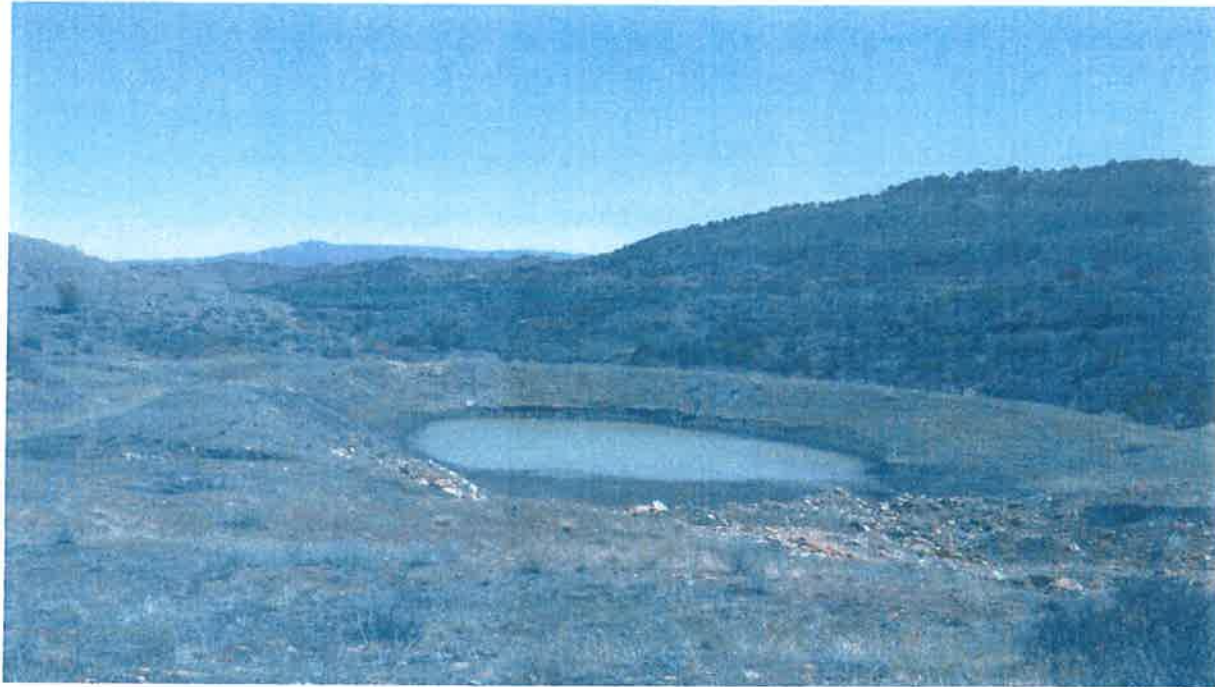
Pond 6

Water level is about 18 below base of
Primary Discharge riser.

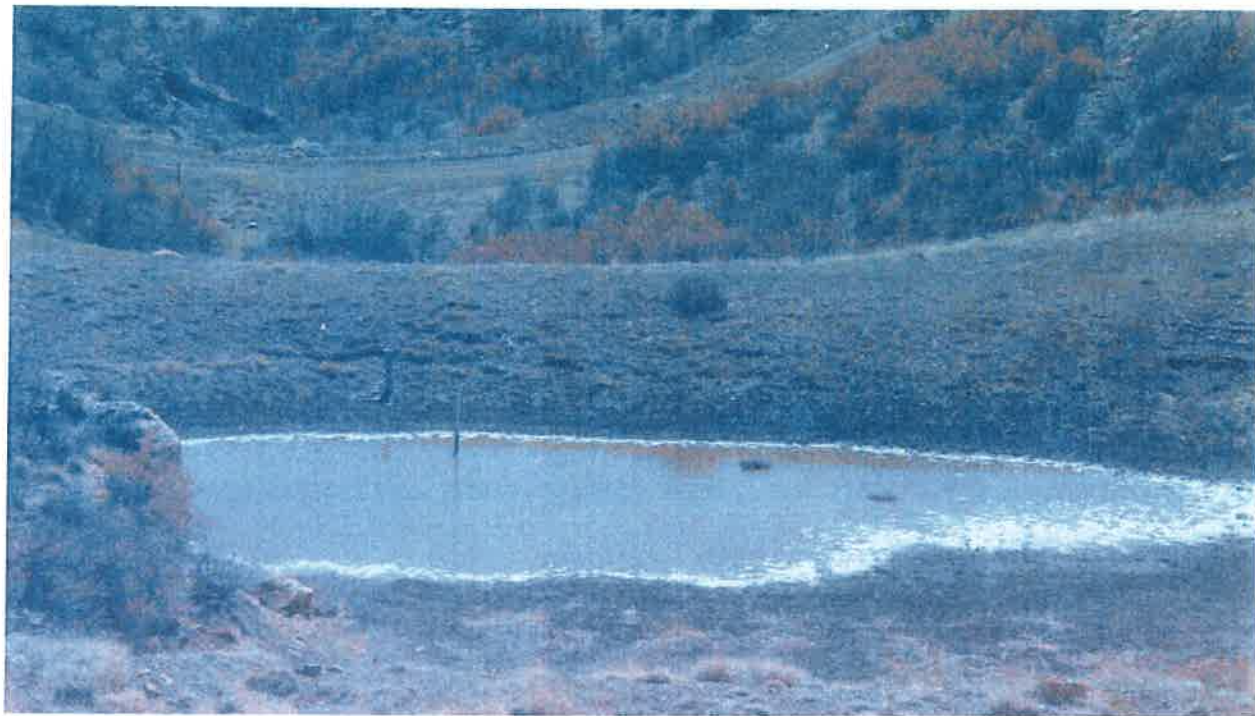
Pond 9A (South)

Pond has minimal water at the base of the pond.

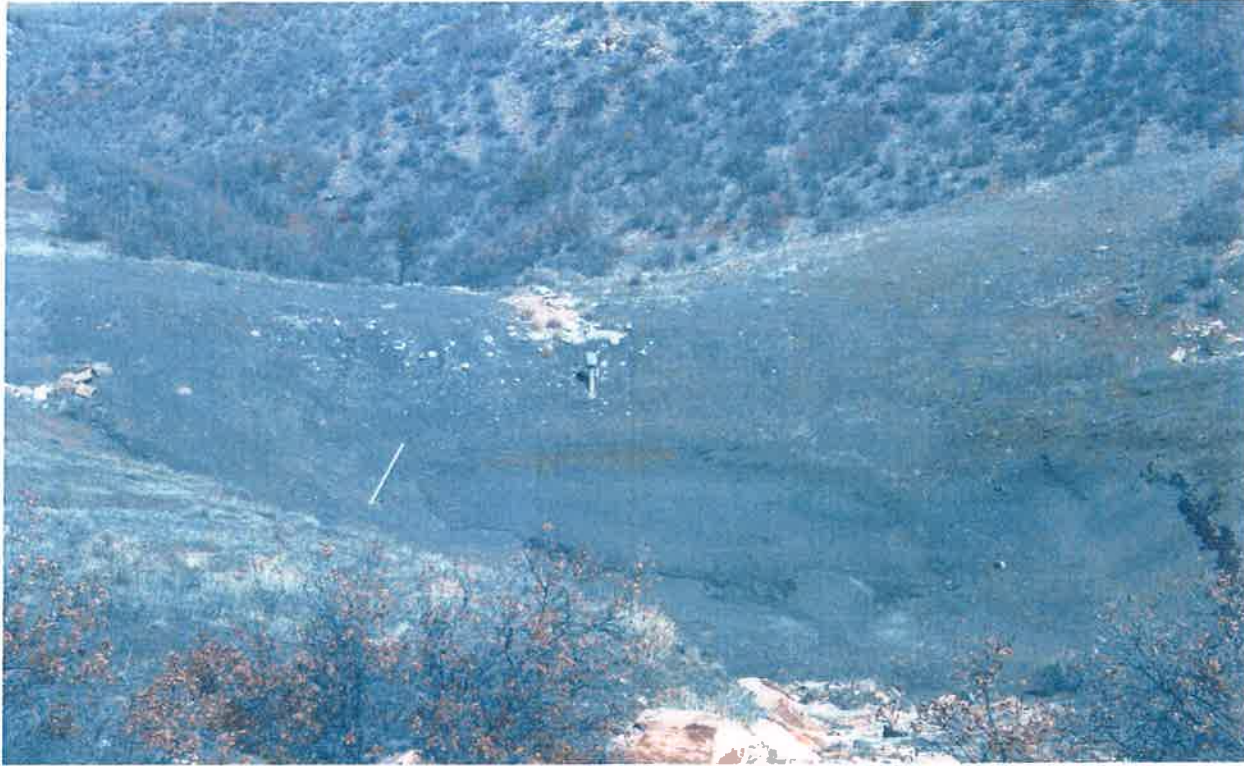
Pond 9B (North)

limited inflow during the winter - water level
diminished by evaporation

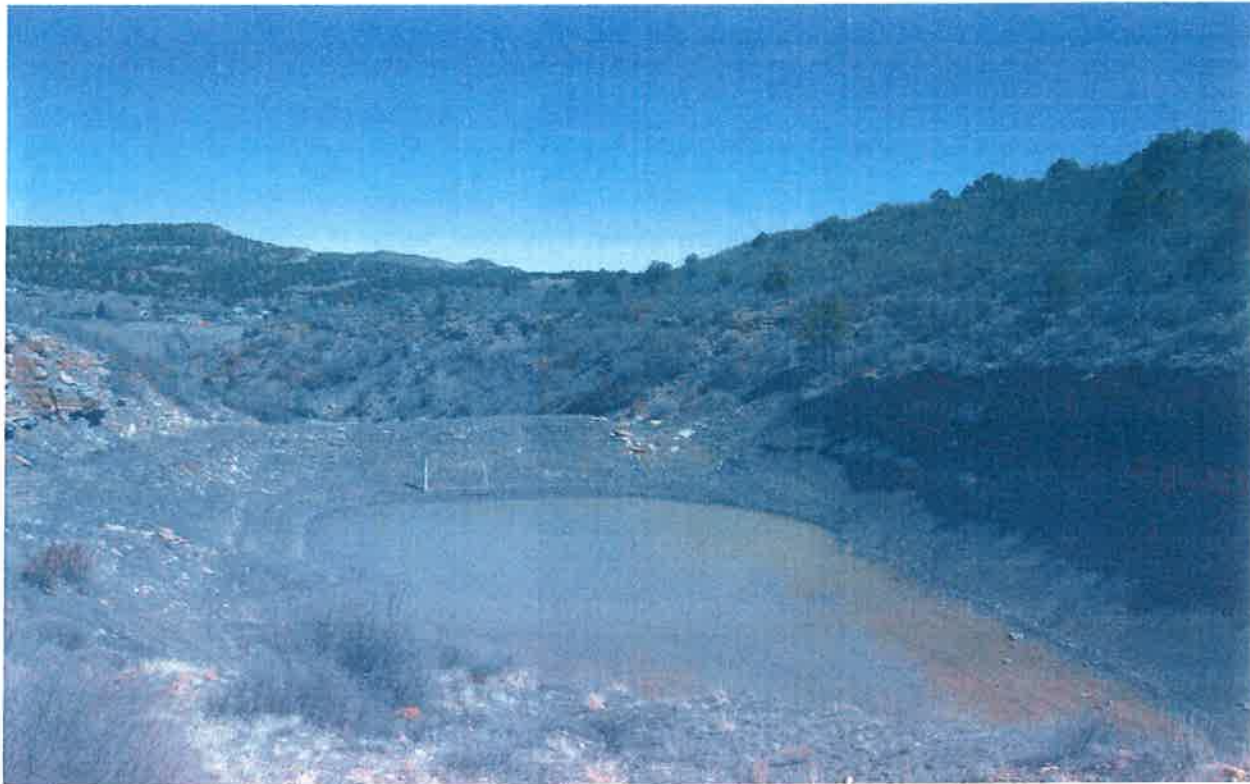
Pond 8

Water level has lowered to about 2 foot below
base of Primary Discharge riser.
