QUARTERLY SEDIMENTATION POND INSPECTION REPORT

Mine: Lorencito

Inspection Period: Second Quarter 2019

QUARTERLY SEDIMENTATION POND INSPECTION REPORT
Lorencito Canyon Mine- June 19, 2019

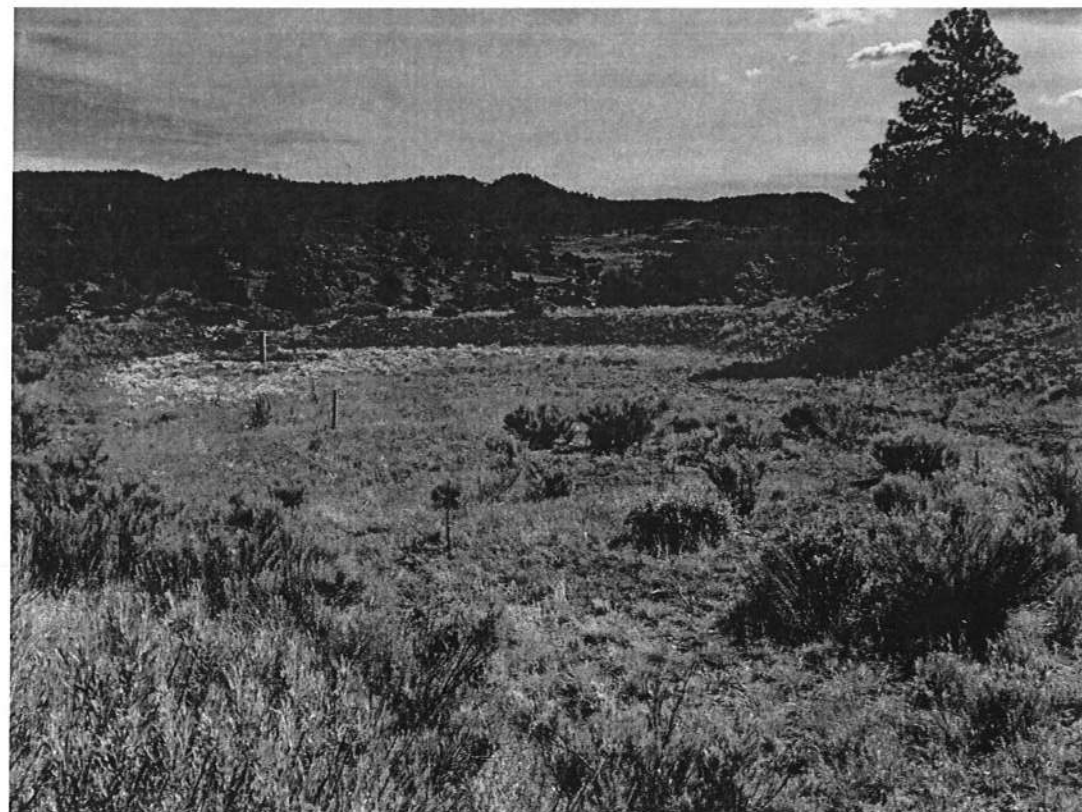
Pond 5

Pond has some sediment and will be surveyed next quarter to ensure storage capacity is not

surpassed. Pond is empty.

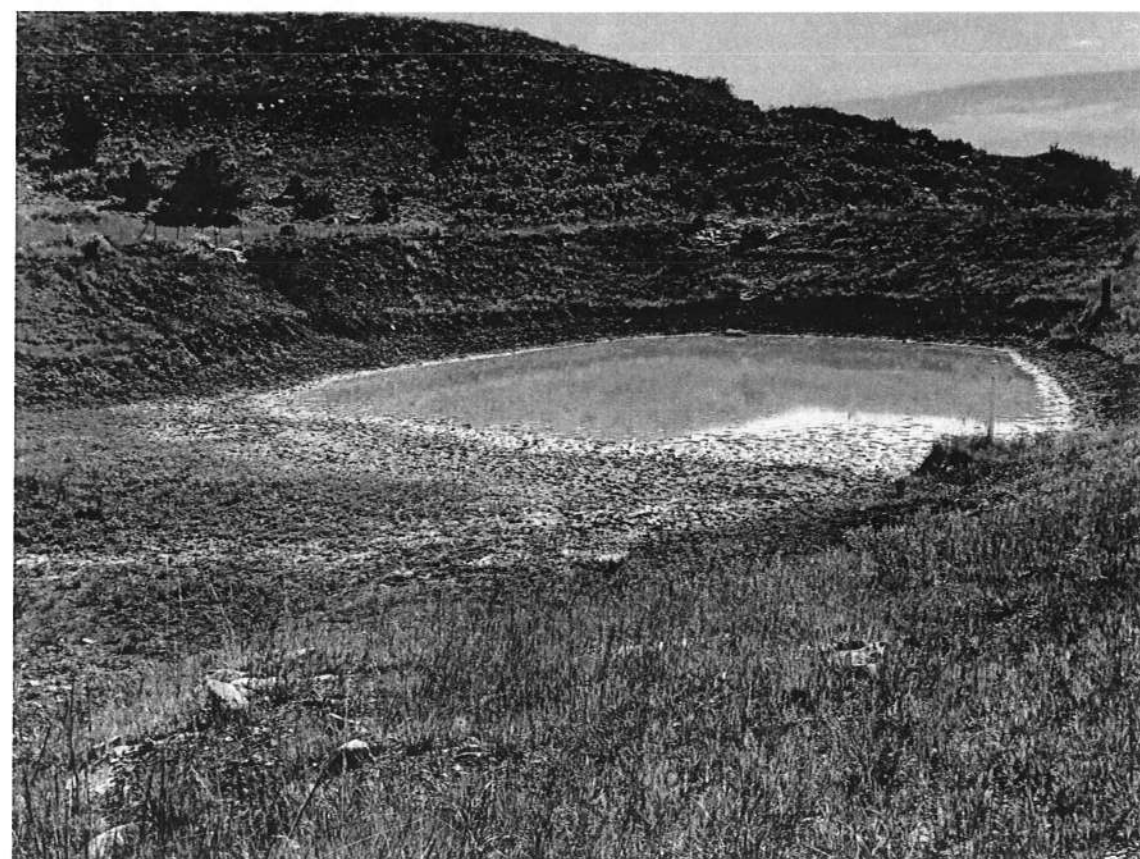
Pond 6

Holding a small amount of water.

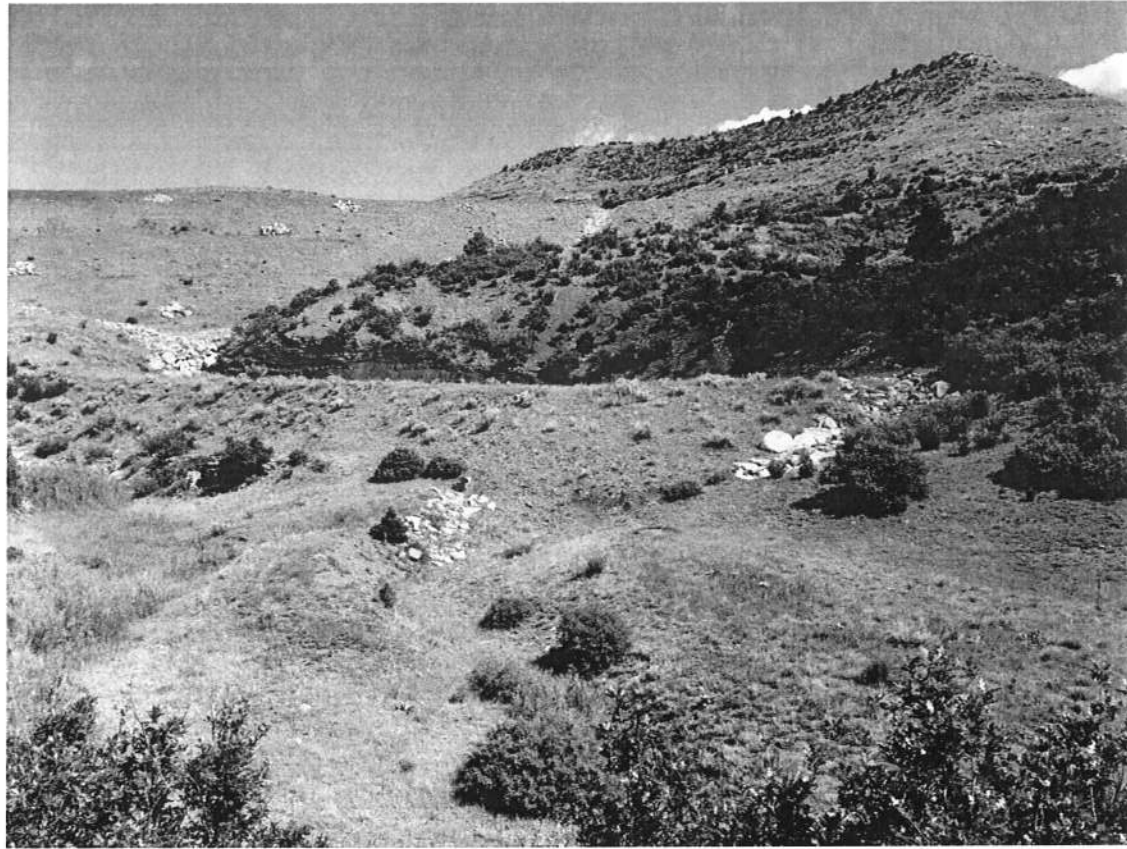
Pond 7

Pond empty at time of inspection.

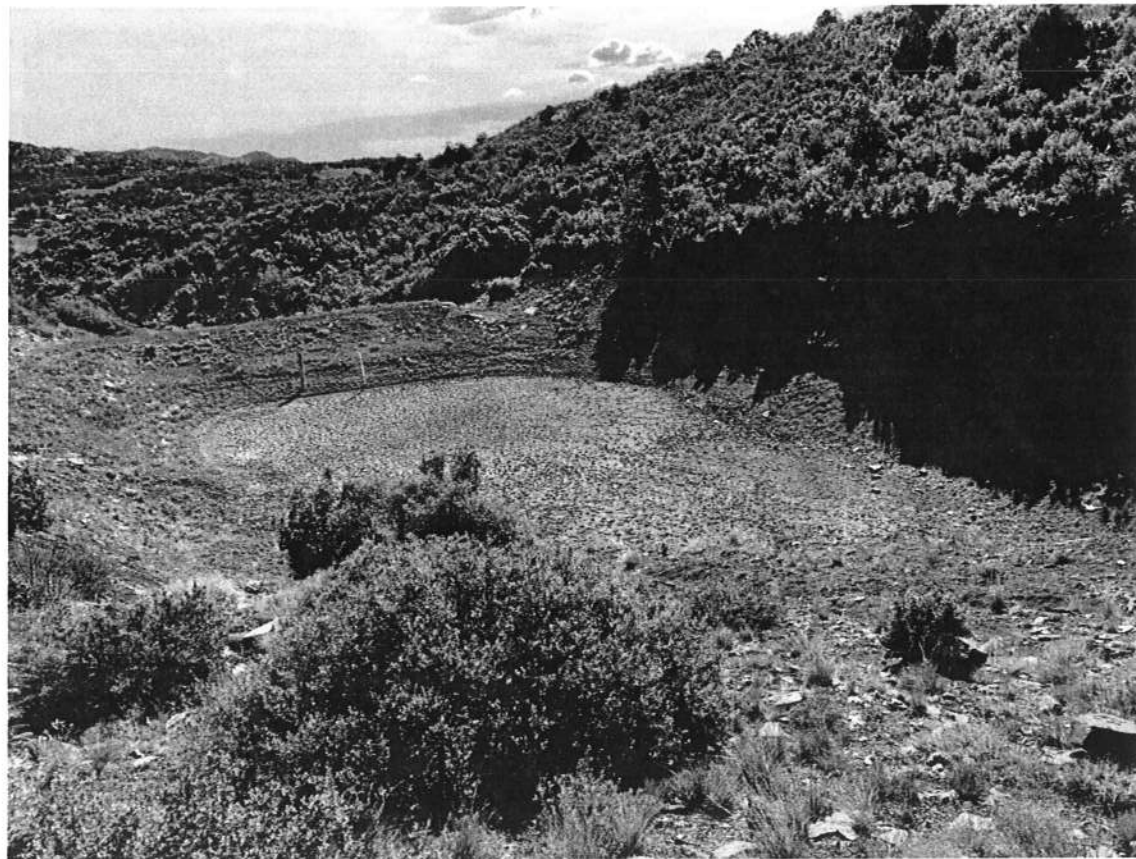
Pond 8

Pond empty at time of inspection.

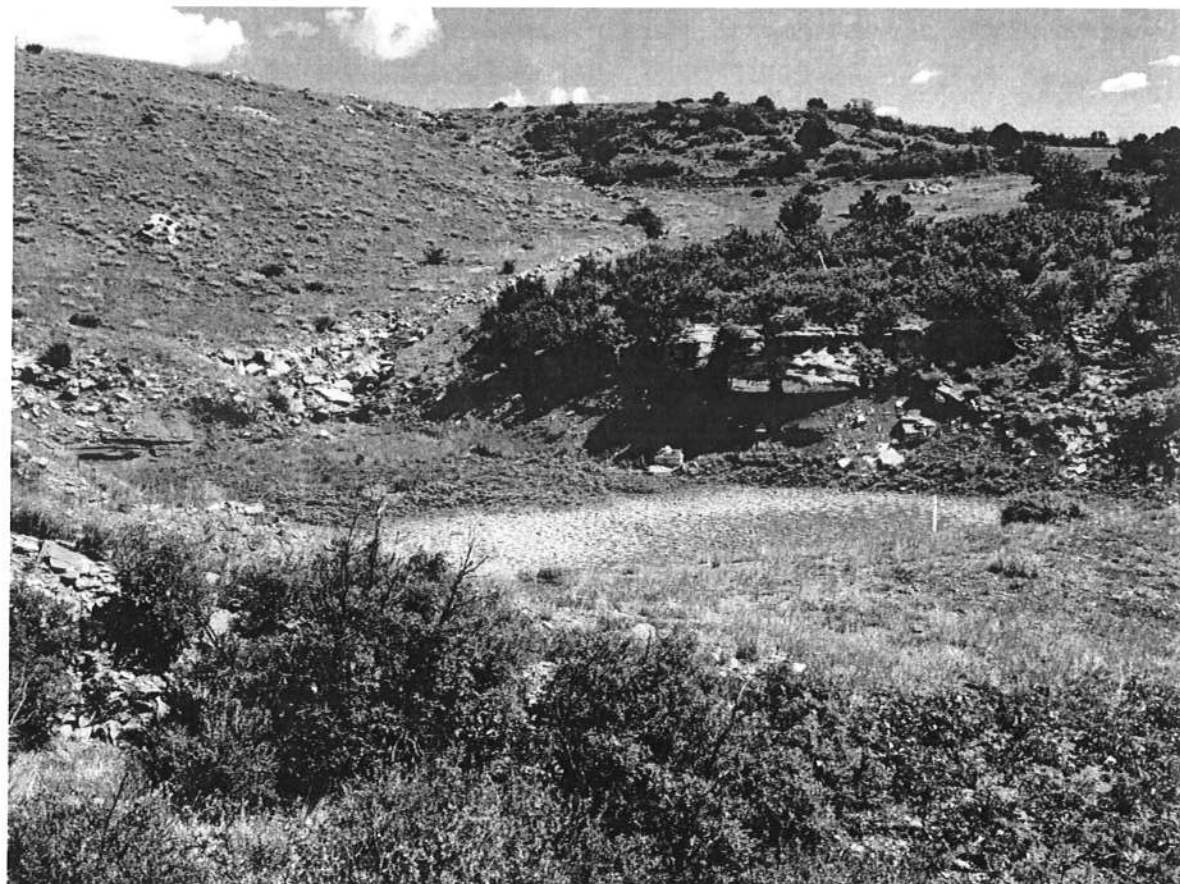
Pond 9a

Pond empty at time of inspection.

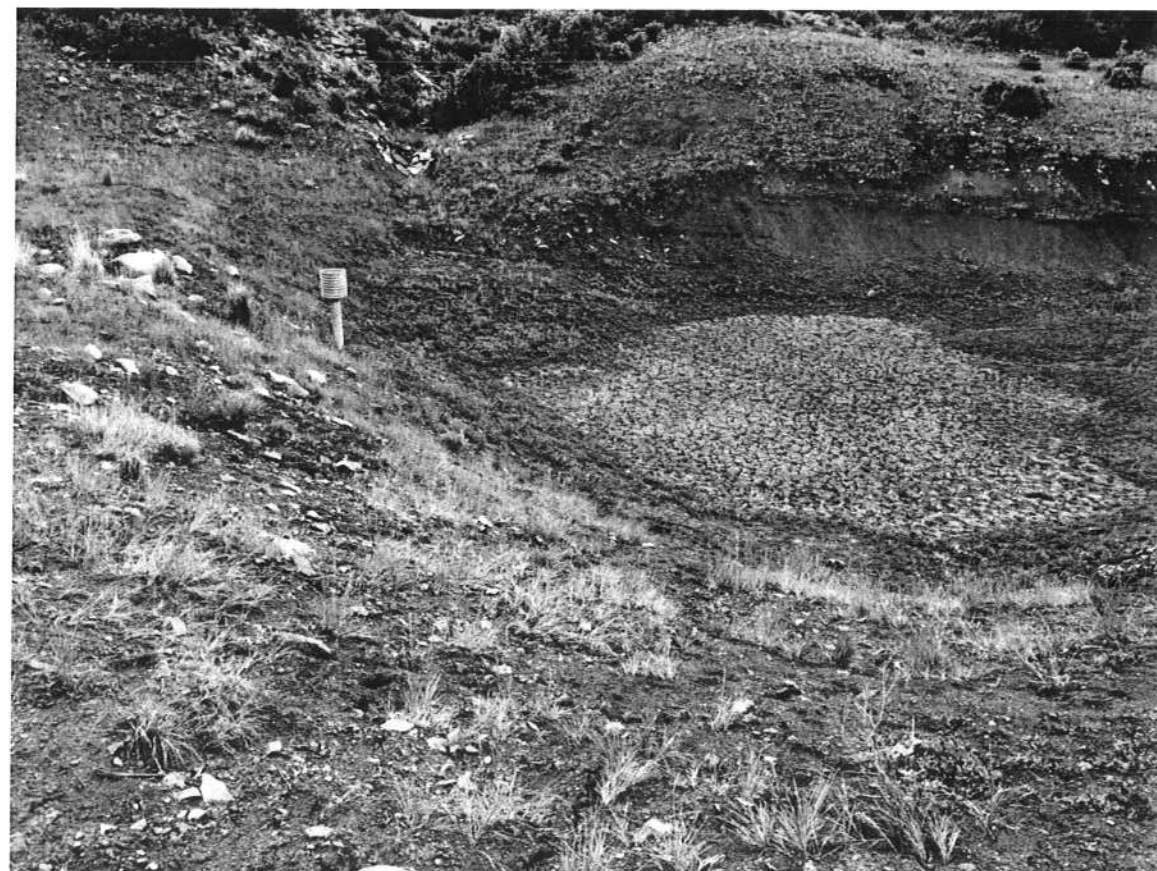
Pond 9

Pond empty at time of inspection.
