QUARTERLY SEDIMENTATION POND INSPECTION REPORT

Mine: Lorencito

Inspection Period: Third Quarter 2019

QUARTERLY SEDIMENTATION POND INSPECTION REPORT
Lorencito Canyon Mine- September 19, 2019

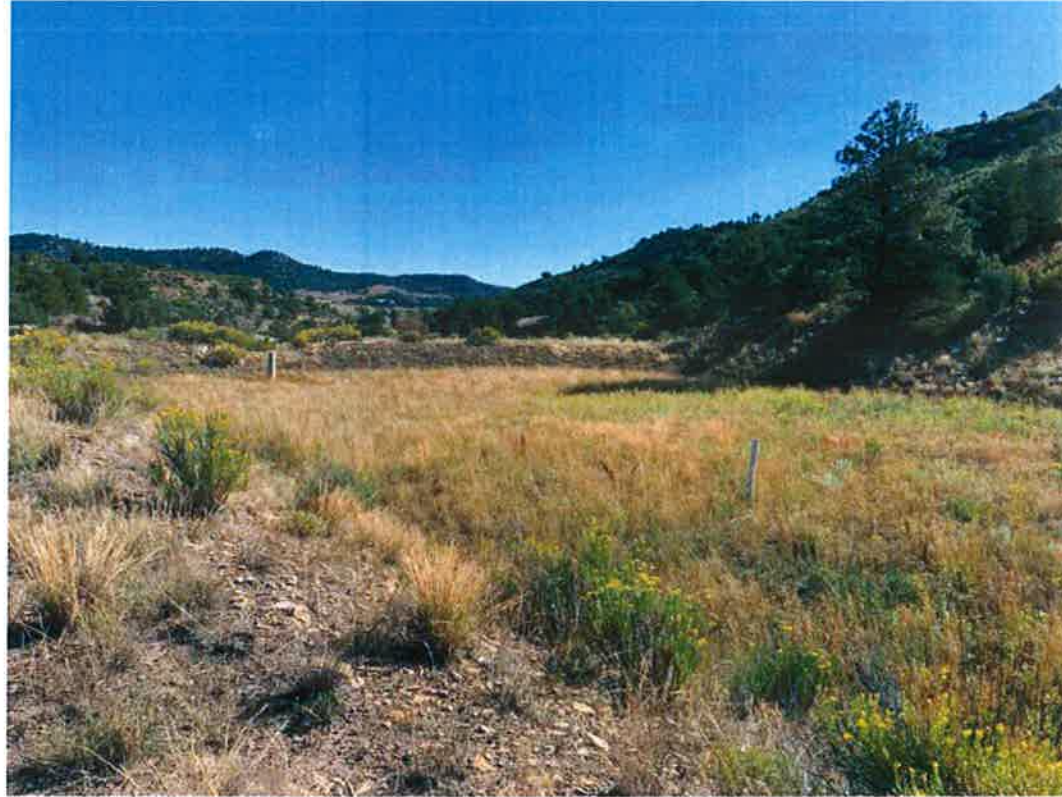
Pond 5

Pond is empty.

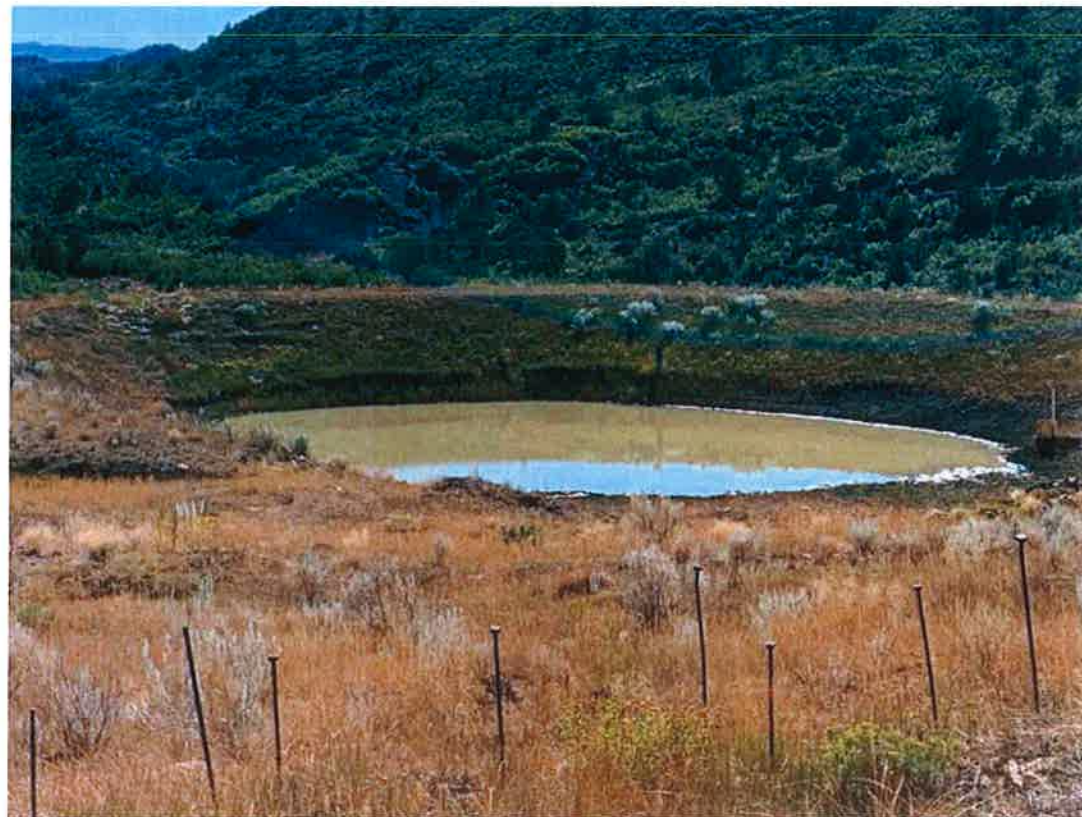
Pond 6

Pond is holding a small amount of water. Water level is well below the decant.

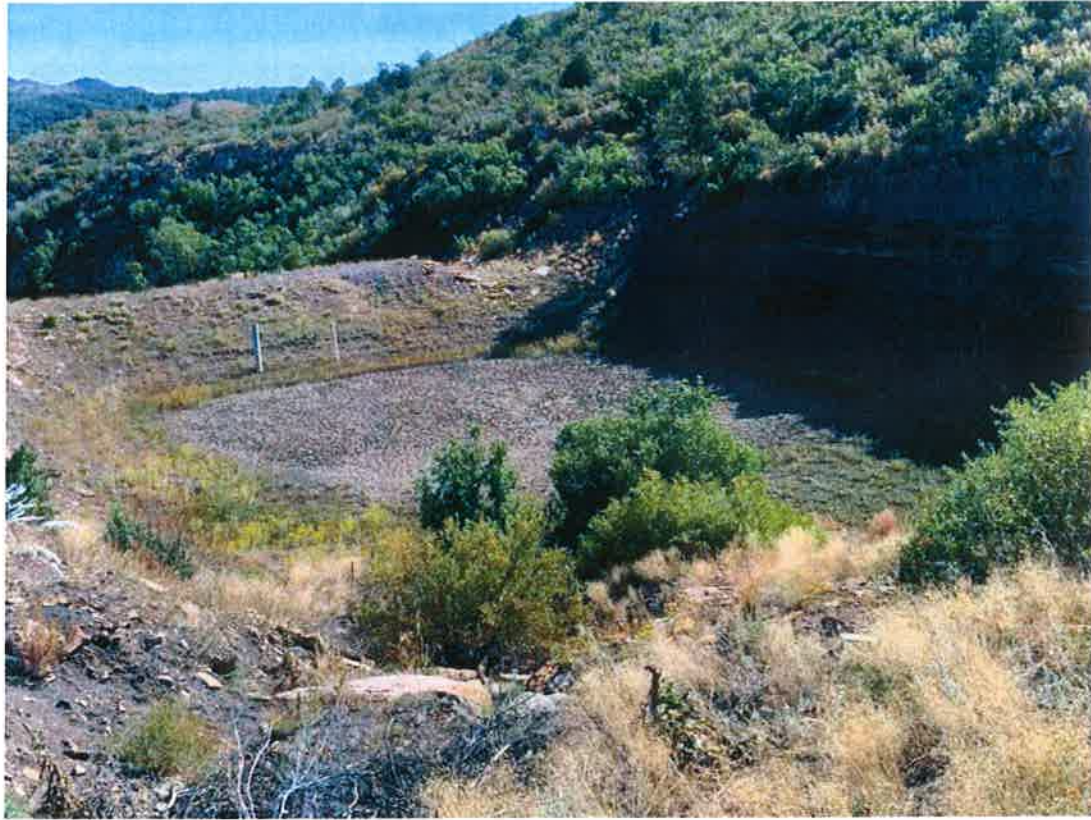
Pond 8

Pond empty at time of inspection.

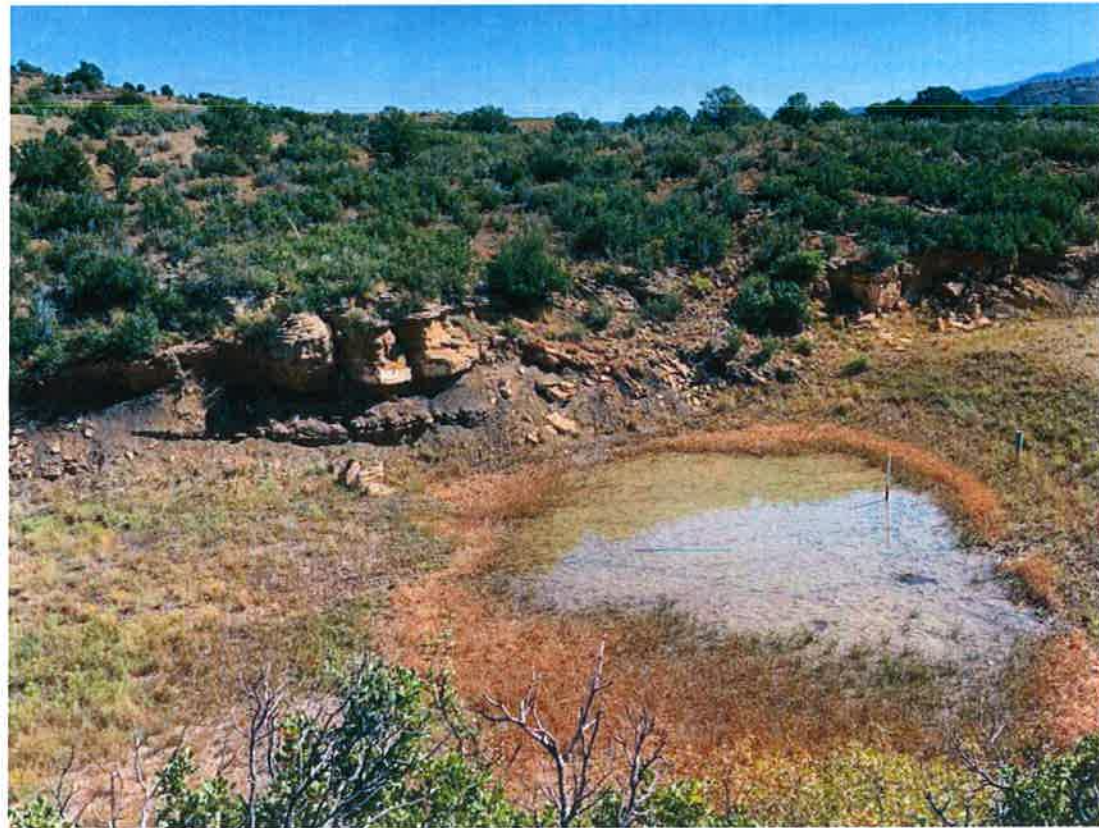
Pond 9a

Pond holding a small amount of water at time of inspection.

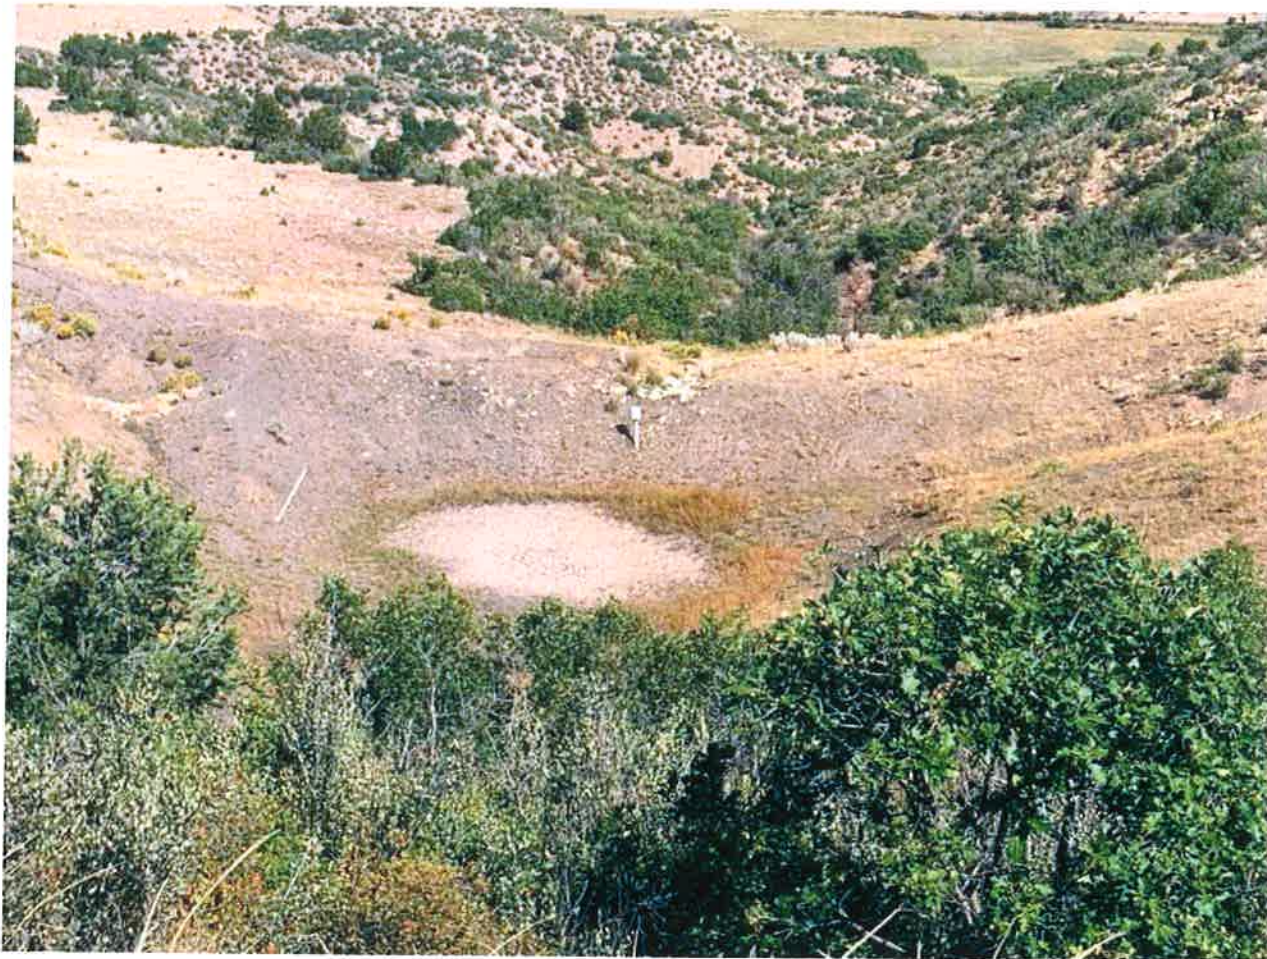
Pond 9

Pond empty at time of inspection.
