QUARTERLY SEDIMENTATION POND INSPECTION REPORT

Mine: Lorencito

Inspection Period: Fourth Quarter 2019

QUARTERLY SEDIMENTATION POND INSPECTION REPORT
Lorencito Canyon Mine- November 26, 2019

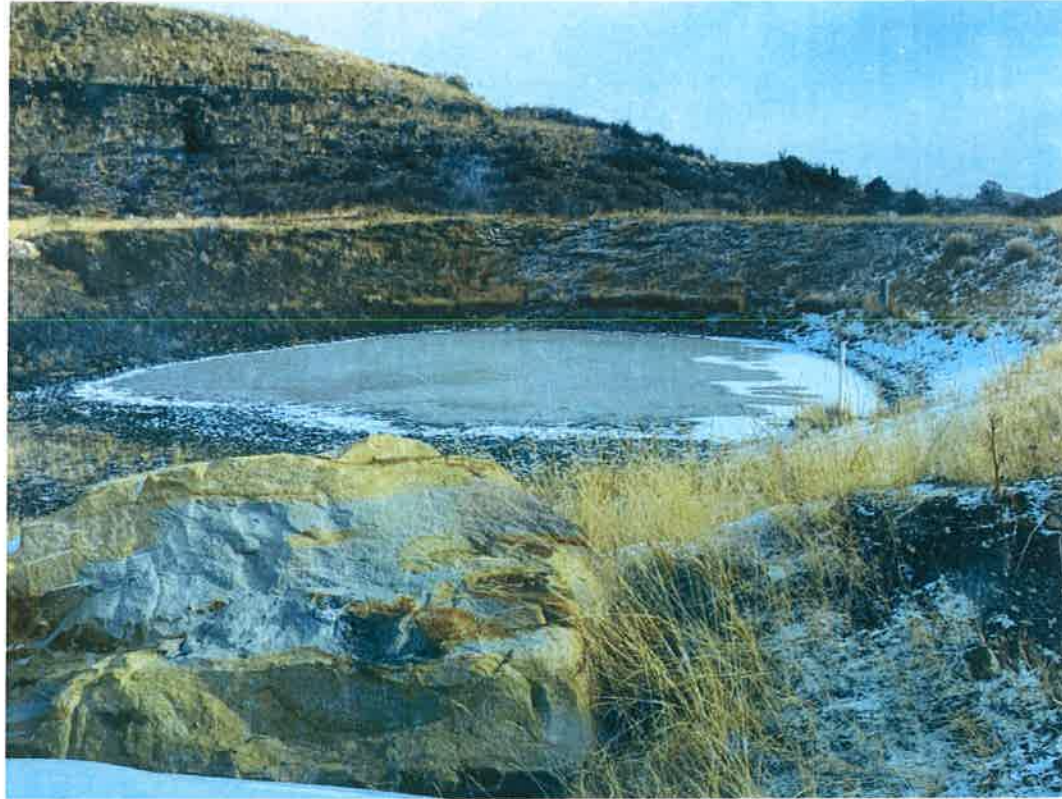
Pond 6

Pond is holding a small amount of water. Water level is well below the decant.

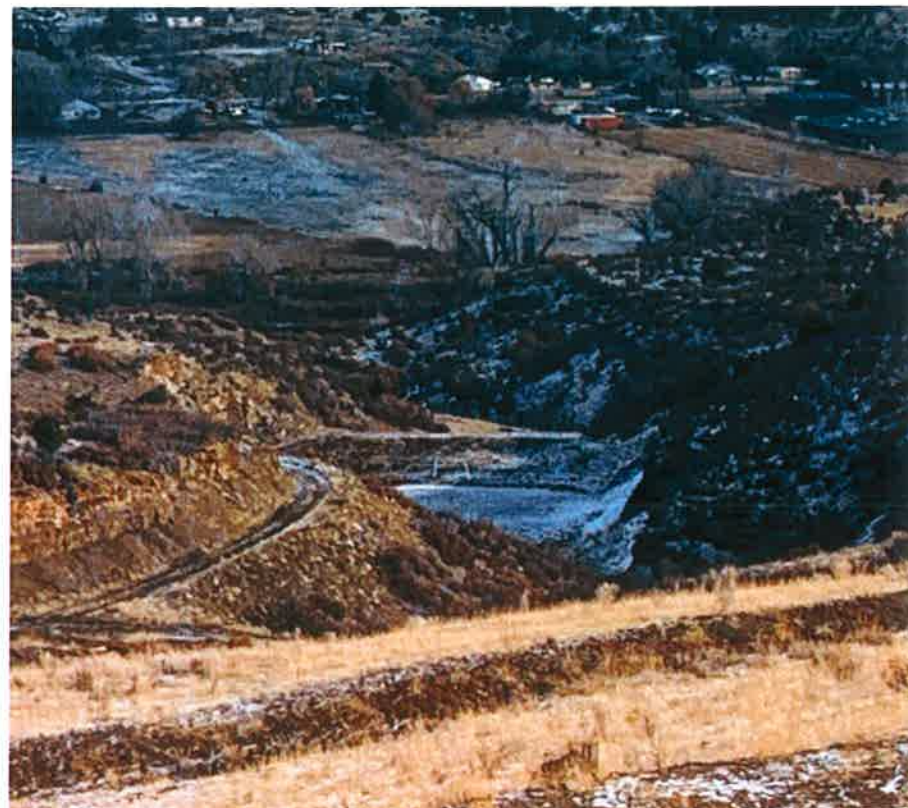
Pond 8

Pond empty at time of inspection.

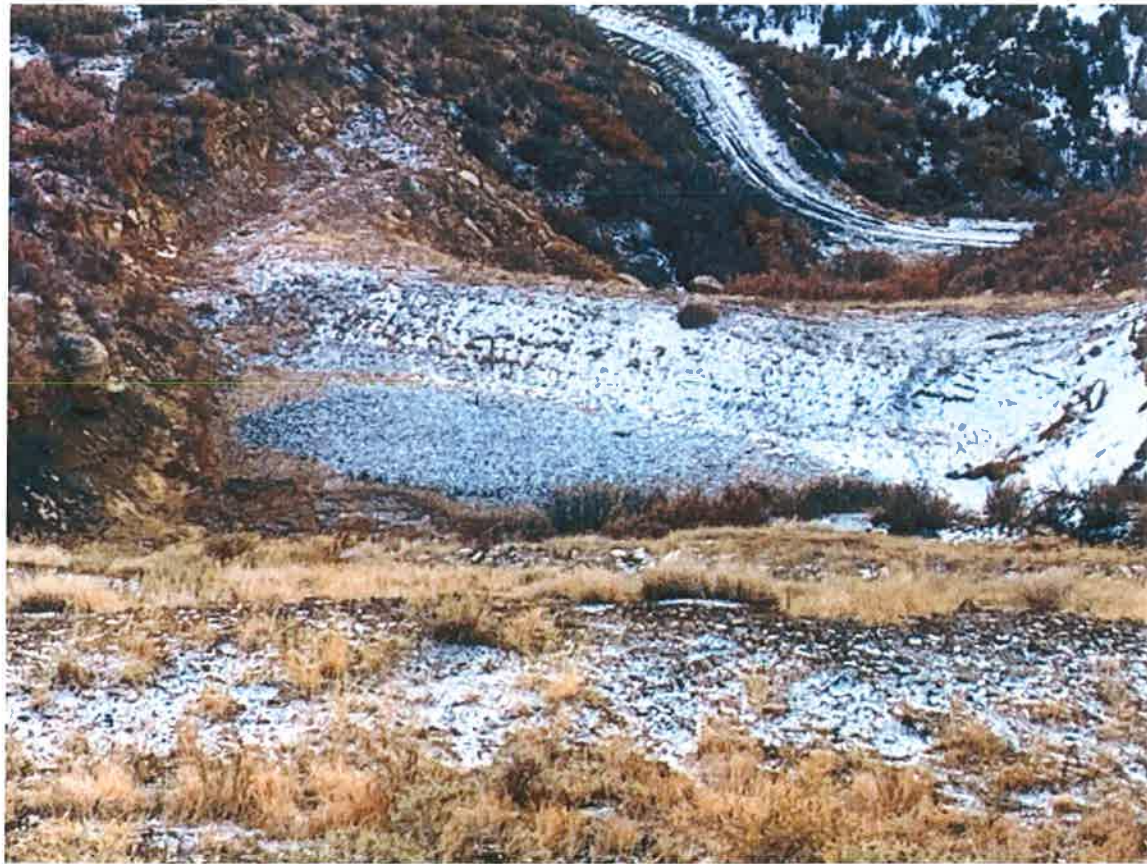
Pond 9a

Pond was holding no water at time of inspection.

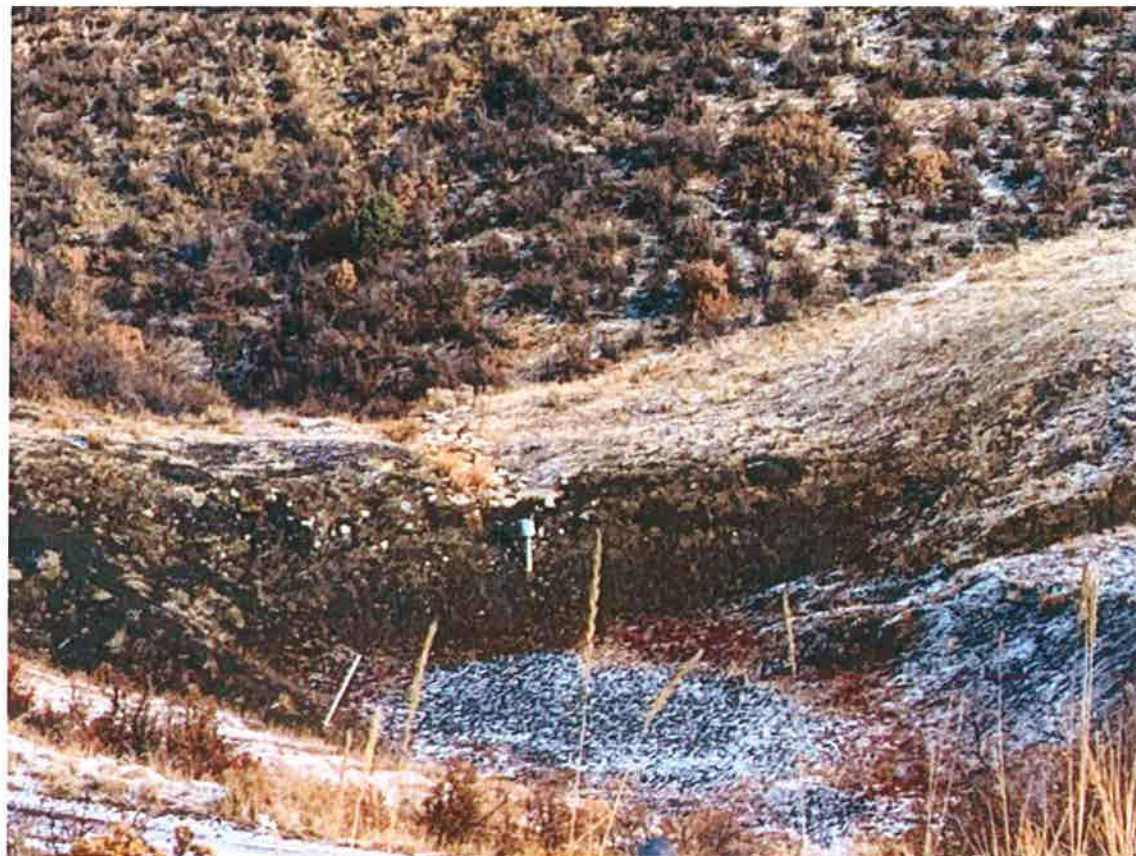
Pond 9

Pond empty at time of inspection.
