NEW ELK MINE
Permit No. C-1981-012

QUARTERLY COAL WASTE BANK INSPECTION REPORT
March 29, 2019

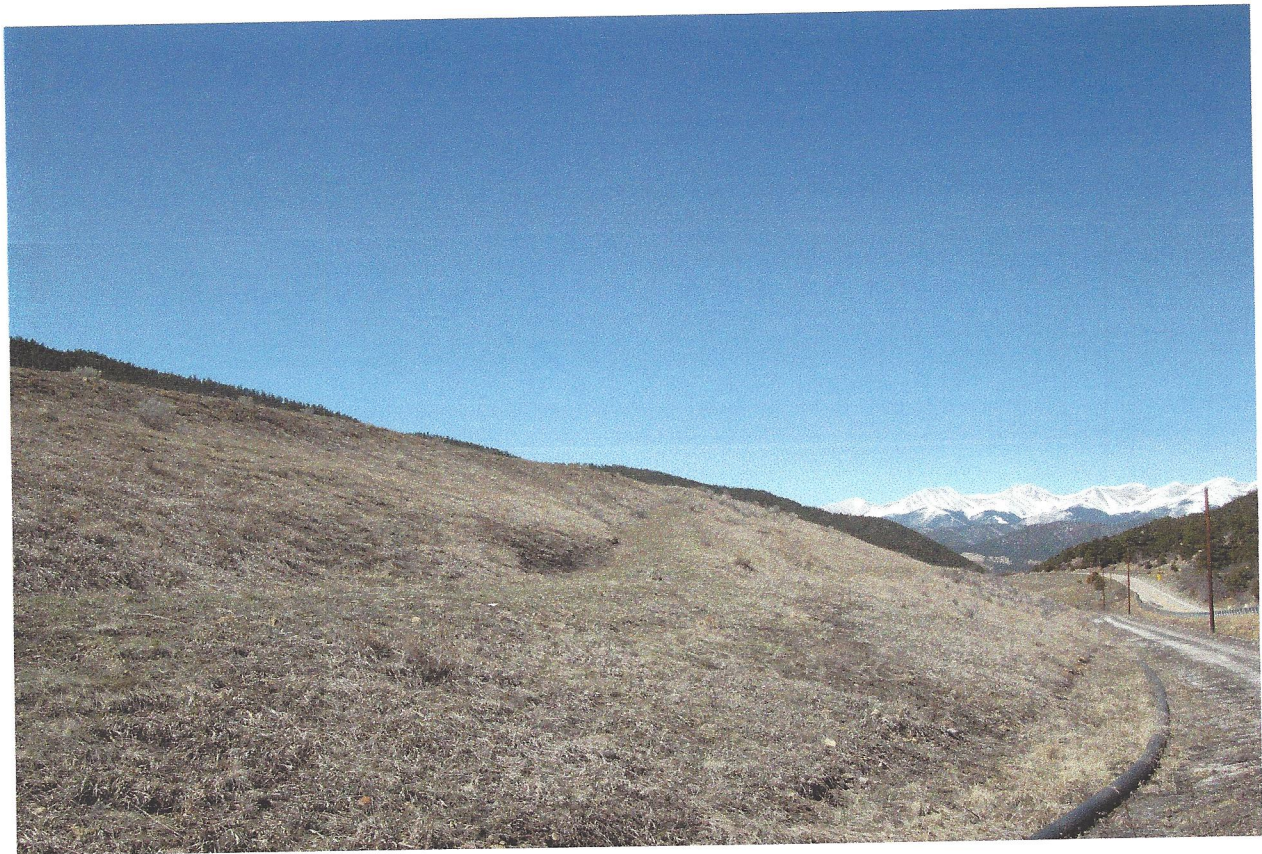
Early spring conditions prevail with the surface dry. Overall the site is in good condition.

DWDA#1 – North Facing Slope – March 29, 2019

None at this time.

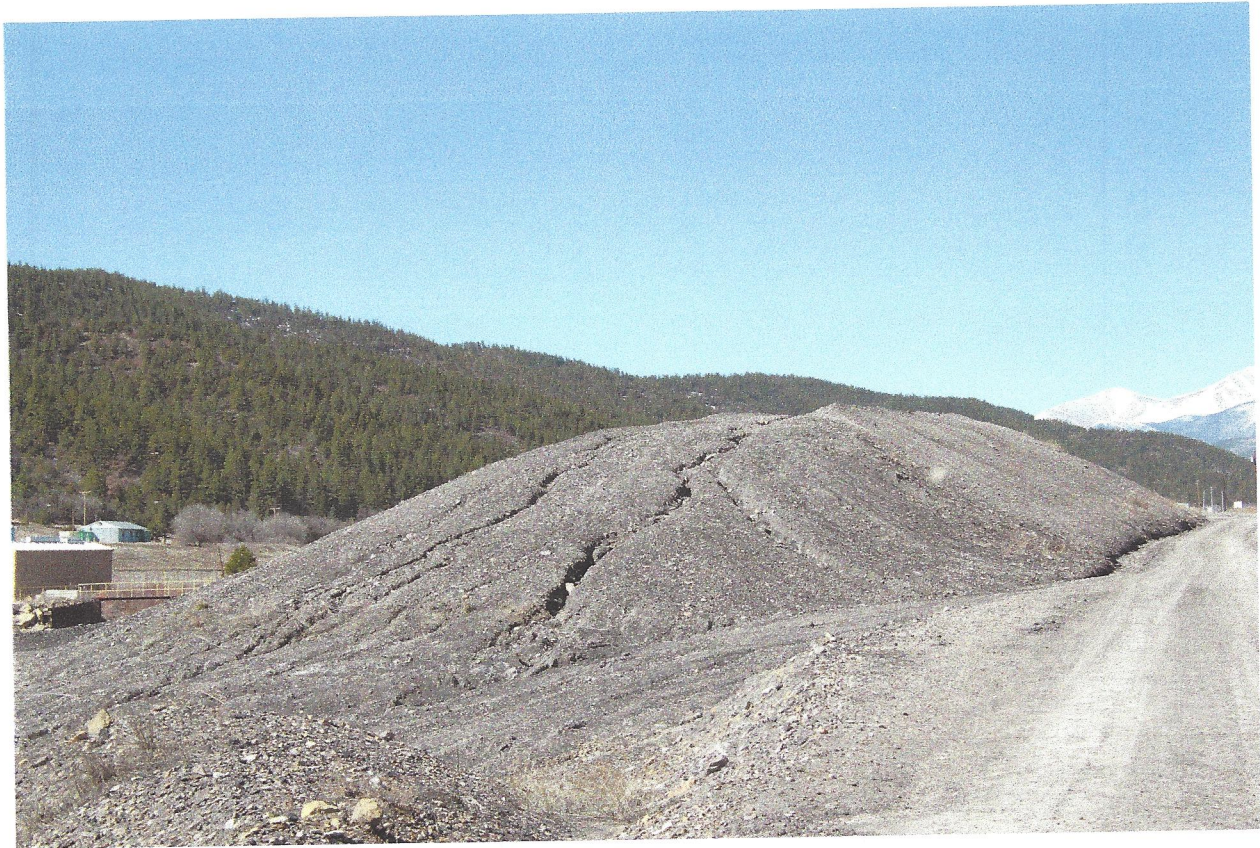
Early spring conditions prevail with the surface dry. Overall the site is in good condition.

DWDA#2 – East Facing Slope – March 29, 2019

Rills are developing primarily on the south and east facing slopes. The area is at storage capacity. Operator is evaluating either reclaiming the area or permitting alternative uses for the land north of the Purgatoire River and south of Highway 12.

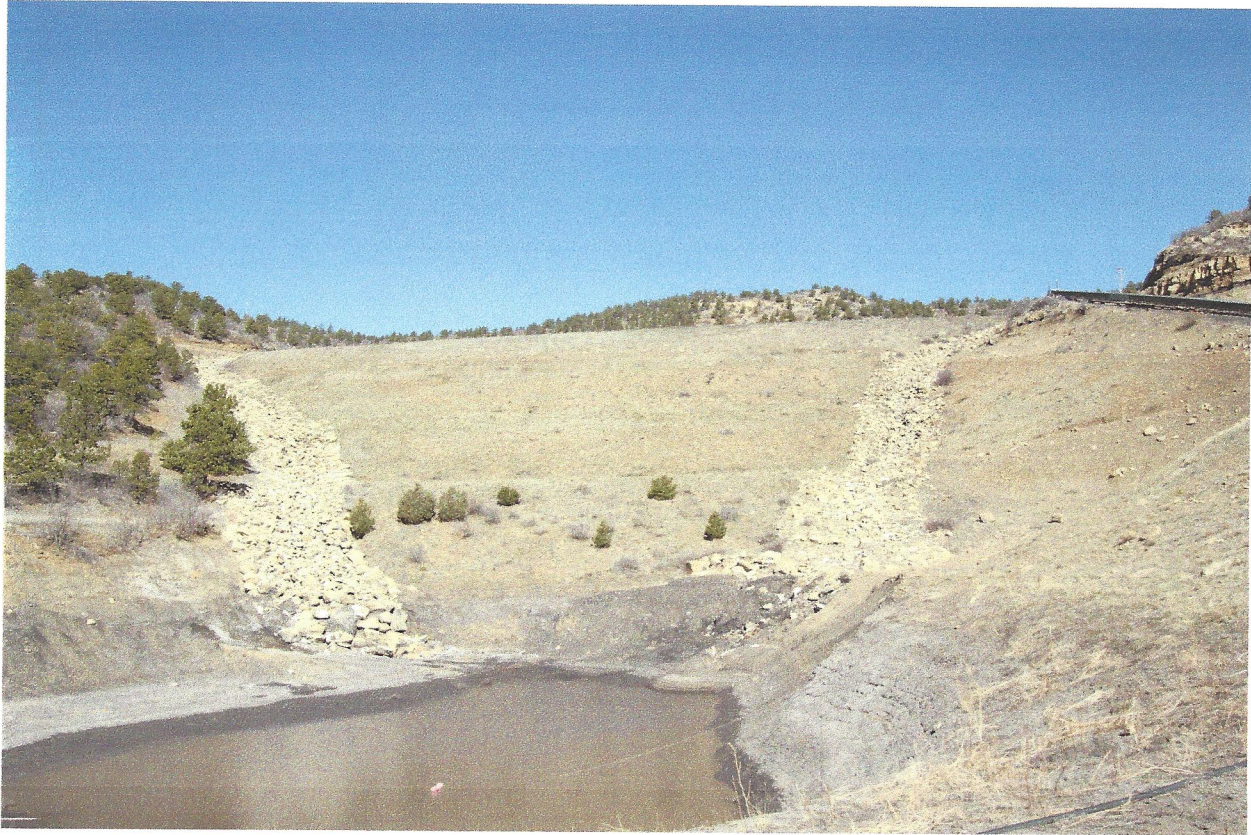
Early spring conditions prevail with the surface dry. Overall the site is in good condition. .

Refuse Disposal Area – Reclaimed Benches and Armored Drainage – March 29, 2019

None required at this time.
