NEW ELK MINE
Permit No. C-1981-012

QUARTERLY COAL WASTE BANK INSPECTION REPORT
June 19, 2019

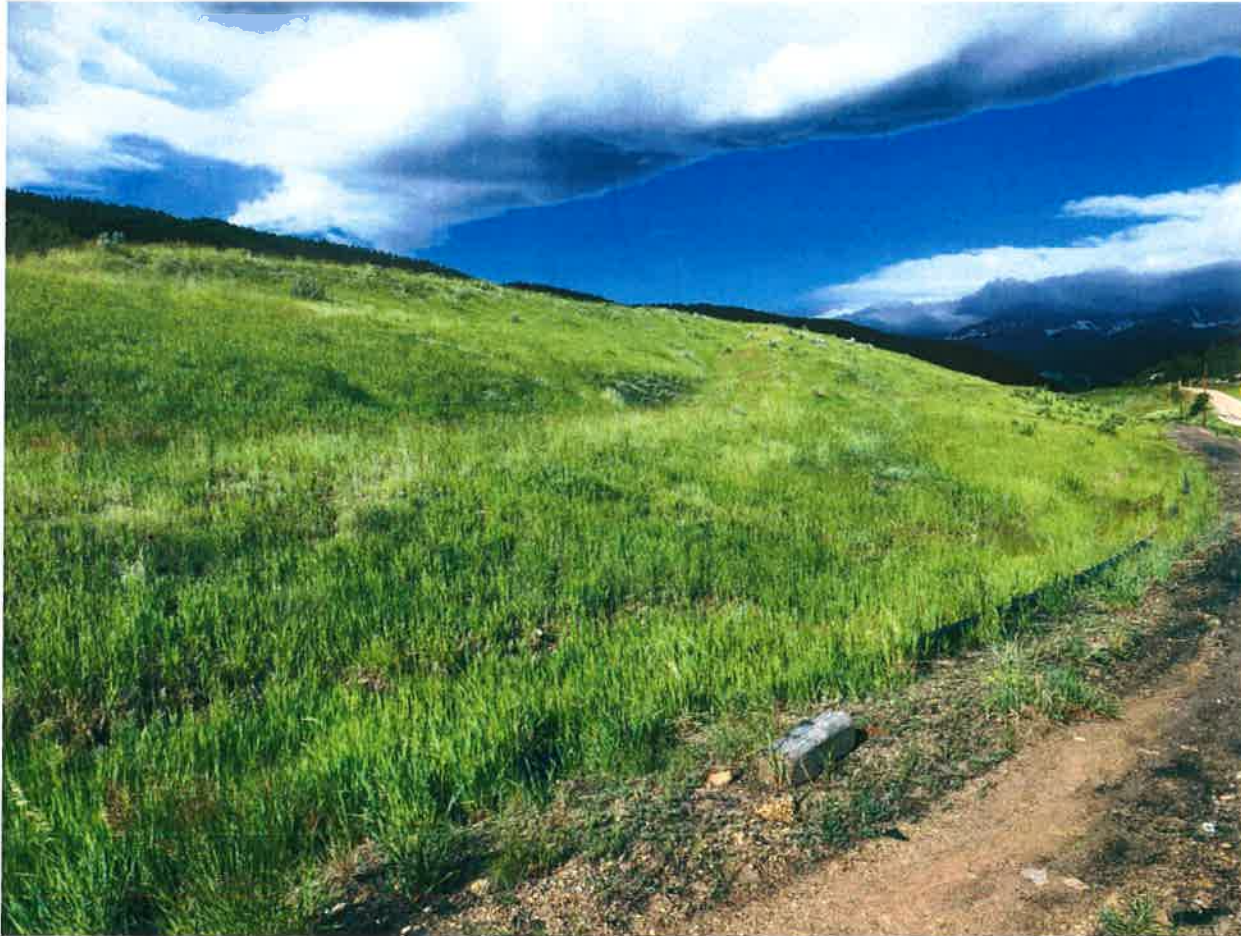
Surface and out slopes of the pile were inspected for visible signs of potential failure or instability. None were observed.

Summer conditions prevail with surface dry. Overall the site is in good condition.

DWDA #1 – North Facing Slope – June 19, 2019

None at this time.

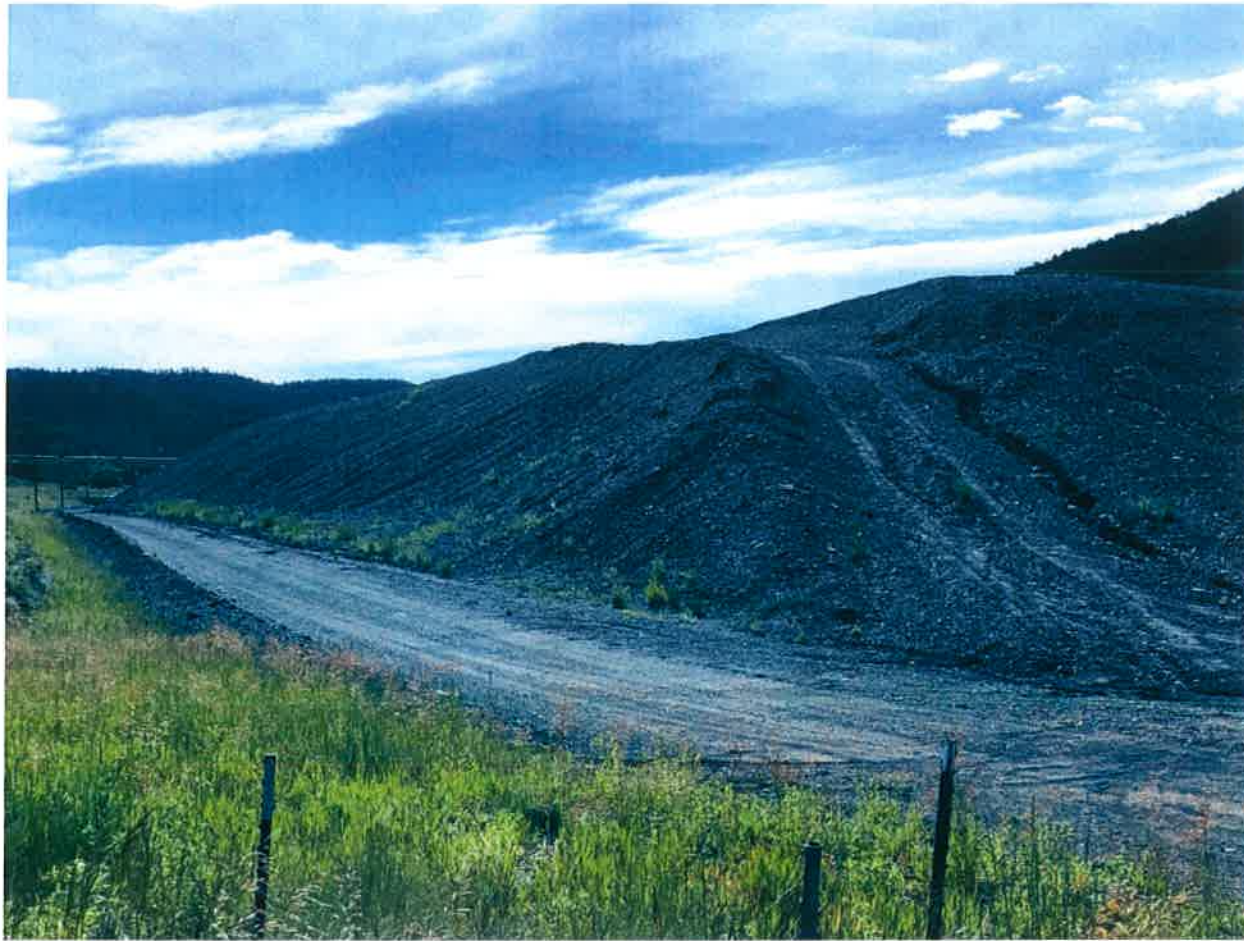
Surface and out slopes of the pile were inspected for visible signs of potential failure or instability. There was some surface erosion but not enough to make the area unstable. In all no signs of failure or instability were observed.

Summer conditions prevail with surface dry. Overall the site is in good condition.

DWDA #2 – North and West Facing Slopes – June 19, 2019

Ditches and sumps are clean around the area. Rills are developing primarily on the south and north facing slopes. Operator is evaluating either reclamation of the area or permitting alternative uses of the land north of the Purgatoire River and south of Highway 12.

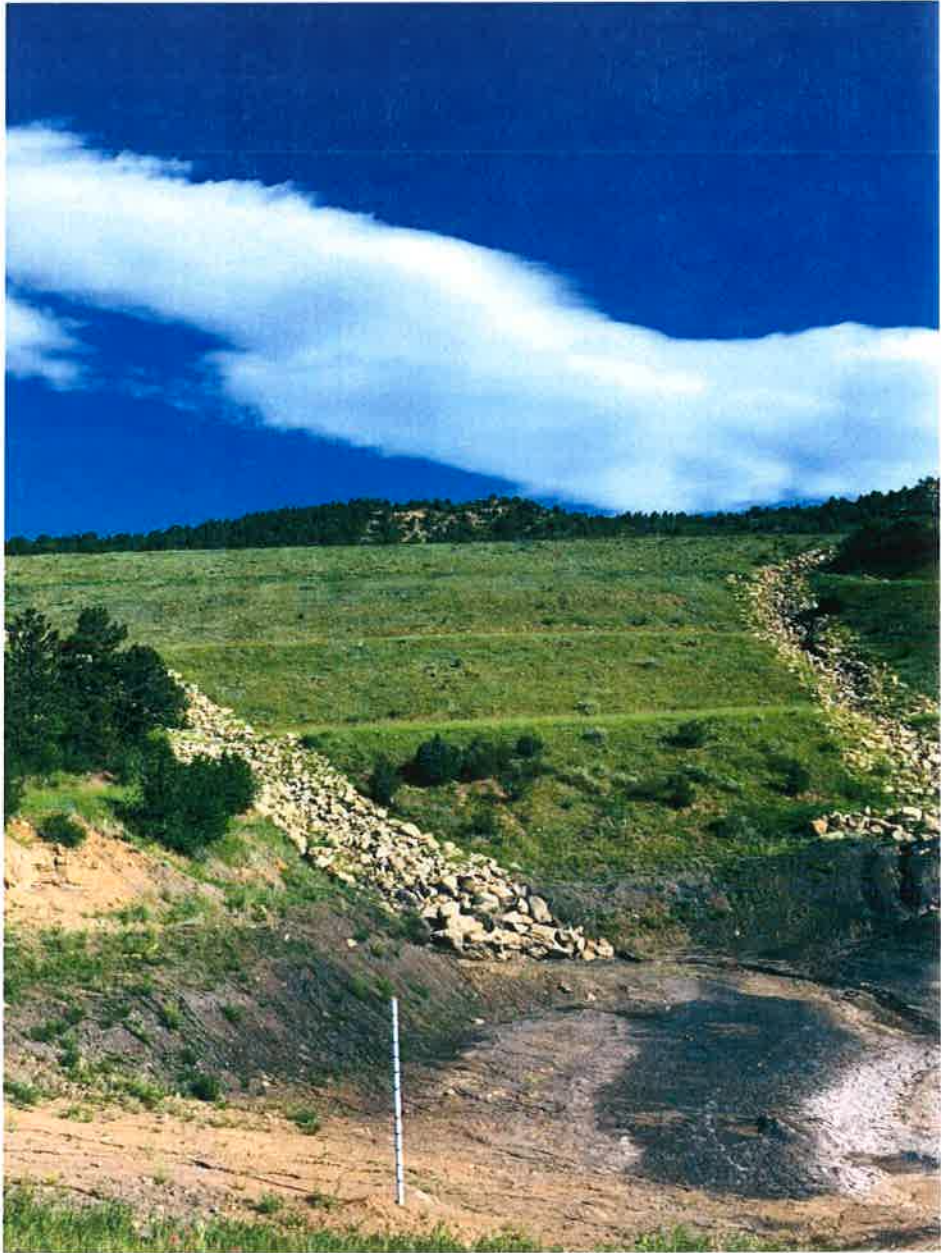
None observed.

Summer conditions prevail with surface dry. Overall the site is in good condition.

Refuse Disposal Area – Reclaimed Benches and Armored Drainage – June 19, 2019

None required at this time.
