**NEW ELK MINE**  
**Permit No. C-1981-012**

**QUARTERLY COAL WASTE BANK INSPECTION REPORT**  
**September 19, 2019**

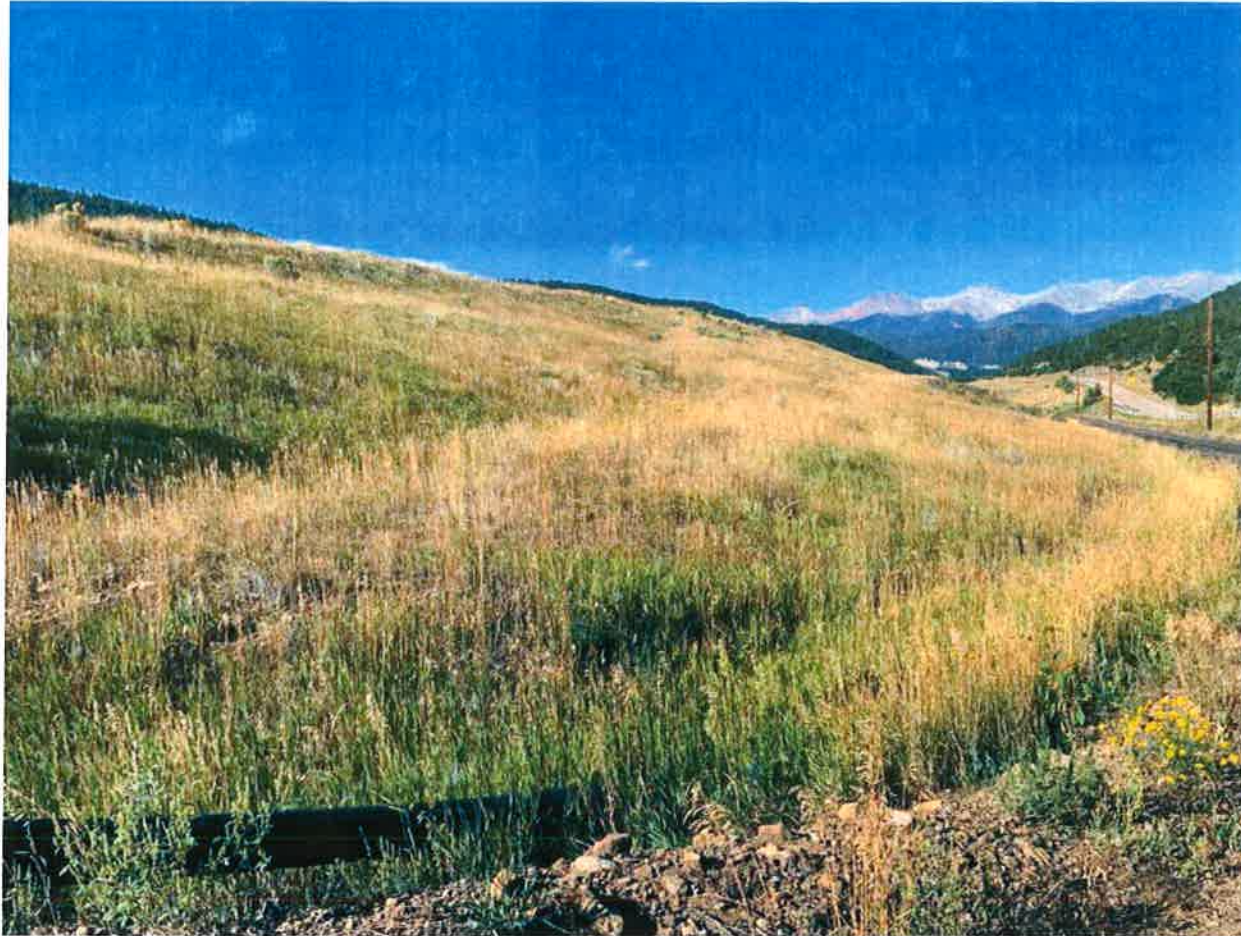
Surface and out slopes of the pile were inspected for visible signs of potential failure or instability. None were observed.

Overall the disposal area is in good condition.

**DWDA #1 – North Facing Slope – September 19, 2019**

None at this time.

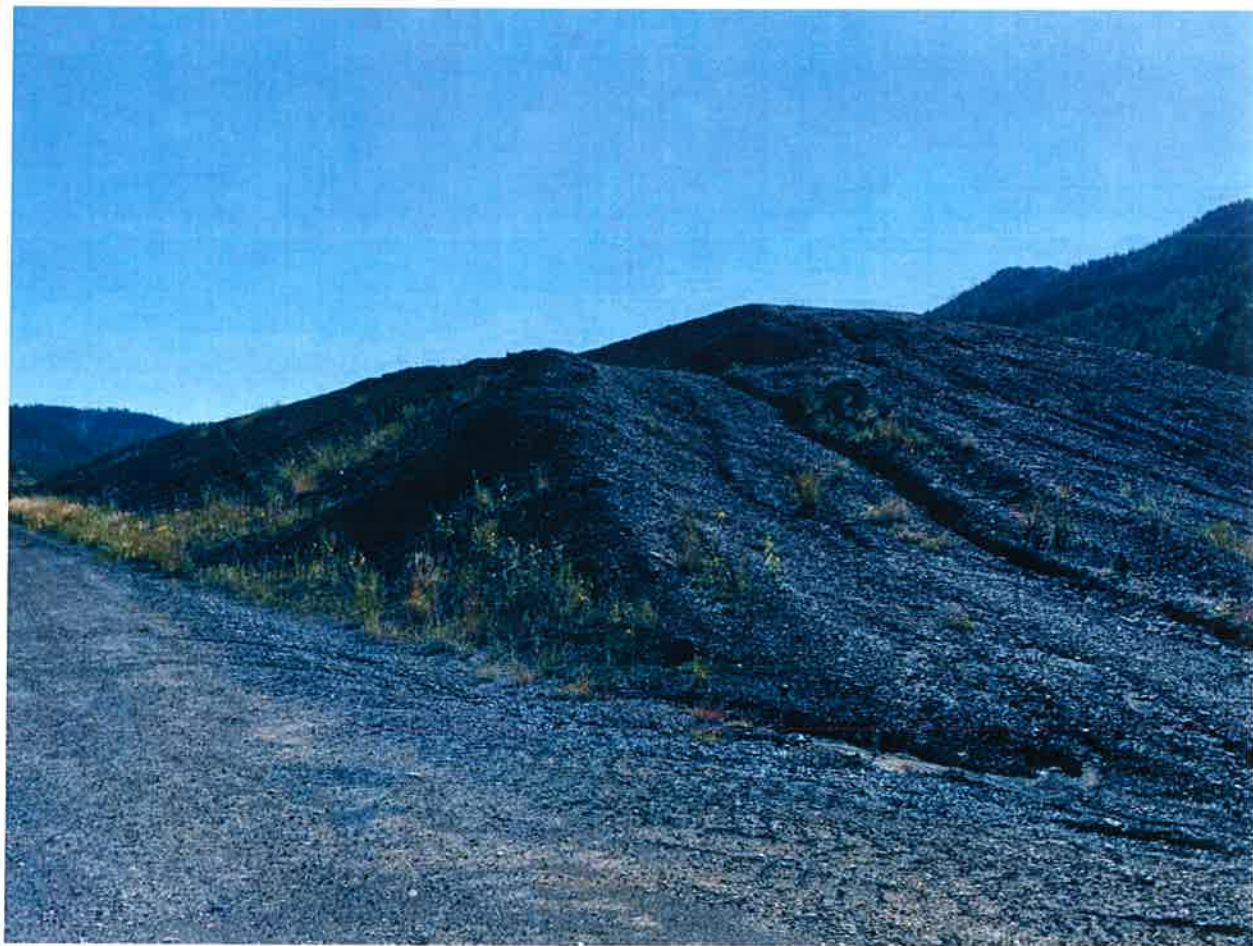
Surface and out slopes of the pile were inspected for visible signs of potential failure or instability. There was some surface erosion but not enough to make the area unstable. In all no signs of failure or instability were observed.

Overall the disposal area is in good condition.

**DWDA #2 – North and West Facing Slopes – September 19, 2019**

Ditches and sumps are clean around the area. Rills are developing primarily on the south and north facing slopes. The Rills are being monitored. Operator is evaluating either reclamation of the area or permitting alternative uses of the land north of the Purgatoire River and south of Highway 12.

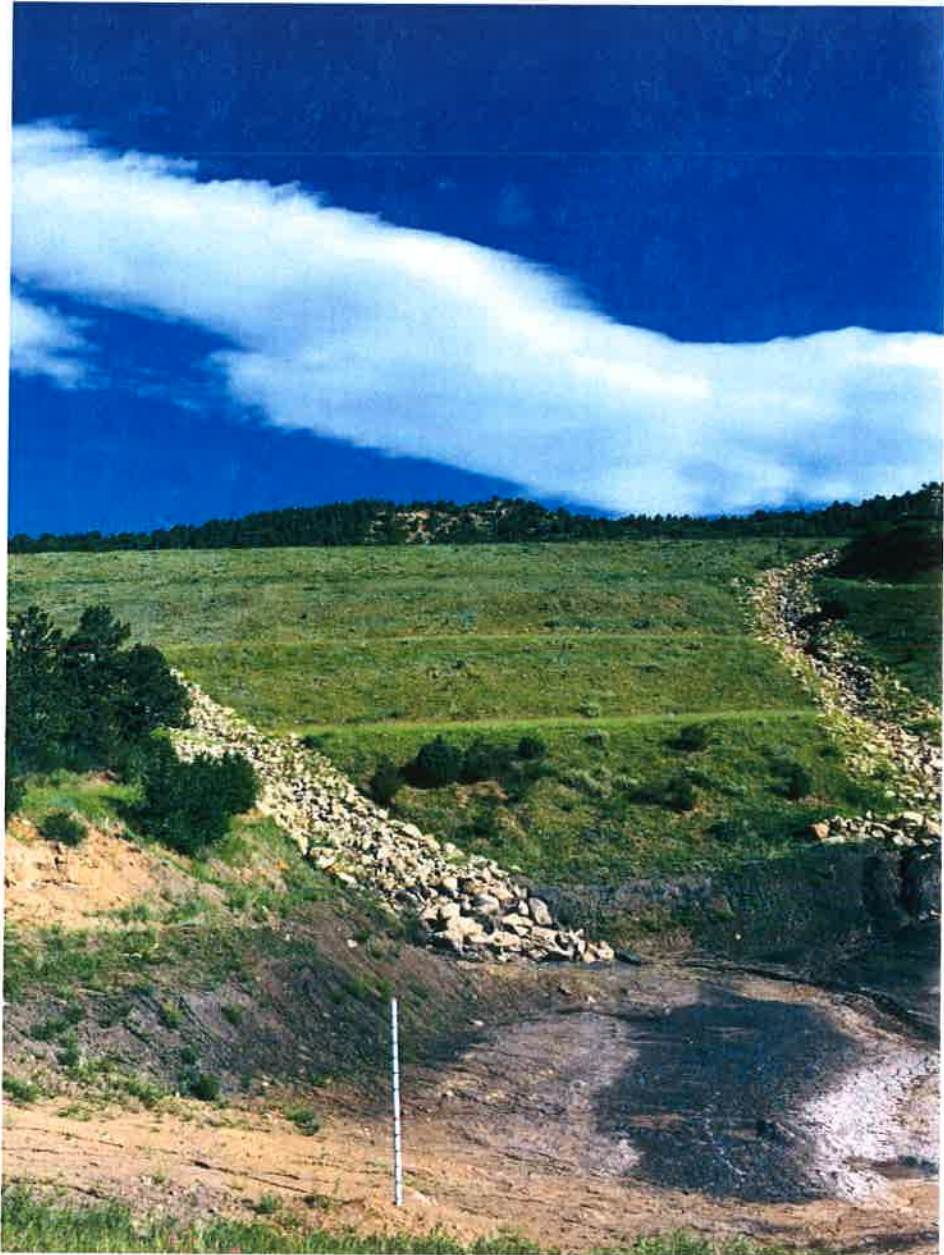
Summer conditions prevail with surface dry. Overall the site is in good condition.

Refuse Disposal Area – Reclaimed Benches and Armored Drainage – September 19, 2019

None required at this time.
