**NEW ELK MINE**  
**Permit No. C-1981-012**

**QUARTERLY COAL WASTE BANK INSPECTION REPORT**  
**November 26, 2019**

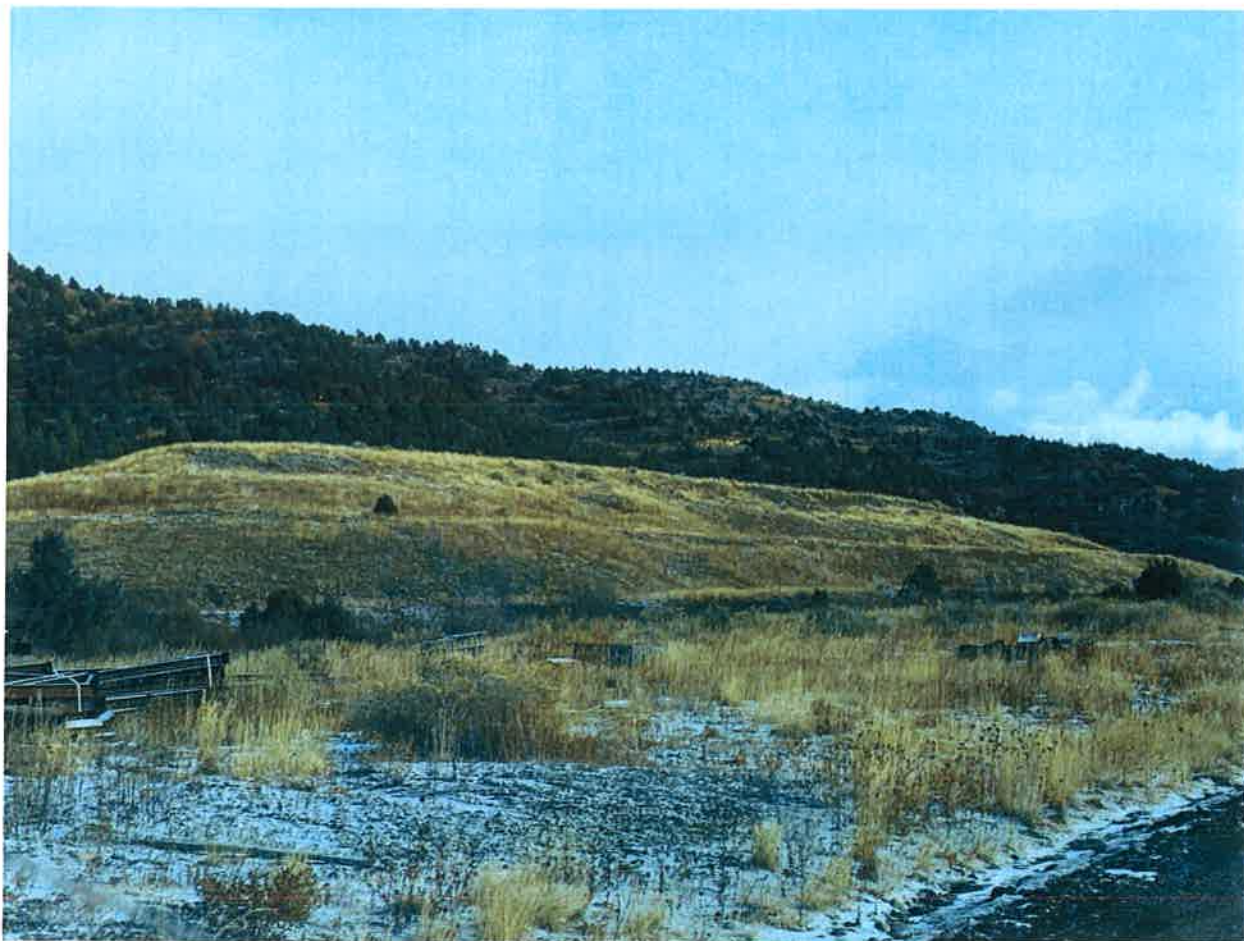
Surface and out slopes of the pile were inspected for visible signs of potential failure or instability. None were observed.

Overall the disposal area is in good condition.

**DWDA #1 – South Facing Slope**

None at this time.

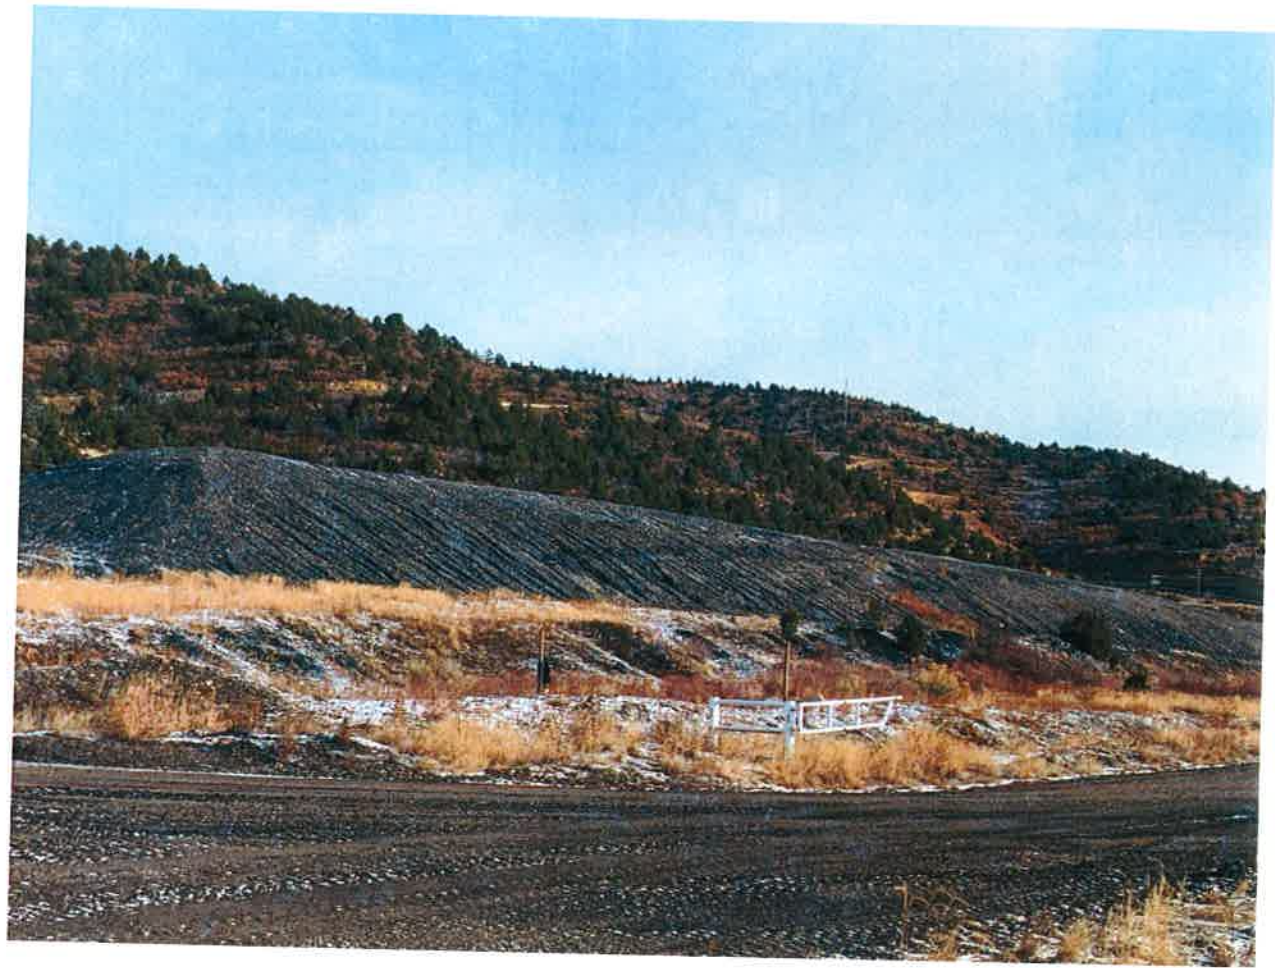
Positive Drainage is maintained on the surface of the DWDA. Sump on East end of pile was recently cleaned and is in good working order. Rills on the disposal area are being monitored. No evidence of springs nor seeps were observed.

Surface and out slopes of the pile were inspected for visible signs of potential failure or instability. There was some surface erosion but not enough to make the area unstable. In all no signs of failure or instability were observed.

Overall the disposal area is in good condition.

**DWDA #2 – South and West Facing Slopes**

The Rills are being monitored and have not gotten any bigger and there is no sediment loading. Operator is evaluating either reclamation of the area or permitting alternative uses of the land north of the Purgatoire River and south of Highway 12.

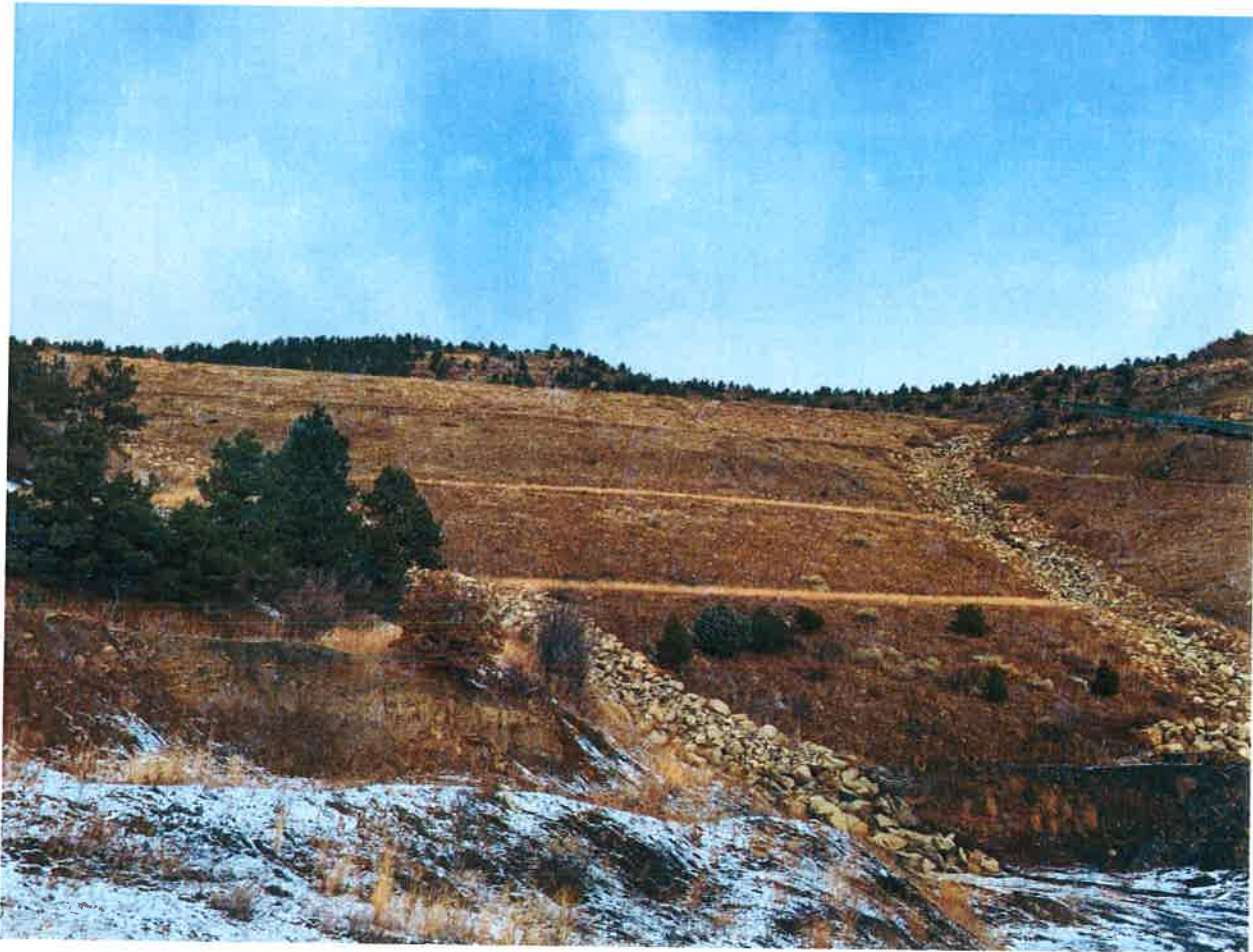
Positive Drainage is maintained on the surface of the RDA. Sumps on top of the RDA have been recently cleaned. There is no ponding on the top of the pile. No evidence of springs nor seeps were observed.

Summer conditions prevail with surface dry. Overall the site is in good condition.

Refuse Disposal Area – Reclaimed Benches and Armored Drainage

None required at this time.
