MINERALS PROGRAM INSPECTION REPORT PHONE: (303) 866-3567

MINE NAME: Tallahassee Pit	MINE/PROSPECTING ID#: M-1999-003	MINERAL: Sand and gravel	COUNTY: Fremont
INSPECTION TYPE: Monitoring	INSPECTOR(S): Timothy Cazier	INSP. DATE: November 8, 2019	INSP. TIME: 08:20
OPERATOR: Seifert Construction dba Seifert Enterprises, LLC	OPERATOR REPRESENTATIVE: Kent Beach	TYPE OF OPERATION: 110c - Construction Limited Impact

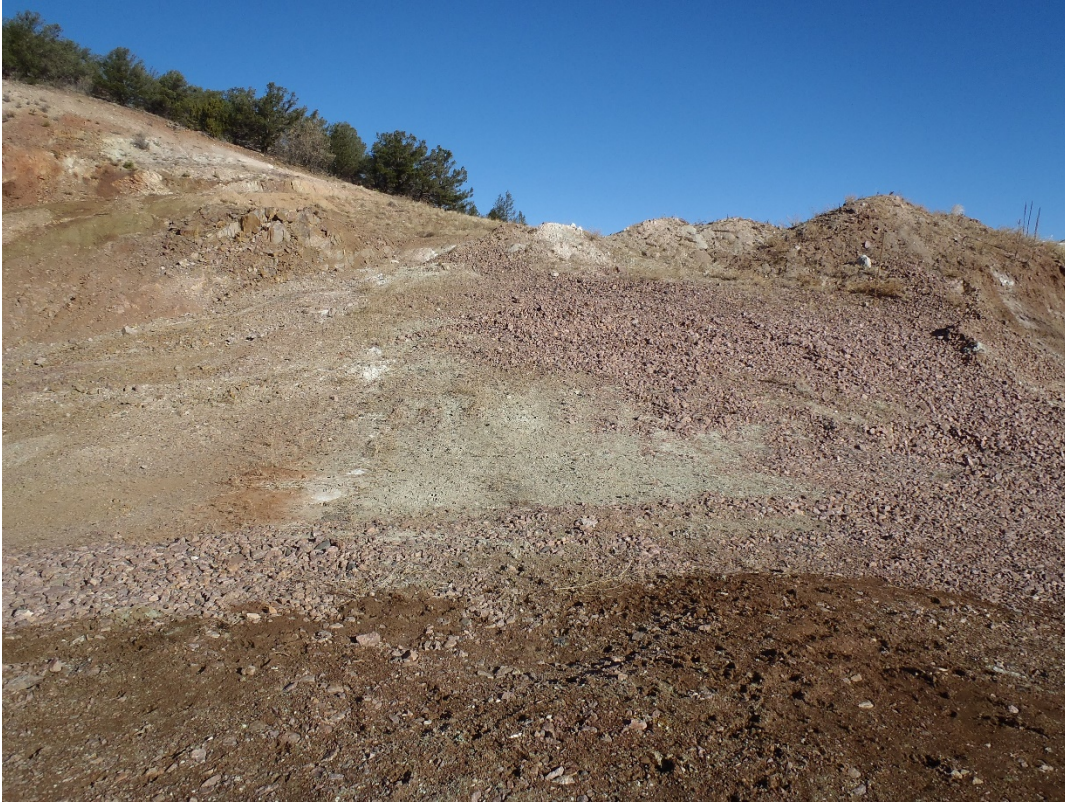
Excess Spoil and Dev. Waste: An overburden pile with higher clay content was observed (see **Photo 1**).

Photo 1. Overburden stockpile north of pit floor (looking north).

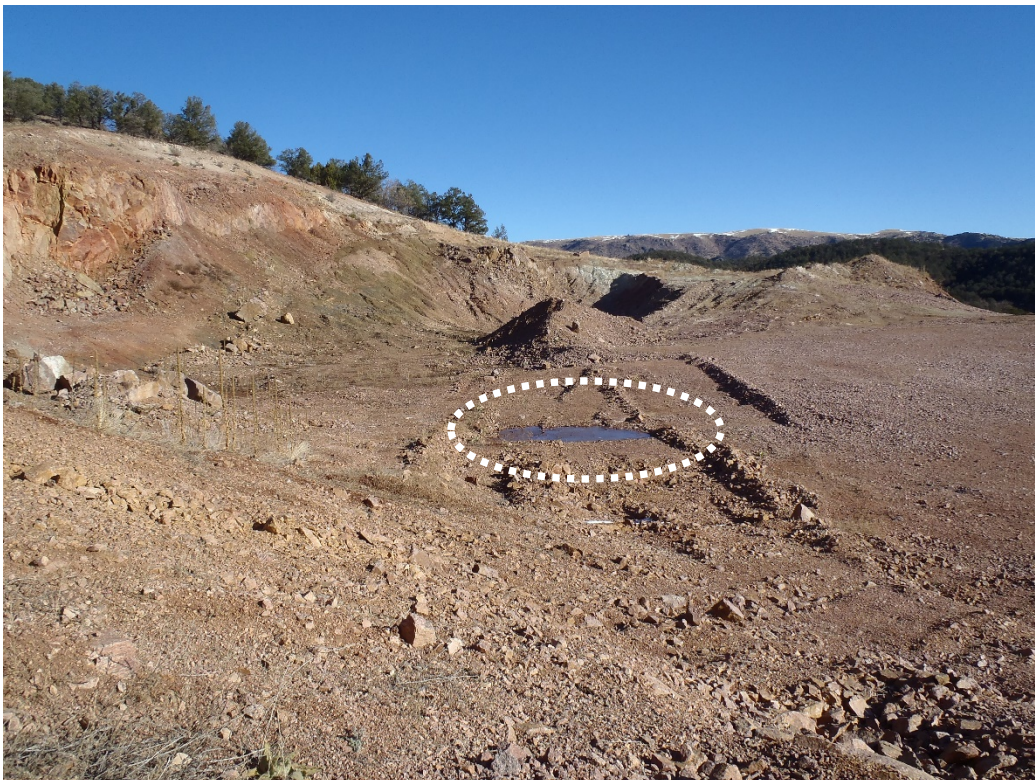
Hydrologic Balance: A small amount of snowmelt was observed in the pit (see **Photo 2**). No exposed groundwater was observed.

Photo 2. Small ponded area of snowmelt on pit floor (looking north).

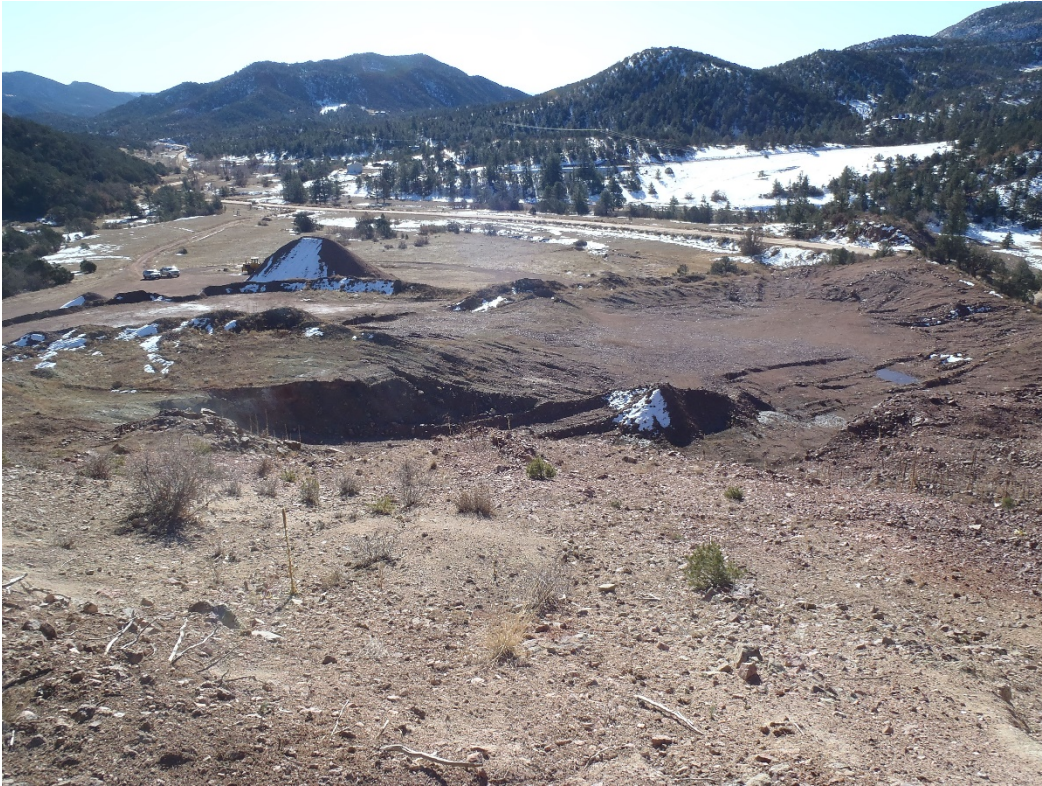
Gen. Compliance with Mine Plan: The extraction of material appeared to be in compliance with the approved mine plan. Overburden was stockpiled to the north end of the pit (see **Photo 3**). The maximum allowed disturbed area is 9.9 acres. Google Earth was used to measure the disturbed area, which was estimated to be approximately 6.65 acres, based on 2016 imagery. The highwall height varied with the height of the ridge being mined, but was estimated not to exceed 25 feet appeared stable (see **Photo 4**). Evidence of stockpiled material removal and a front-end loader were observed.

Photo 3. Pit floor and overburden stockpile (left center) from top of highwall (looking SE).

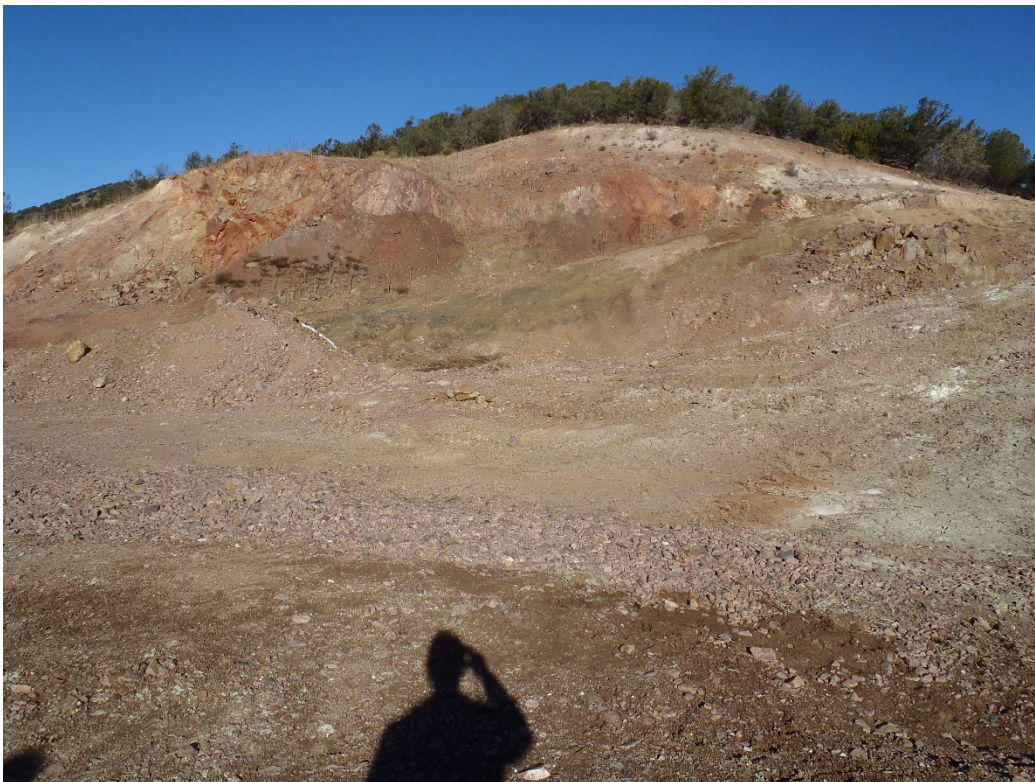
Photo 4. Pit highwall (looking NW from pit floor).

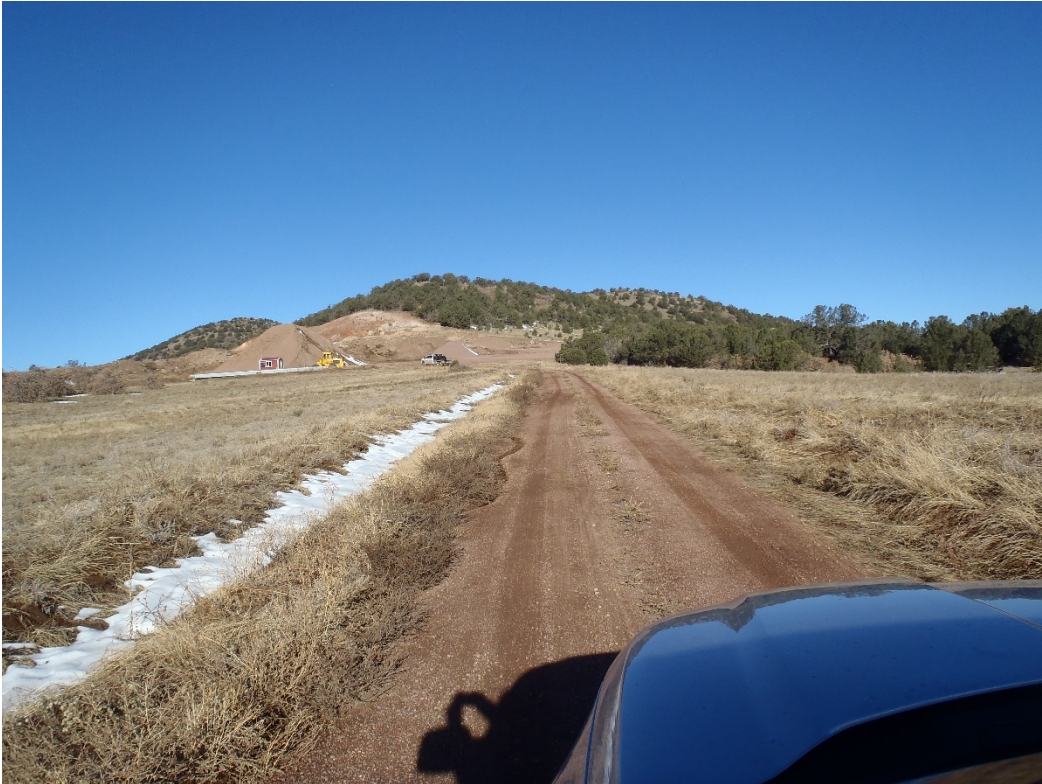
Roads: Haul and access roads did not appear to be a source of sediment that could be tracked offsite. Road side ditches free of sediment, but the south side could benefit from mowing (see **Photo 5**).

Photo 5. Access/haul road with ditches on both sides (looking NW – mowing recommended).

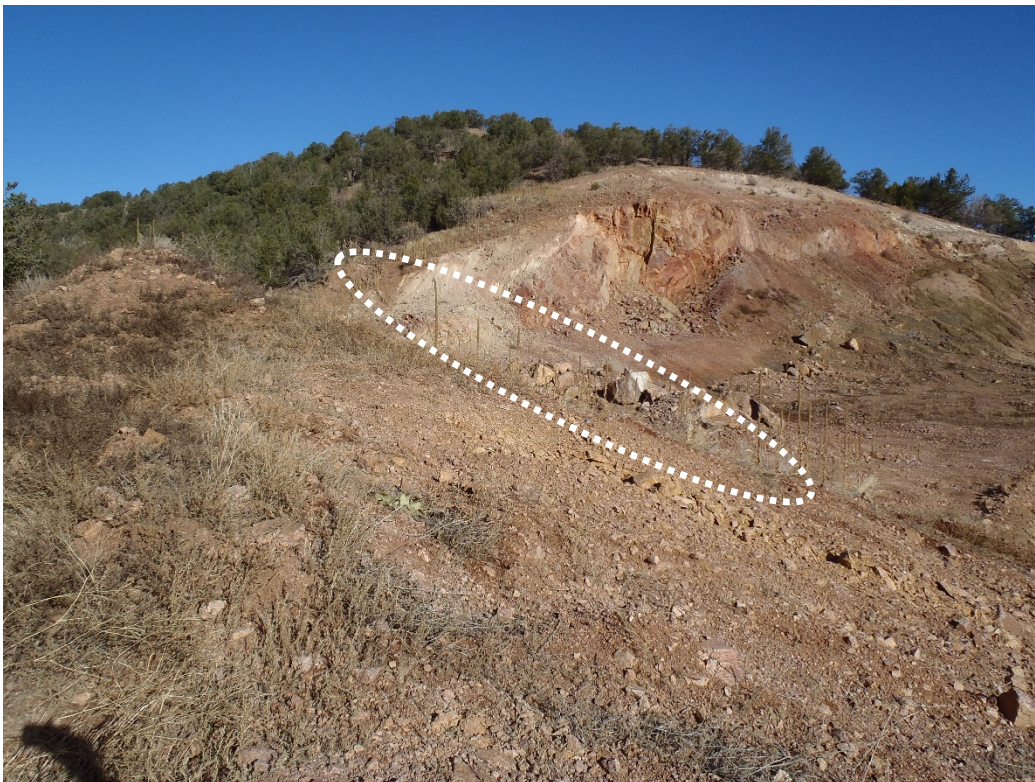
Revegetation: No revegetation has been initiated. Some Common Mullein was observed (see **Photo 6**). This is a noxious weed List C species, so it was not cited as a problem. However, [the Operator should implement a weed control program to reduce the number of mullein plants on site.](#)

Photo 6. Common Mullein south of highwall.

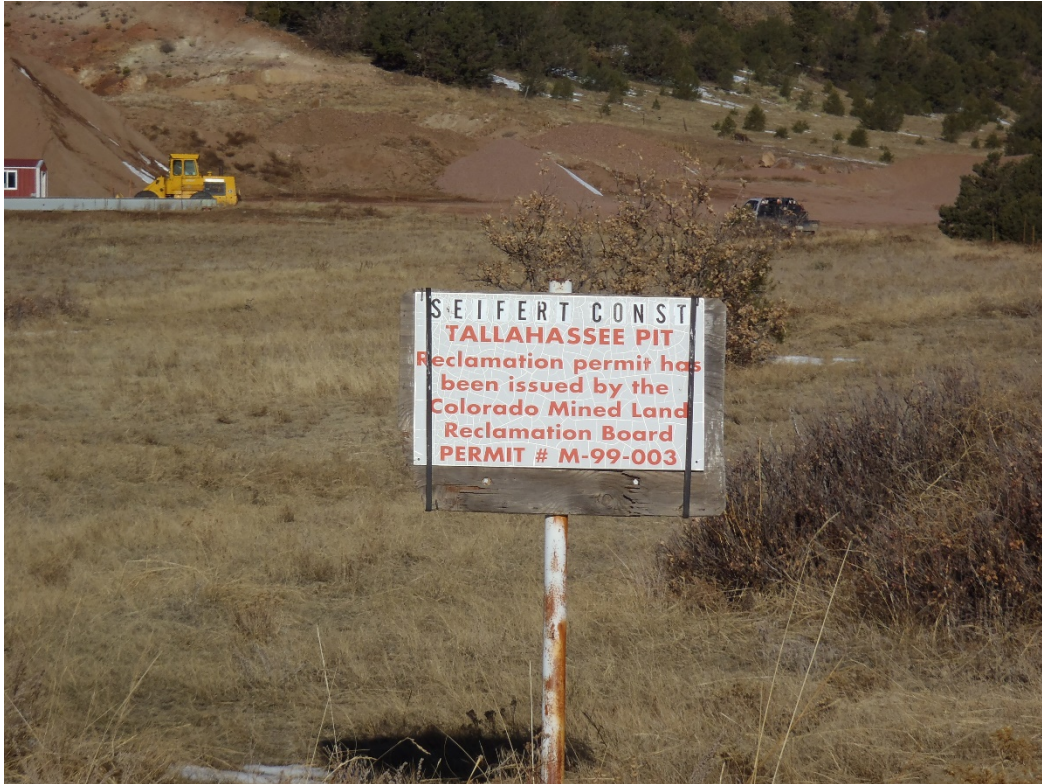
Support Facilities On-site: A truck scale was observed on site (see **Photo 7**).

Photo 7. Required permit sign (near entrance, note loader & truck scale in left background).

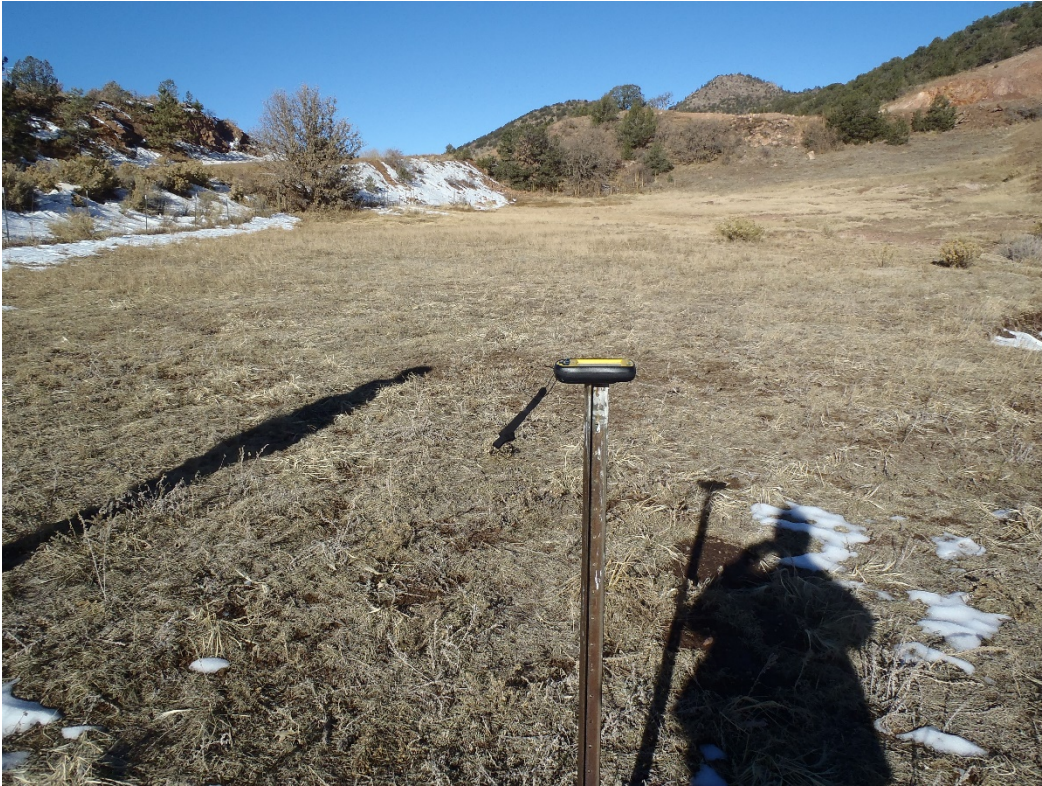
Photo 9. Typical permit boundary T-post (SE corner, looking NW).

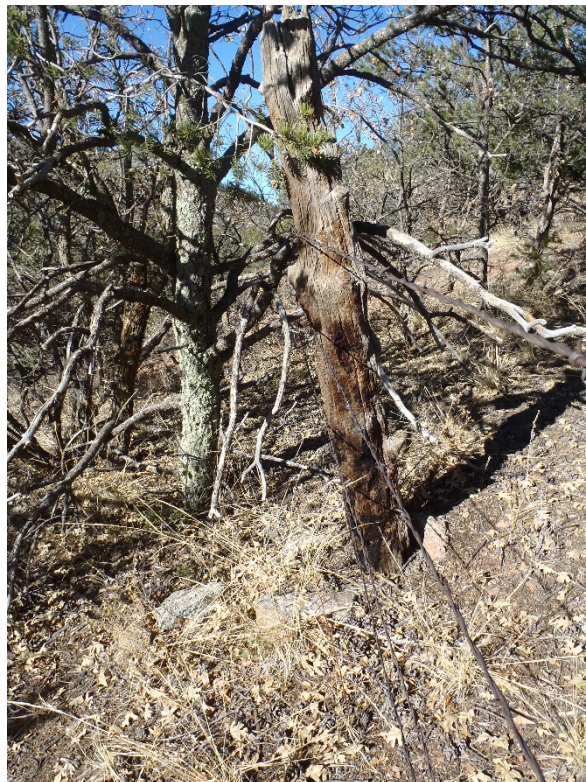
Photo 10. BLM fence line (above highwall, looking west).

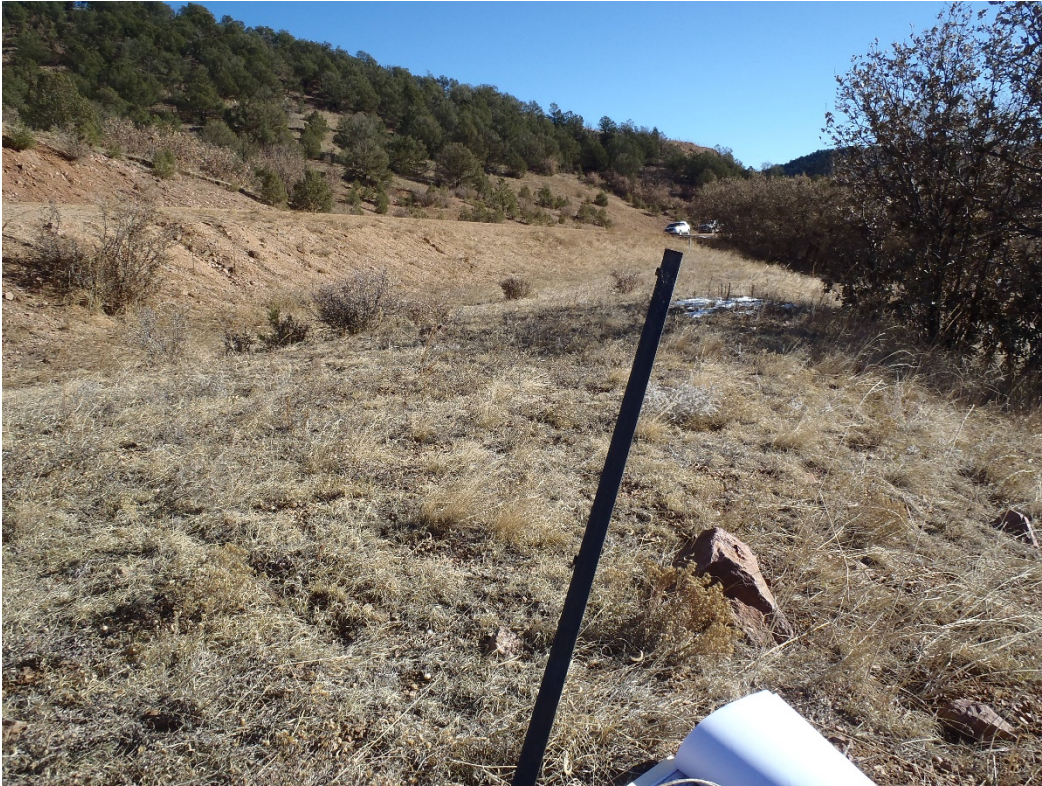
Photo 11. T-post on old CR2 alignment, mine on other side of CR2 (SW corner, looking east).

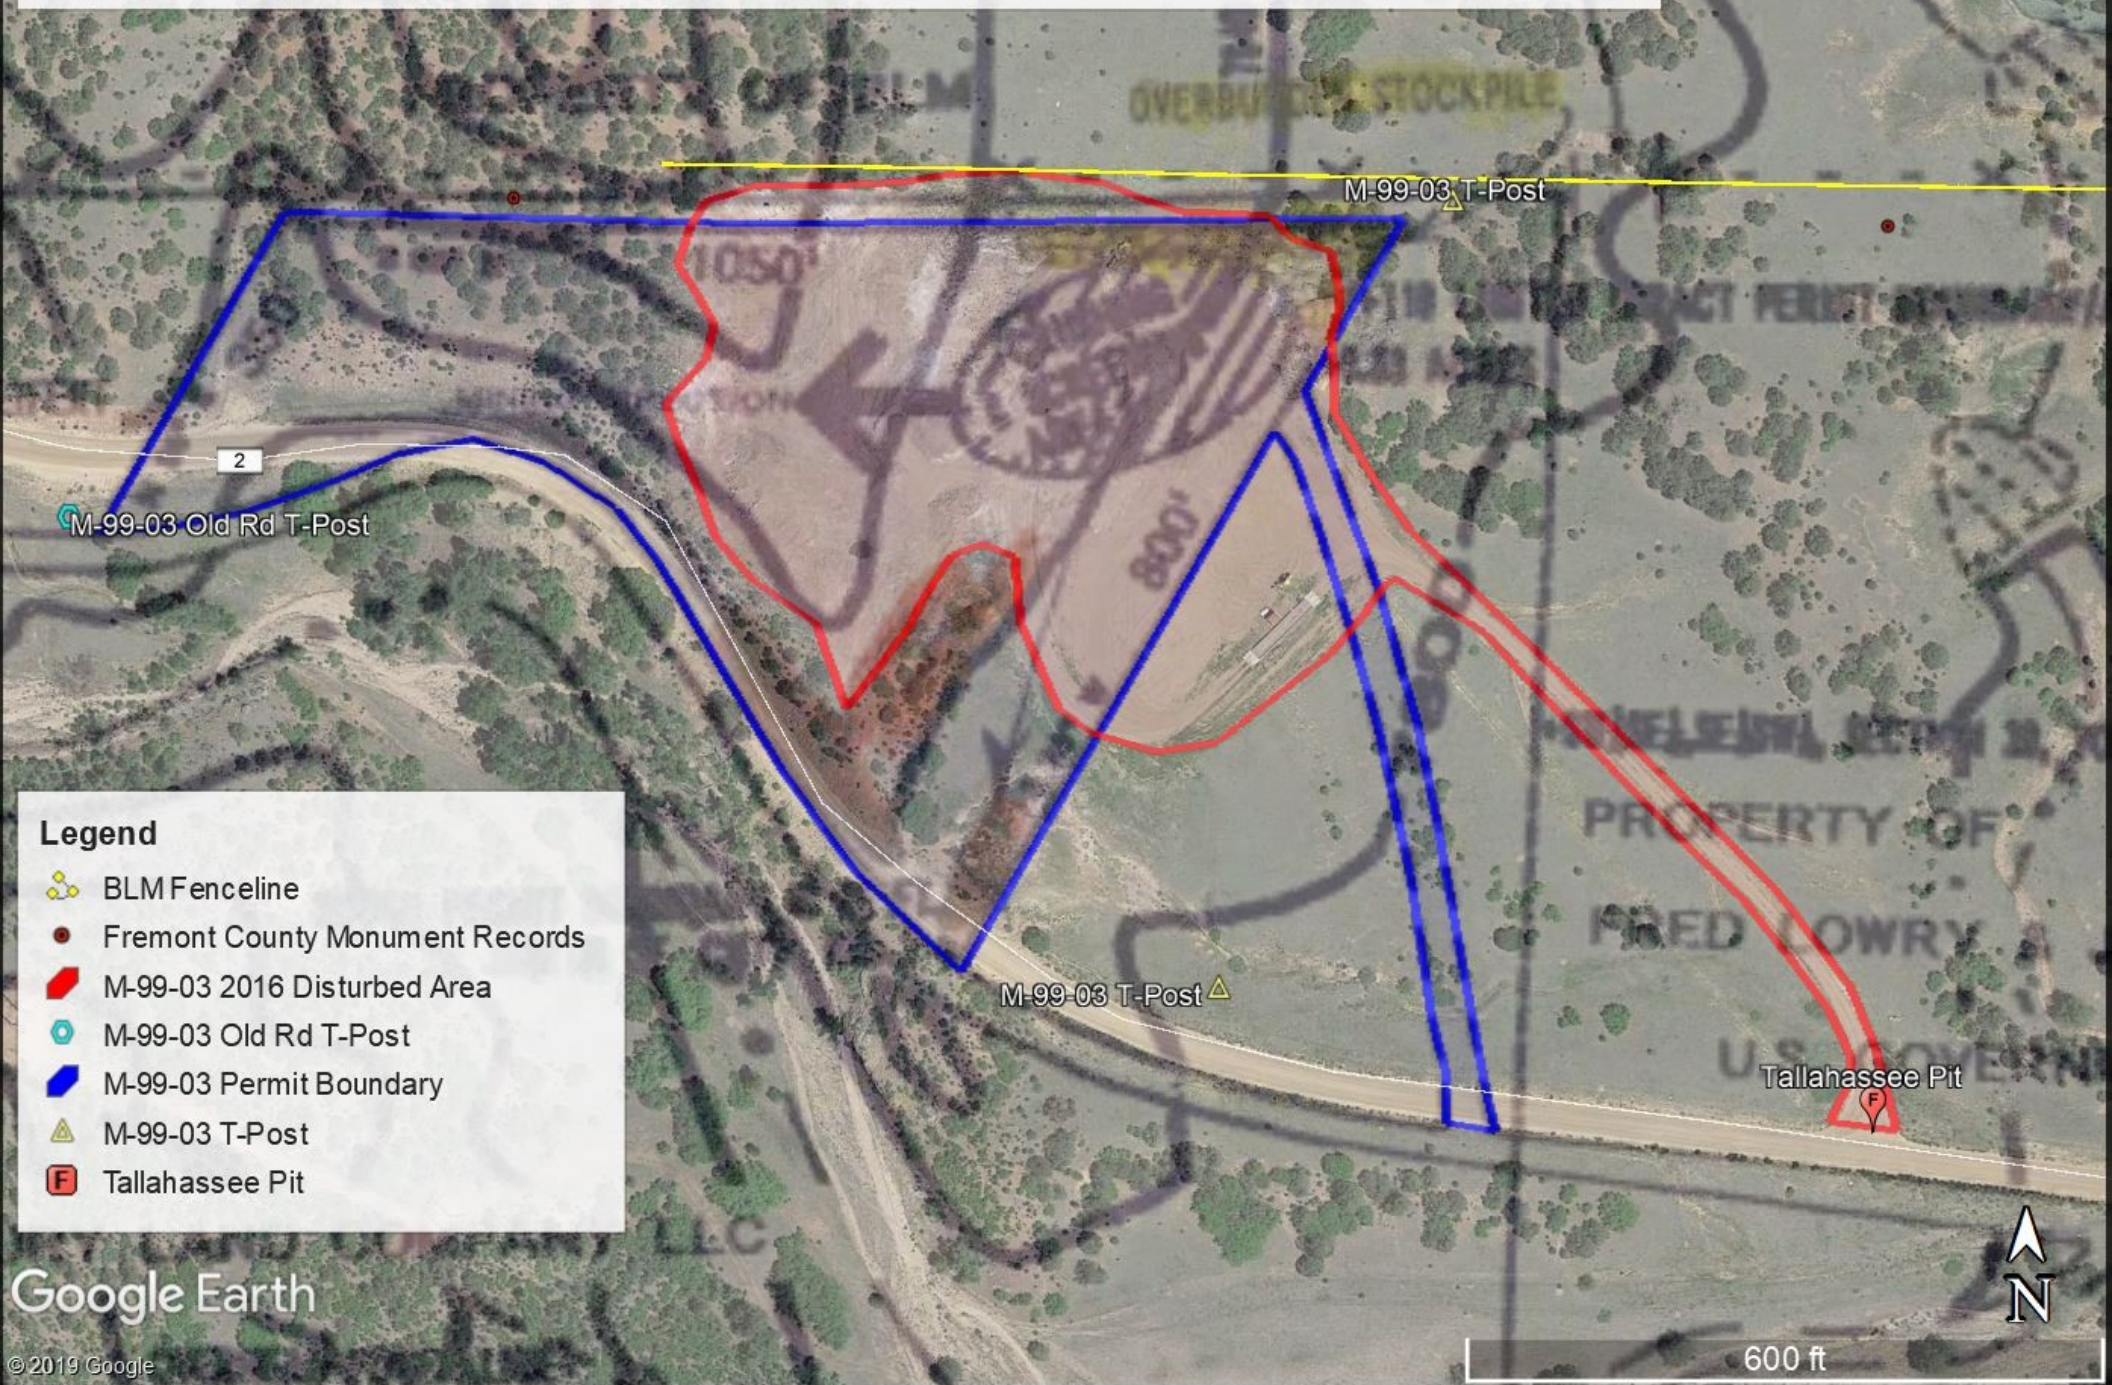
M-1999-003 2019 Post Inspection Map

PROBLEM/POSSIBLE VIOLATION: Problem: The in place boundary markers do not coincide with those of the proposed permit boundary in the approved permit.

Signs and Markers: The permit sign was properly posted (see **Photo 7**) and the majority of the permit boundary was marked with T-posts or fencing (see **Photo 8**). Two segments of the boundary were either missing markers or they could not be found: 1) no markers or fencing were observed on the southwest side where the pit floor is above the adjacent county road, CR2 (see **Photos 9**); and 2) no markers were found on the northwest boundary, which is obscured by trees (see **Photos 10**). Mr. Beach indicated they would not likely mine the west end as the topography steepens significantly and the permit boundary narrows, thereby not leaving much room for either mining or reclamation. A T-post was located on the south side of CR2 on what appeared to be an old road grade (see **Photo 11**), which could be the southwest corner of the permit boundary. The approved permit boundary map shows the permit area being on the north side of CR2, but it appears the road alignment was shifted north at some time. Mr. Beach could not say whether the road was moved before or after the permit was approved by the DRMS in 1999, but a comparison of Google Earth images and the USGS quad map used to delineate the permit boundary clearly shows the change in alignment of CR2 (see attached **Post Inspection Map**). As referenced above under "Off-site Damage", the observed boundary markers do not coincide with the permit boundary map approved during the original application review process in 1999. **The discrepancy in the permit boundary between that marked in the field and that in the 1999 application is cited as a Problem on page 1 of this report.**

CORRECTIVE ACTIONS: Submit a technical revision (along with the required \$216 fee) with a map clarifying the permit boundary not to exceed 9.9 acres, including the access road.
