**MINERALS PROGRAM INSPECTION REPORT**  
**PHONE: (303) 866-3567**

<b>MINE NAME:</b> Borrow Site for Bennett Crossing Filing 2 (Parcel 1) / (Parcel 2)	<b>MINE/PROSPECTING ID#:</b> M-2019-029 / M-2019-030	<b>MINERAL:</b> Borrow Material	<b>COUNTY:</b> Adams
<b>INSPECTION TYPE:</b> Monitoring	<b>INSPECTOR(S):</b> Elliott Russell and DJ Cunningham	<b>INSP. DATE:</b> December 27, 2019	<b>INSP. TIME:</b> 10:00
<b>OPERATOR:</b> LGI Homes - Colorado, LLC	<b>OPERATOR REPRESENTATIVE:</b> Kacy Flemons	<b>TYPE OF OPERATION:</b> 111(1)(b) - Special One-Time Incidental	
<b>REASON FOR INSPECTION:</b> Normal I&E Program	<b>BOND CALCULATION TYPE:</b> Partial Bond	<b>BOND AMOUNT:</b> \$75,000.00 / \$75,000.00	
<b>DATE OF COMPLAINT:</b> NA	<b>POST INSP. CONTACTS:</b> None	<b>JOINT INSP. AGENCY:</b> None	
<b>WEATHER:</b> Clear	<b>INSPECTOR'S SIGNATURE:</b>

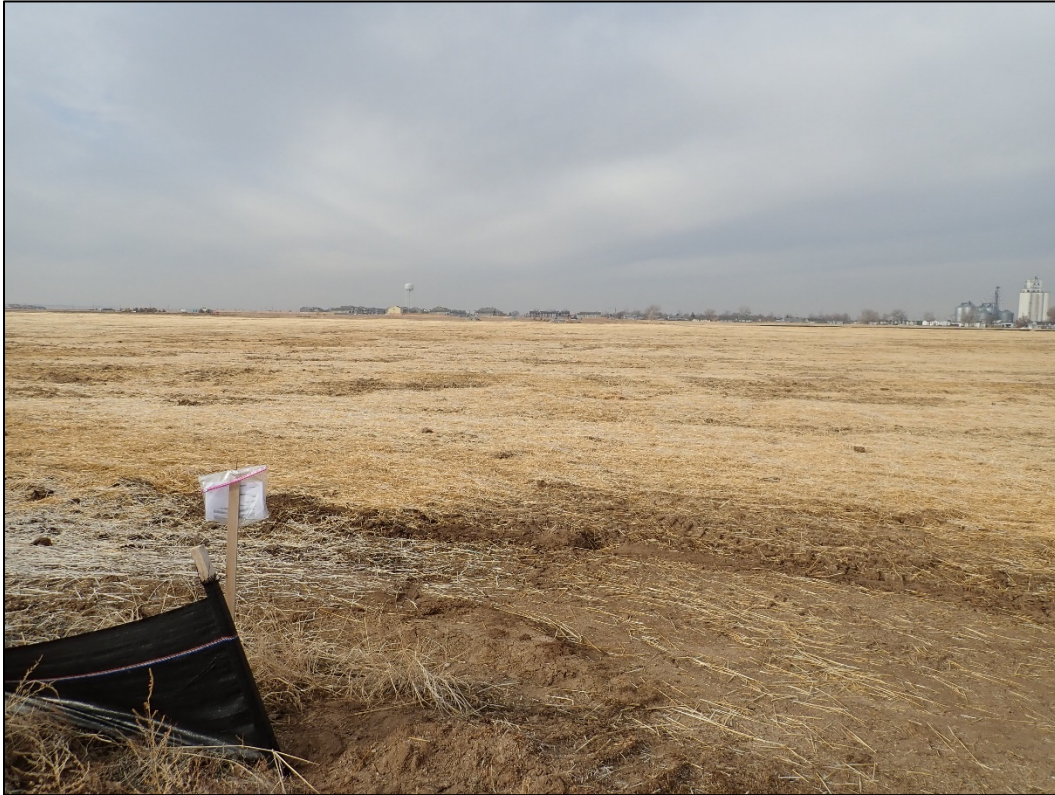
Signs and Markers: The permit signs were properly posted and boundary markers were observed to delineate the permit boundary.

**Photo 1.** Mine identification sign for M-2019-029; looking west.

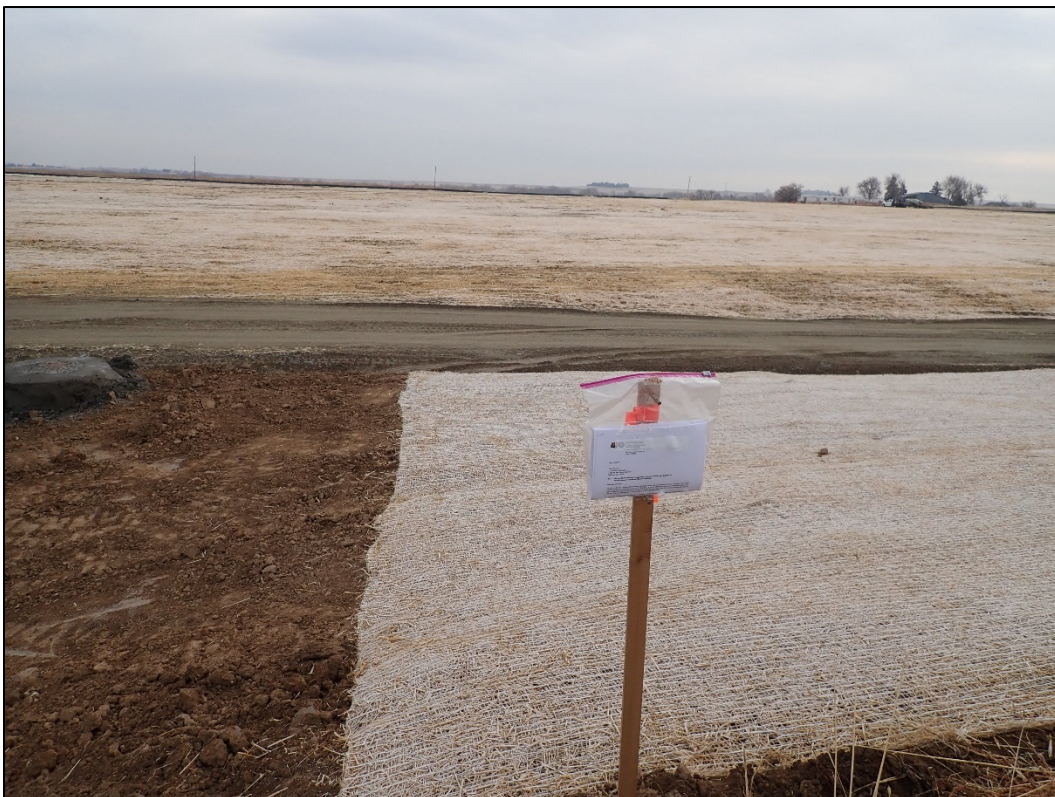
**Photo 2.** Mine identification sign for M-2019-030; looking east.

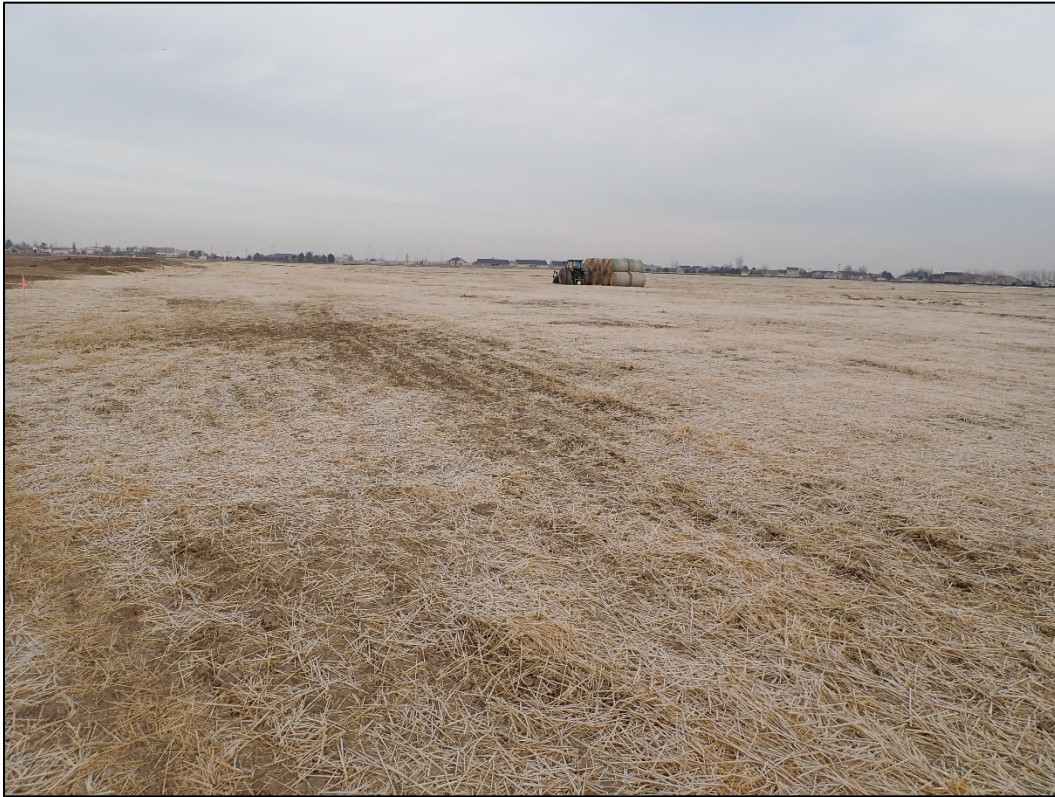
Revegetation: The site was recently seeded and mulched. No noxious weeds were observed, however, the Operator should monitor the site to ensure no noxious weeds become established on the site. The Division recommends the Operator evaluate the site after the next growing season and conduct inter-seeding on areas which do not successfully become revegetated.

**Photo 3.** Sample photo of large borrow area which has just been mulched; looking northeast.

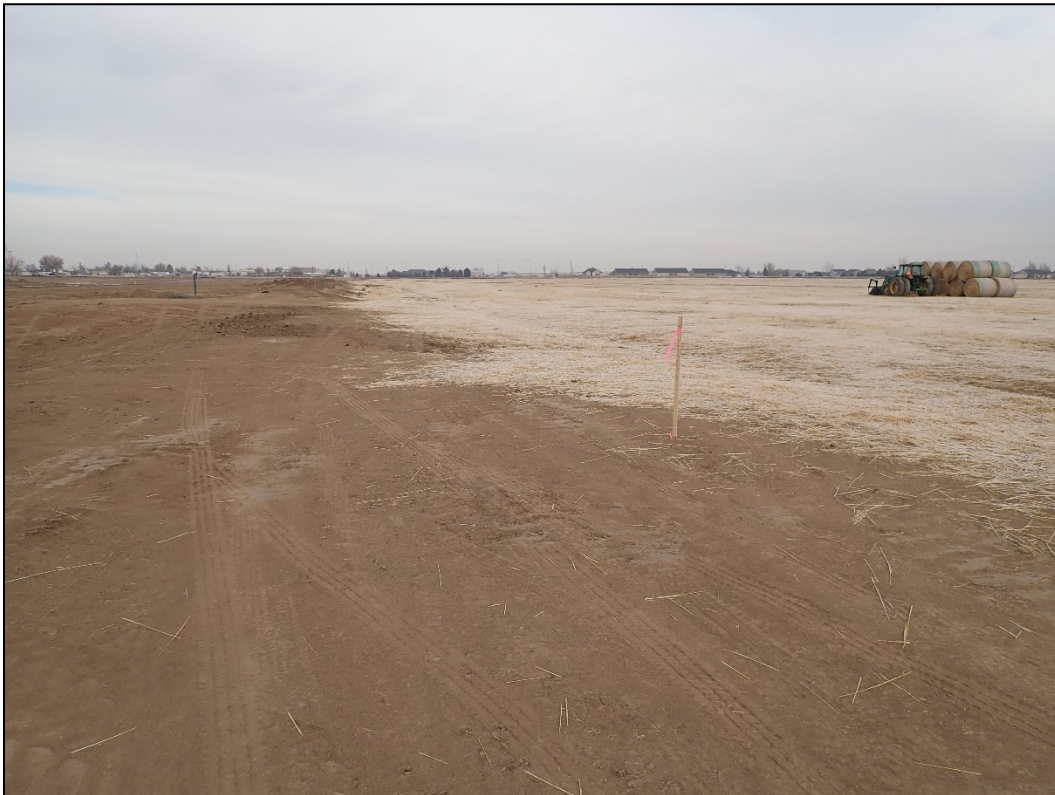
**Photo 4.** Western edge of permit areas; looking north.

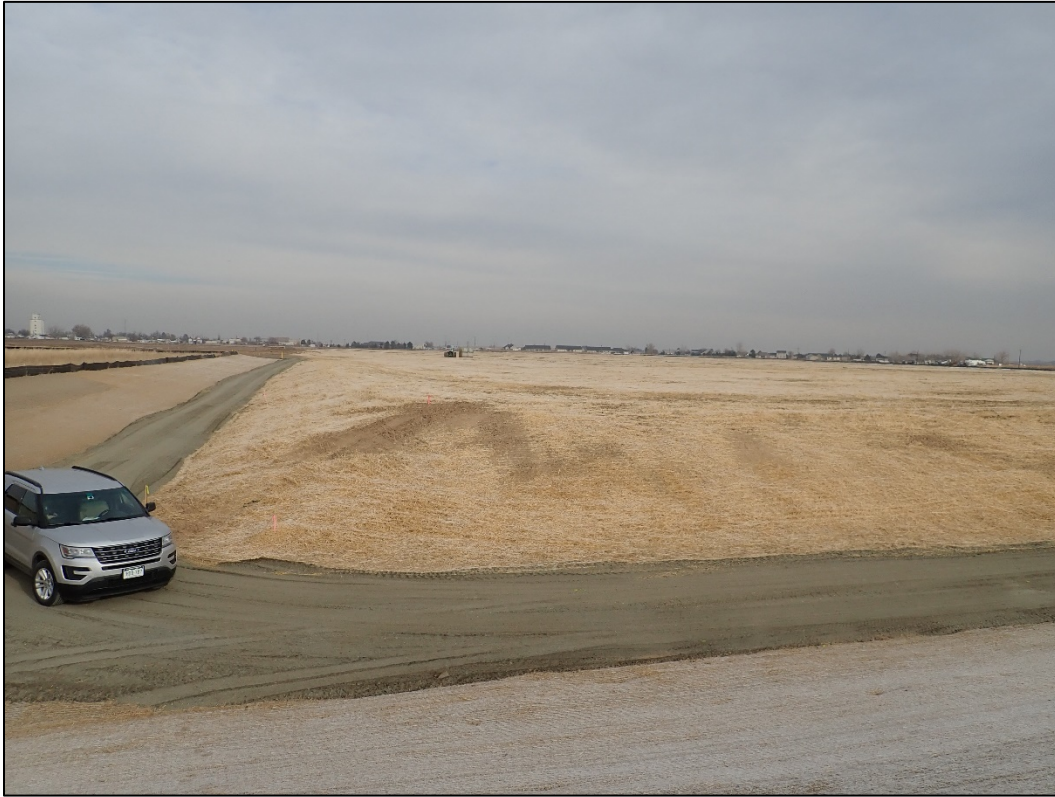
Backfilling and Grading: Backfilling and grading has been completed on the site. A large storm water channel has been constructed along the southwest and south sides of Parcel 2.

**Photo 5.** Southwest corner of Parcel 2 where the storm water channel turns from south to east; looking north.

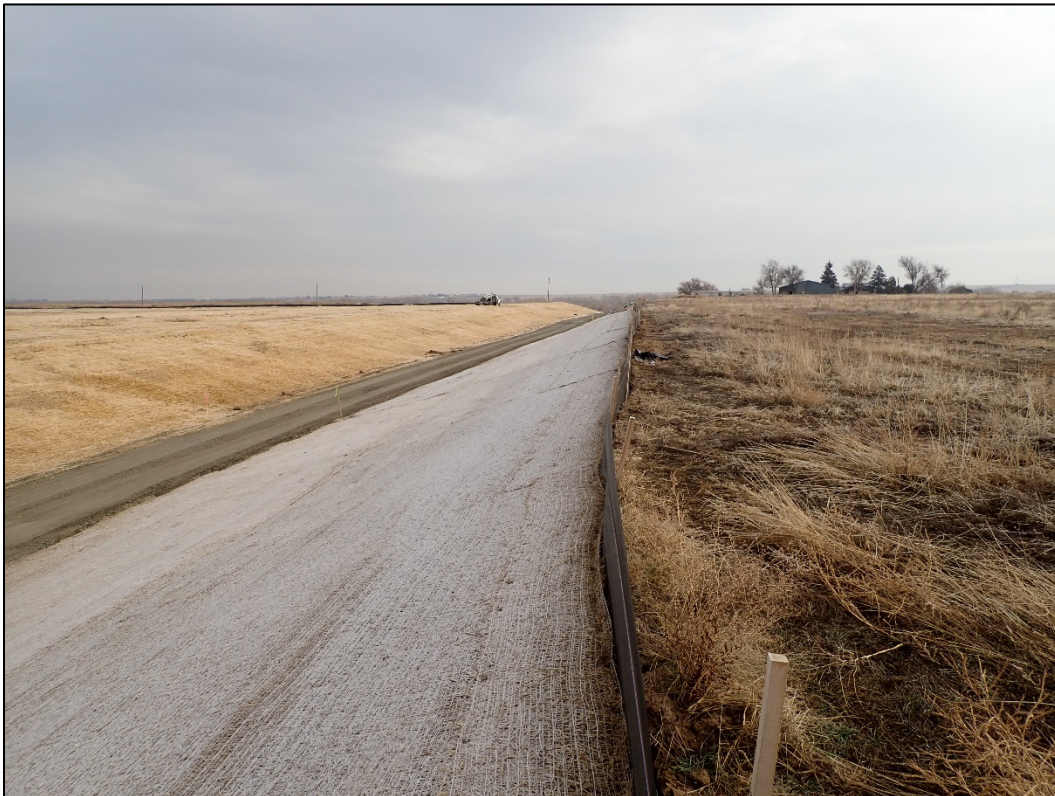
**Photo 6.** Storm water channel along southern edge of affected lands; looking east.

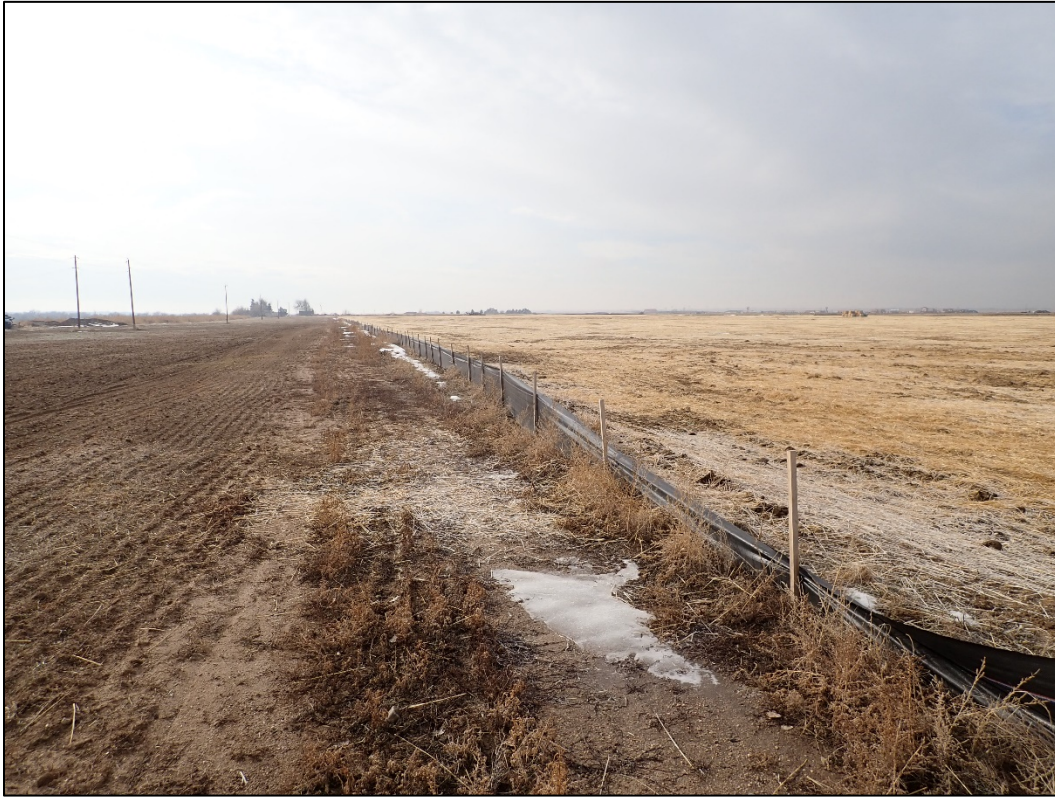
**Photo 7.** Eastern edge of permit areas; looking south.
