Follow up comments / questions AR2, Castle resubmit 1.14.201 message

MEMORANDUM

Re: Review of DRMS Letter Dated December 18, 2019, Continental Materials Corporation January 9, 2020 resubmittal, and January 10, 2020 meeting

Re: Continental Materials Corporation/Castle Aggregate, Pikeview Quarry, Permit M-1977-211, Amendment 04, December 11, 2019 Operator Adequacy Answer Review.

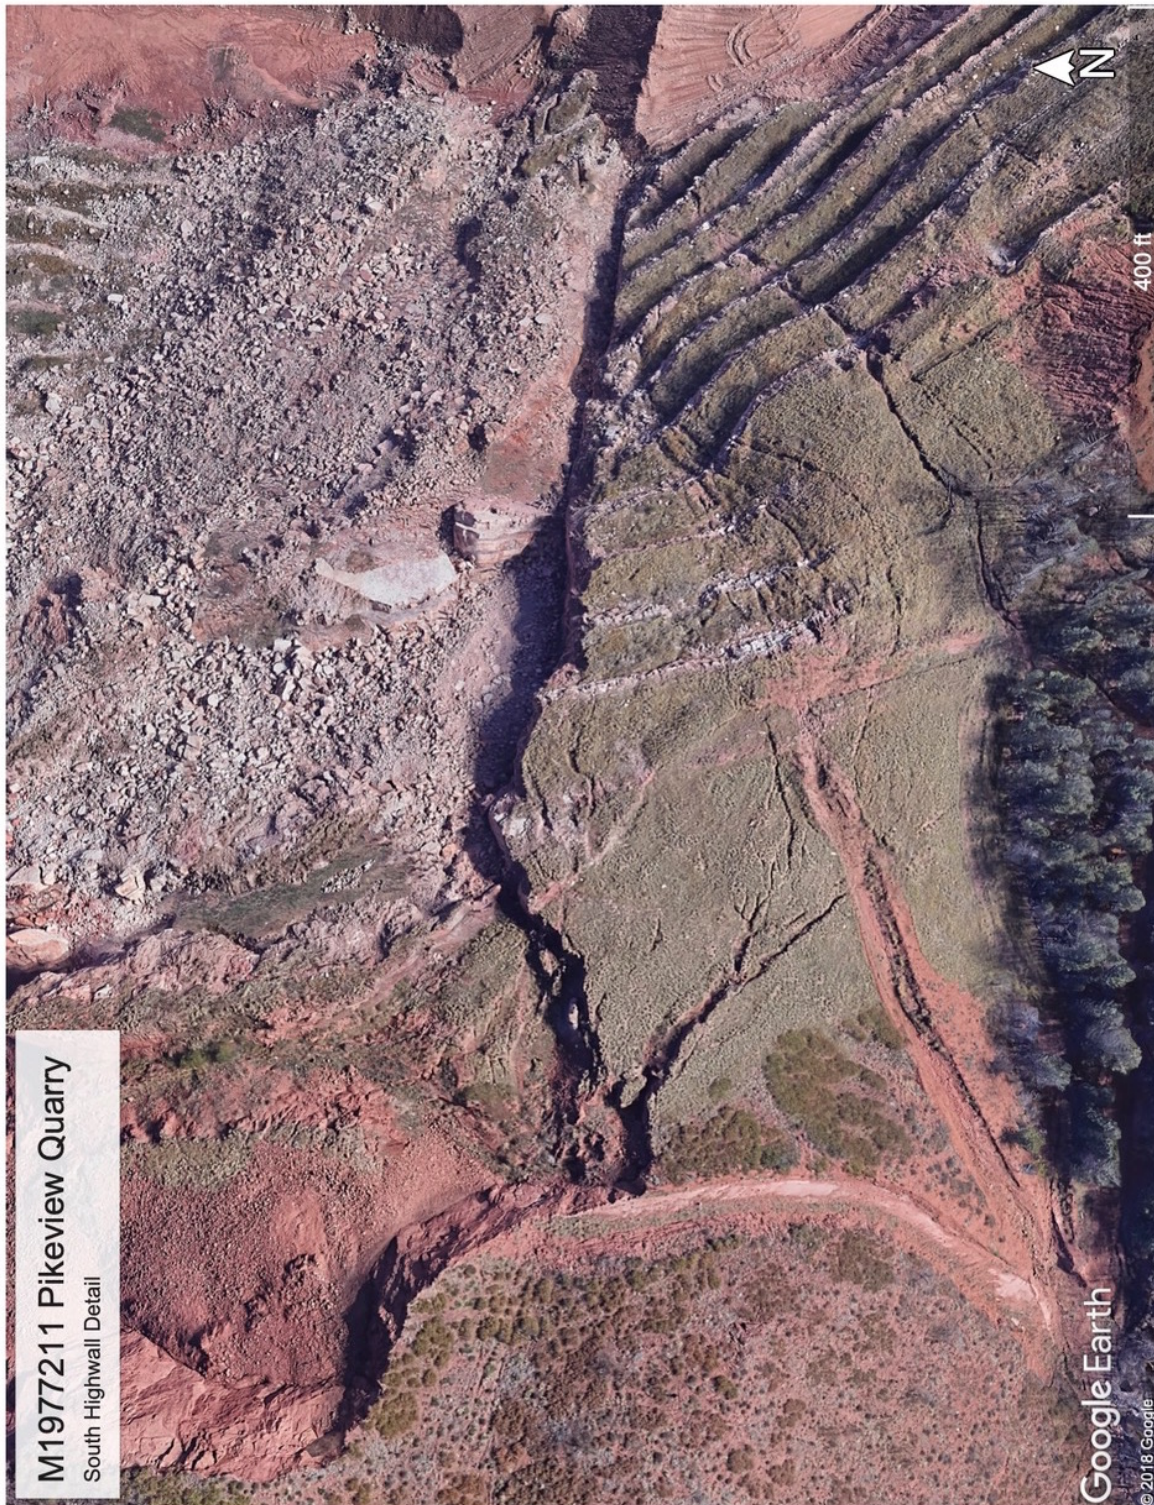
- 9. Review of aerial photographs (attached to this memo) from June 6, 2018 (available via Google Earth) indicate that there is another conchoidal tension crack and scarp developing in the upper south highwall of the quarry (Figure 1). Nothing in the mining and reclamation plans recognizes this or makes for any allowance to buttress this feature properly. None of the cross sections on Maps C-1 or C-2 intersect this possible hanging block of limestone material. DRMS and the operator need to address this dangerous situation.

Figure 1 – Pikeview Quarry – Detail of conchoidal fractures in the south part of the West Highwall, 2018.

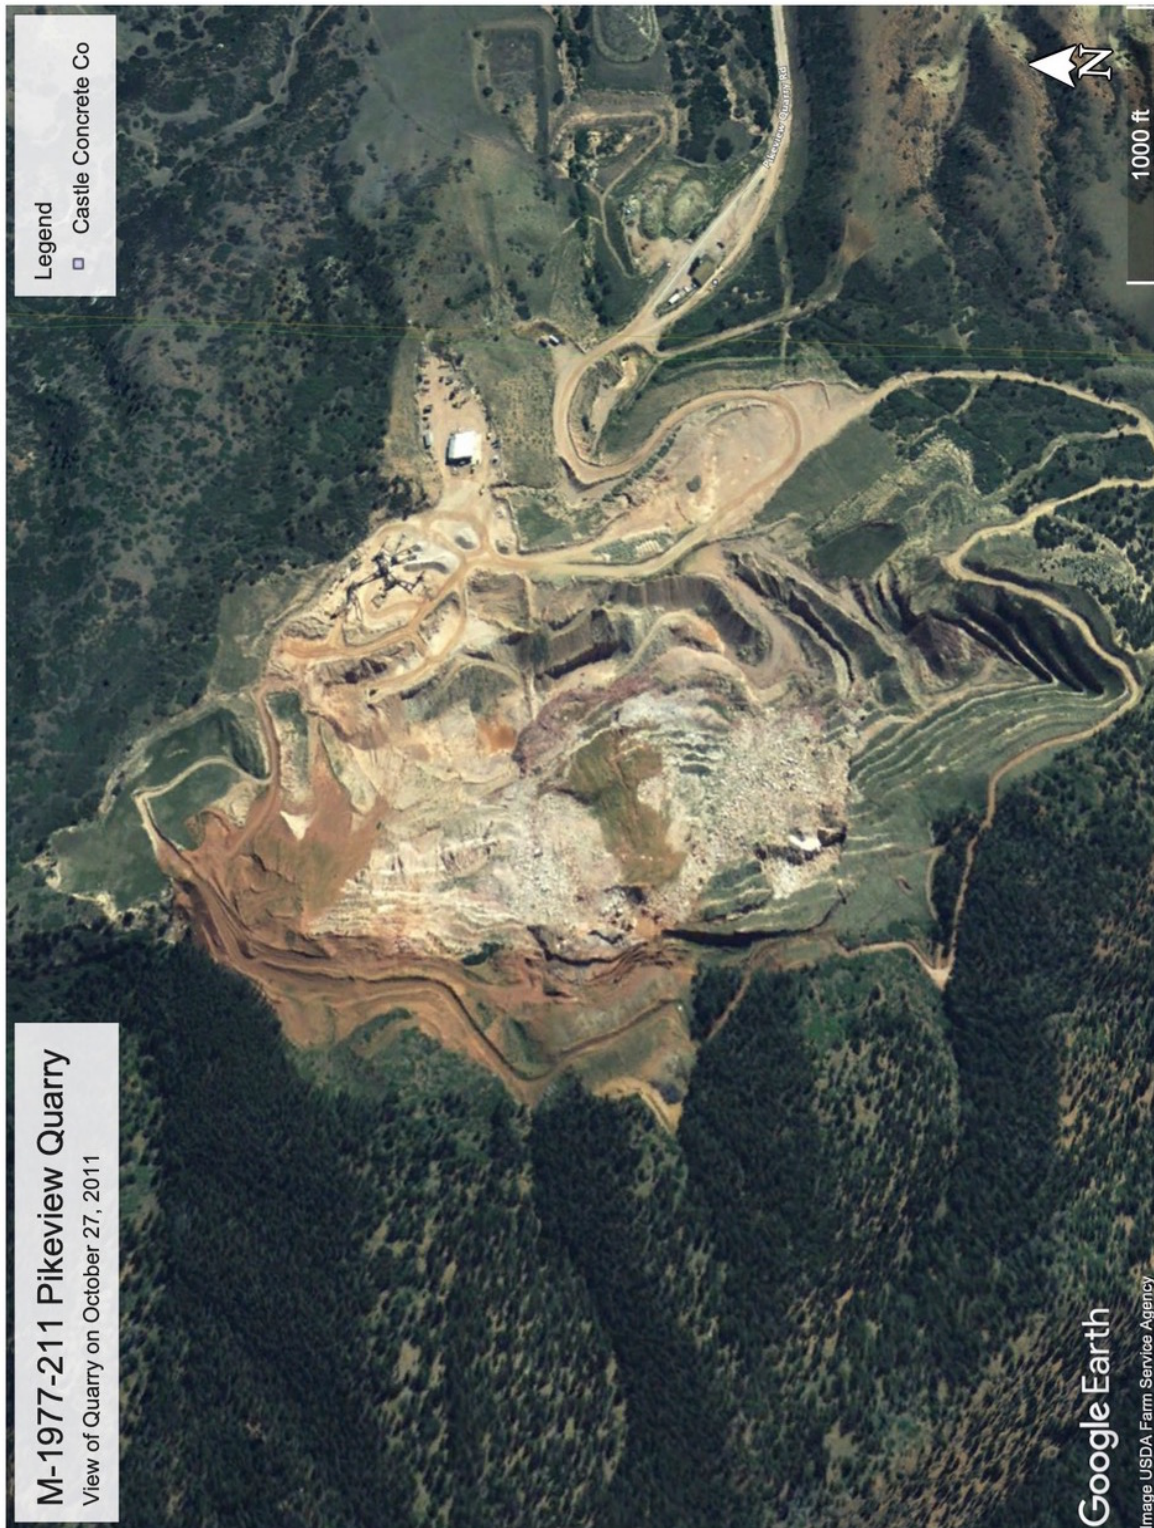
Figure 2 – Pikeview Quarry, October 27, 2011 after December, 2008 and September, 2009 slide but before May, 2015 slide.

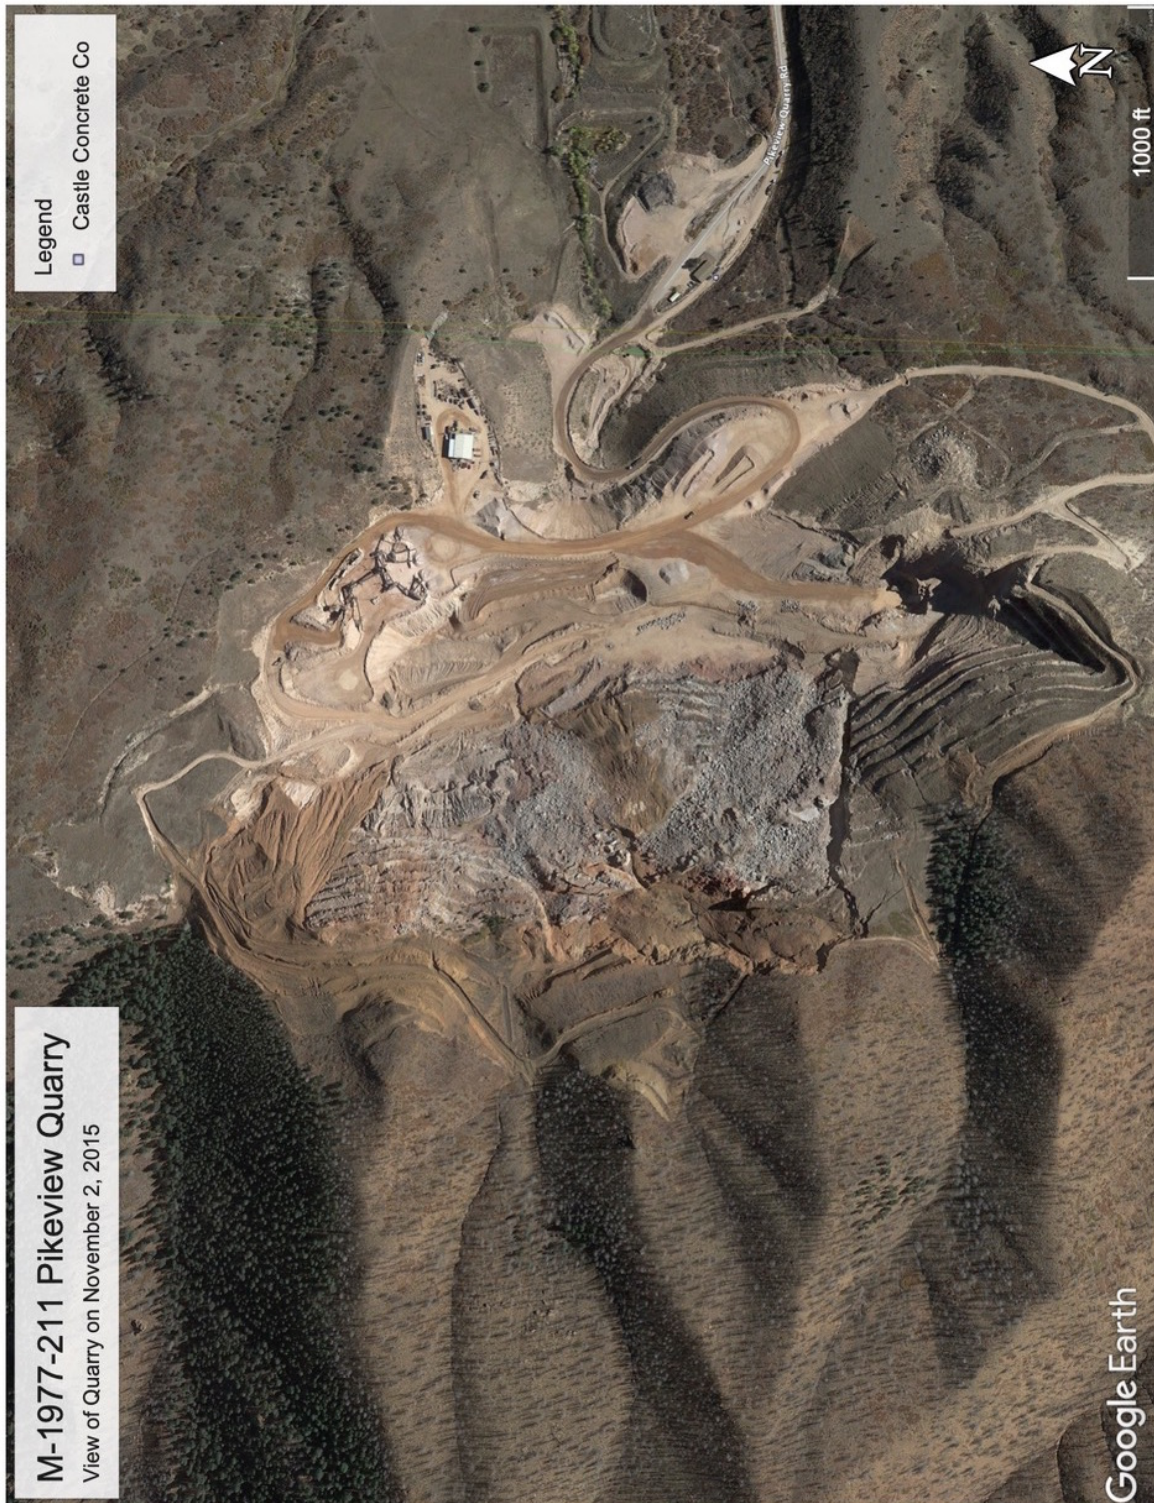
On May 11, 2015 another large slide occurred at Pikeview and DRMS inspected the quarry on May 15, 2015. The inspection was written and delivered to the operator on February 23, 2016 (more than 9 months after the inspection was performed). The inspection noted that the operator notified DRMS via email on May 12, 2015 that a slide had occurred. A copy of the email cannot be located in the public file.

Figure 3 – Pikeview Quarry after May, 2015 Slide.

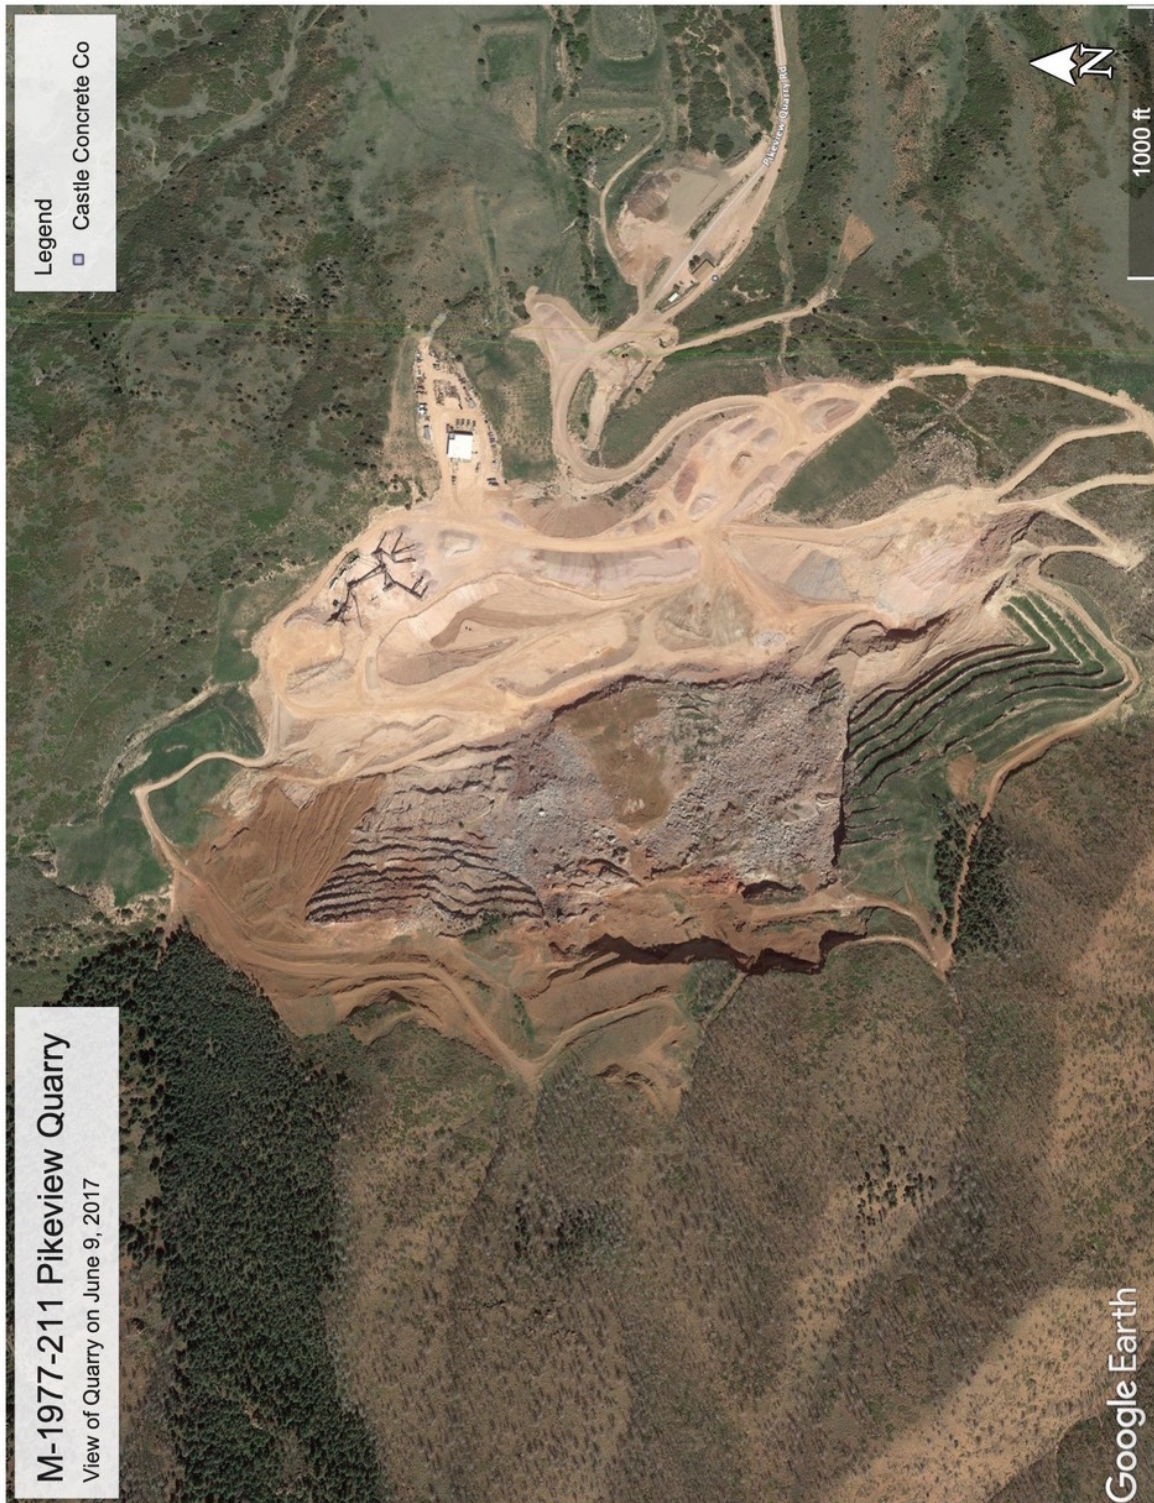
Figure 4 – Pikeview Quarry conditions on June 9, 2017.

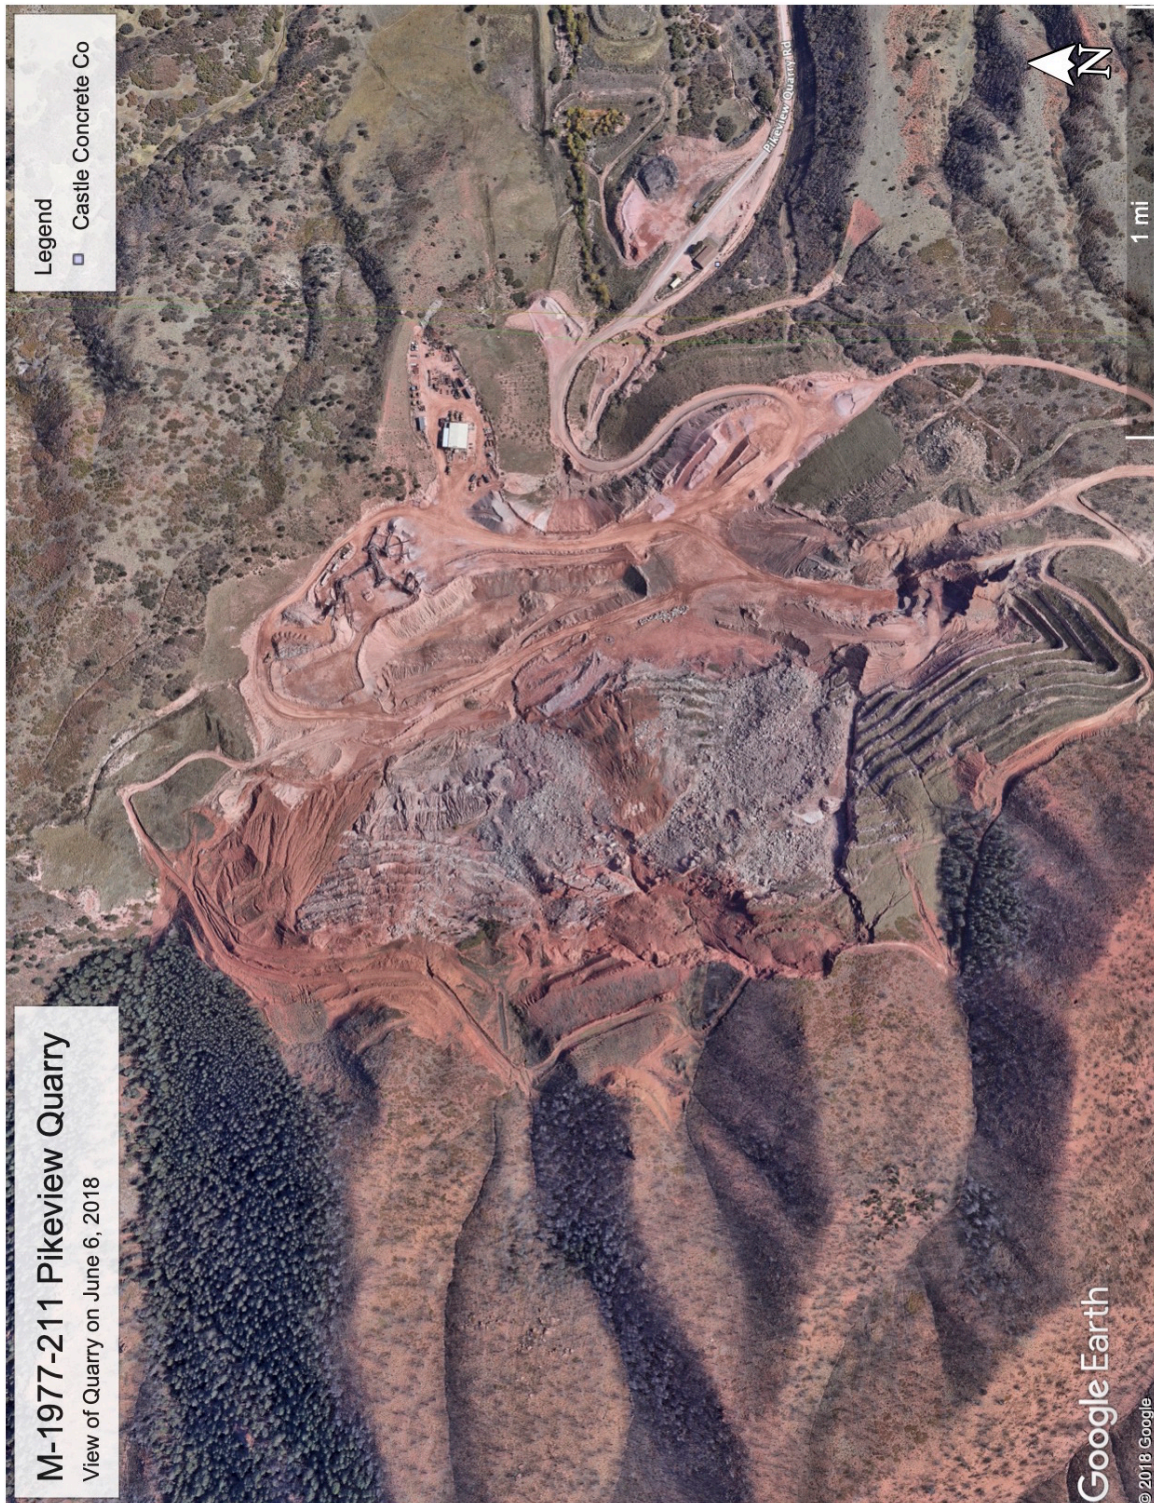
Figure 5 – Pikeview Quarry conditions on June 6, 2018.

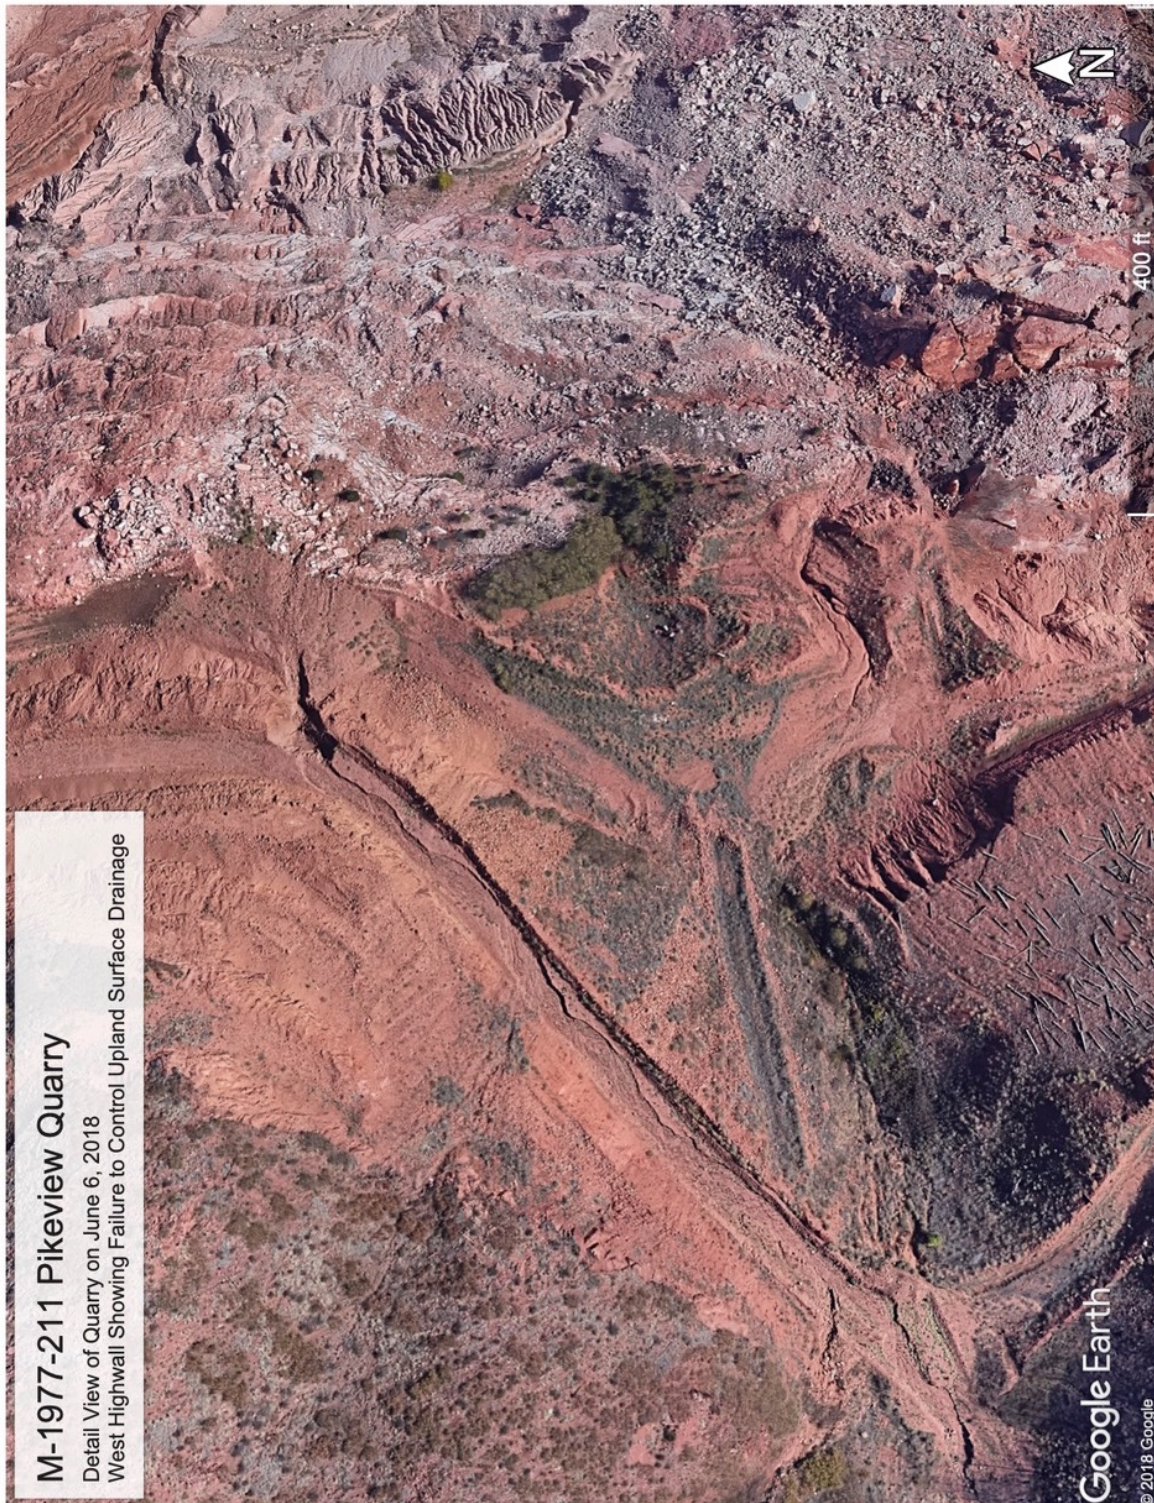
21. The reclamation plan states, "Surface runoff from the hills above the disturbed areas will be diverted around the stabilized and reclaimed slope." The informal drainage diversions in place prior to the 2015 rainstorm and subsequent slide, attributed to the rainstorm by the operator, failed and allowed surface drainage onto the site in at least two places. Photos taken the next day by DRMS showed water cascading down the face of the quarry. The Google Earth aerial photos of 2018 attached to this memo show that the informal upland diversion ditch has breached in at least two places above the quarry highwall scarp. This problem has been noted in the DRMS adequacy review letter (2012) of AM03 and ignored by the operator. The informal upland diversion ditch is not preventing upland runoff from entering the quarry and has not for at least 7 years. Good engineering practice would

Figure 6 – Detail of West Highwall showing breaches in the informal upland surface water control structure.
