MINERALS PROGRAM INSPECTION REPORT
PHONE: (303) 866-3567

MINE NAME: Haynes Hereford Ranch Pit	MINE/PROSPECTING ID#: M-2004-023	MINERAL: Sand and gravel	COUNTY: Phillips
INSPECTION TYPE: Monitoring	INSPECTOR(S): Brock Bowles	INSP. DATE: December 17, 2019	INSP. TIME: 12:00
OPERATOR: Phillips County	OPERATOR REPRESENTATIVE: Mike Salyards	TYPE OF OPERATION: 112c - Construction Regular Operation	
REASON FOR INSPECTION: Normal I&E Program	BOND CALCULATION TYPE: None	BOND AMOUNT: \$0.00	
DATE OF COMPLAINT: NA	POST INSP. CONTACTS: None	JOINT INSP. AGENCY: None	
WEATHER: Clear	INSPECTOR'S SIGNATURE:

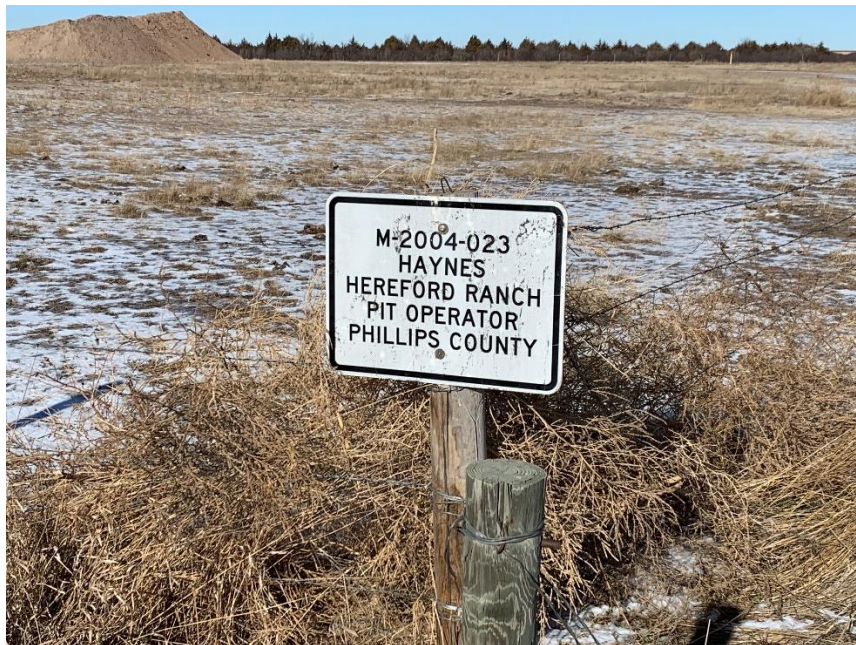
The mine entrance sign was in place. The entire permit boundary is marked with a fence and the fence was in good condition. The delineator posts where Frenchman Creek crosses the west and east permit boundaries were in place.

Mine entrance sign from CR 24

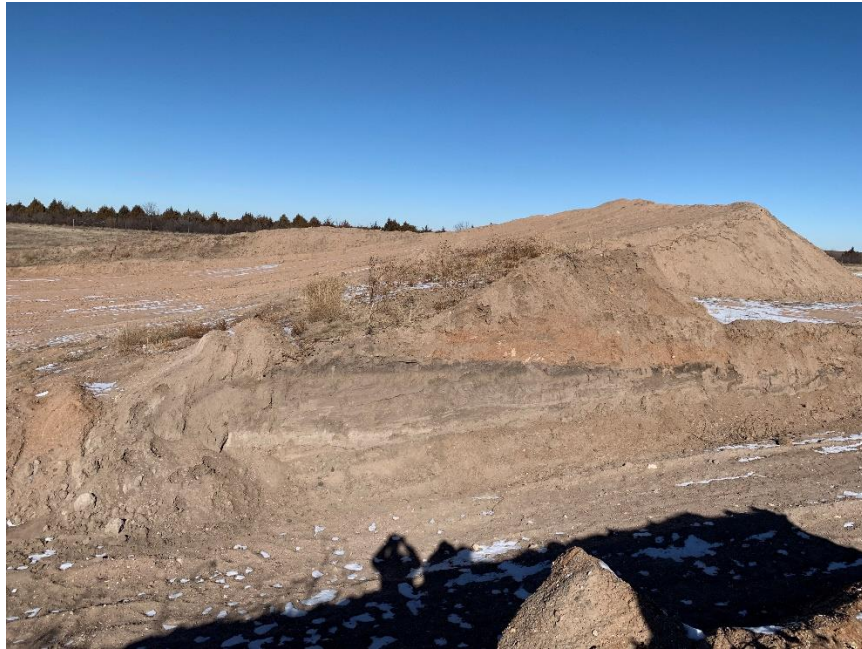
Soil was pushed up from the creek bottom into stockpiles along the south east section of the creek. No disturbance was seen on the north side of the creek. Some soil had been mined from the bottom of the creek bed in the south west section but the creek banks were not disturbed.

Stockpile on southeast section of creek bank looking north

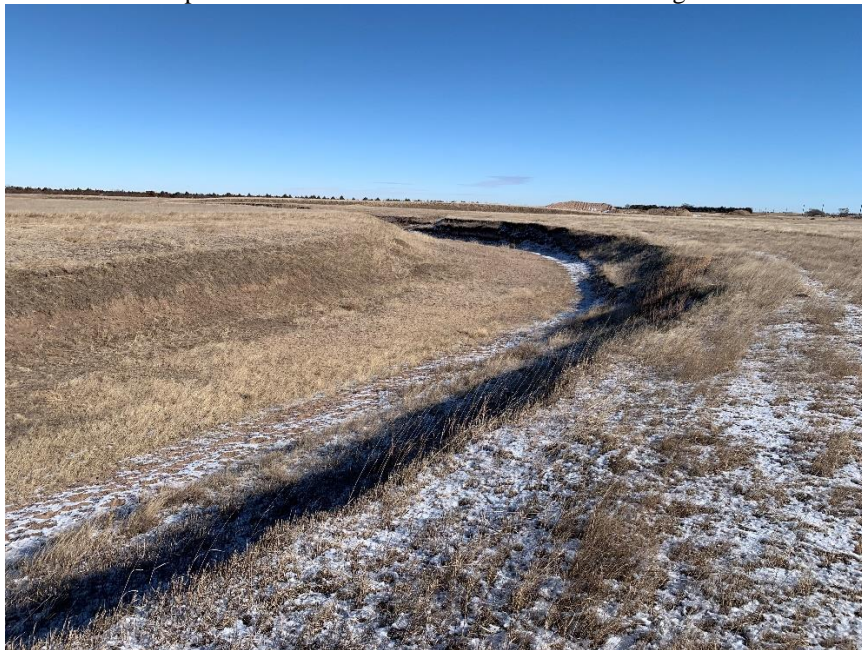
No mining equipment was on site at the time of the inspection. The Frenchman Creek was not flowing and no standing water was seen in the creek bed. No obstructions were seen in the creek bottom that would impede the water flow if the creek should start to flow.

Southern section of Frenchman Creek looking east
