MINERALS PROGRAM INSPECTION REPORT
PHONE: (303) 866-3567

MINE NAME: Rocky Ford East Pit	MINE/PROSPECTING ID#: M-1977-560	MINERAL: Sand and gravel	COUNTY: Otero
INSPECTION TYPE: Surety-Related Inspection	INSPECTOR(S): Amy Eschberger, DJ Cunningham	INSP. DATE: January 14, 2020	INSP. TIME: 12:45
OPERATOR: VALCO, Inc.	OPERATOR REPRESENTATIVE: Tom Brubaker	TYPE OF OPERATION: 112c - Construction Regular Operation	
REASON FOR INSPECTION: Surety Related	BOND CALCULATION TYPE: None	BOND AMOUNT: \$193,678.00	
DATE OF COMPLAINT: NA	POST INSP. CONTACTS: None	JOINT INSP. AGENCY: None	
WEATHER: Clear	INSPECTOR'S SIGNATURE:

M-1977-560 / Rocky Ford East Pit / Valco, Inc.

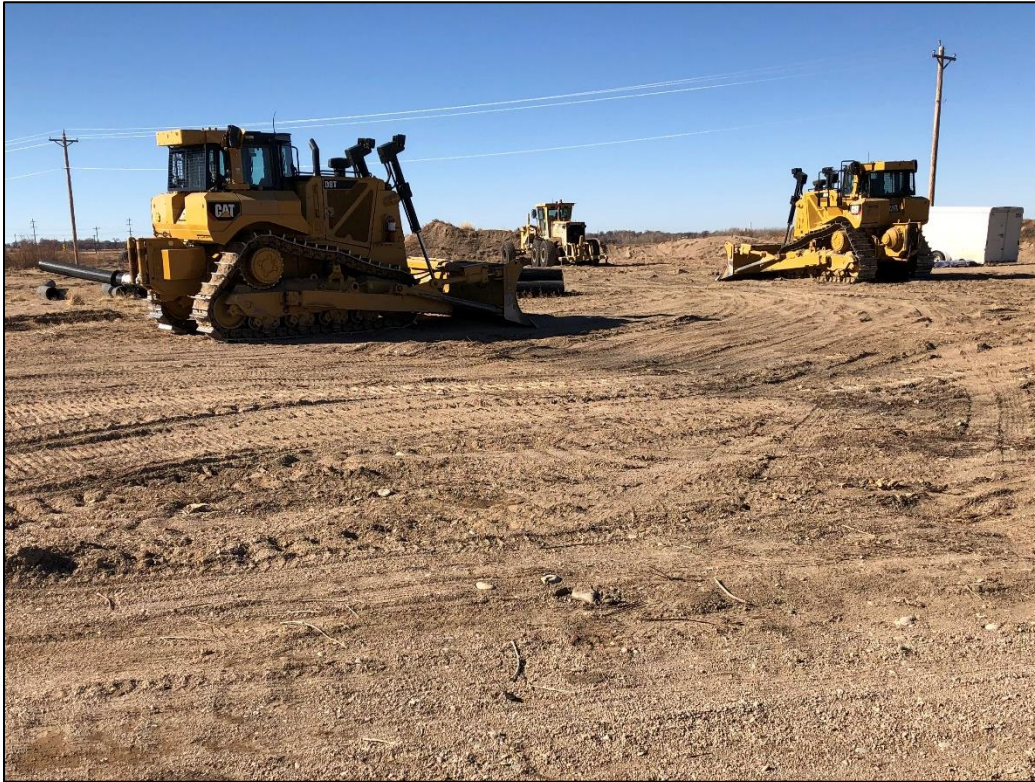
The site was not active during the inspection. However, two (D8) dozers and a grader were stored on site near the ponds. The operator informed the Division the backfill project had begun in December as planned; however, the equipment was currently down due to trespassers having entered the site over the weekend and potentially tampered with the equipment. The contractor had already notified Caterpillar of the issue and was waiting for confirmation the equipment is in adequate condition for continued use. Pond D (the larger pond) was being dewatered from its northwestern corner during the inspection (via a floating submersible pump), and the water was being routed westward to the adjacent Pond C via an above-ground pipeline, in accordance with TR-3. The Division observed that a significant portion of Pond D had been backfilled, primarily along its southern edge, where the pond was filled in to the edge of the island that existed near the center of the pond. Portions of the western and eastern edges of the pond had also been backfilled. Based on observations made during the inspection, and a comparison of photos taken during this inspection with those taken during the last inspection, the Division estimates approximately 4 acres of Pond D have been backfilled (see enclosed Google Earth image of site showing approximate portion of Pond D backfilled). Portions of these backfilled areas have not quite reached the approved final grade (a minimum of two feet above the static water level).

Photo 1. View looking northwest across area just west of Pond D where two (D8) dozers and a grader were stored during the inspection.

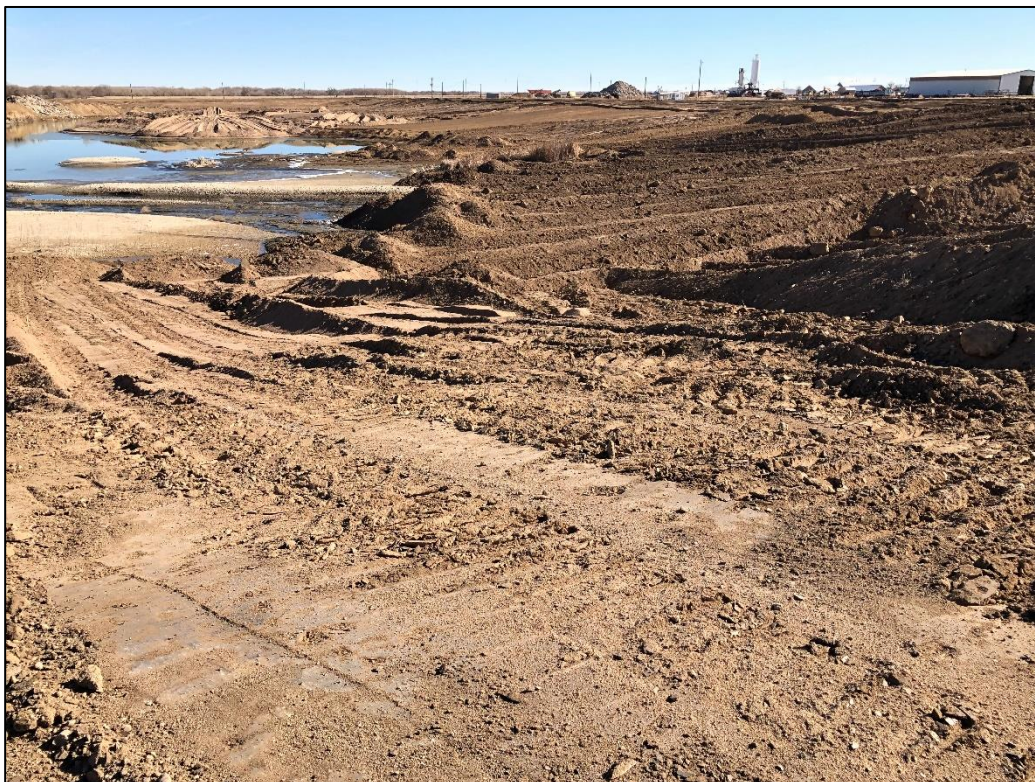
Photo 2. View looking southeast across backfilled southwestern edge of Pond D.

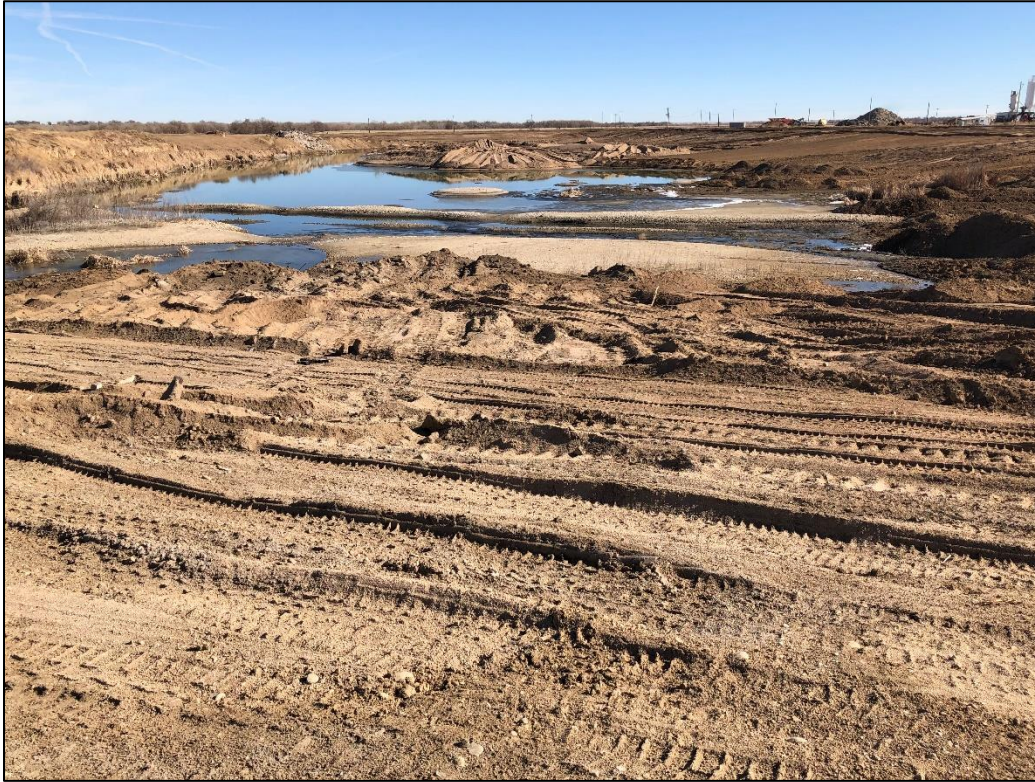
Photo 3. View looking east across Pond D from its backfilled western edge.

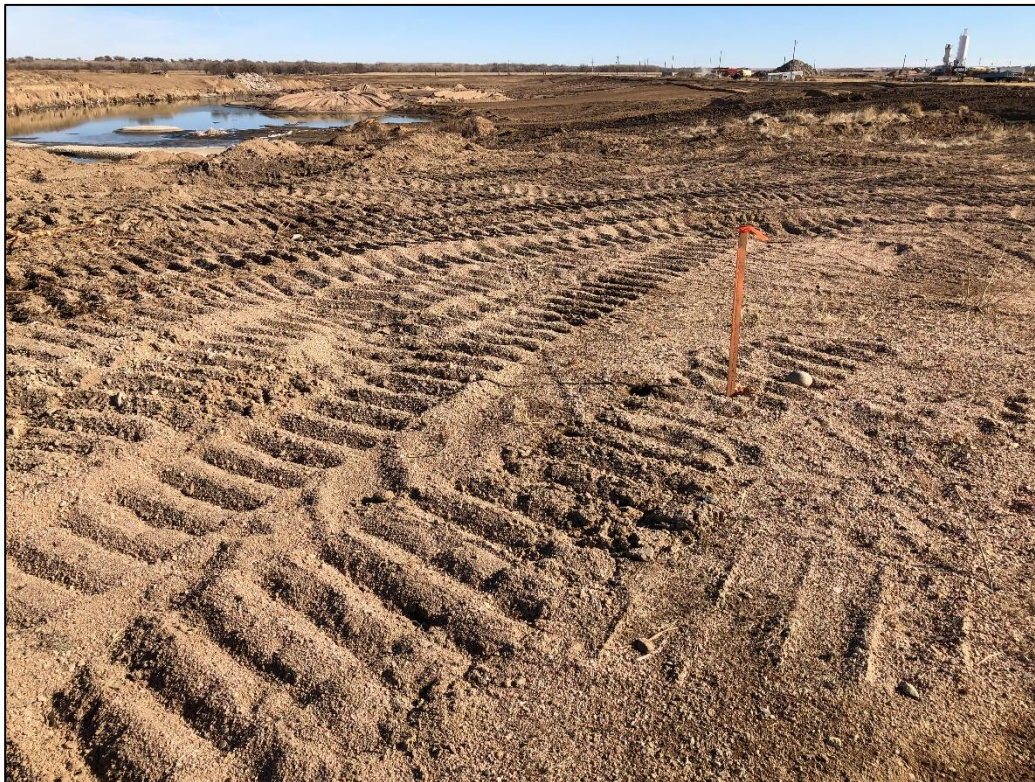
Photo 4. View looking east across backfilled southwestern edge of Pond D.

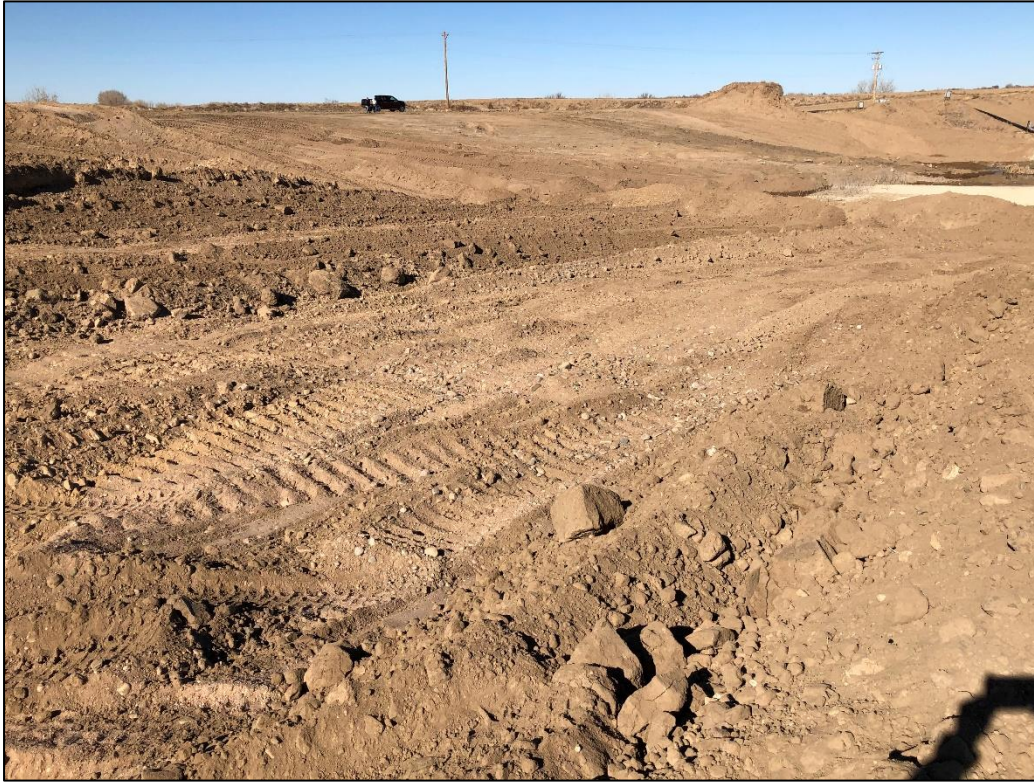
Photo 5. View looking northwest across backfilled southwestern edge of Pond D.

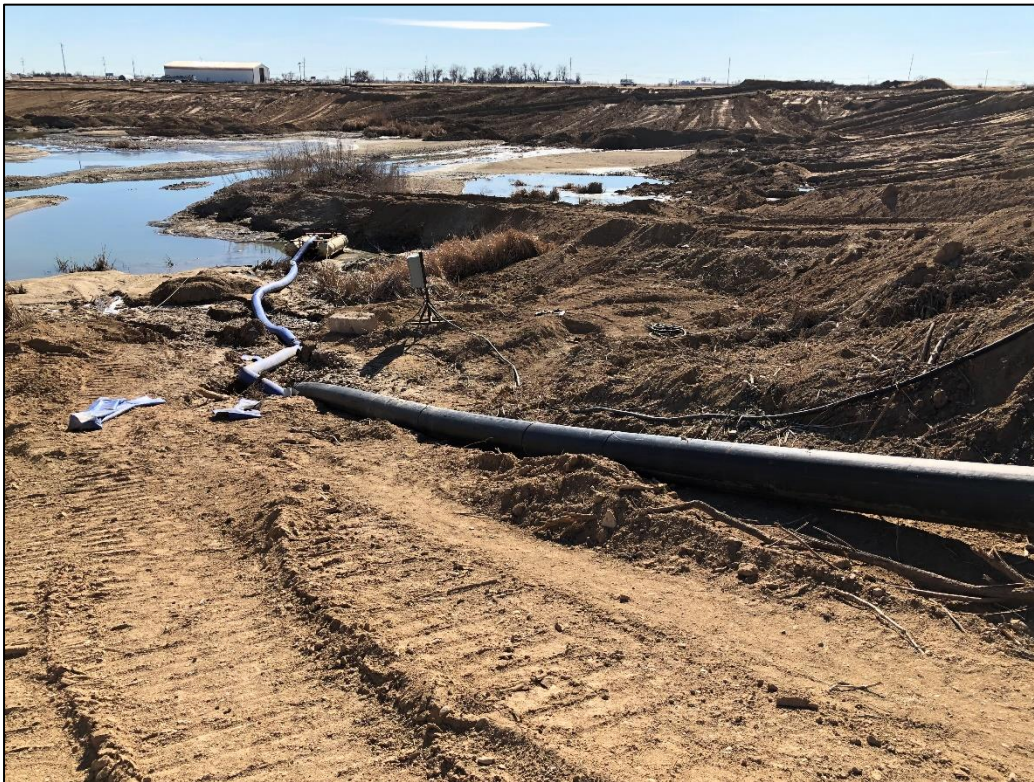
Photo 6. View looking southeast across Pond D, showing dewatering pump and above-ground pipeline located at its northwestern corner.

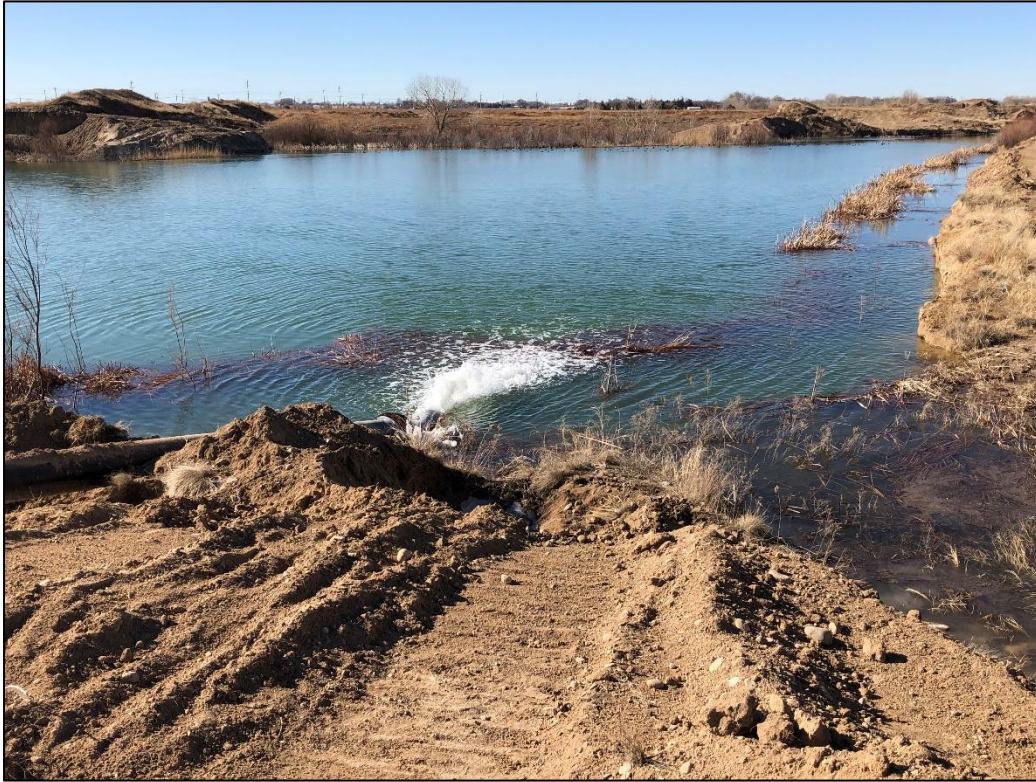
Photo 7. View looking southwest across Pond C from its northeastern corner, showing above-ground pipeline discharging water pumped from Pond D.

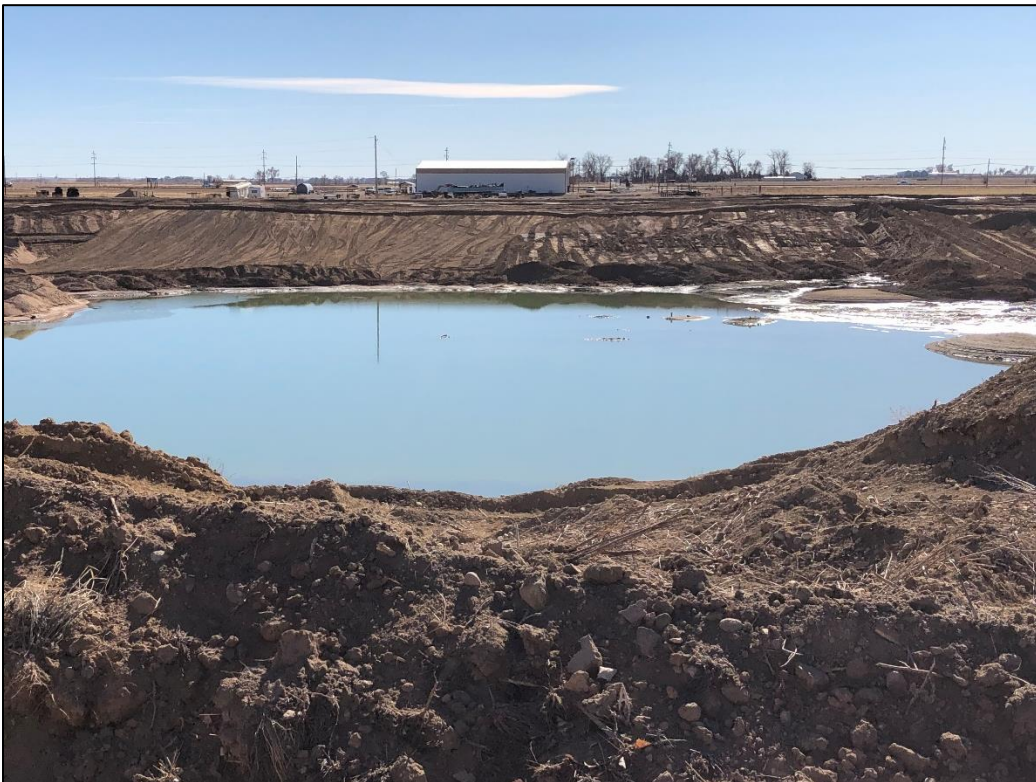
Photo 8. View looking south across western portion of Pond D from its northern edge, showing backfilled southern edge of pond (in background).

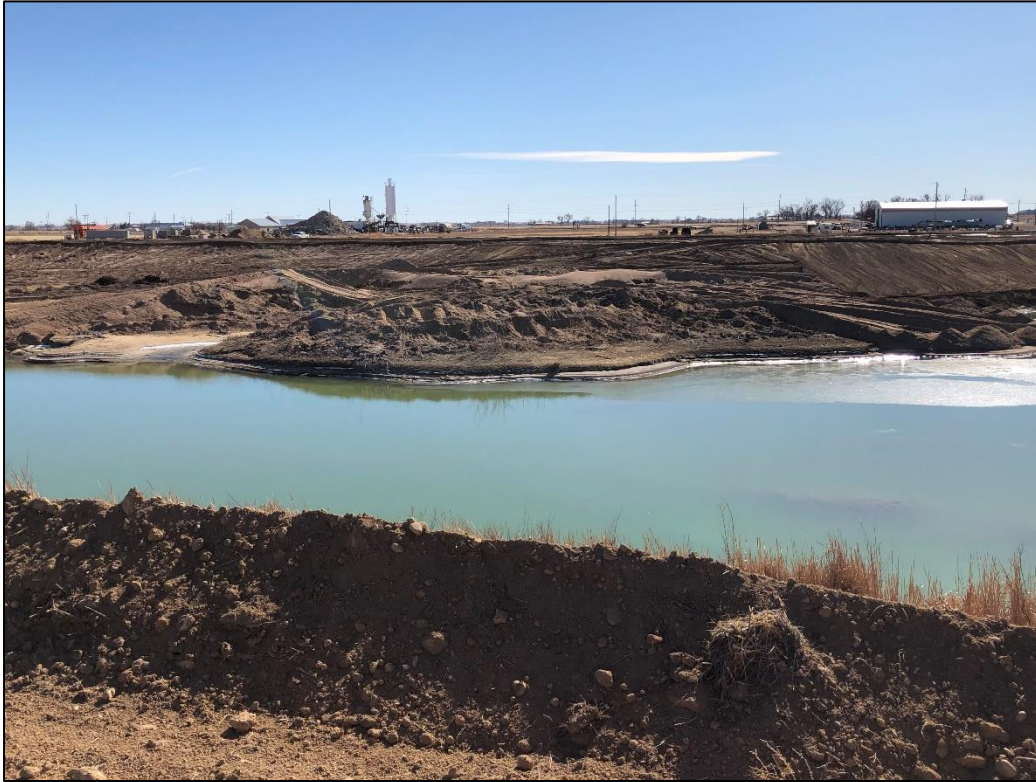
Photo 9. View looking south across central portion of Pond D from its northern edge, showing backfilled southern edge of pond to existing island (in background).

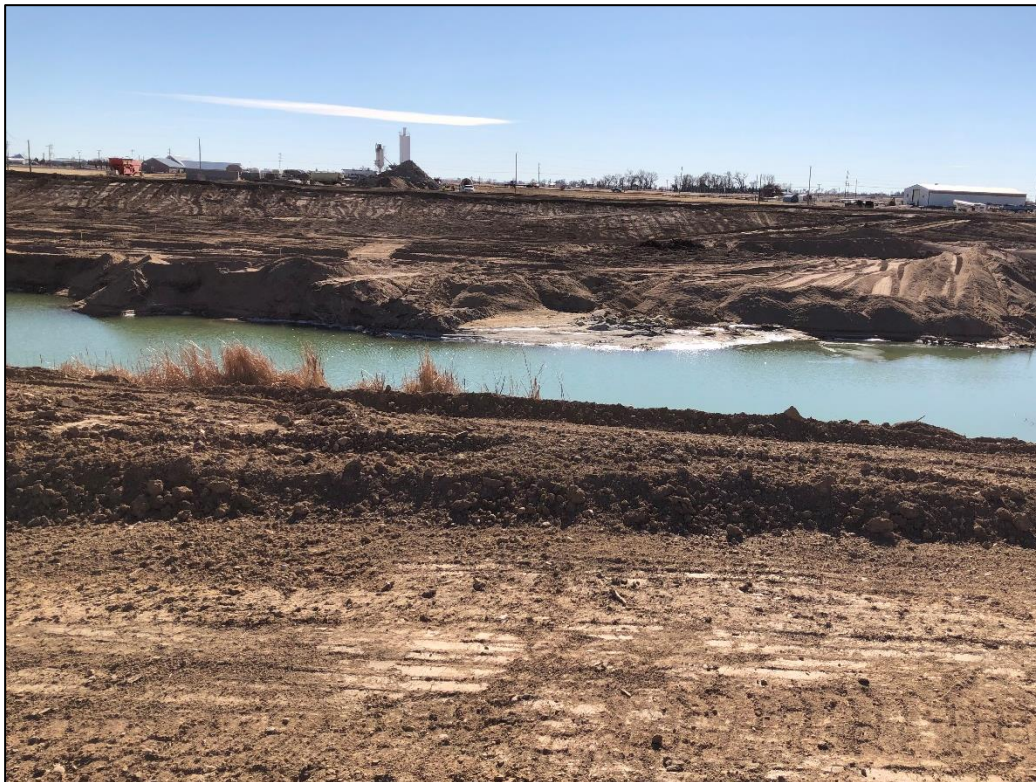
Photo 10. View looking south across central portion of Pond D from its northern edge, showing backfilled southern edge of pond to existing island (in background).

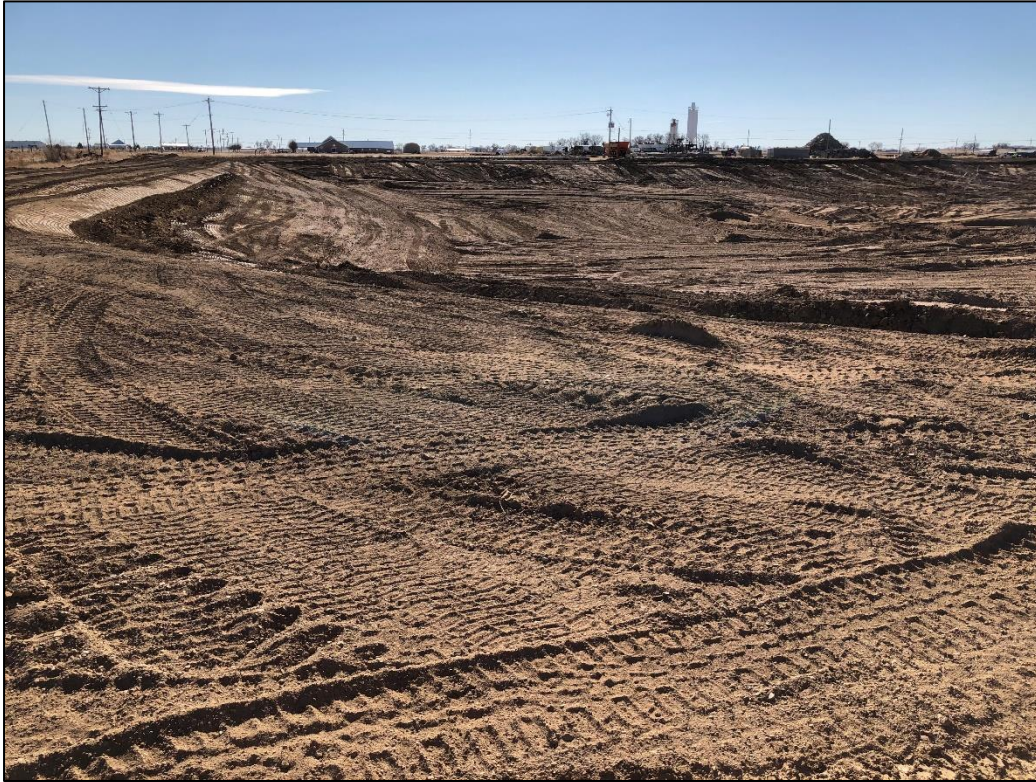
Photo 11. View looking south across backfilled eastern portion of Pond D.

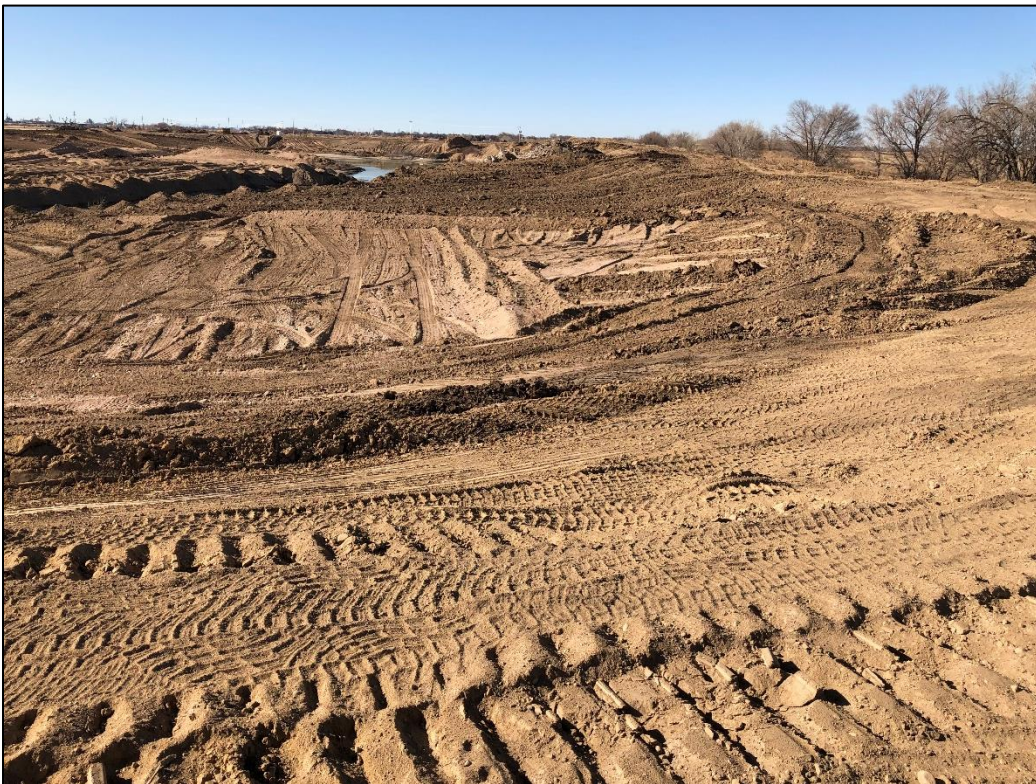
Photo 12. View looking west across backfilled northeastern edge of Pond D.

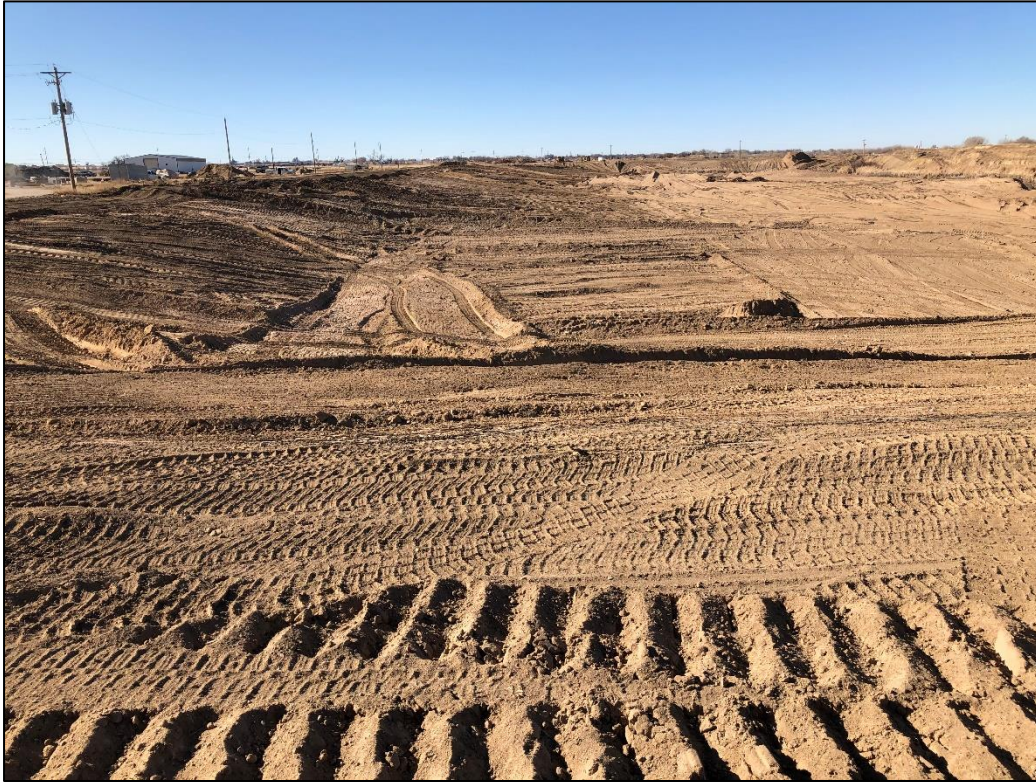
Photo 13. View looking west across backfilled southeastern edge of Pond D.

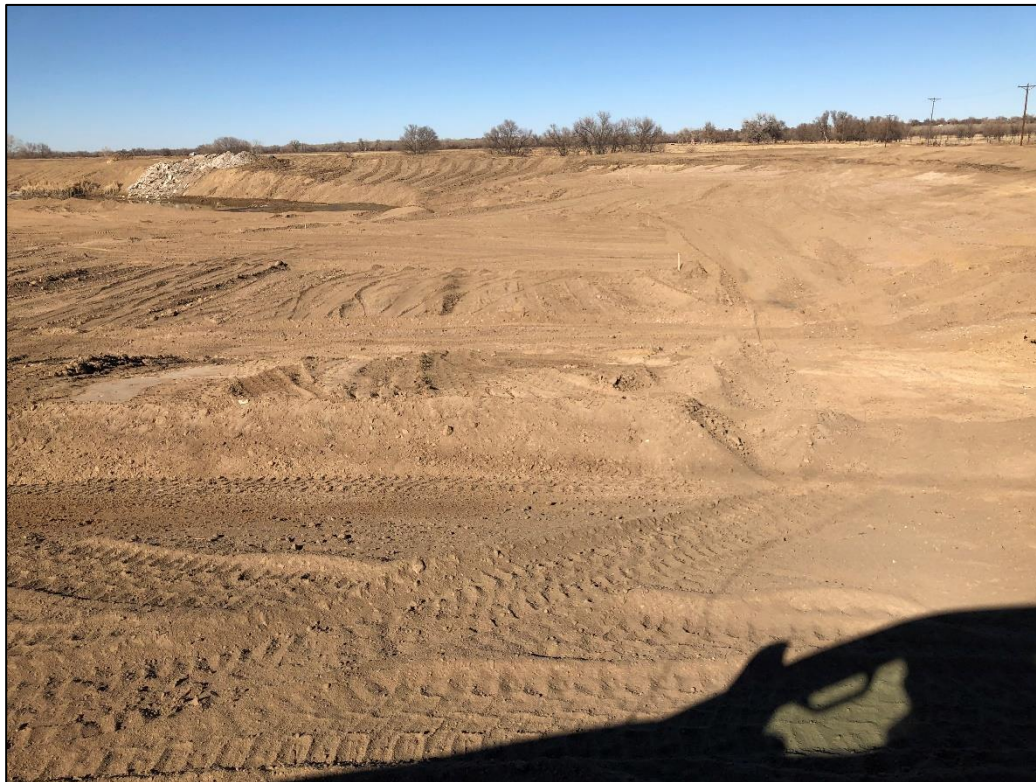
Photo 14. View looking north across backfilled eastern portion of Pond D.

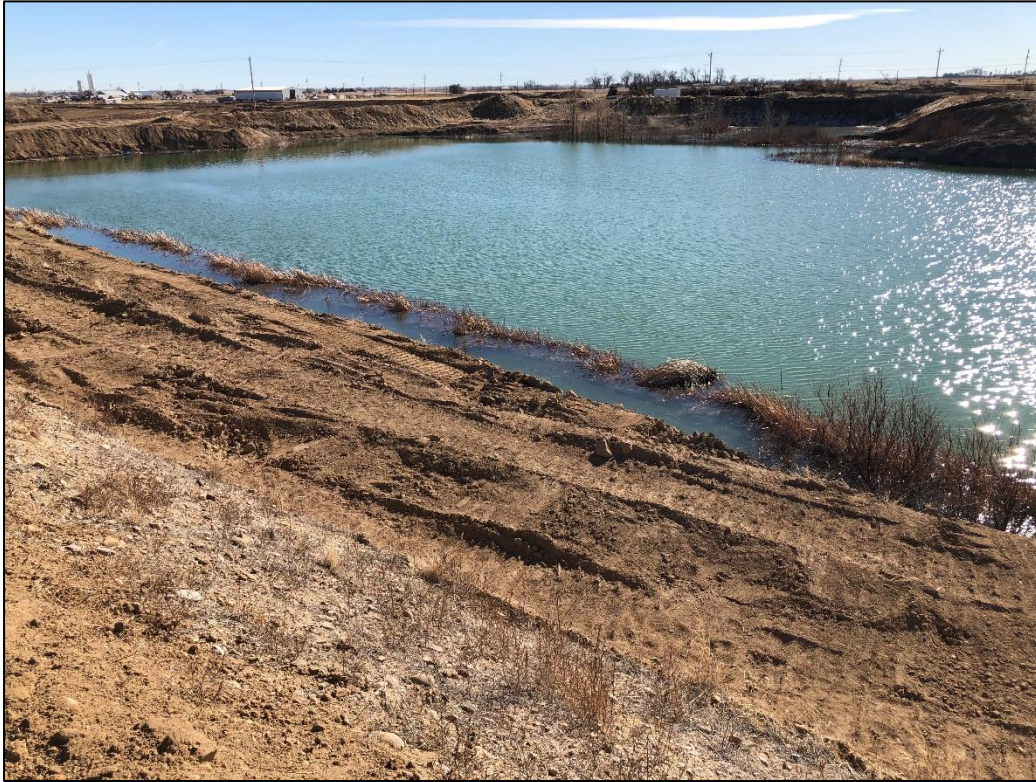
Photo 15. View looking southeast across Pond C which will be dewatered and backfilled after Pond D has been backfilled.

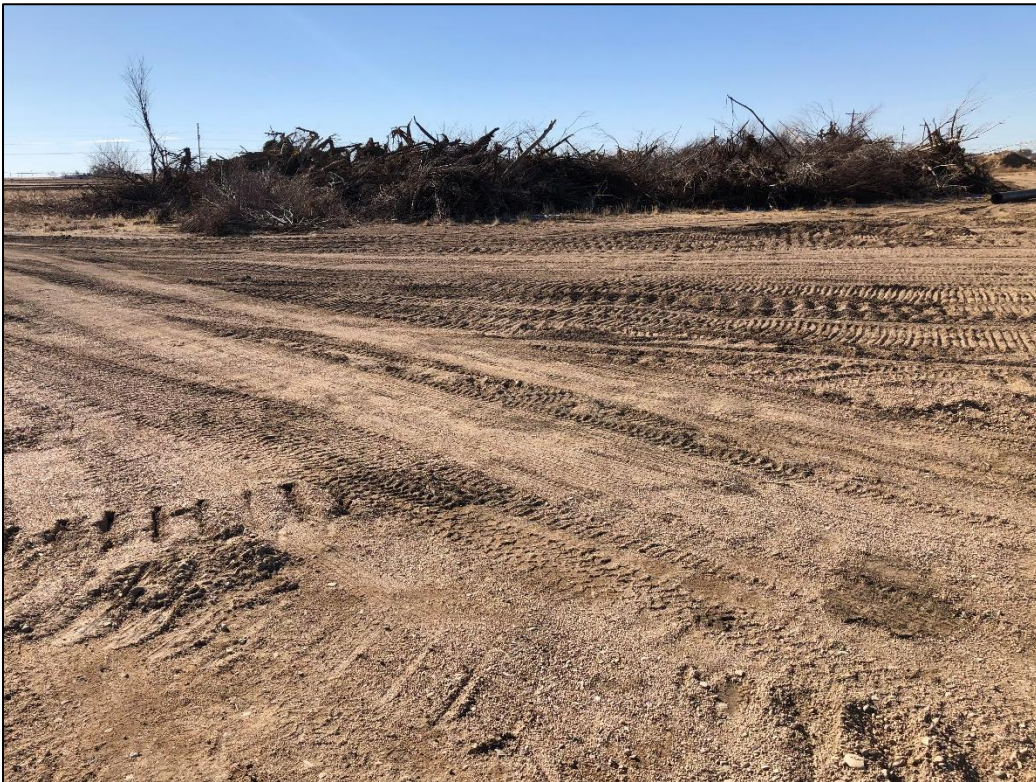
It should be noted, the contractor is removing Tamarisk trees present in and around the pond as the pond is backfilled and graded, per the weed control and management plan approved for the site through Technical Revision No. 4 (TR-4) on July 17, 2019. The removed Tamarisk trees are currently being stockpiled in an area west of Pond D. According to TR-4, the removed Tamarisk trees will be chipped or burned to prevent regrowth.

Photo 16. View looking southwest at pile of Tamarisk trees removed from Pond D area during backfill project.

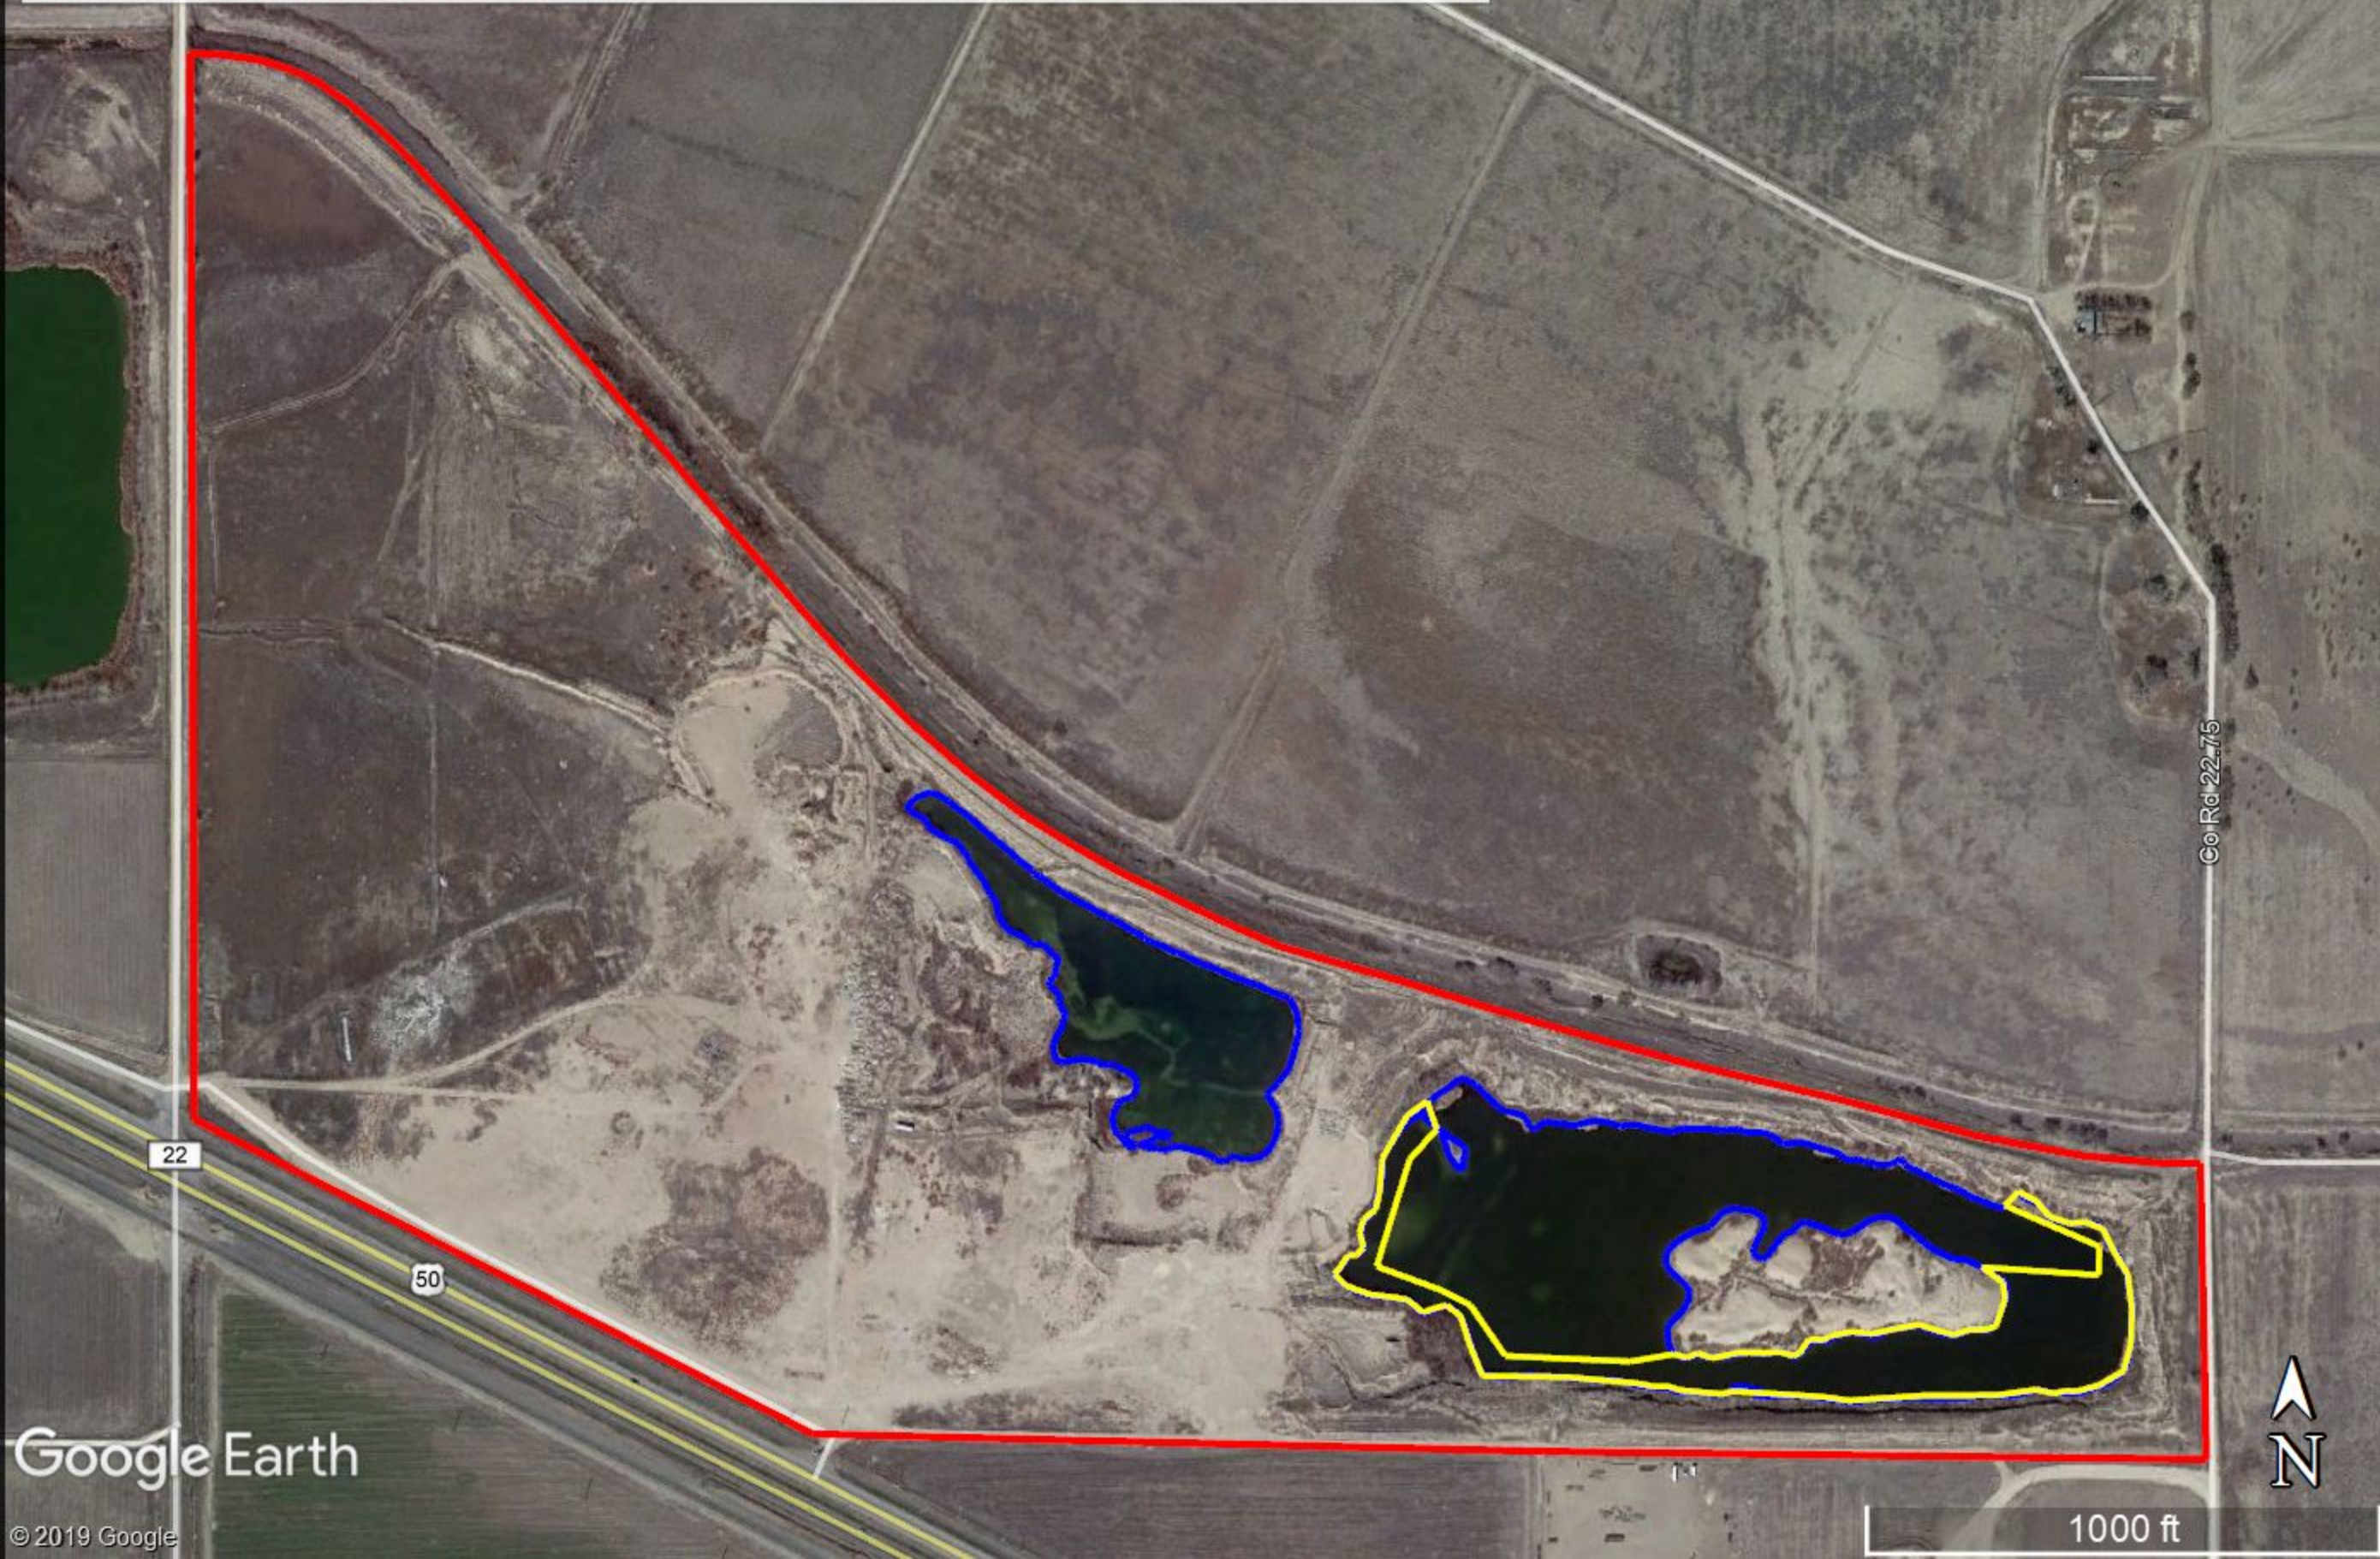
Encl: Google Earth image of site showing approximate portion of Pond D backfilled

Yellow Outline = 4 acres = Approximate Portion of Pond D Backfilled as of 1/14/2020 Inspection
(Image data from 3/19/2016)
