MINERALS PROGRAM INSPECTION REPORT PHONE: (303) 866-3567

MINE NAME:		MINE/PROSPECTING ID#:	MINERAL:	COUNTY:
La Veta Site		M2020-003	Gravel	Huerfano County
INSPECTION TYPE:		INSPECTOR(S):	INSP. DATE:	INSP. TIME:
Illegal(Unpermitted Operation)		Patrick Lennberg	January 16, 2020	09:30
OPERATOR:		OPERATOR REPRESENTATIVE:	TYPE OF OPERATION:	
Meridiam Partners		Brittany Ciarlo and Jason Buesing	ILL - Illegal	
REASON FOR INSPECTION:		BOND CALCULATION TYPE:	BOND AMOUNT:	
Citizen Complaint		None	No Bond Held	
DATE OF COMPLAINT:		POST INSP. CONTACTS:	JOINT INSP. AGENCY:	
1/10/2020		None	None	
WEATHER:	INSPECTOR'S SIGNATURE:		SIGNATURE DATE:	
Cloudy	Patrick So		January 21, 2020

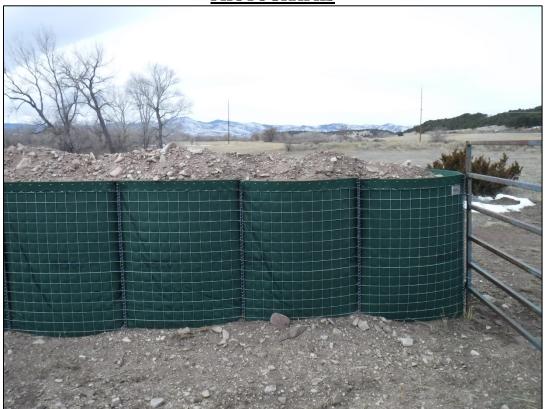
Photo 1: The western most end of the flood control barrier

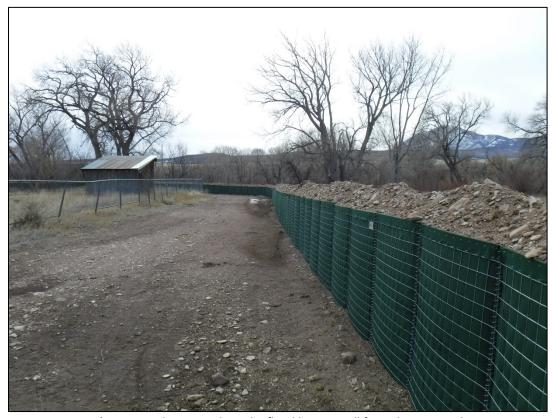
Photo 2: Looking east along the flood barrier wall from the west end

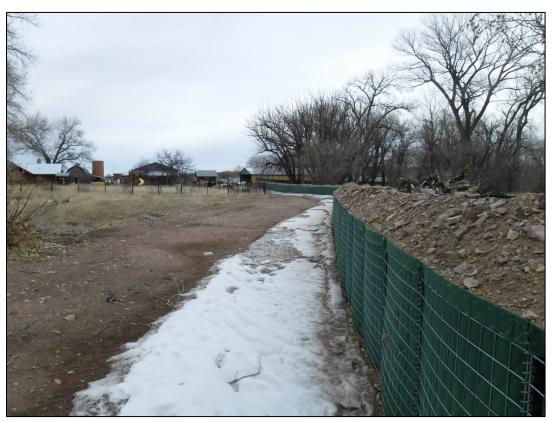
Photo 3: Looking east along the flood barrier wall, ~1/4 of the over length

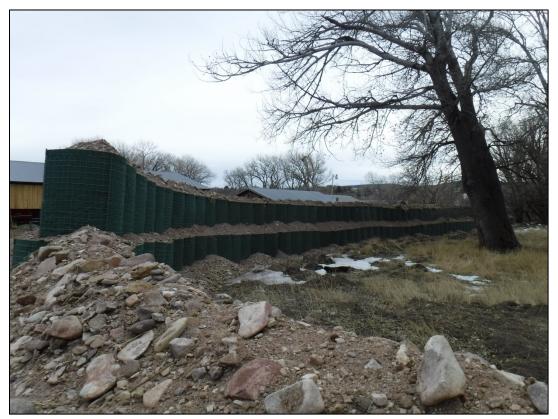
Photo 4: Looking east along the flood barrier wall about half way along the overall length where the flood barrier wall is stacked

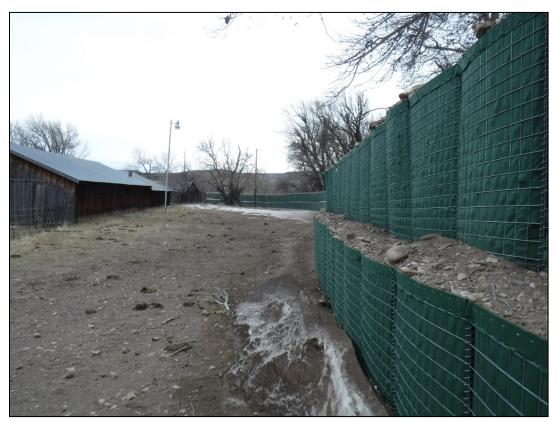
Photo 5: Looking east along the flood barrier wall after the stacking has begun

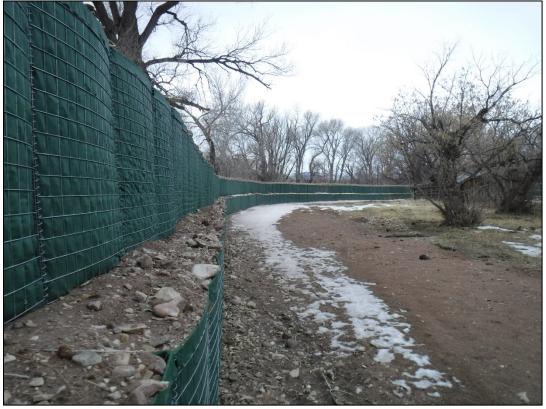
Photo 6: Looking west along the flood barrier wall

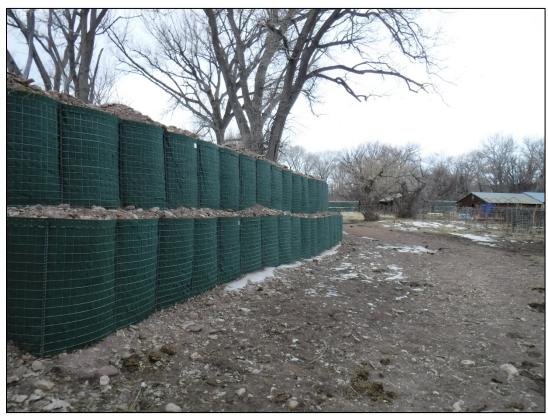
Photo 7: Looking west along the flood barrier wall from the eastern end of wall

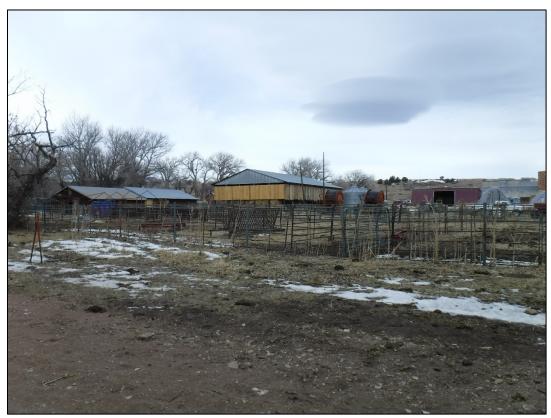
Photo 8: Structures being protected by the flood barrier wall

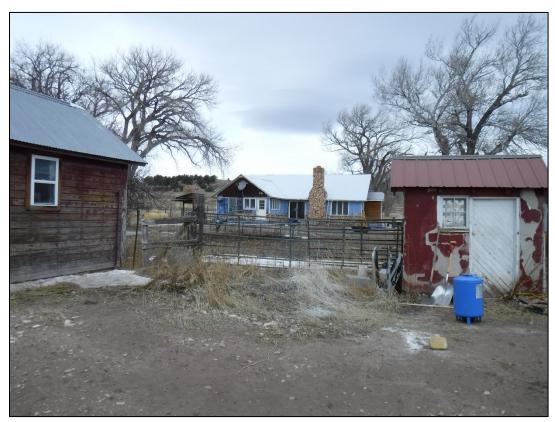
Photo 9: Home being protected by the flood barrier wall

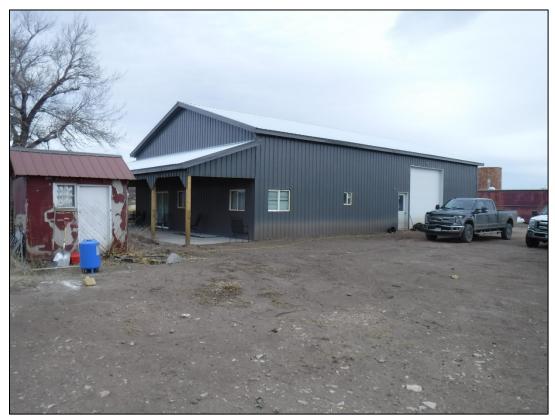
Photo 10: Warehouse being protected by the flood barrier wall

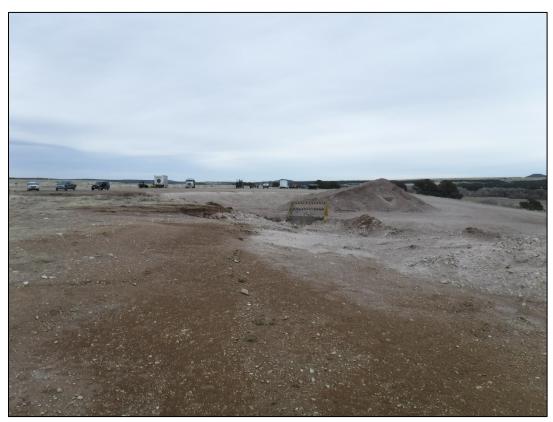
Photo 11: Pit area looking east from the western end of disturbance

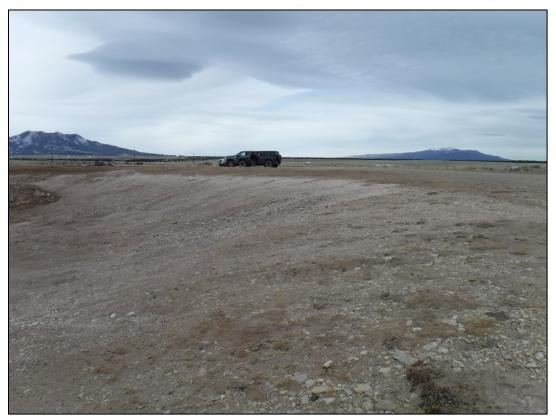
The excavation is occurring in a proper manner and meets the performance standards that the Division typically associates with permits, side slopes are graded to 3H:1V or shallower, topsoil has been salvaged, and it does not appear that storm water is being impounded. The landowners indicated that the excavated area was going to be used to build another barn or storage building well away from any potential flood impacts.

Photo 12: Eastern end of pit with side slopes graded to a 3H:1V slope

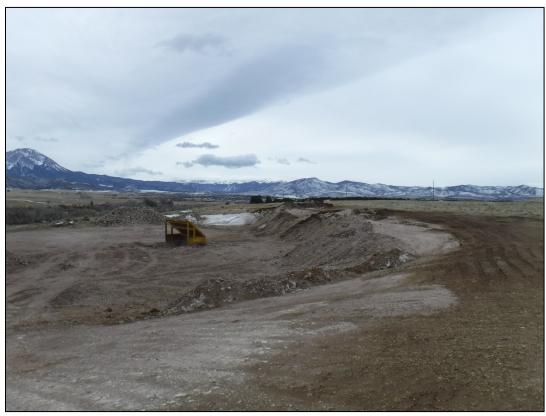
Excavation has occurred in an area that was previously used for material on the land managed by the previous owners. The current owners indicated that Huerfano County was interested in the location, a few years ago, for a new county pit but test pits indicated that the material did not meet their specifications. Currently, the majority of material that has been excavated from the site and processed has been used on the landowner's property as part of flood mitigation efforts. The material was used to fill approximately 1,400 lineal feet of HESCO flood control barriers, in some locations the barriers were stacked two units in high. Jason stated that a minor amount of material, 100 cubic yards, was used on other recovery projects where onsite material was not readily available. Jason indicated that they have used other permitted pits in the area to source the material used in their projects.

Photo 13: Northeastern area of the pit, the expansion of the previous disturbance was from the grizzly to the north (right) and east(lower left hand corner of picture)

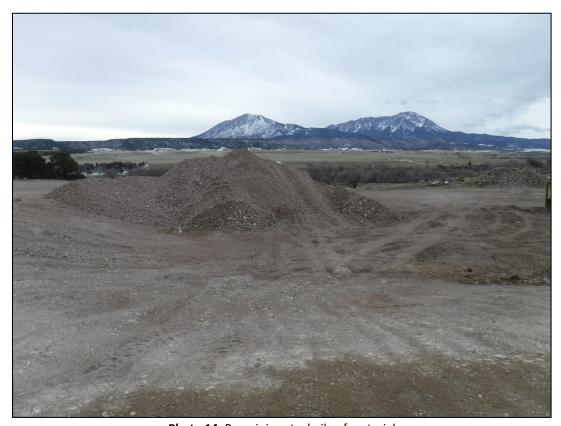
The vast majority of material that was excavated remained and was used onsite and was not hauled or transported on a public road. A small amount of material was used off site but was done so in support of flood mitigation and recovery projects. Given this, the Division will not require the operator or landowner to obtain a Reclamation Permit at this time. However, if any additional material leaves the site for any purpose, including use on another owned parcel of land, from the date of this inspection report, the owner (Matt and Kelli Bjorum), operator (Meridiam Partners), and county should be aware that the Division will require a permit to be obtained.

Photo 14: Remaining stockpile of material

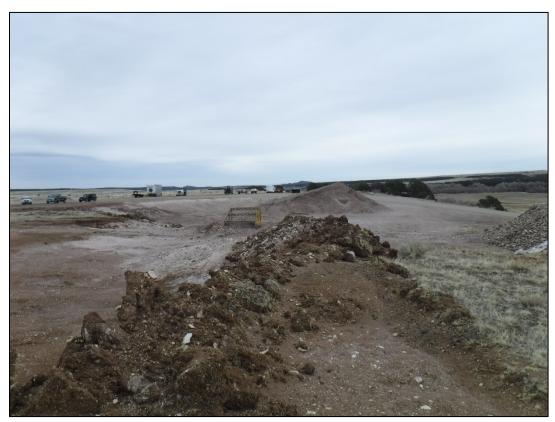
Photo 15: Salvaged topsoil material, center foreground

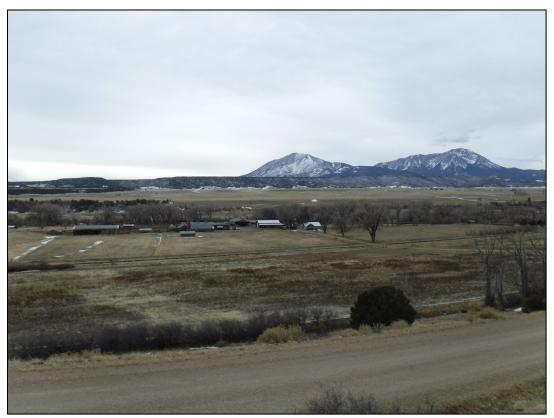
Photo 16: Looking from the pit area south towards the river and farm where the flood barrier is located
