**MINERALS PROGRAM INSPECTION REPORT**  
**PHONE: (303) 866-3567**

<b>MINE NAME:</b> Western Slope Flagstone Quarry No. 2	<b>MINE/PROSPECTING ID#:</b> M-1996-076	<b>MINERAL:</b> Gravel	<b>COUNTY:</b> Mesa
<b>INSPECTION TYPE:</b> Monitoring	<b>INSPECTOR(S):</b> Lucas West	<b>INSP. DATE:</b> January 15, 2020	<b>INSP. TIME:</b> 14:10
<b>OPERATOR:</b> Rudolph Fontanari	<b>OPERATOR REPRESENTATIVE:</b> Rudy Fontanari	<b>TYPE OF OPERATION:</b> 112c - Construction Regular Operation	
<b>REASON FOR INSPECTION:</b> Normal I&E Program	<b>BOND CALCULATION TYPE:</b>	<b>BOND AMOUNT:</b> \$88,251.00	
<b>DATE OF COMPLAINT:</b> NA	<b>POST INSP. CONTACTS:</b> None	<b>JOINT INSP. AGENCY:</b> None	
<b>WEATHER:</b> Clear	<b>INSPECTOR'S SIGNATURE:</b>

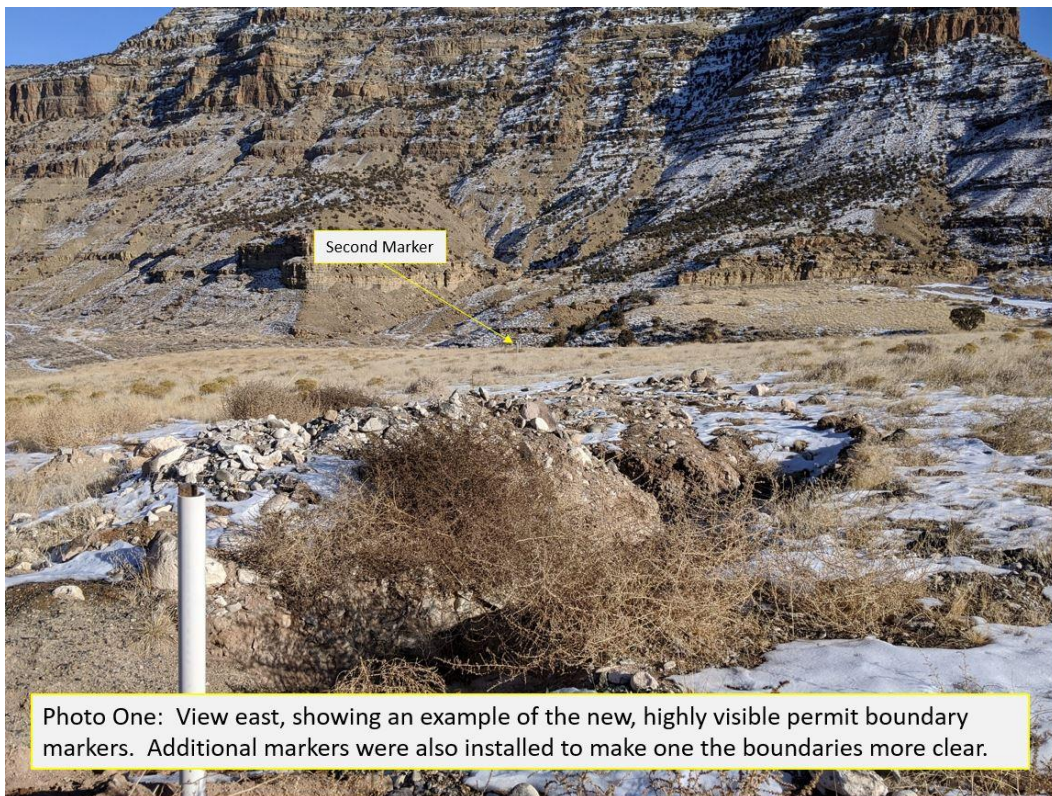
**Permit Boundary Markers:** The Operator has used the Division's recommendation and installed white PVC covers over the Permit Boundary Markers to make them more visible. All points that were included in TR-03 were verified. Examples of the markers with the PVC pipe can be seen in Photos One and Two. The offset that proposed in TR-03 is to mark the cliff edge running from north to south along the eastern edge of the middle mine area. The markers along the edge were observed. Mining will not take place in the space between the cliff edge and the eastern permit boundary. The recommended additional markers between points that were too far apart were also observed. Upon approval of TR-03 these markers will be incorporated to the Permit and the Inspection Problem will be considered resolved.

Photo One: View east, showing an example of the new, highly visible permit boundary markers. Additional markers were also installed to make one the boundaries more clear.

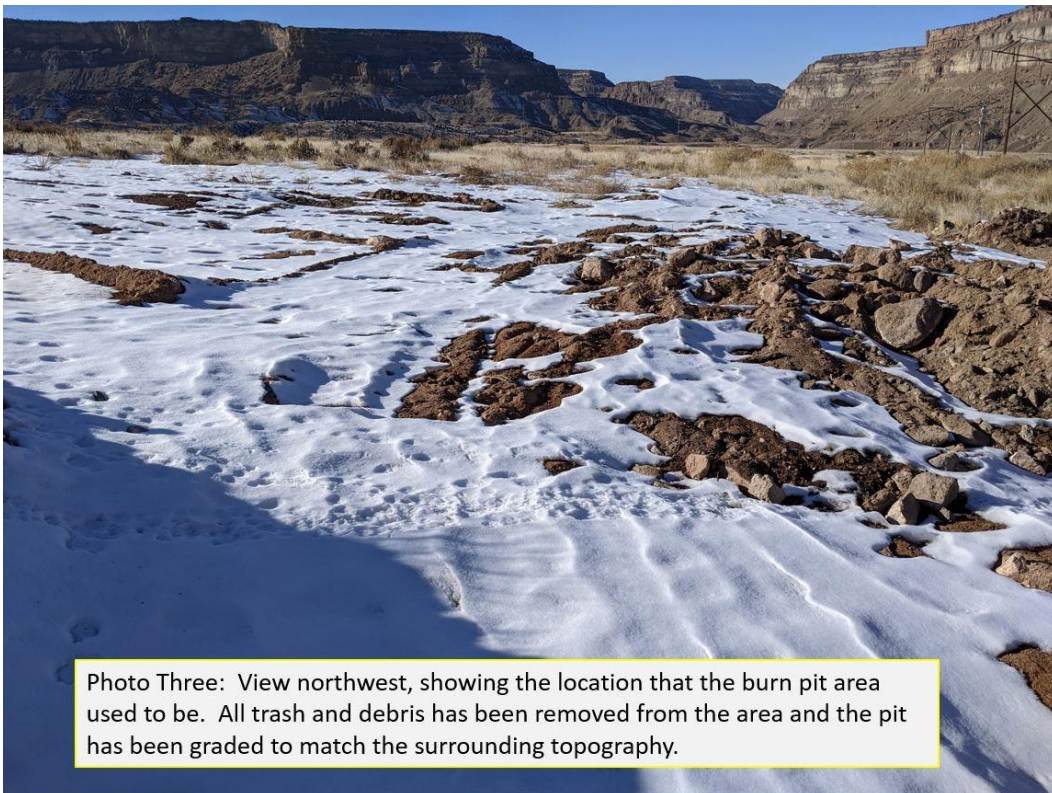
**Burn Pit:** The area referred to as the Burn Pt was observed in the northeastern area of the pit. Some final grading and material removal was required as a result of the previous inspection. The area can be seen in Photos Three and Four. All material that was required to be removed had been removed from the site and the final grading was stable at the time of the inspection and in good condition. At this time the Inspection Problem for excessive trash and debris is considered resolved.

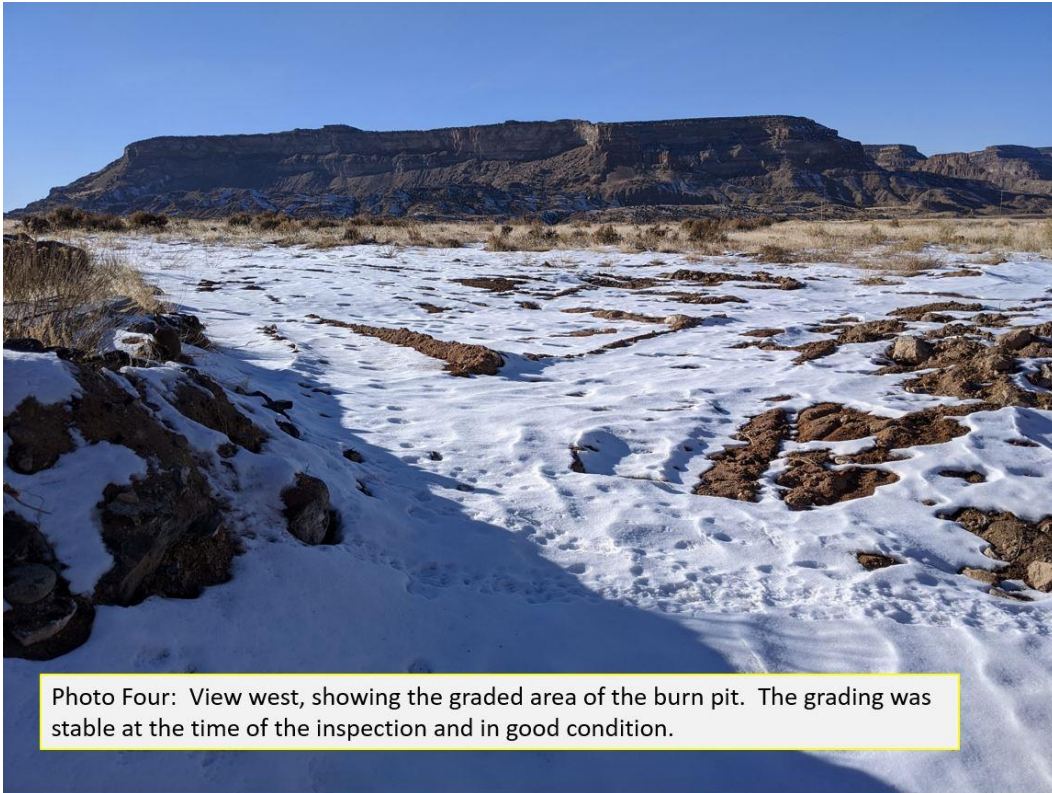
Photo Four: View west, showing the graded area of the burn pit. The grading was stable at the time of the inspection and in good condition.
