MINERALS PROGRAM INSPECTION REPORT
PHONE: (303) 866-3567

MINE NAME: 22 West Pit	MINE/PROSPECTING ID#: M-2017-032	MINERAL: Borrow material for construction, sand and gravel	COUNTY: Otero
INSPECTION TYPE: Monitoring	INSPECTOR(S): Amy Eschberger, DJ Cunningham	INSP. DATE: January 14, 2020	INSP. TIME: 11:30
OPERATOR: Deep Cut LLC	OPERATOR REPRESENTATIVE: Chris Tomky	TYPE OF OPERATION: 112c - Construction Regular Operation

M-2017-032 / 22 West Pit / Deep Cut LLC (112c Operation)

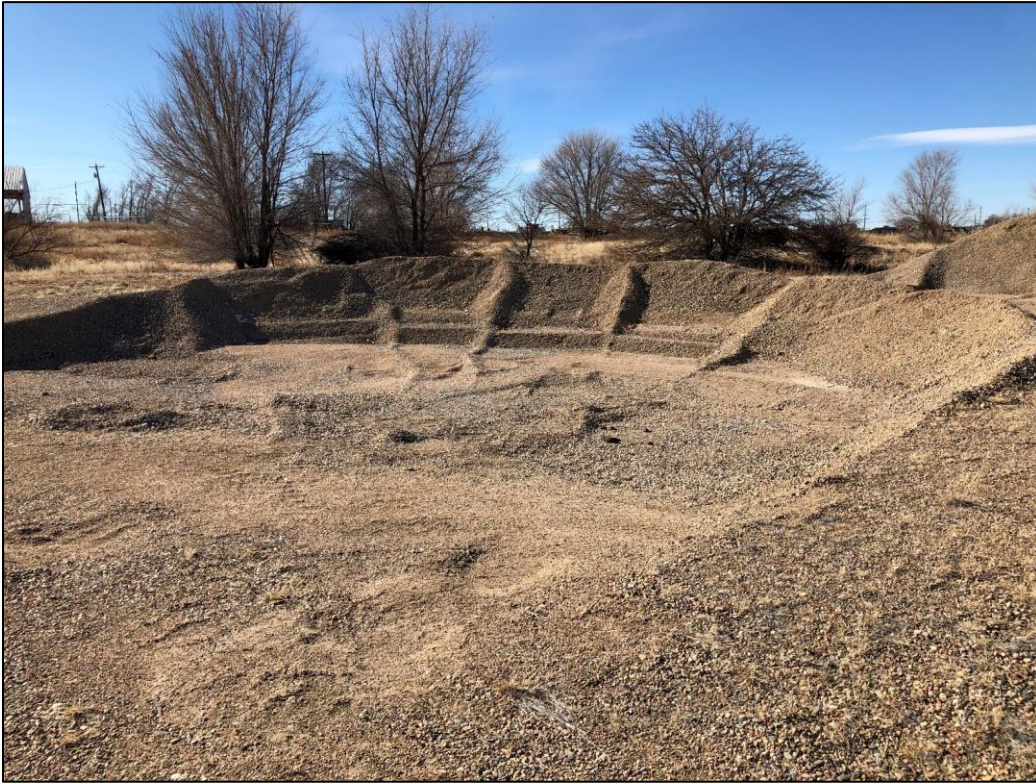
Photo 1. View looking southwest, showing old material stockpiles left in western portion of permit area which operator is currently hauling off from.

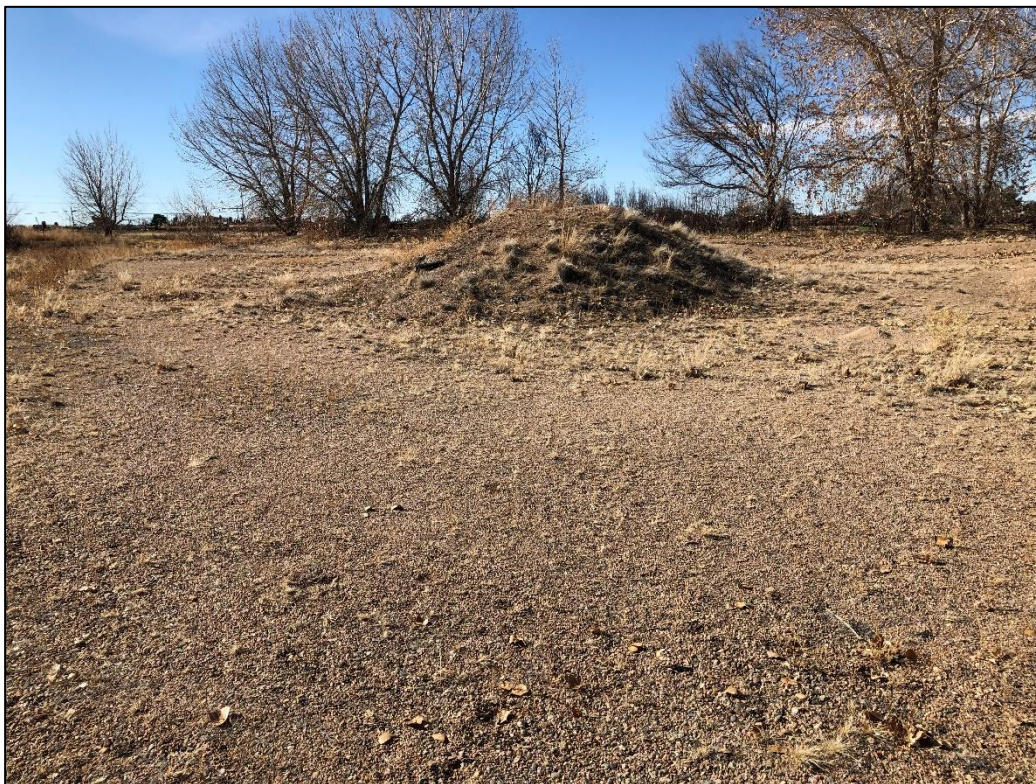
Photo 2. View looking west, showing small material stockpile left in western portion of permit area.

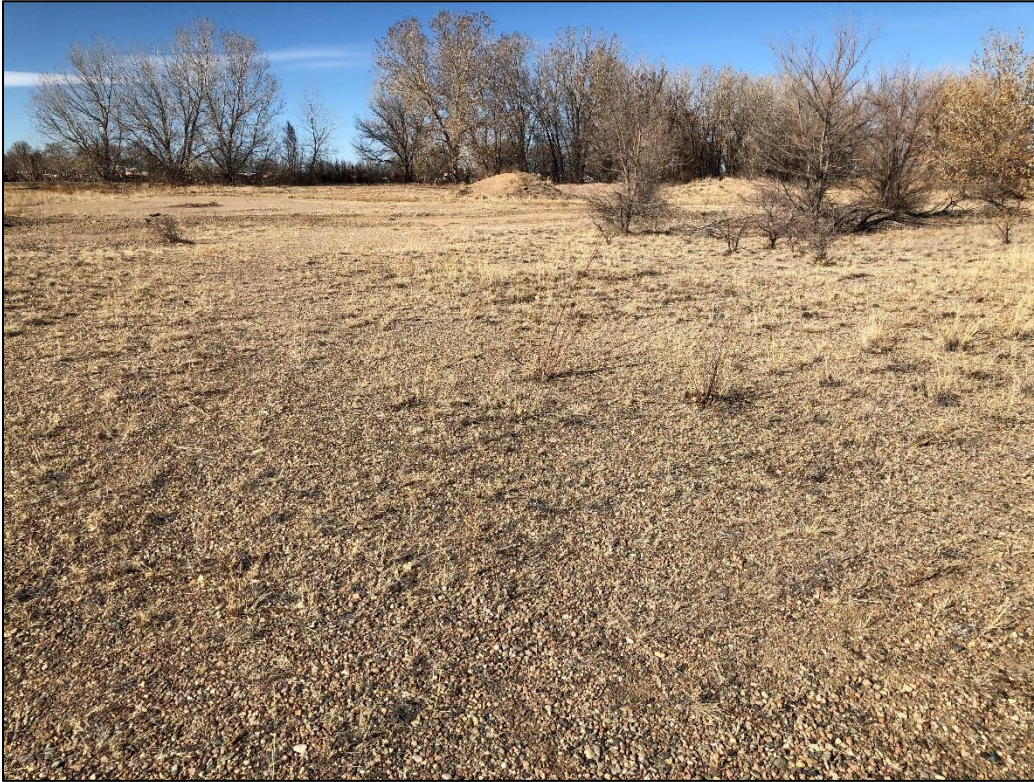
Photo 3. View looking north across western half of permit area which will be used as a stockpiling area by this operation.

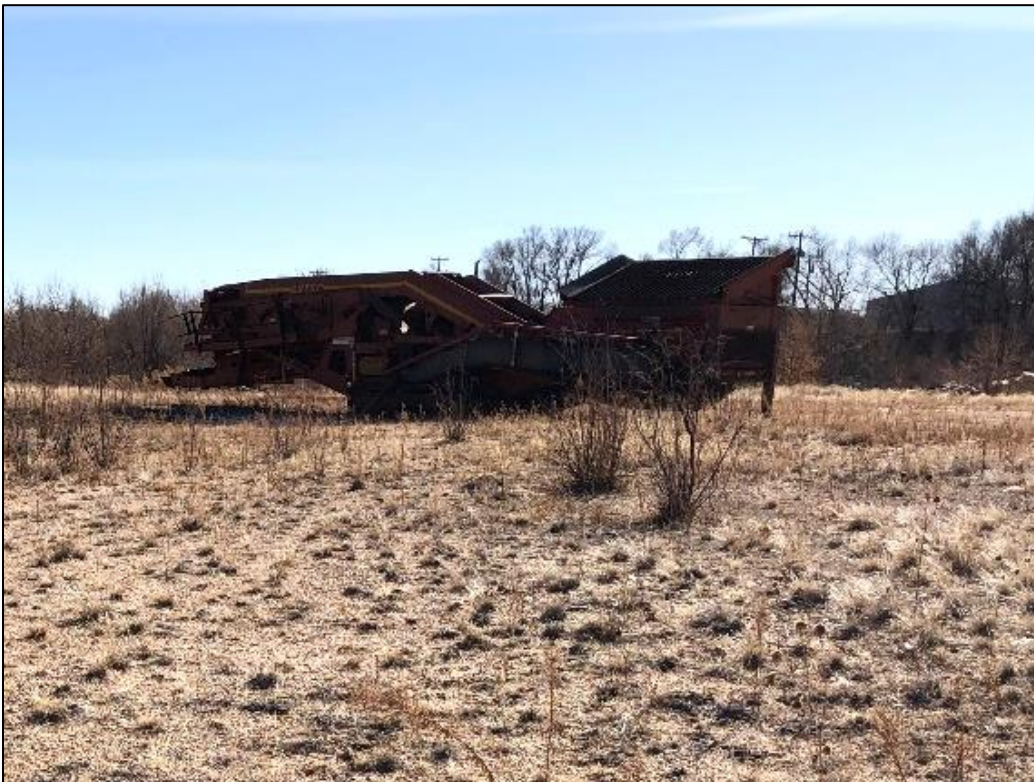
Photo 4. View looking south, showing portable screening plant brought to site, currently stored near ponds.

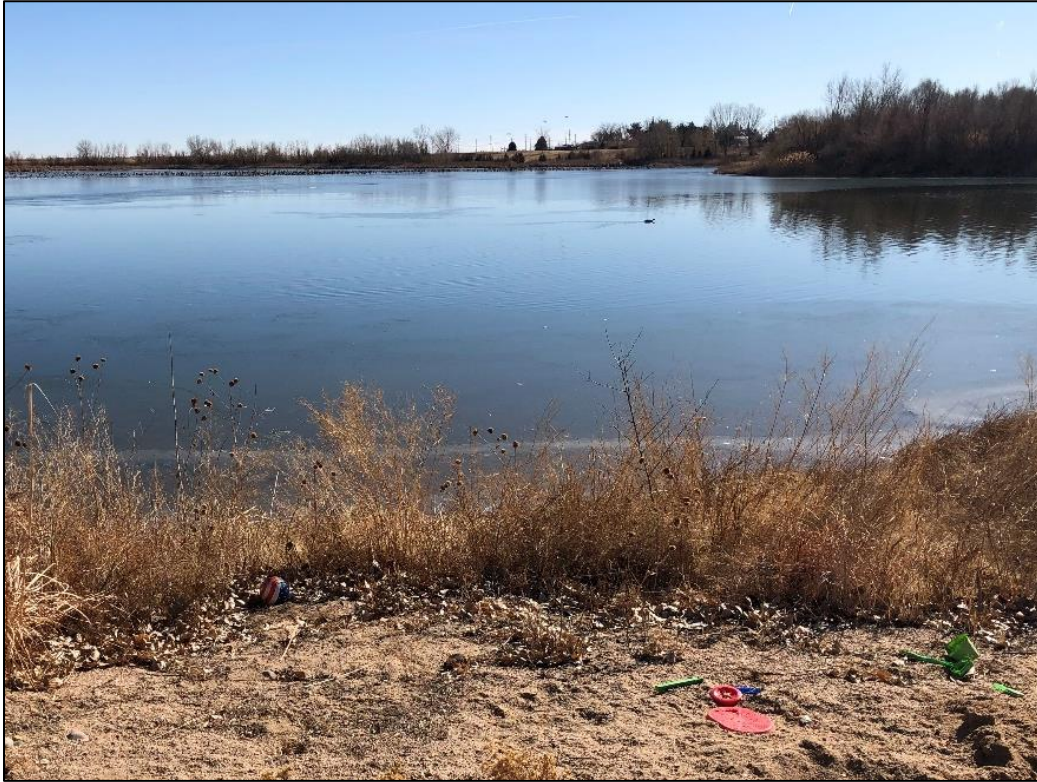
Photo 5. View looking southeast across larger pond. The southern permit boundary cuts across the center of this pond.

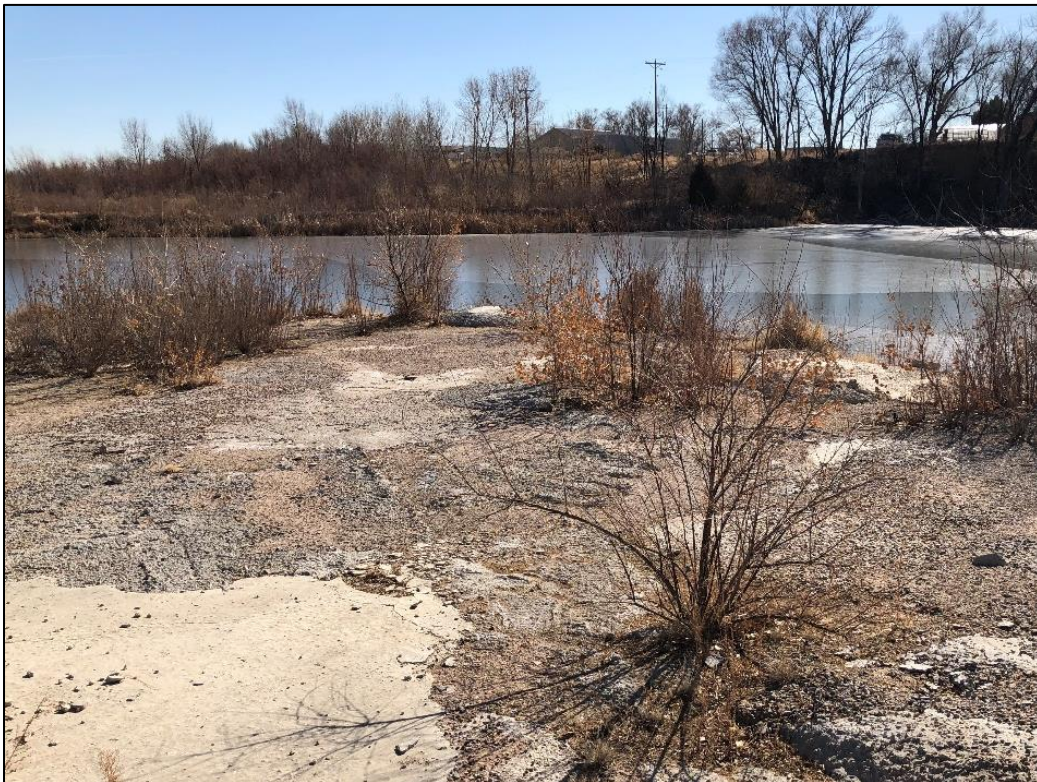
PROBLEM: Tamarisk (salt cedar) trees are present within or have volunteered into the permit area and are becoming established. This is a problem for failure to employ weed control methods for a state-listed noxious weed species within the permitted area, and to reduce the spread of weeds to nearby areas as required by Rule 3.1.10(6).

During its pre-operation inspection of the site (on October 25, 2017), the Division observed several weeds in the permit area including the state-listed noxious weed species Tamarisk (salt cedar). The Division instructed the operator to address this weed problem once the permit was issued. During the current inspection, the Division observed no evidence the operator is implementing the approved weed control and management plan at the site. Numerous Tamarisk trees were observed on site, primarily along the northern edge of the permit area and between the two ponds. **Therefore, the Division is citing a problem in this report (see page 1) for failure to employ weed control methods for a state-listed noxious weed species within the permitted area, and to reduce the spread of weeds to nearby areas as required by Rule 3.1.10(6). The operator will need to either implement the approved weed control and management plan and submit photographic evidence this has been done, or develop a new plan in consultation with the county extension agency or weed control district office, and submit this plan in a Technical Revision.**

Photo 6. View looking southeast across smaller pond, the northwestern edge of which was used as a concrete washout area by the previous batch plant operation (note concrete in foreground). Also note Tamarisk trees present in this area.

CORRECTIVE ACTIONS: By the corrective action date, the operator shall either implement the existing weed control plan and submit photographic evidence demonstrating this has been done, or develop a new weed control and management plan in accordance with Rule 3.1.10(6) and submit this plan as a Technical Revision to the approved plan with the appropriate fee of \$216.00. The proposed weed control and management plan should be developed in consultation with the county extension agency or weed control district office, and should include specific control measures to be applied, a schedule for when control measures will be applied, and a post-treatment monitoring plan.

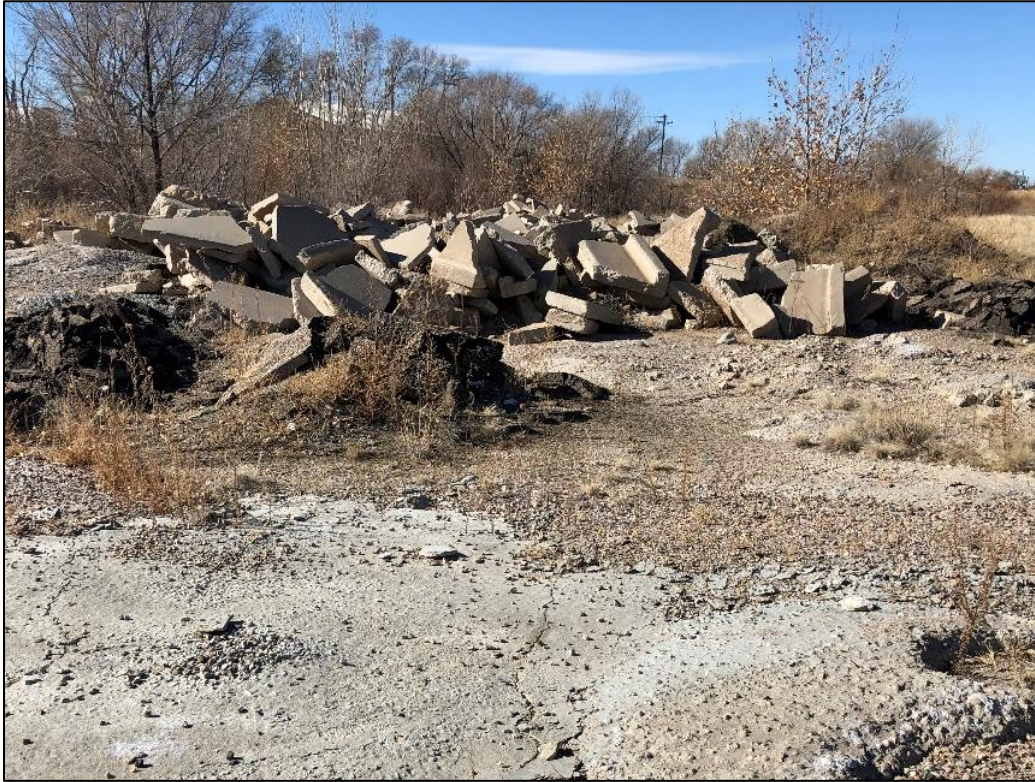
Photo 7. View looking west, showing concrete rubble and some asphalt paving fragments stored just west of smaller pond.

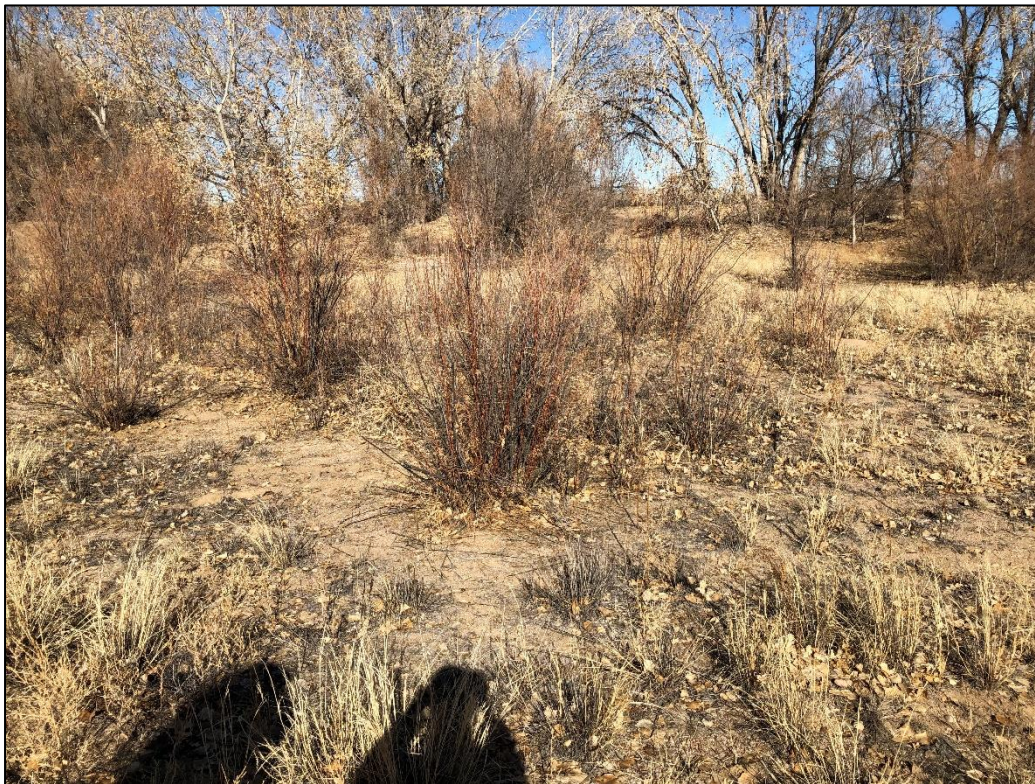
Photo 8. View looking north, showing Tamarisk trees present along northern edge of permit area.

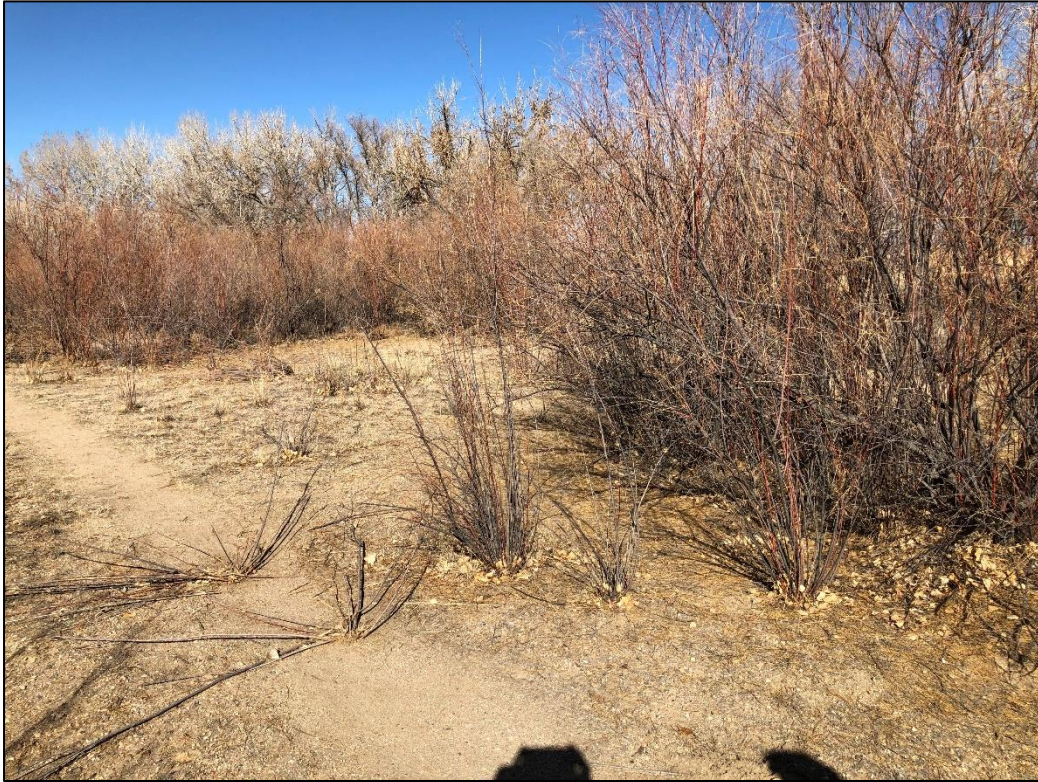
Photo 9. View looking northwest, showing Tamarisk trees present along northern edge of permit area.

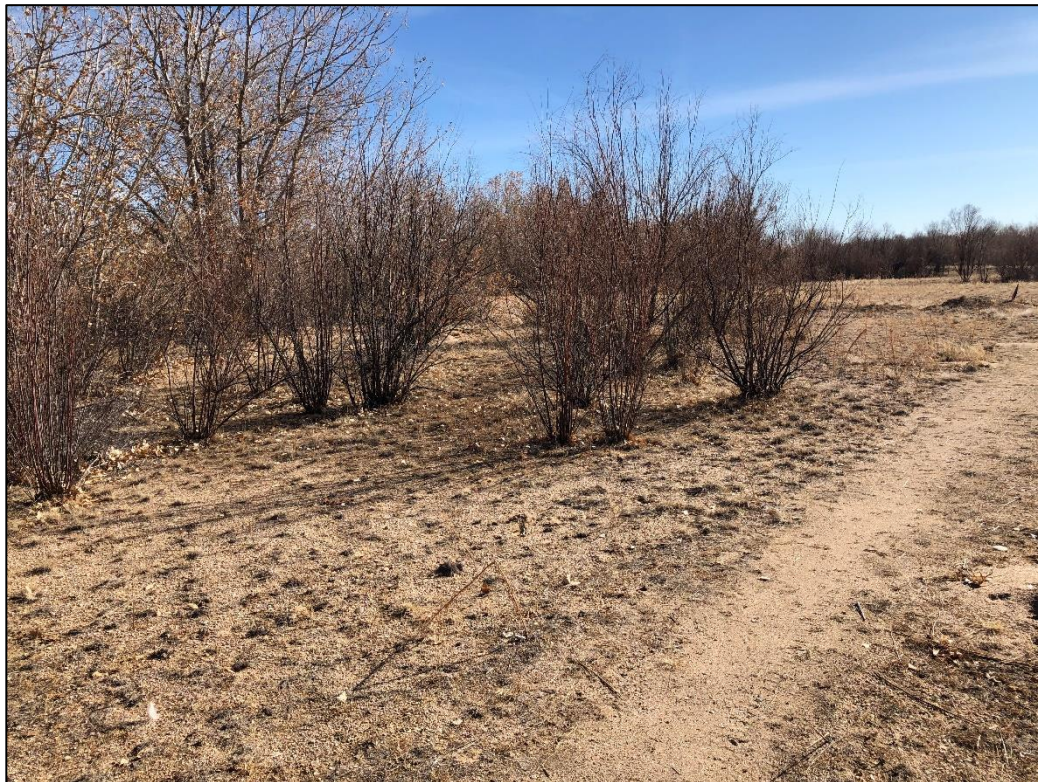
Photo 10. View looking northeast, showing Tamarisk trees present along northern edge of permit area.

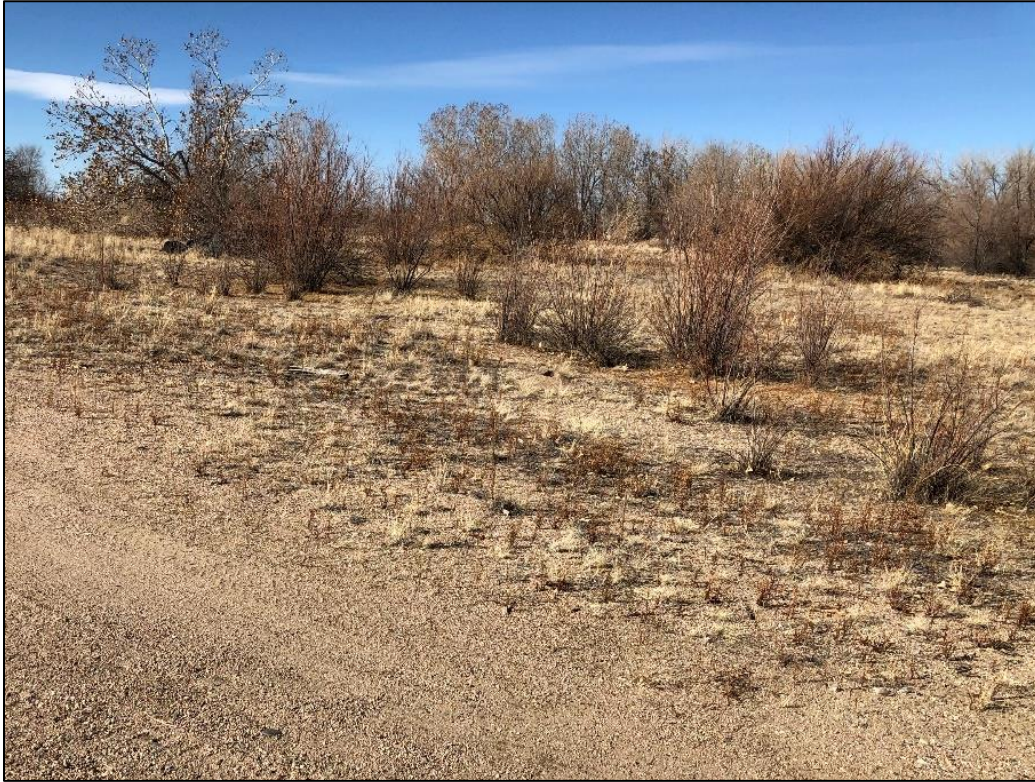
Photo 11. View looking north, showing Tamarisk trees present near center of permit area, adjacent to main access road.

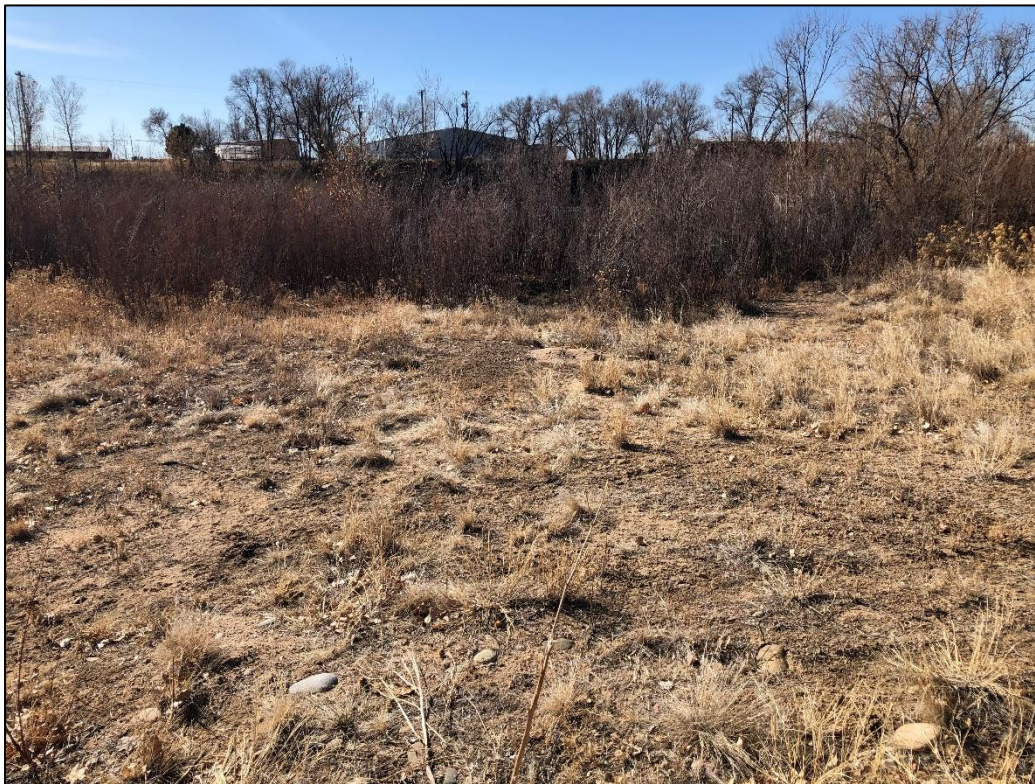
Photo 12. View looking south across sliver of land separating the two ponds. Note the numerous Tamarisk trees present in this area.

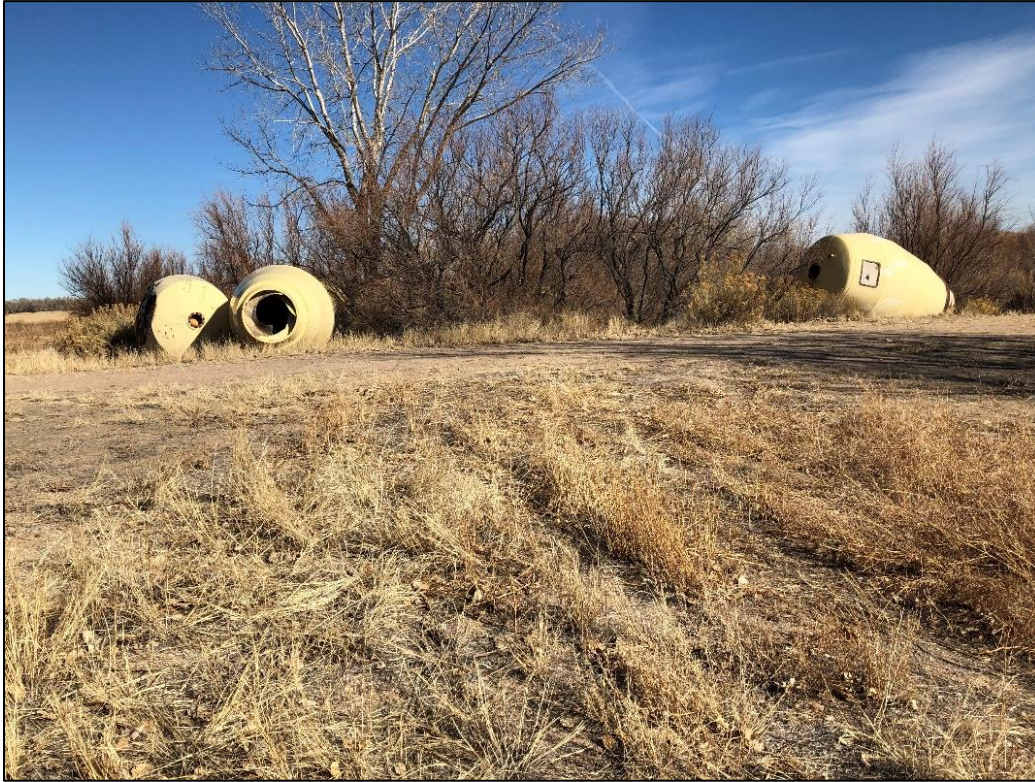
Photo 13. View looking north, showing 3 of 5 old cement mixer drums left on site (near ponds) from previous batch plant operation.

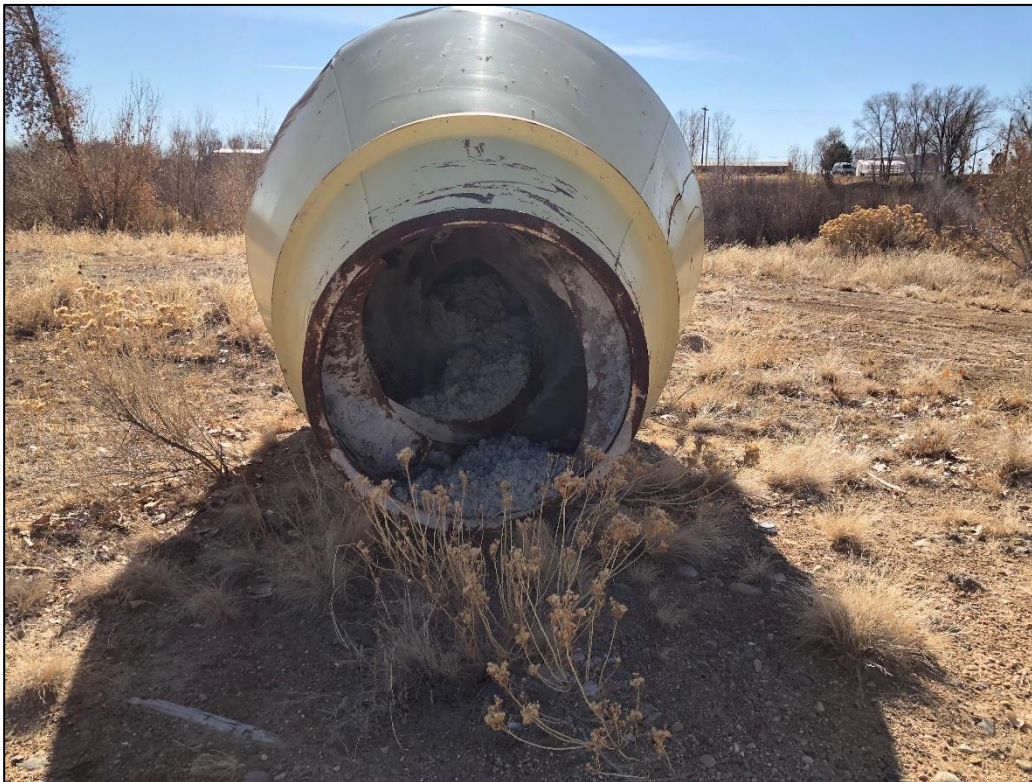
Photo 14. Closer view of one of old cement mixer drums left on site by previous batch plant operation. Note concrete left inside drum.
