MINERALS PROGRAM INSPECTION REPORT
PHONE: (303) 866-3567

MINE NAME: Two Rivers	MINE/PROSPECTING ID#: M-1998-038	MINERAL: Gravel	COUNTY: Pueblo
INSPECTION TYPE: Monitoring	INSPECTOR(S): Patrick Lennberg	INSP. DATE: January 17, 2020	INSP. TIME: 09:30
OPERATOR: Kirkland Construction, R.L.L.P.	OPERATOR REPRESENTATIVE: Baxter Kirkland and Tim Gerken	TYPE OF OPERATION: 112c - Construction Regular Operation

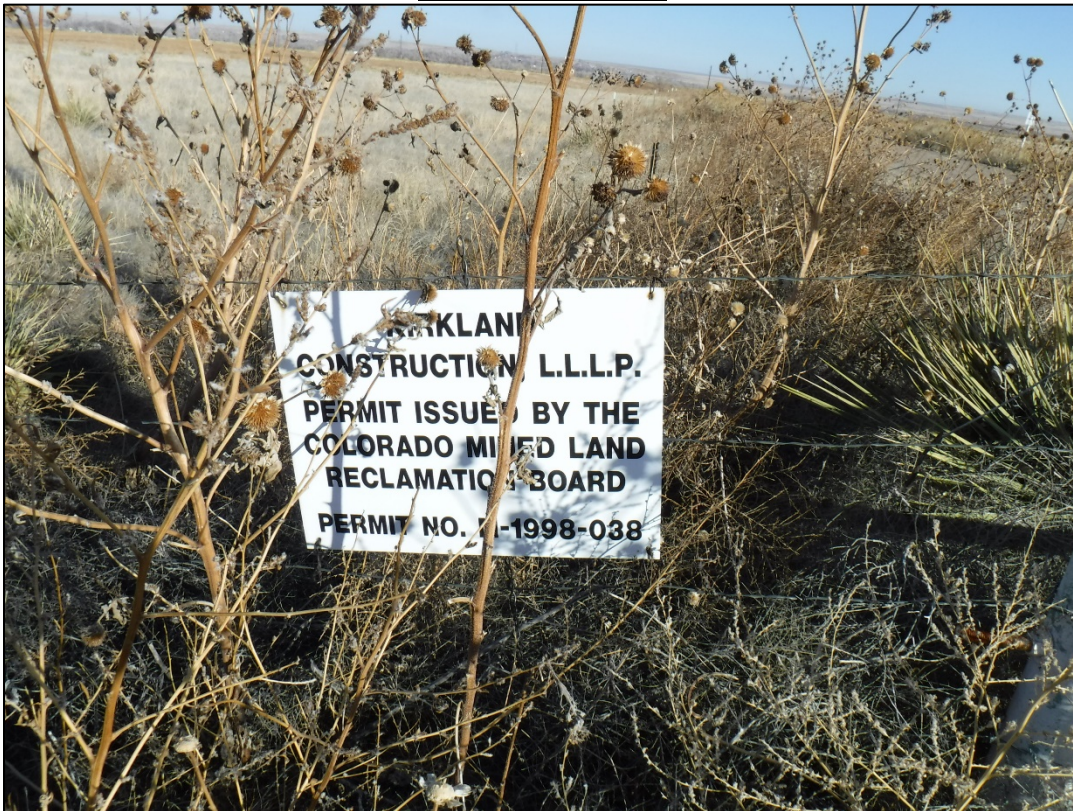
The Two Rivers Pit is located in Pueblo County approximately 5.5 miles east of Avondale, Colorado. The Two Rivers Pit is a 339-acre 112c Construction Materials Reclamation Permit with a maximum allowed disturbance of 99 acres. The primary commodity being mined at the site is sand and gravel. The 112c Construction Materials Reclamation Permit was issued in July 1998. The 112c Two Rivers Pit was permitted over the area previously permitted by a 111 permit. The approved post-mining land use is rangeland. The mine site was surrounded by the following land uses: residential, agricultural, and rangeland. A mine sign was observed as required by Rule 3.1.12.

Photo 1: Mine sign at entrance to mine site

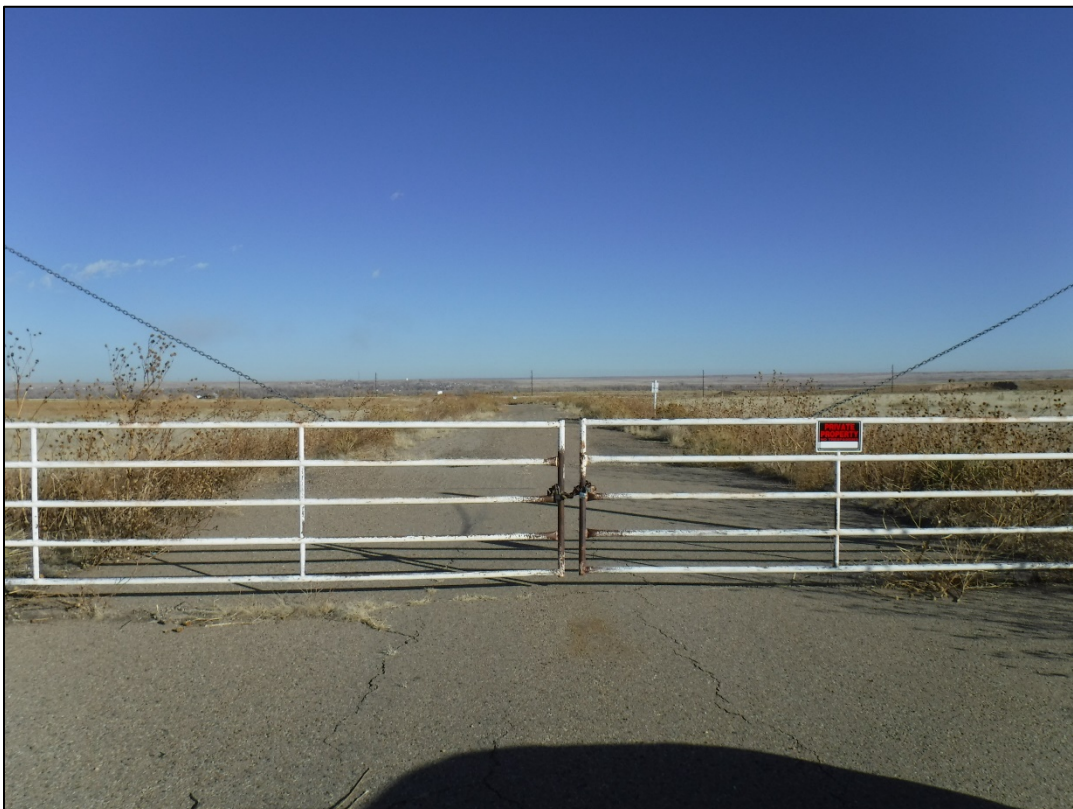
Photo 2: Main haul road to mine

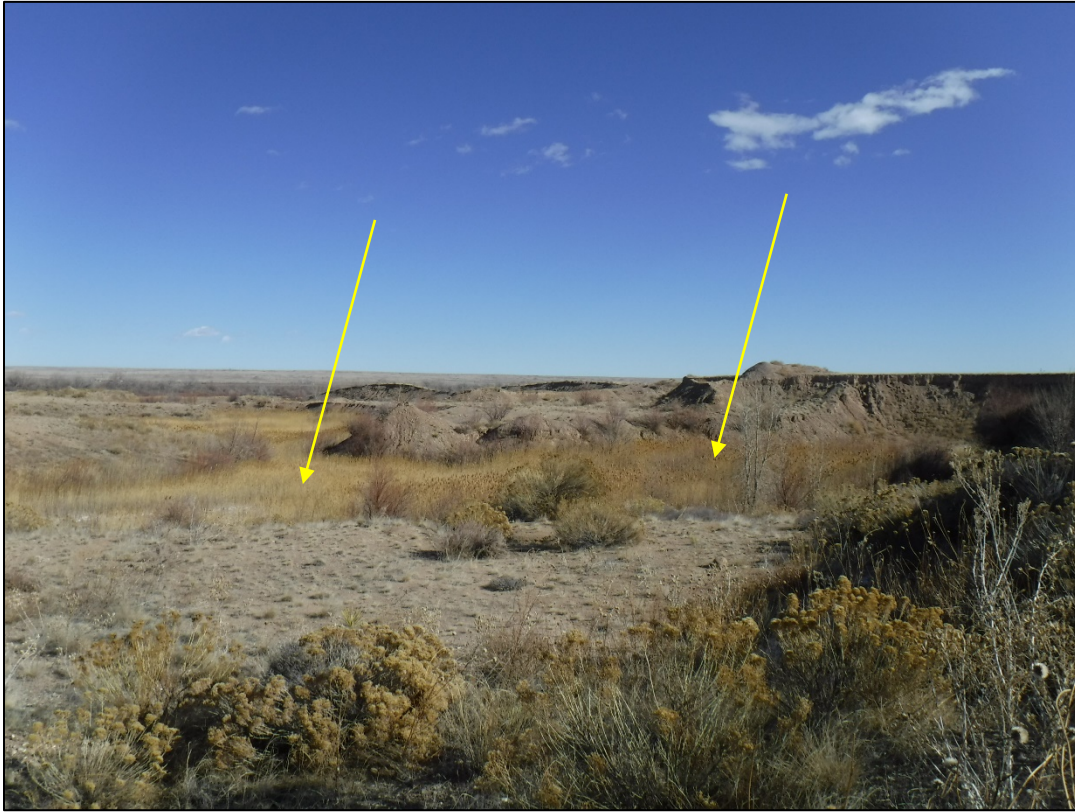
Photo 3: Southeast corner of mine, arrows indicate deep excavation needing fill

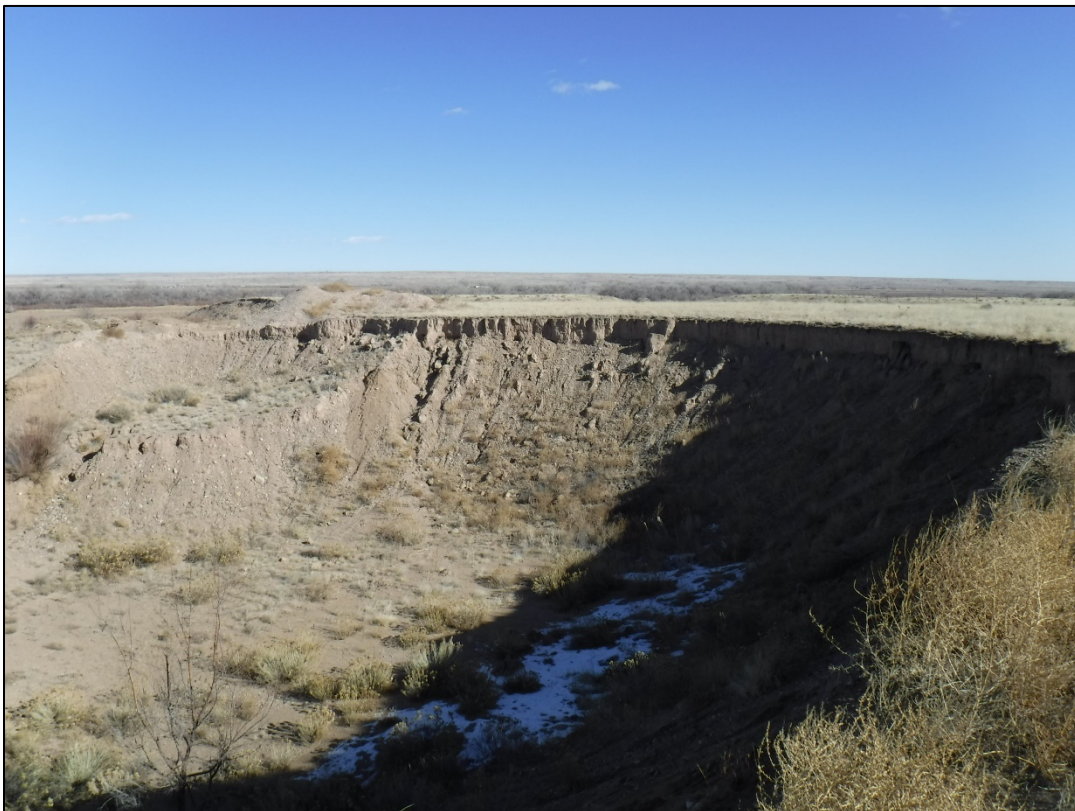
PROBLEM: The affected area boundary markers are missing or incorrectly placed. This is a problem for failure to maintain boundary markers around the affected area as required by Rule 3.1.12(2).

There are several stockpiles scattered throughout the affected area. There are also a few stockpiles of broken up concrete and asphalt. In the southeastern corner of the affected area the highwall appears to be close to the permit boundary. The permit boundary is not clearly marked in this area and is being cited as a problem per Rule 3.1.12(2) in this report. The Operator needs to mark the boundary to prevent offsite damages. With the highwall close to permit boundary the Operator will have to grade the slopes to 3H:1V or shallower by pushing-up material. Also, there is a deep excavation immediately adjacent to the highwall that has the potential for capturing and detaining storm water. The Operator needs to backfill this area and re-establish the natural drainage in the area. There is another area to the north that also appears to have the potential for capturing and detaining storm water and can possibly be linked to southern area.

Photo 4: Southeast corner highwall near permit boundary, looking east

CORRECTIVE ACTIONS: The operator shall conduct a survey and replace the boundary markers in the correct location(s). The operator shall provide proof to the Division that this has been done by the corrective action date.

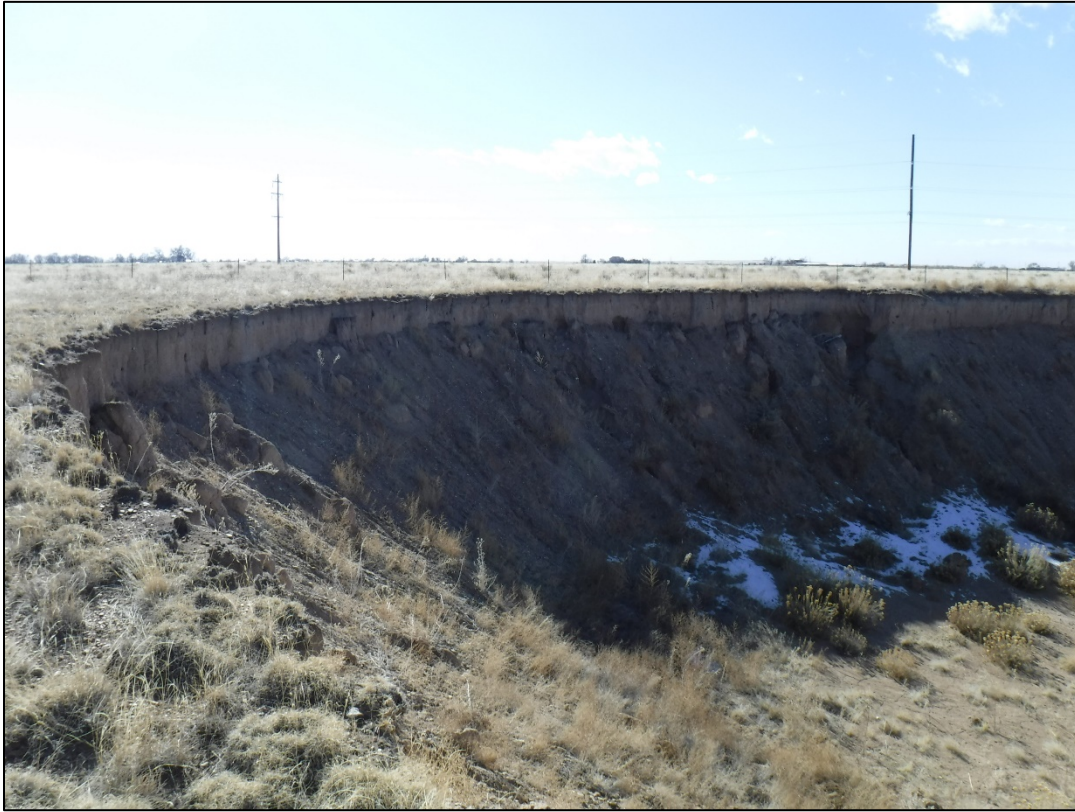
Photo 5: Southeast corner highwall near permit boundary, looking south

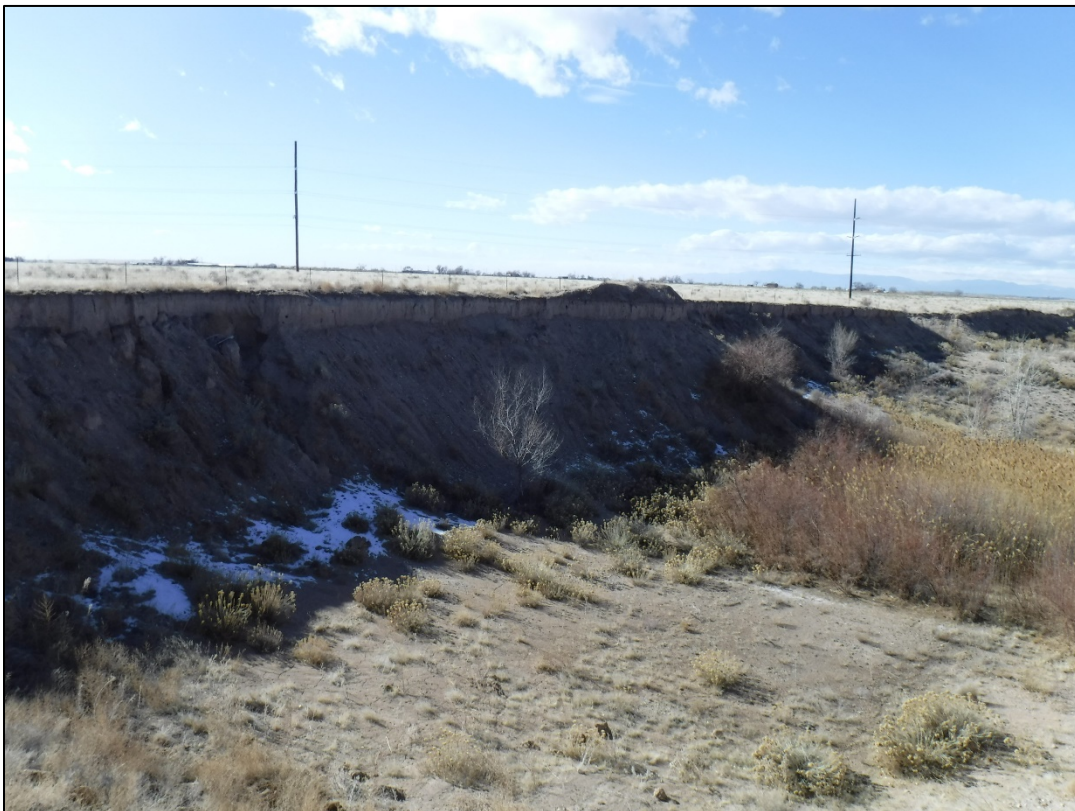
Photo 6: Southeast corner highwall near permit boundary, looking west

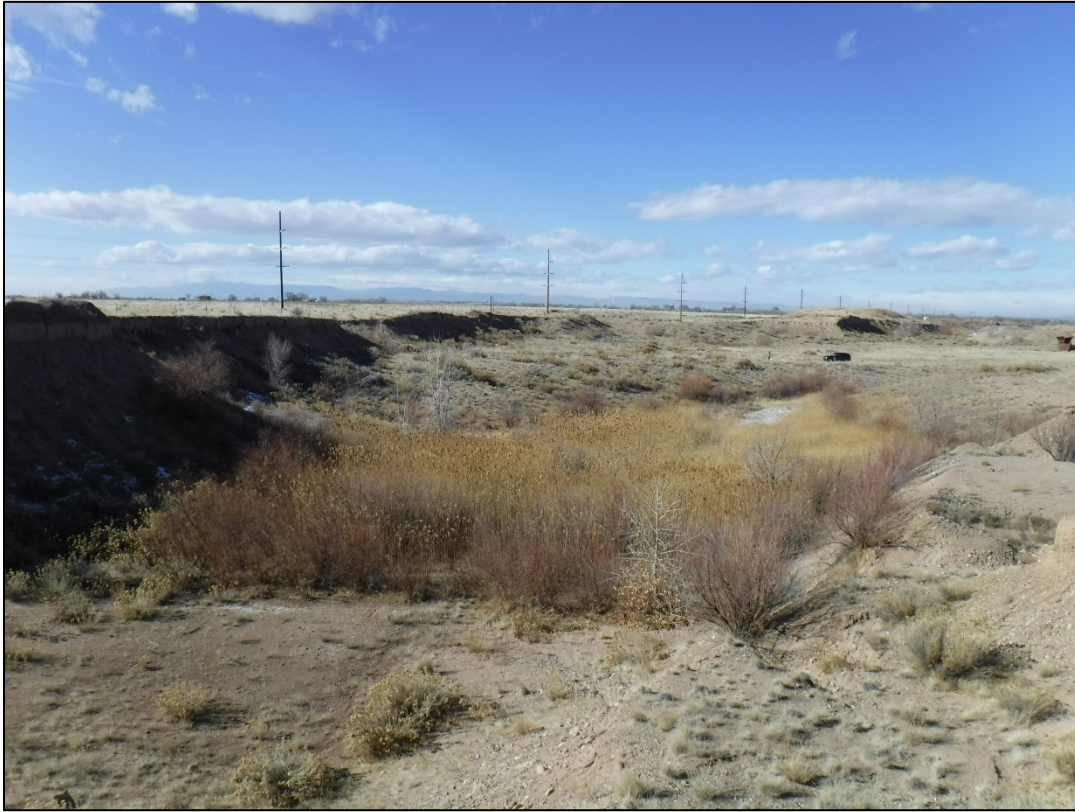
Photo 7: Southeast corner deep excavation, looking west

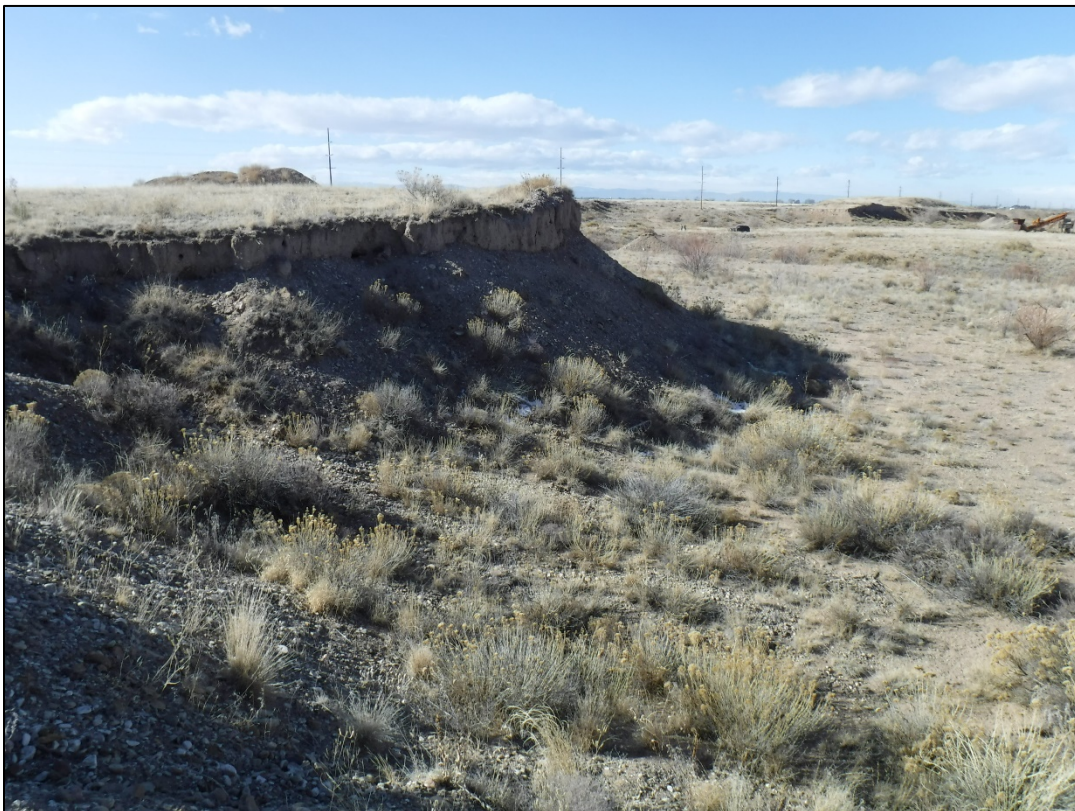
The southern border of the excavation has highwalls that ranges in slope from 1H:1V to just flatter than 1.5H:1V. All highwalls will need to be graded to a 3H:1V or shallower slope. The Division estimates there is approximately 4,100 feet of highwall that needs reclaiming. The majority of the highwalls can be graded out using a push-down method with a dozer however there is approximately 1,100 feet of highwall that will need material pushed-up to achieve the desired reclamation slope. Highwalls vary greatly in height, ranging from 15 feet to near 40 feet with an average estimated to be 20 feet high.

Photo 8: Highwall conditions north of the SE corner area, looking southwest

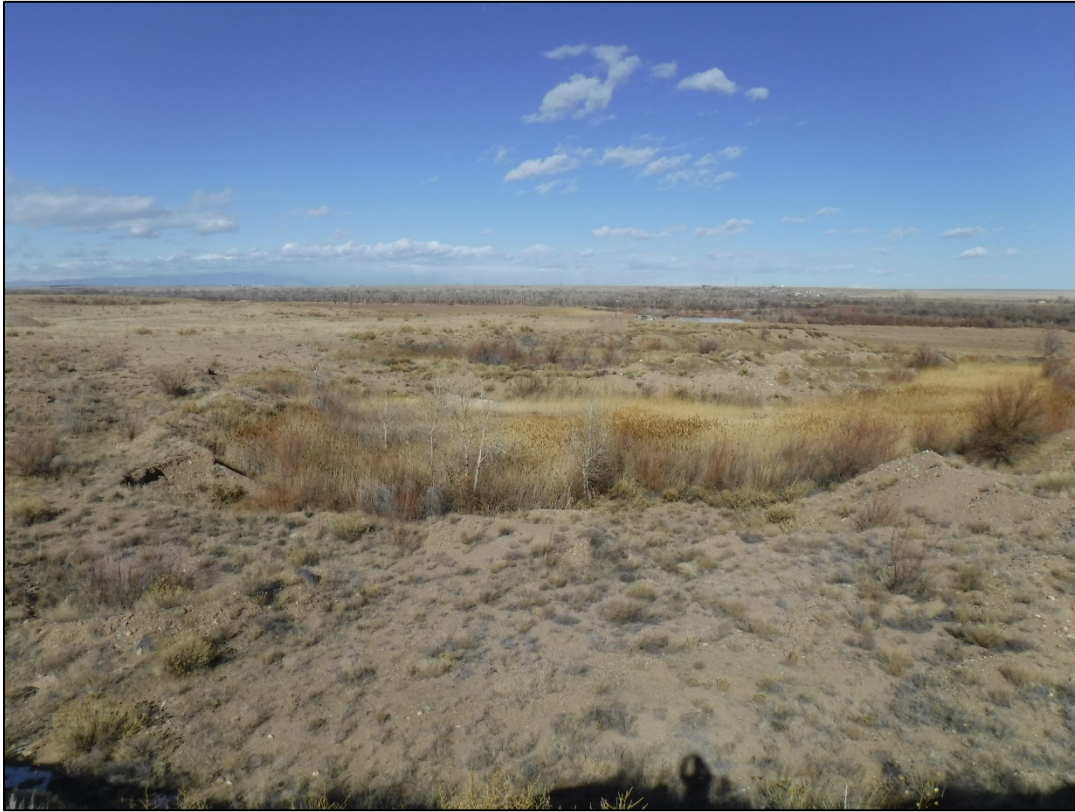
Photo 9: Area to the north of the SE corner deep excavation, looking northwest

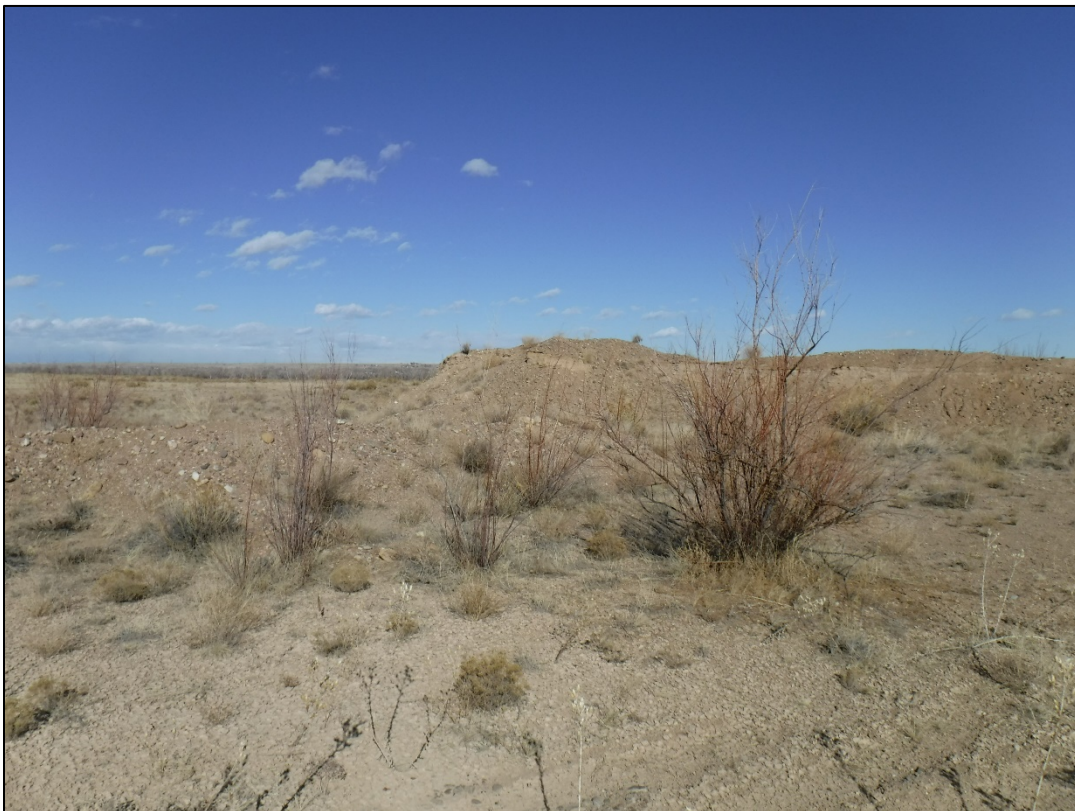
PROBLEM: Tamarisk (salt cedar) and Russian Olive trees are present within the permit area and are becoming established. This is a problem for failure to employ the approved weed control plan for a state listed noxious weed species within the permitted area, and to reduce the spread of weeds to nearby areas as required by Rule 3.1.10 (6).

Tamarisk (salt cedar) and Russian olive trees are present within portions of the reclaimed pit floor and toe of pit slopes. This is a problem for failure to employ the approved weed control plan for state listed noxious weed species within the affected lands, and to reduce the spread of weeds to nearby areas as required by Rule 3.1.10 (6). This has been cited as a problem within this inspection report.

Photo 10: Typical Tamarisk trees encountered throughout the site

CORRECTIVE ACTIONS: The operator shall implement the existing weed control plan and provided evidence (photos and/or invoices) that the plan is being implemented.

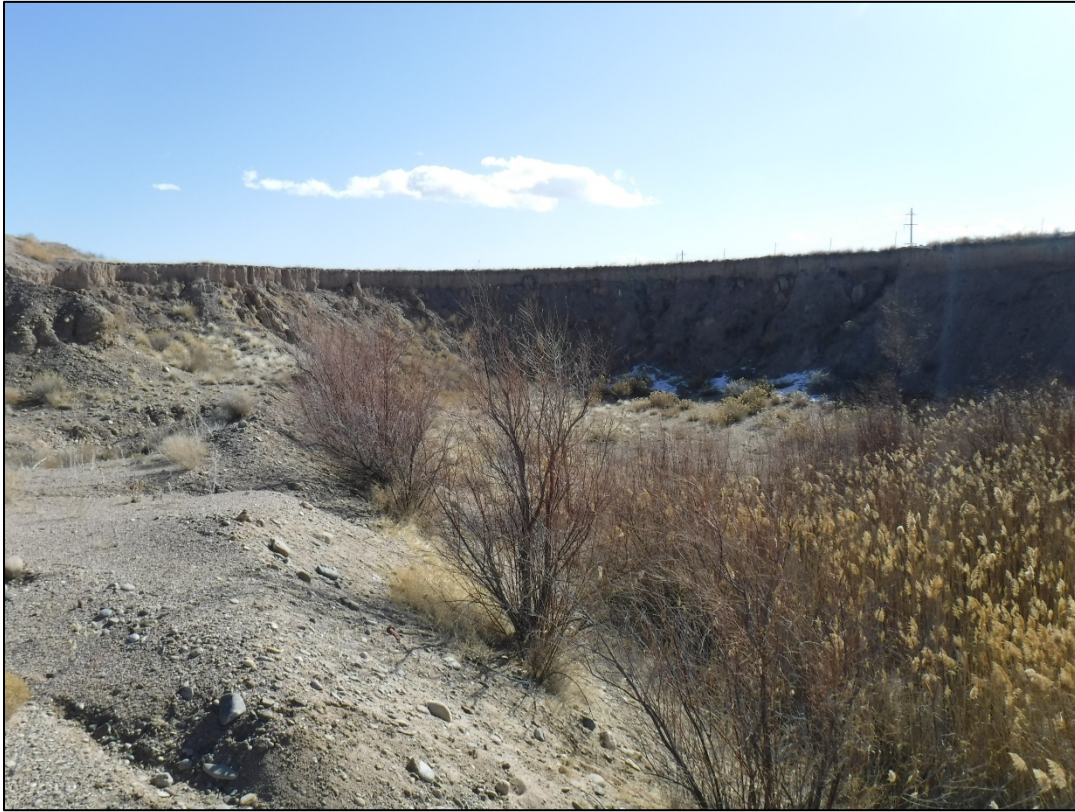
Photo 11: Southeast corner near permit boundary, looking southeast

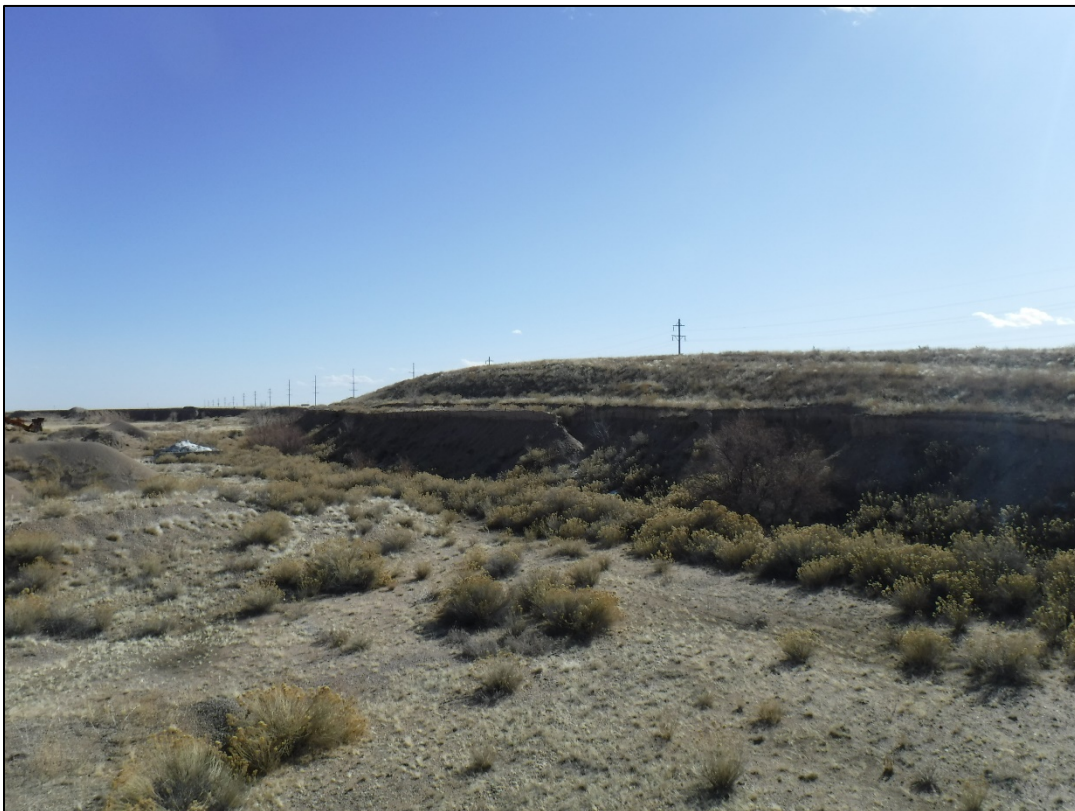
Photo 12: Middle portion of pit showing highwall conditions and topsoil stockpile, looking east

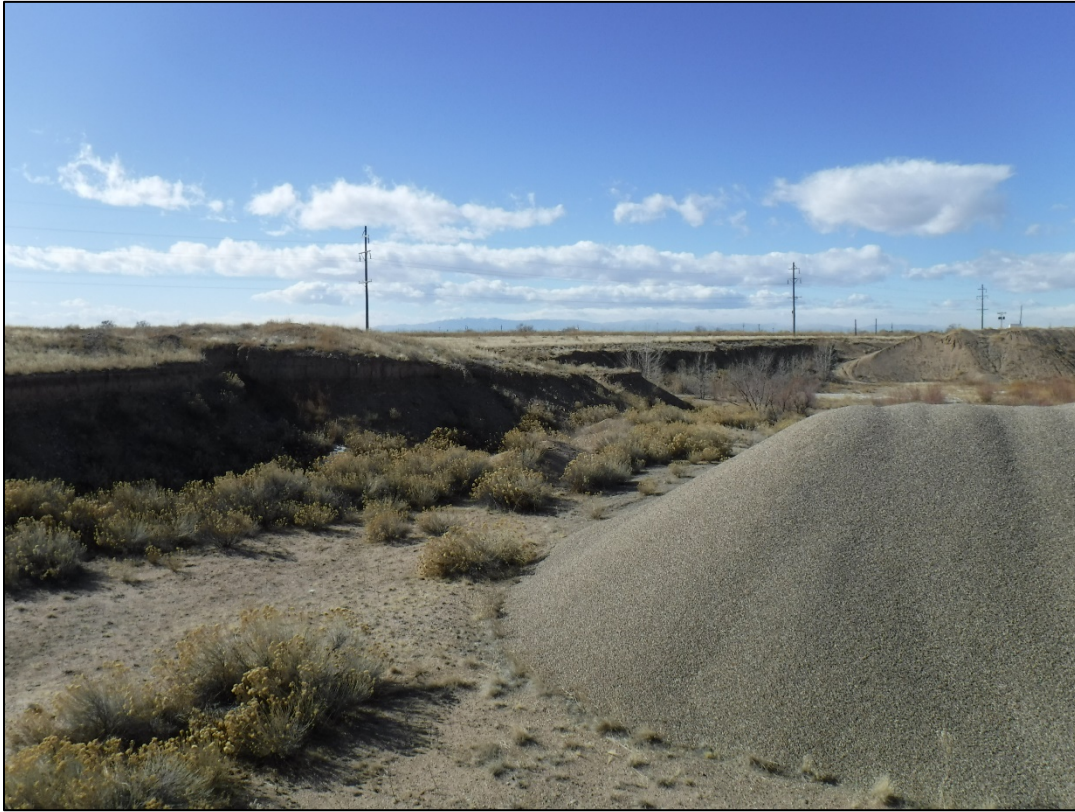
Photo 13: Middle portion showing highwall conditions and product stockpiles, looking west

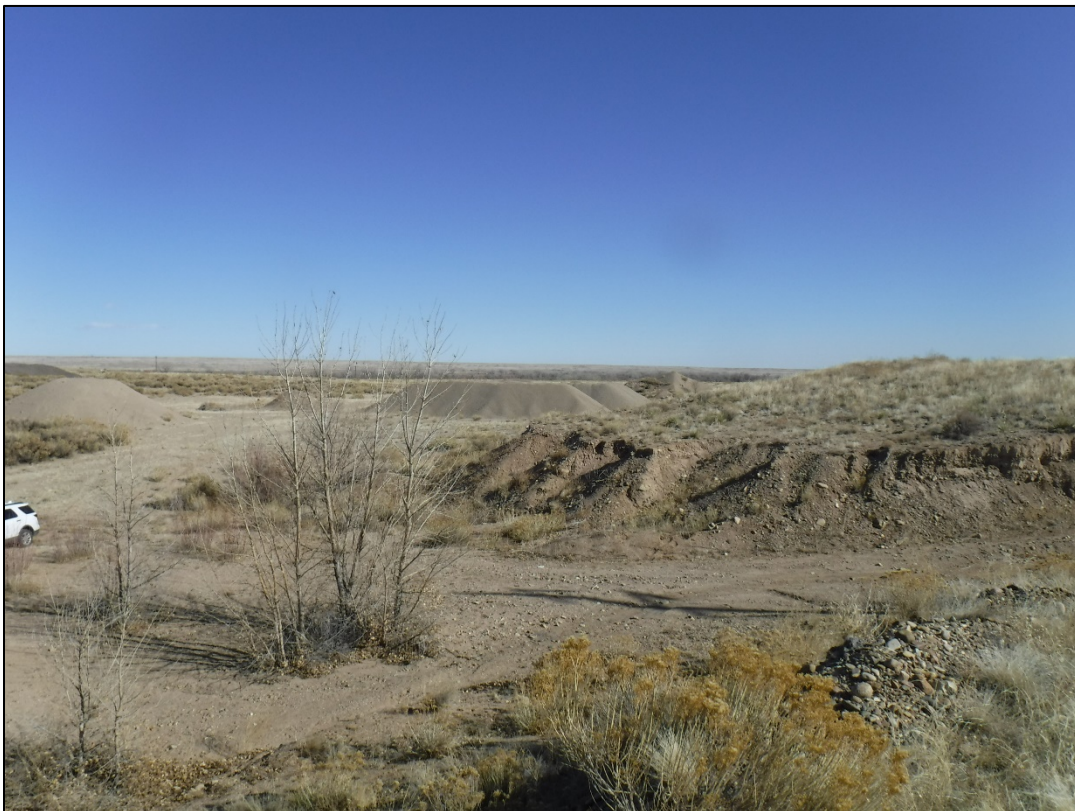
Photo 14: Western portion showing product stockpiles to the east

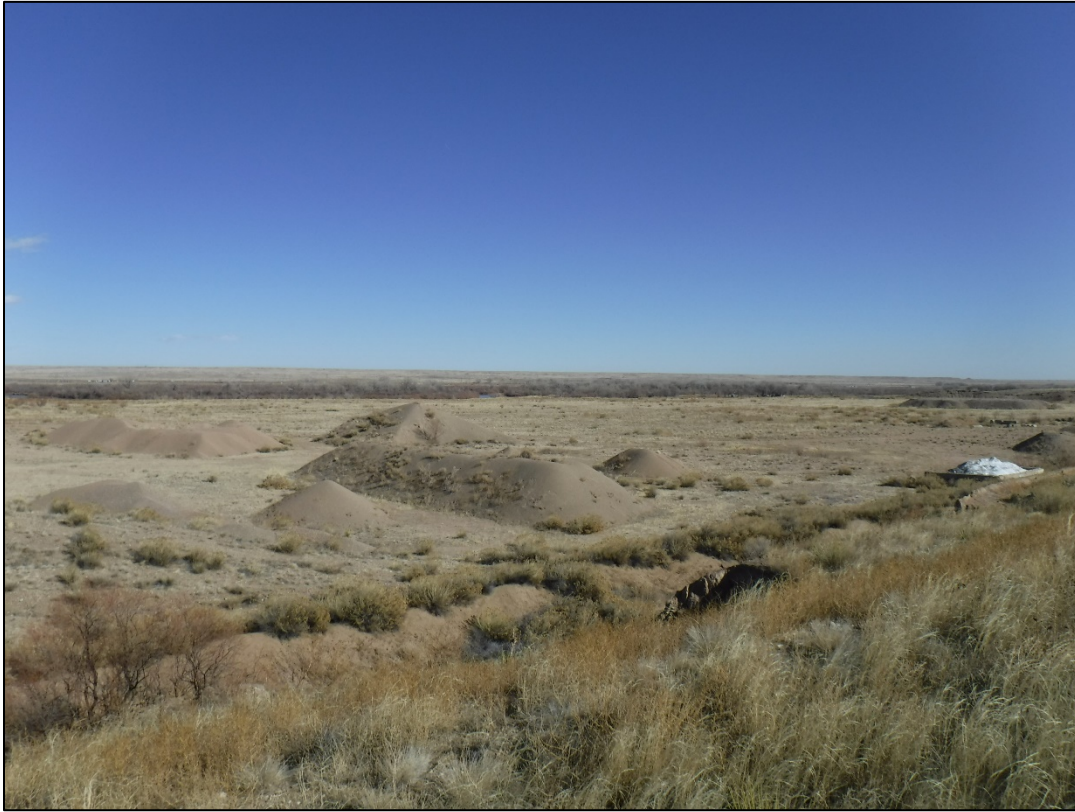
Photo 15: Product stockpiles looking northeast from topsoil stockpile

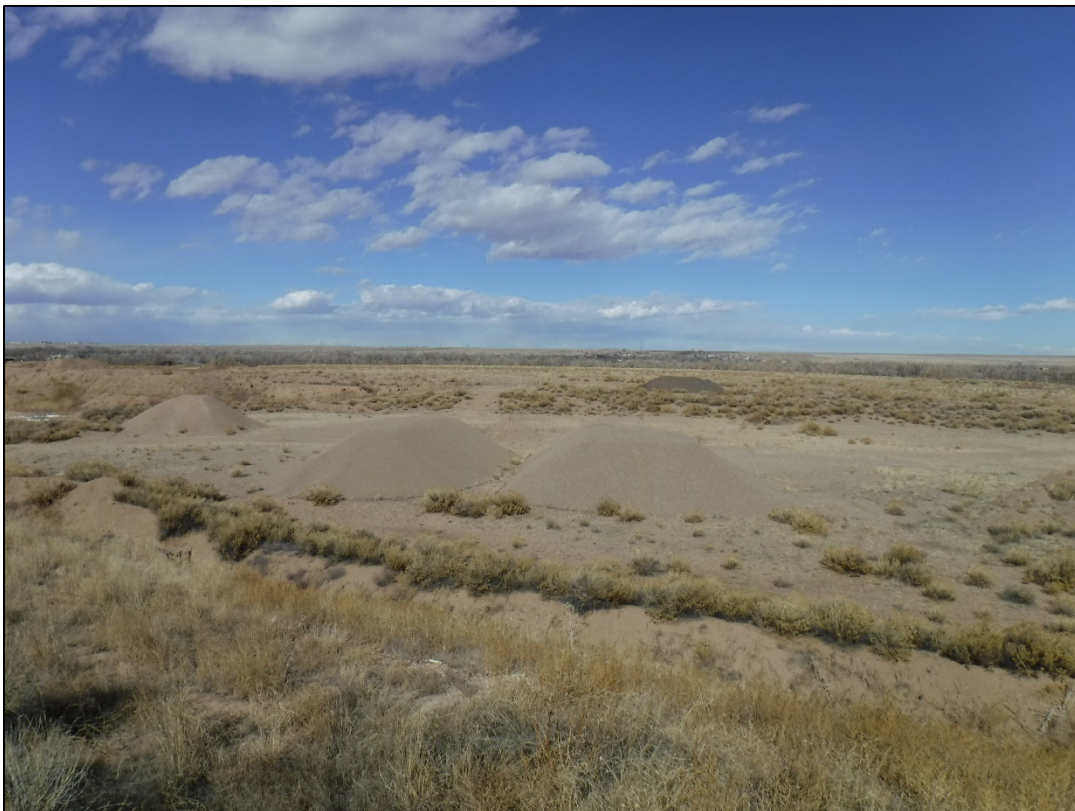
Photo 16: Product stockpiles looking northwest from topsoil stockpile

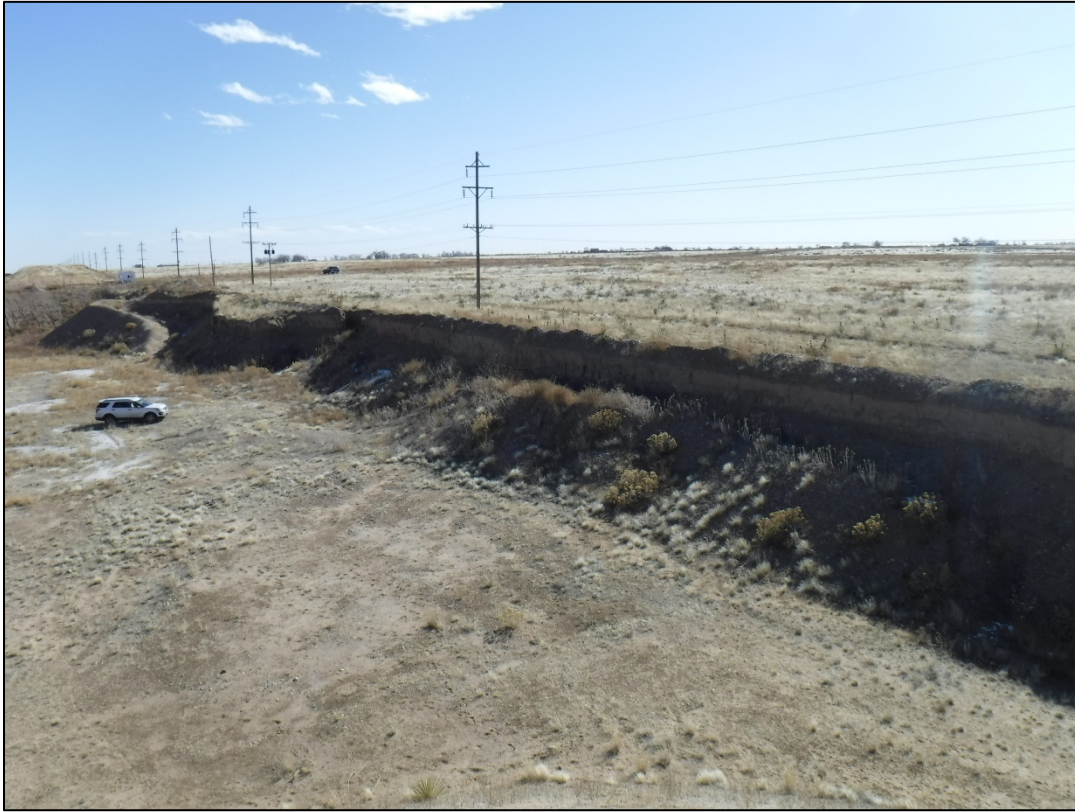
Photo 17: Typical highwall conditions in the western portion of the mining area, looking east

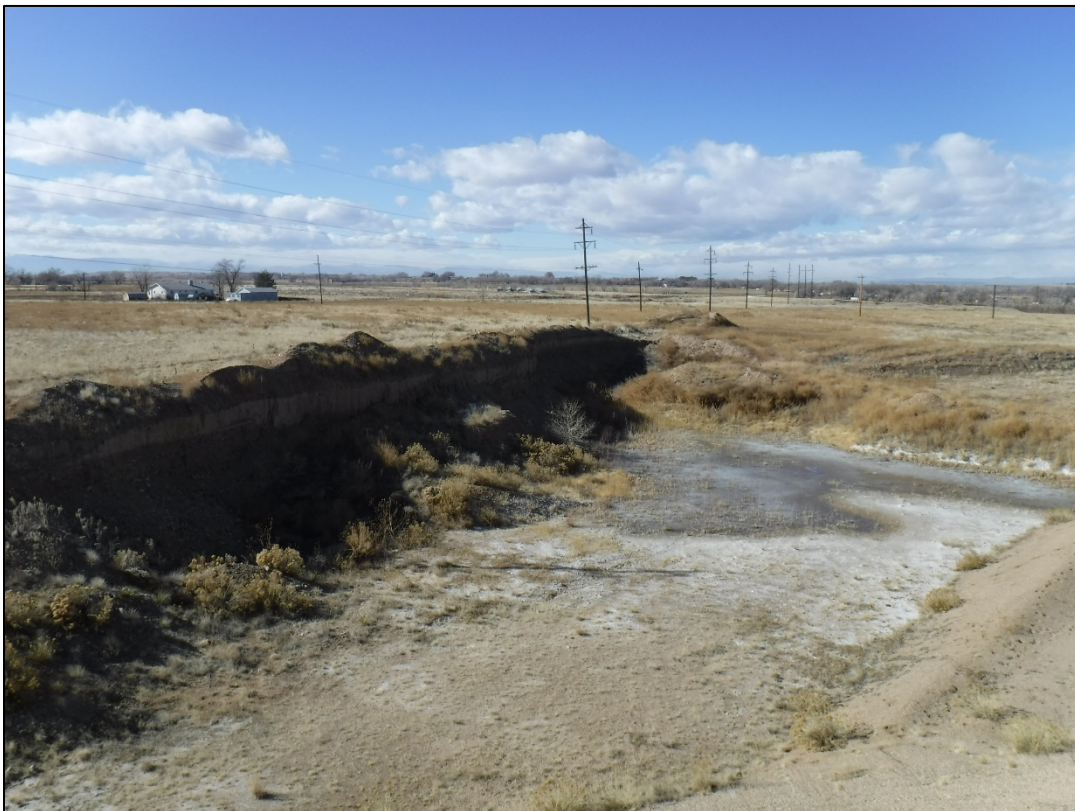
Photo 18: Typical highwall conditions in the western portion of the mining area, looking west

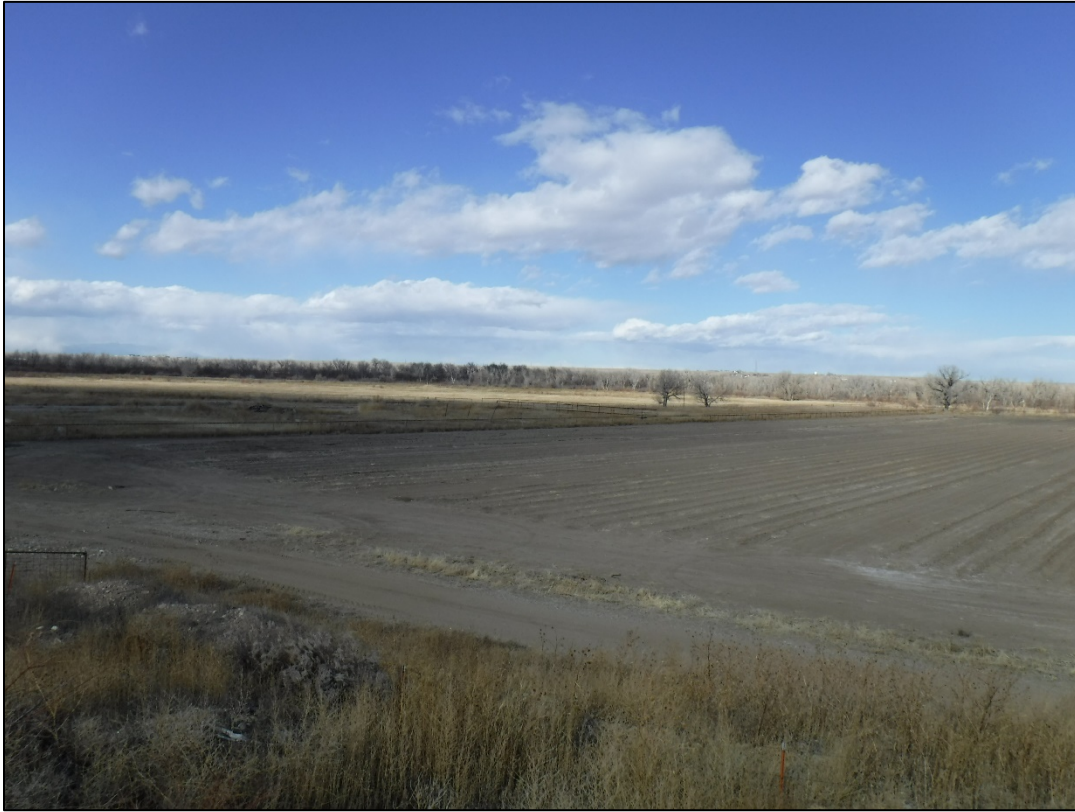
Photo 19: Looking northwest from disturbed lands to unaffected areas of the permit

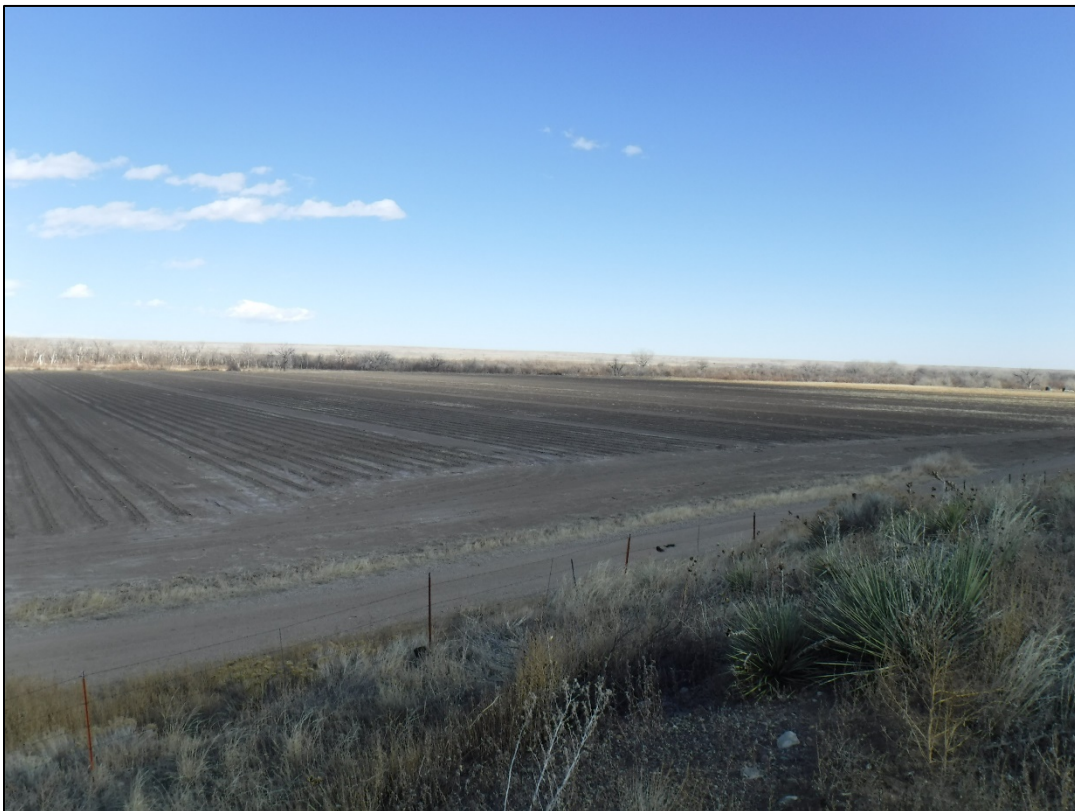
Photo 20: Looking northeast from disturbed lands to unaffected areas of the permit

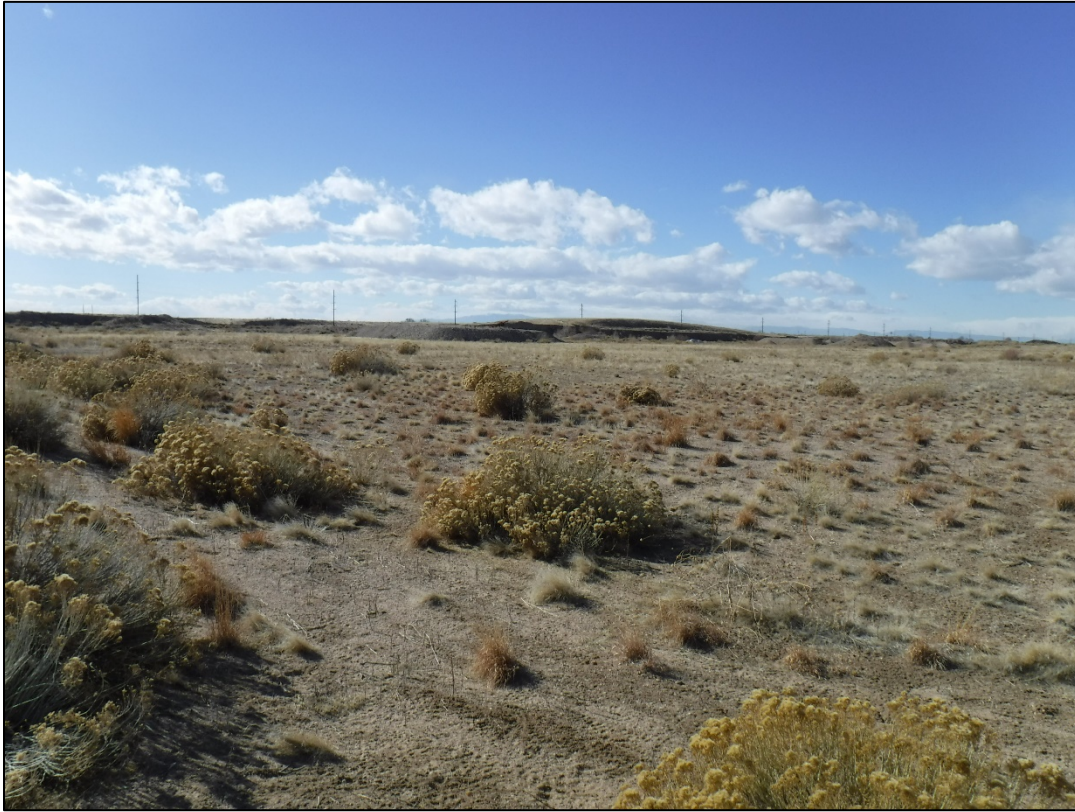
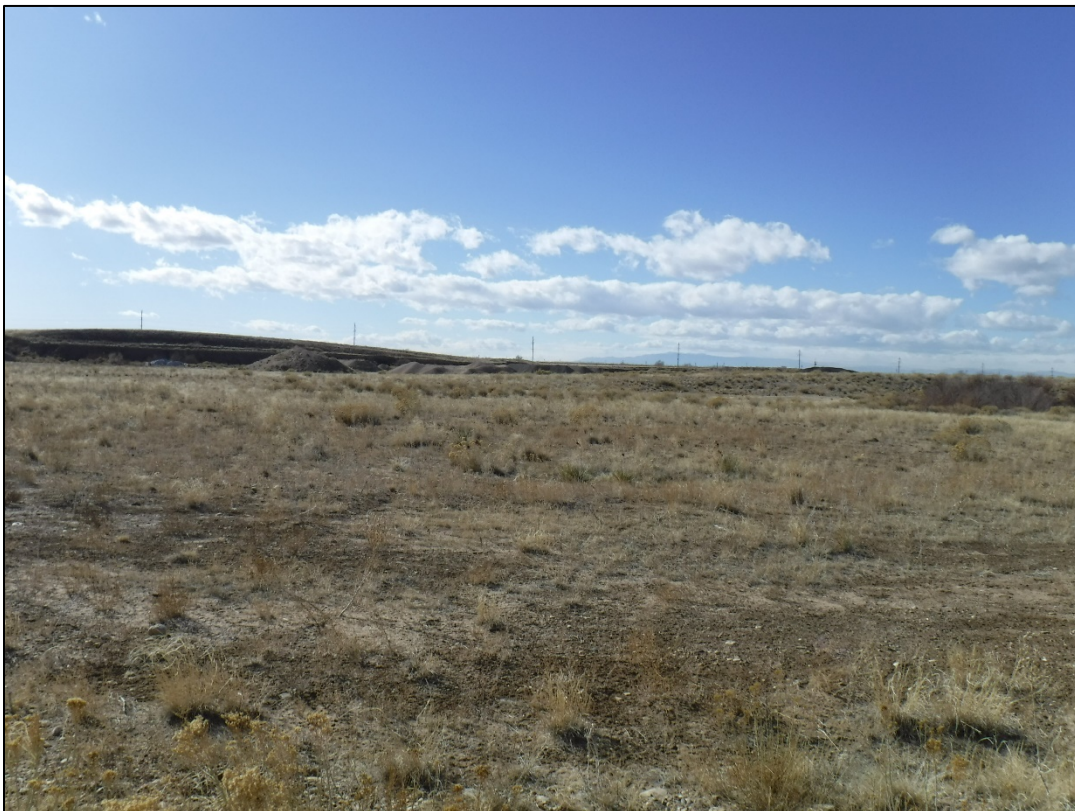
The Operator has successfully backfilled and graded the northern portions of the terrace to 3H:1V or flatter. The Operator has conducted reclamation on approximately 37 acres. The vegetative cover on the 37 acres has established with desired species. There are a few areas within the 37 acres that need Tamarisk trees removed and there are a few stockpiles that need to be relocated.

Photo 21: Typical conditions of those areas in final reclamation

Photo 22: Typical conditions of those areas in final reclamation
