MINERALS PROGRAM INSPECTION REPORT
PHONE: (303) 866-3567

MINE NAME: Lopez Quarry No. 2	MINE/PROSPECTING ID#: M-2007-034	MINERAL: Sand and gravel	COUNTY: Las Animas
INSPECTION TYPE: Monitoring	INSPECTOR(S): Daniel Cunningham	INSP. DATE: January 15, 2020	INSP. TIME: 14:30
OPERATOR: S & S Services	OPERATOR REPRESENTATIVE: Lonnie Lopez	TYPE OF OPERATION: 110c - Construction Limited Impact	
REASON FOR INSPECTION: Normal I&E Program	BOND CALCULATION TYPE: Complete Bond	BOND AMOUNT: \$22,685.00	
DATE OF COMPLAINT: NA	POST INSP. CONTACTS: None	JOINT INSP. AGENCY: None	
WEATHER: Clear	INSPECTOR'S SIGNATURE:

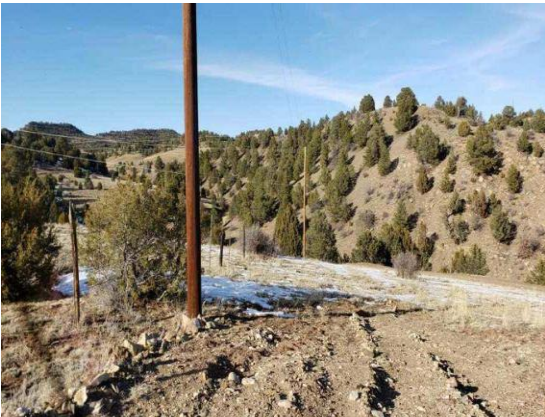
Photo 3: Boundary Markers

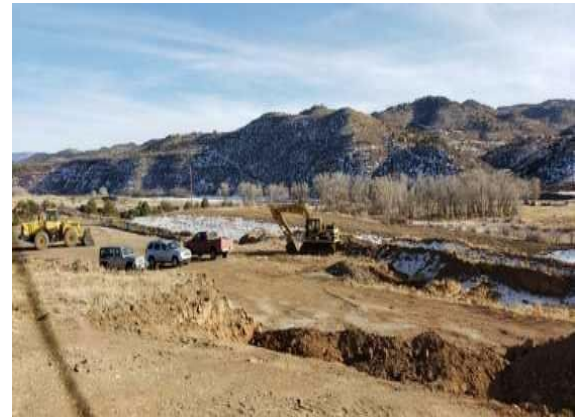
Photo 4: Disturbed Area

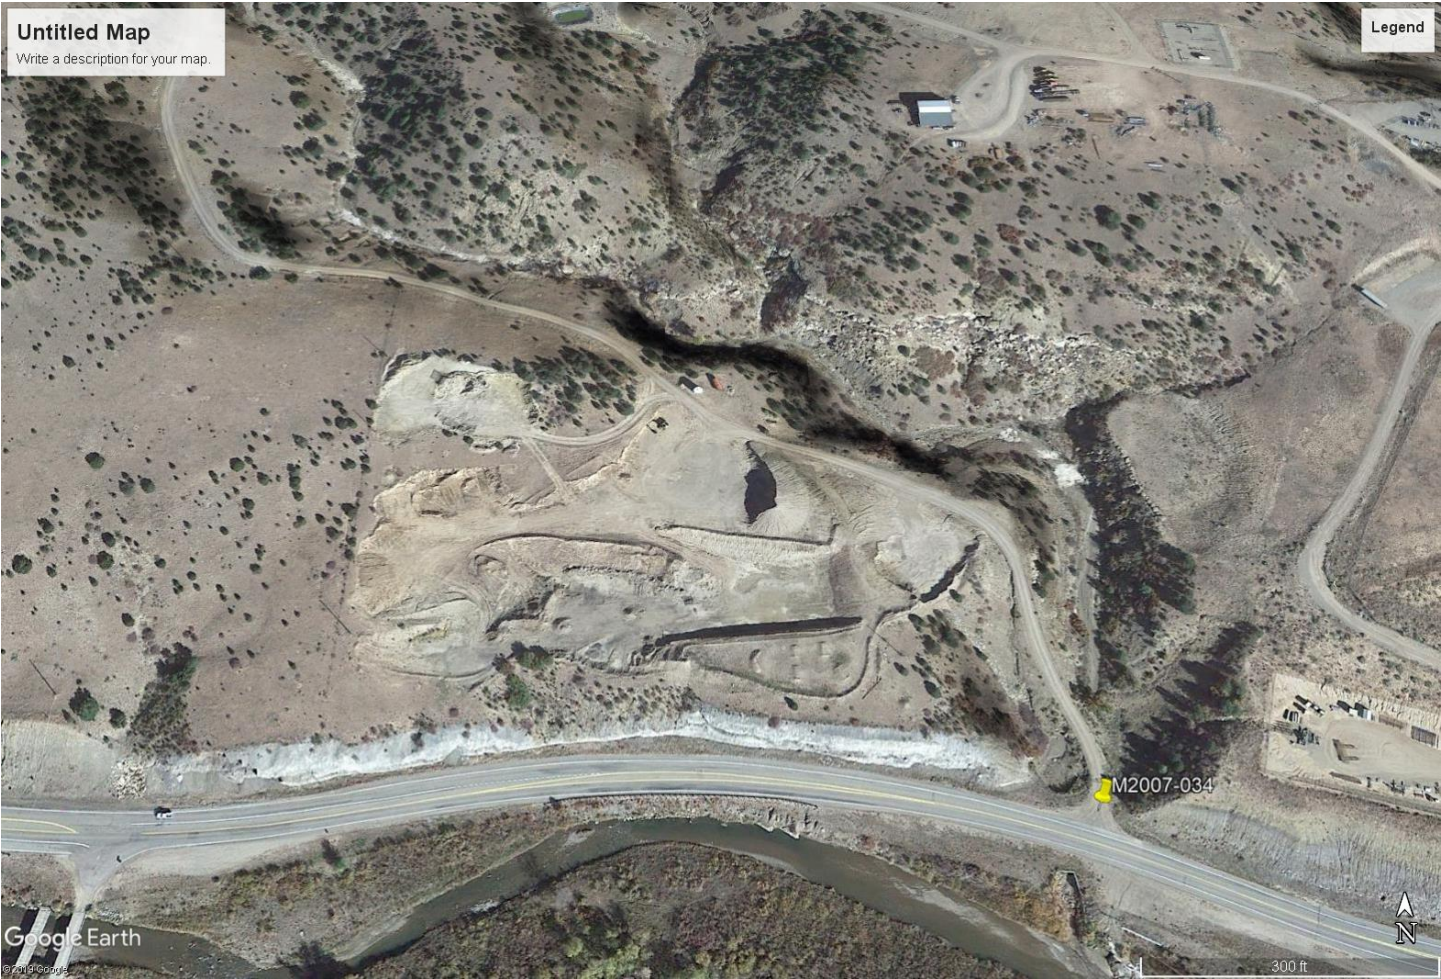
An aerial photo of the site area has been included to depict the general condition of the site at this time. All activity appeared to be in compliance with the approved mining plan, and no other issues requiring corrective action were observed during this inspection.
