MINERALS PROGRAM INSPECTION REPORT
PHONE: (303) 866-3567

MINE NAME: Leone Gravel Pit #2	MINE/PROSPECTING ID#: M-2006-085	MINERAL: Sand and gravel	COUNTY: Las Animas
INSPECTION TYPE: Monitoring	INSPECTOR(S): Daniel Cunningham	INSP. DATE: January 15, 2020	INSP. TIME: 13:00
OPERATOR: Leone Sand & Gravel LLC	OPERATOR REPRESENTATIVE: Frank and Wayne Leone	TYPE OF OPERATION: 112c - Construction Regular Operation	
REASON FOR INSPECTION: Normal I&E Program	BOND CALCULATION TYPE: Complete Bond	BOND AMOUNT: \$87,509.00	
DATE OF COMPLAINT: NA	POST INSP. CONTACTS: None	JOINT INSP. AGENCY: None	
WEATHER: Clear	INSPECTOR'S SIGNATURE:

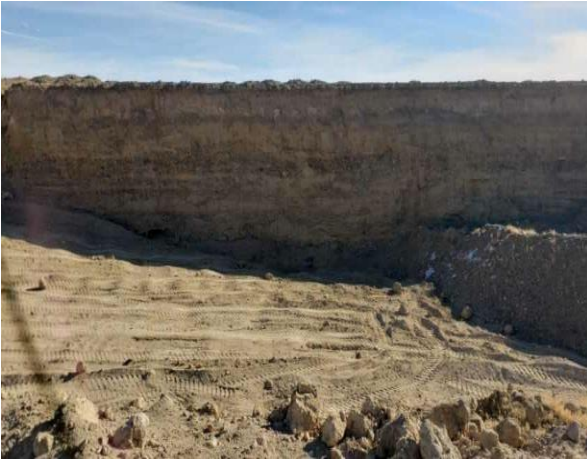
The site identification sign was posted and permit markers were observed to be in place throughout the entire operation. All activity appeared to be in compliance with the approved mining plan including a high wall of approximately 25 feet with a slope of 0.5:1. No issues requiring corrective action were observed during this inspection.

Photo 1: High wall

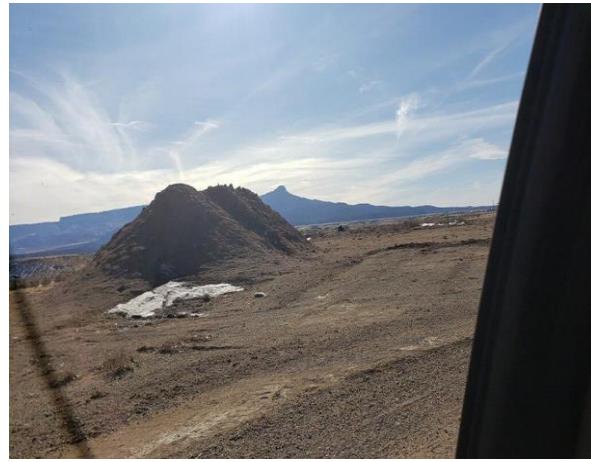
It was noted during the inspection that recently stripped topsoil stockpiled adjacent to the active mine area had not been stabilized with vegetation. It is the recommendation of the Division that the Leone Sand and Gravel, LLC seed the topsoil stockpile to help prevent erosion. This is in accordance with Rule 3.1.9 which states "Where it is necessary to remove overburden in order to mine the construction material, topsoil shall be removed and segregated from other spoil. If such topsoil is not replaced on a backfill area within a time short enough to avoid deterioration of the topsoil, vegetative cover or other means shall be employed so that the topsoil is protected from erosion, remains free of any contamination by toxic or acid-forming material, and is in a usable condition for reclamation."

Photo 2: Topsoil stockpile

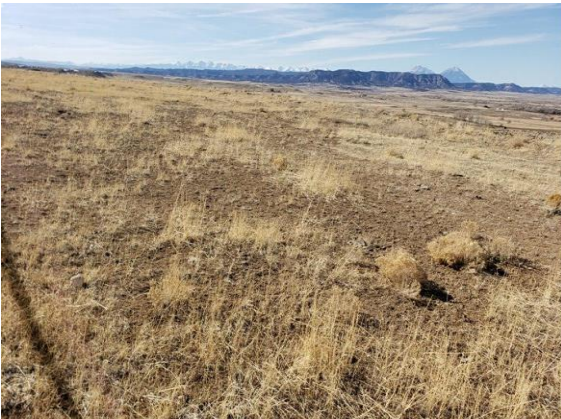
The 90-acre on the north side of the site that was being reclaimed had a less than 3:1 slope in most areas and appeared stable. The topography of the graded area was gentle and blended well with the surrounding unaffected land. Vegetation was noted throughout the area, however it was not adequate at this time. The Operator indicated they had seeded the area several times but very little of the desired vegetation had established. It was also noted that cattle had been grazing in the area being reclaimed and it is the recommendation of the Division that efforts be made to limit the grazing on the area until desired vegetation can be established.

Photo 3: Reclamation area

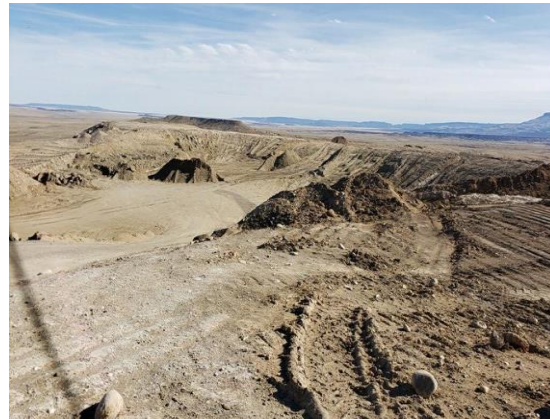
Photo 4: Disturbed Area
