MINERALS PROGRAM INSPECTION REPORT
PHONE: (303) 866-3567

MINE NAME: Cesar Pit	MINE/PROSPECTING ID#: M-1998-101	MINERAL: Sand and gravel and	COUNTY: Pueblo
INSPECTION TYPE: Monitoring	INSPECTOR(S): Patrick Lennberg	INSP. DATE: January 15, 2020	INSP. TIME: 11:30
OPERATOR: Tony J. Beltramo and Sons, Inc.	OPERATOR REPRESENTATIVE: Tim Beltramo	TYPE OF OPERATION: 112c - Construction Regular Operation	
REASON FOR INSPECTION: Normal I&E Program	BOND CALCULATION TYPE: Complete Bond	BOND AMOUNT: \$219,000.00	
DATE OF COMPLAINT: NA	POST INSP. CONTACTS: None	JOINT INSP. AGENCY: None	
WEATHER: Clear	INSPECTOR'S SIGNATURE:

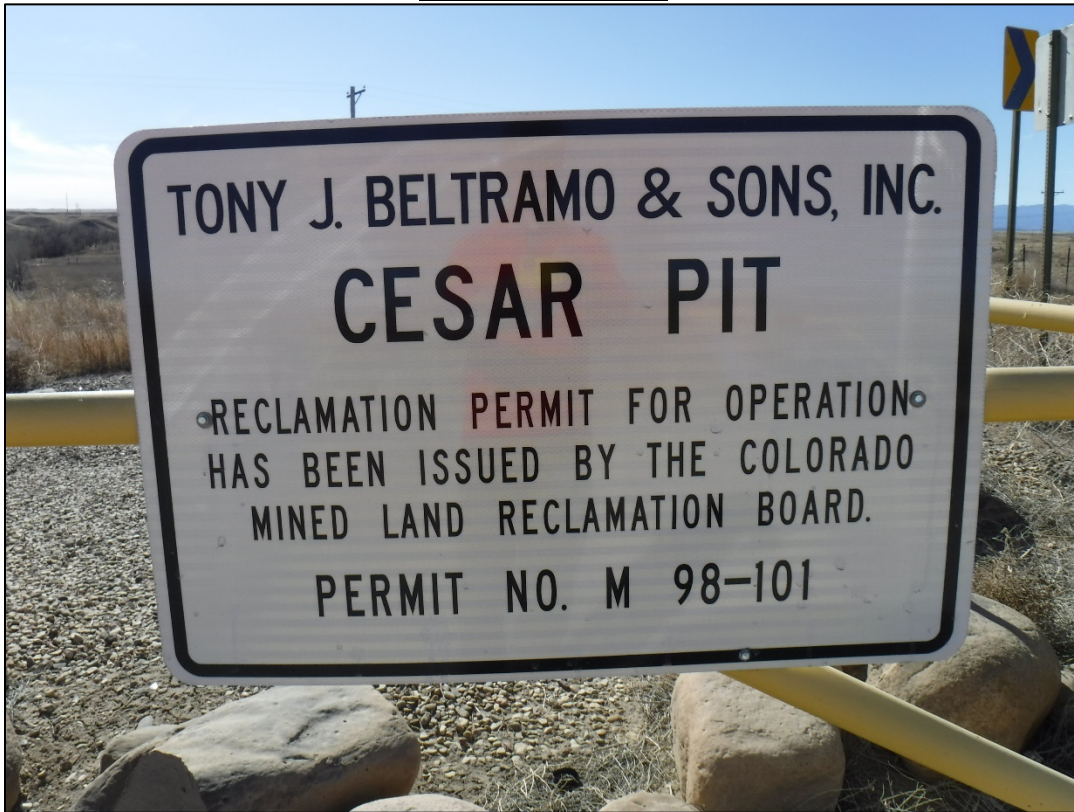
Photo 1: Mine sign at entrance to mine site

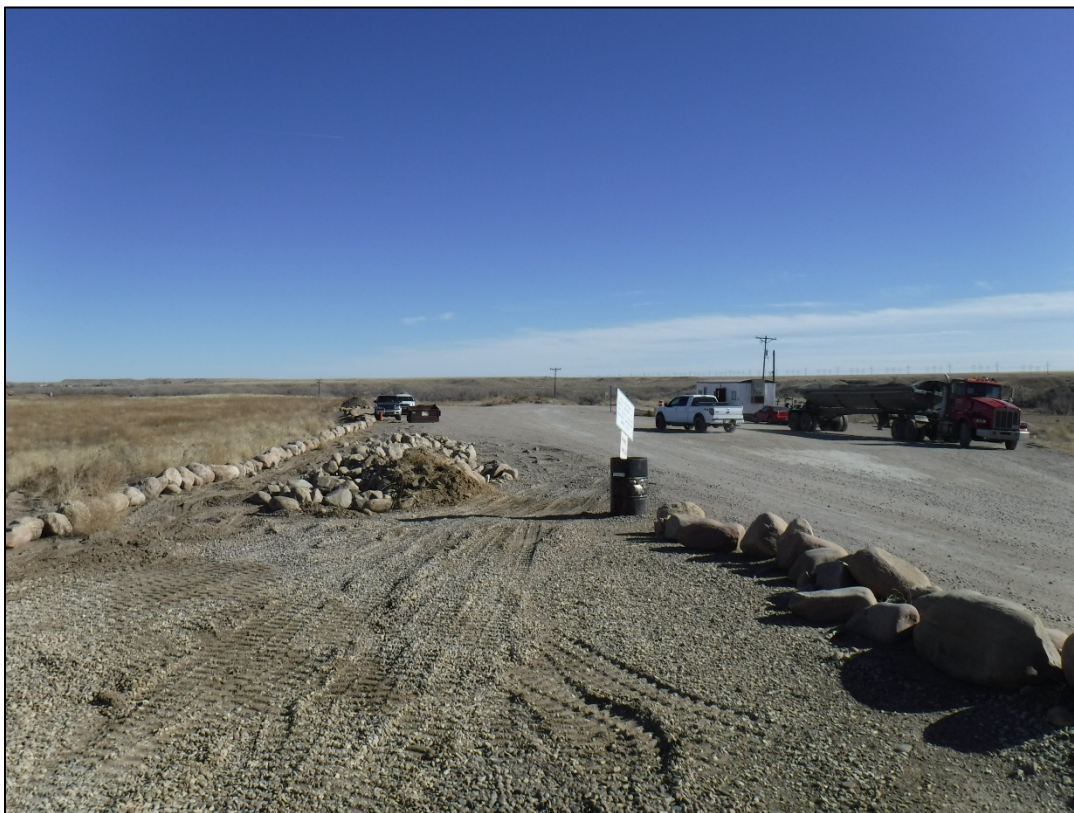
Photo 2: Scalehouse at entrance to mine

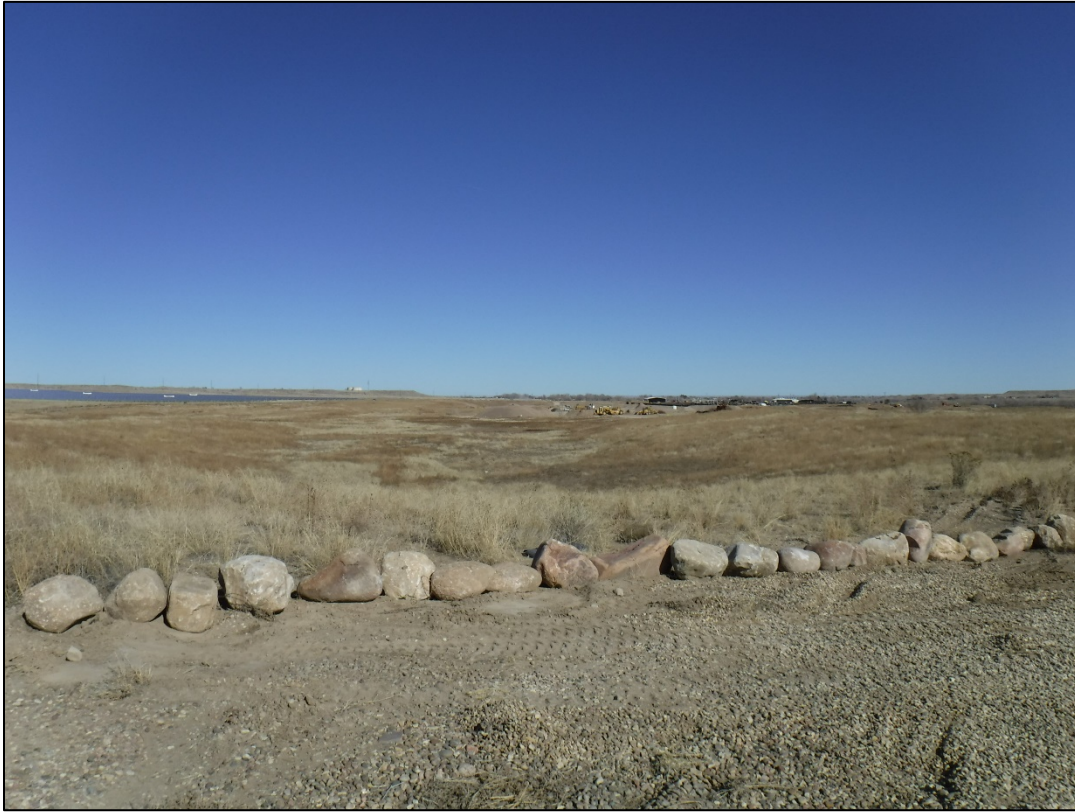
Photo 3: Reclaimed area to the north of the scalehouse, ~20 acres

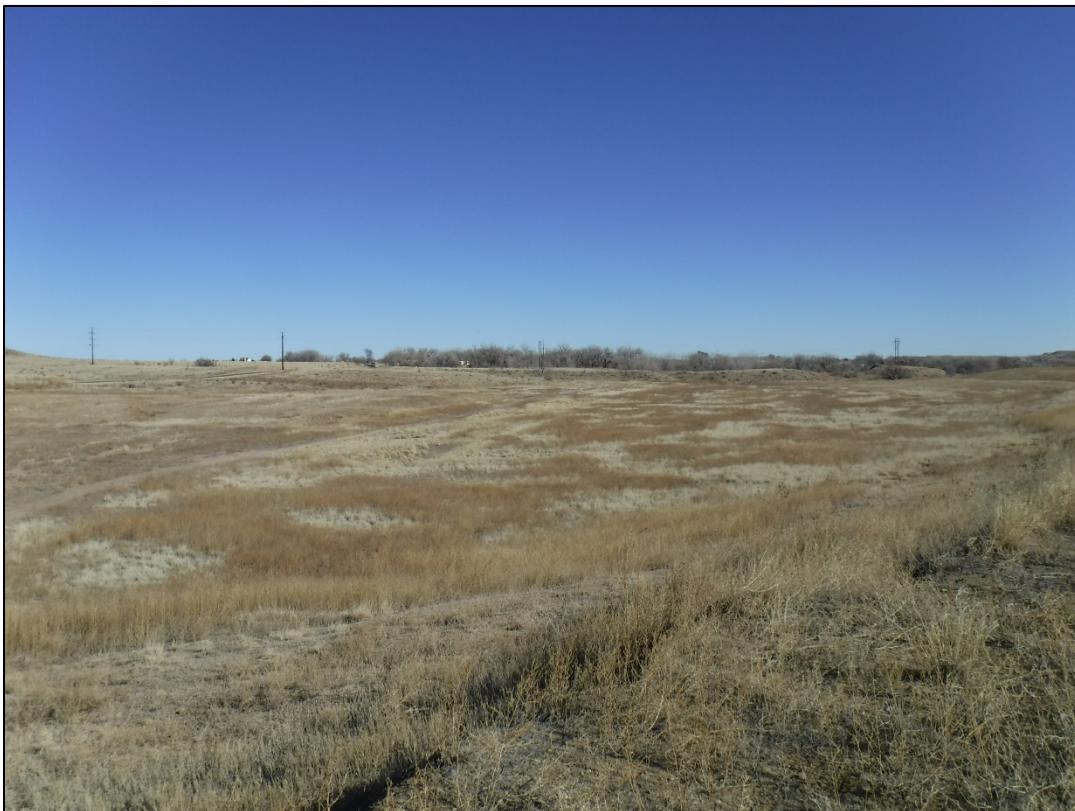
Photo 4: Reclaimed area in the north of the permit area, ~33 acres

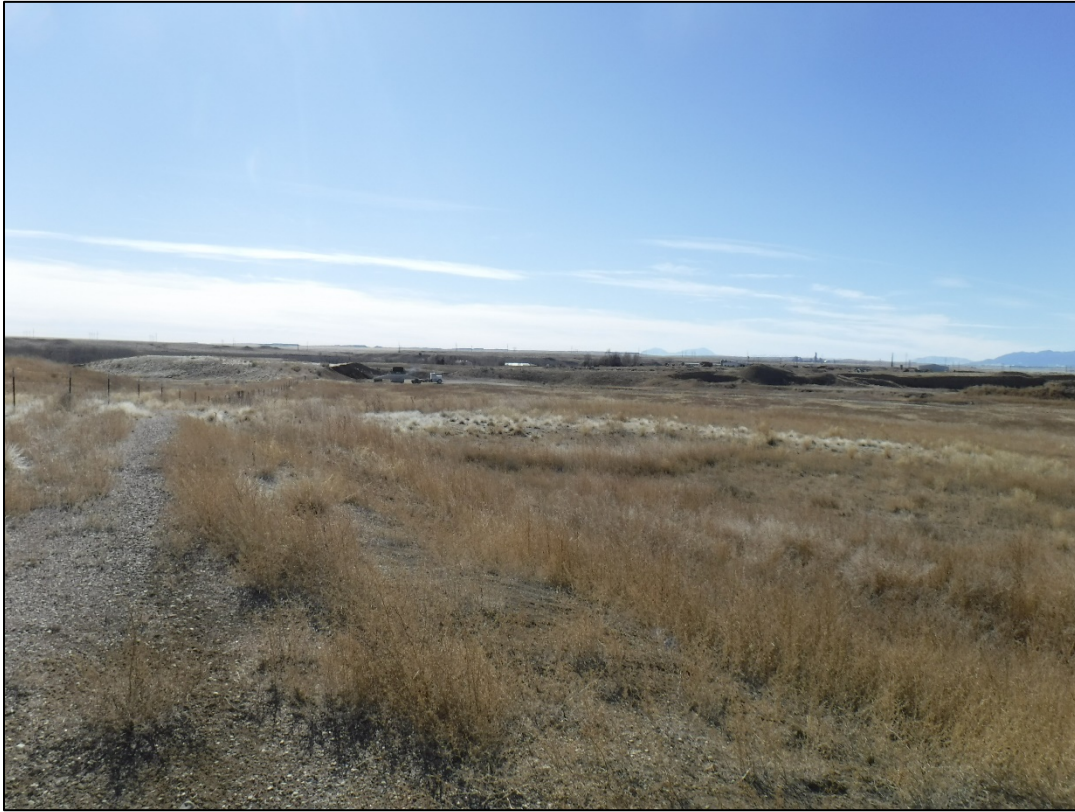
Photo 5: Fence to the left of picture marks the permit boundary, equipment at center of picture is reclaiming slope, highwall is located center right of picture

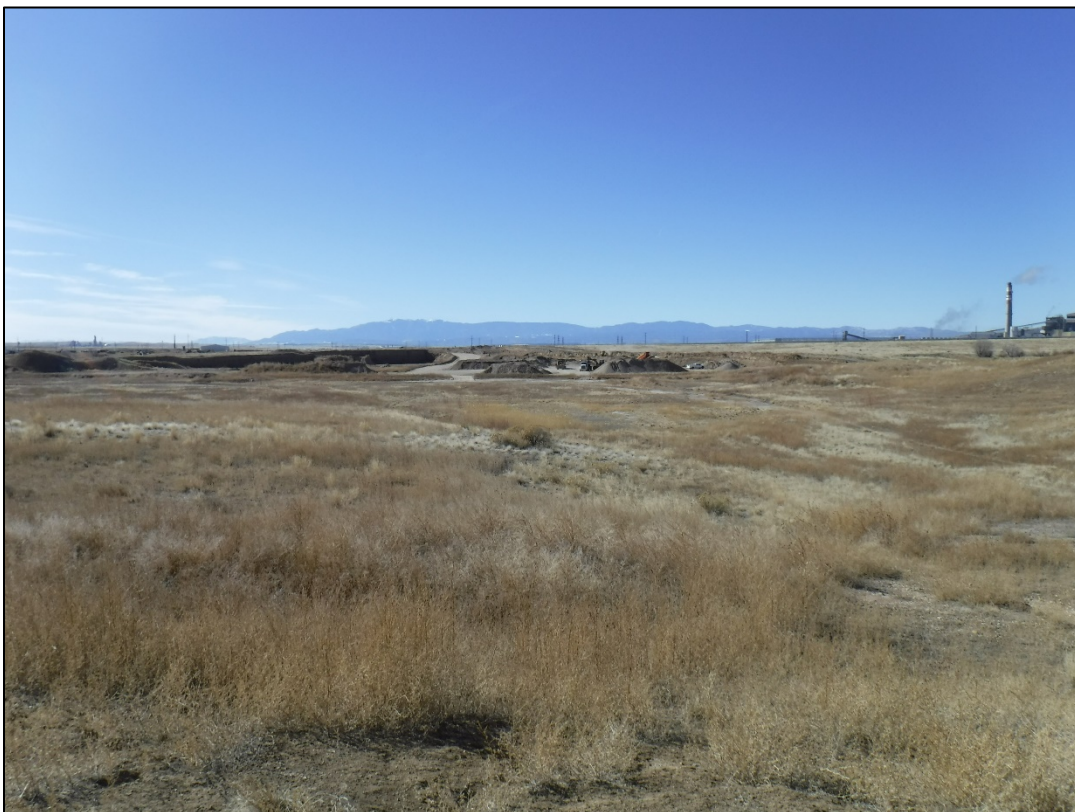
Photo 6: Northern area where stockpiles are being removed

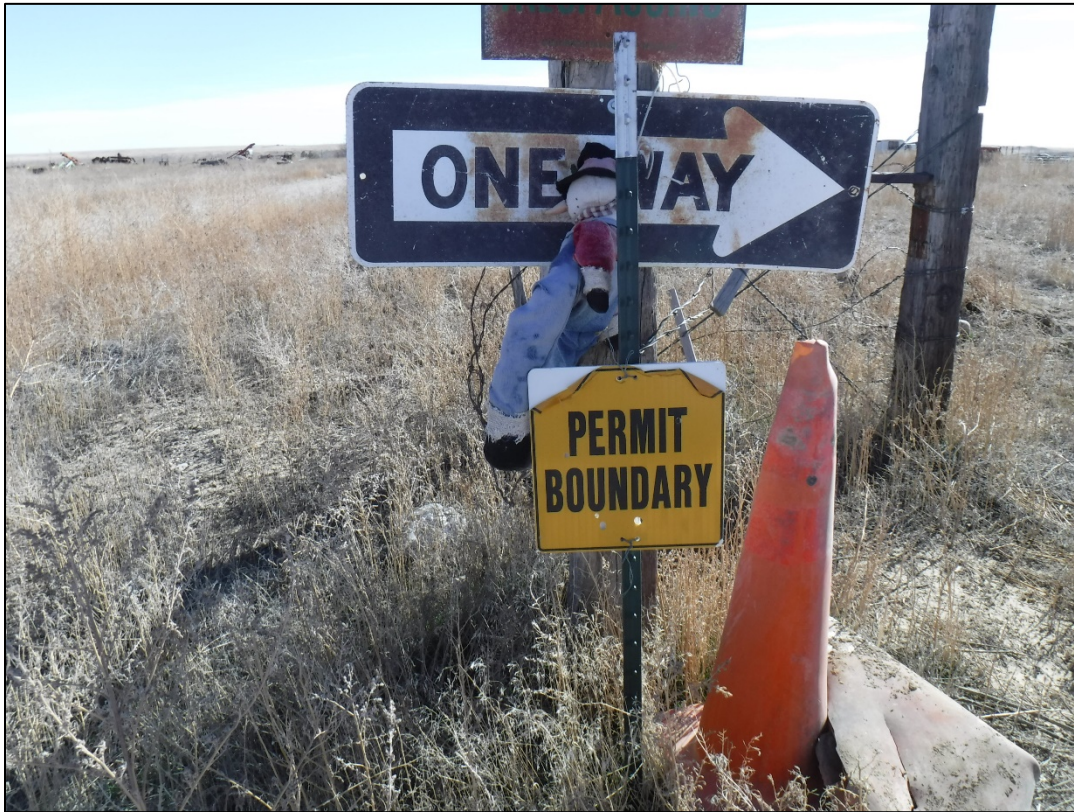
Photo 7: Typical permit boundary marker

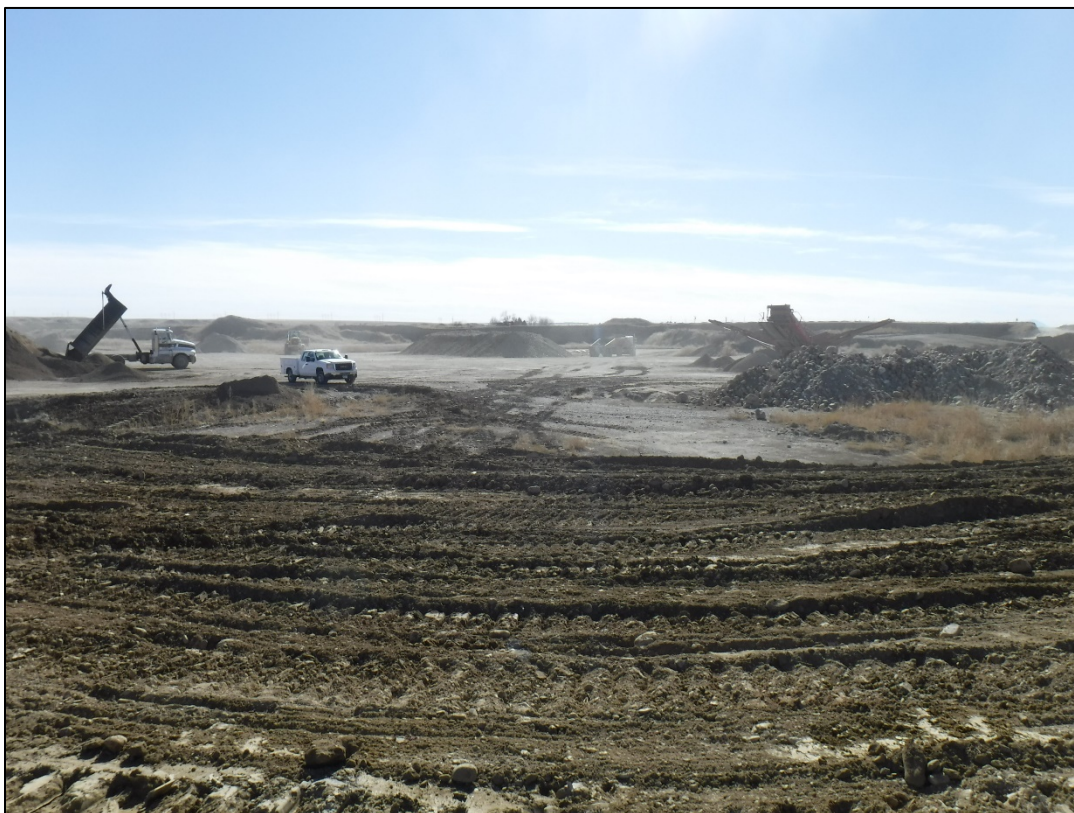
Photo 8: Mine activity related to relocating stockpiles to the south

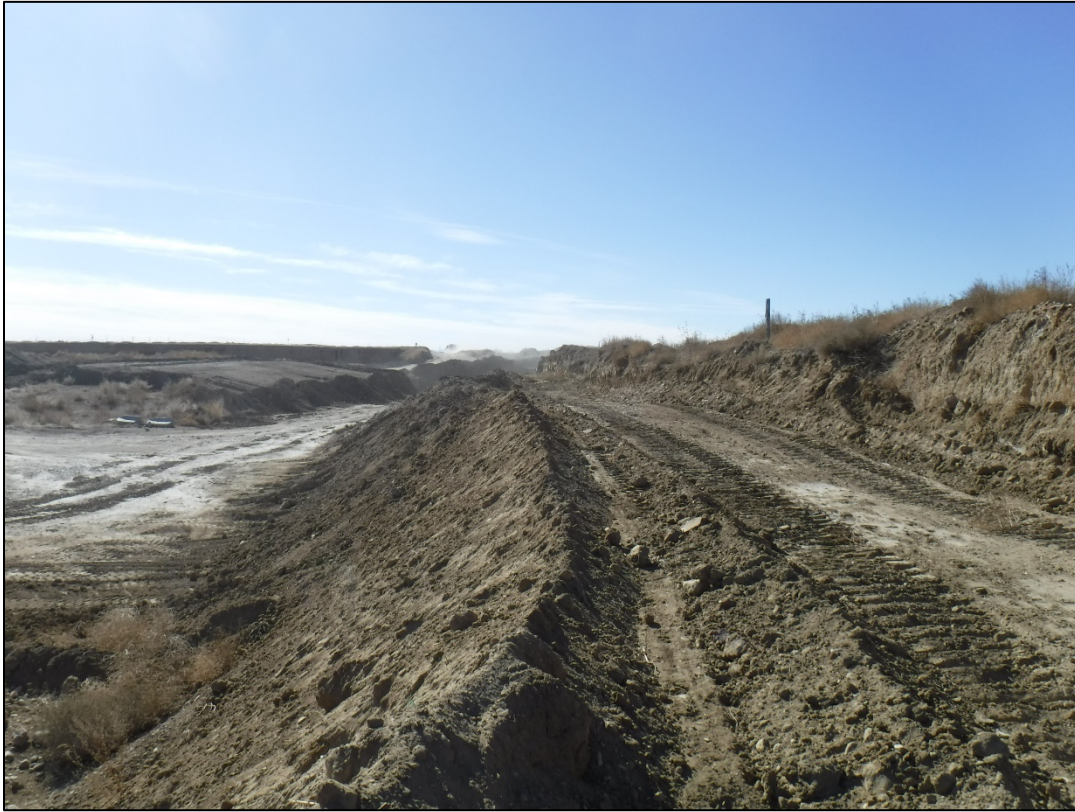
Photo 9: Reclaiming the slope adjacent to Cesar Road to a 3H:1V grade.

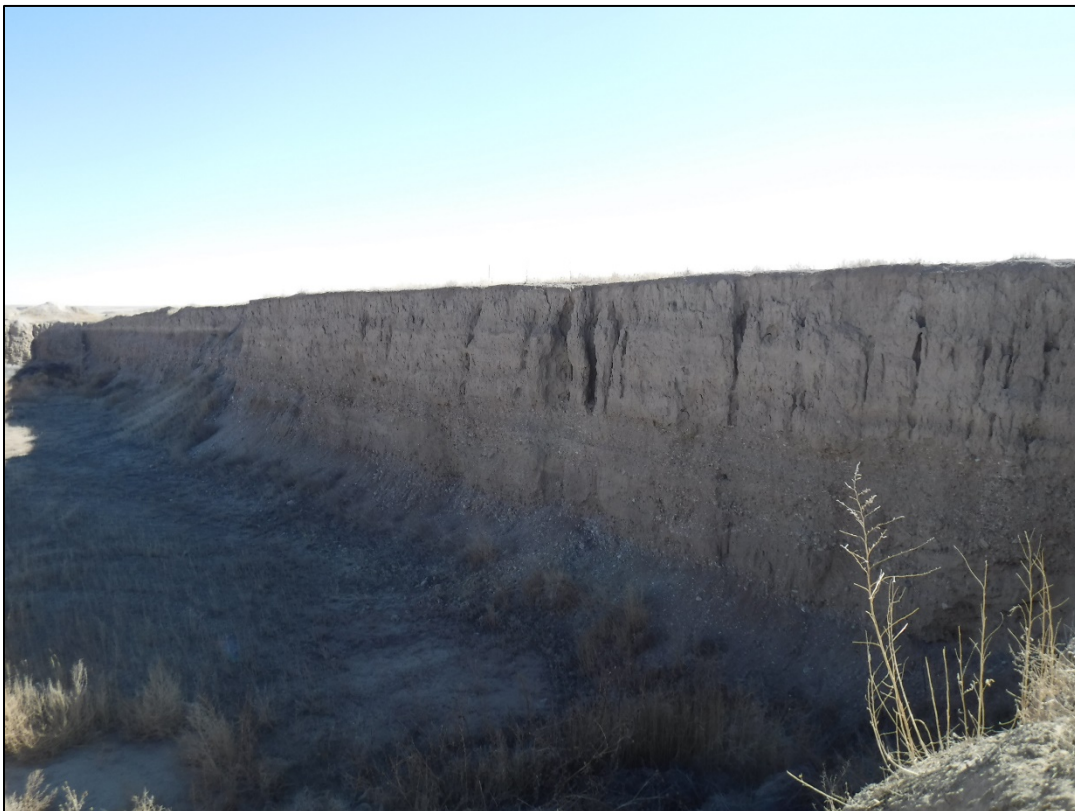
Photo 10: Mining will resume at the highwall and proceed south, highwall is ~20 feet high

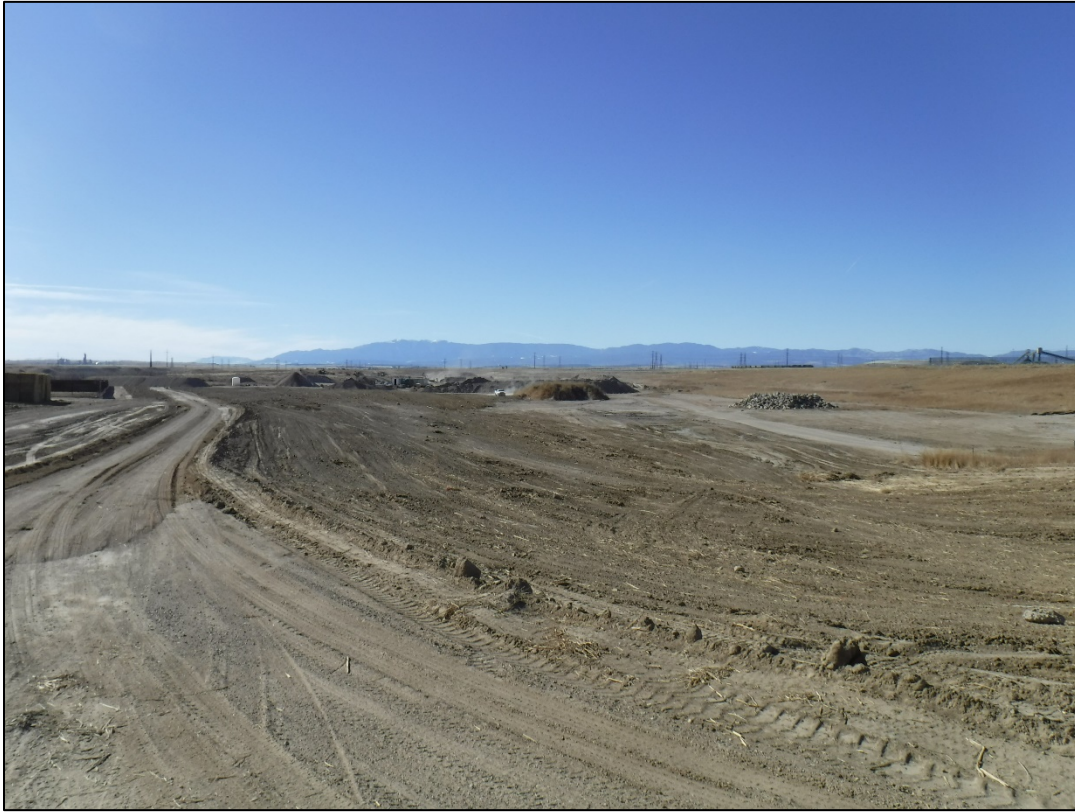
Photo 11: Southern processing area where material from the north is being hauled, reclamation activities are occurring in the center foreground, looking south

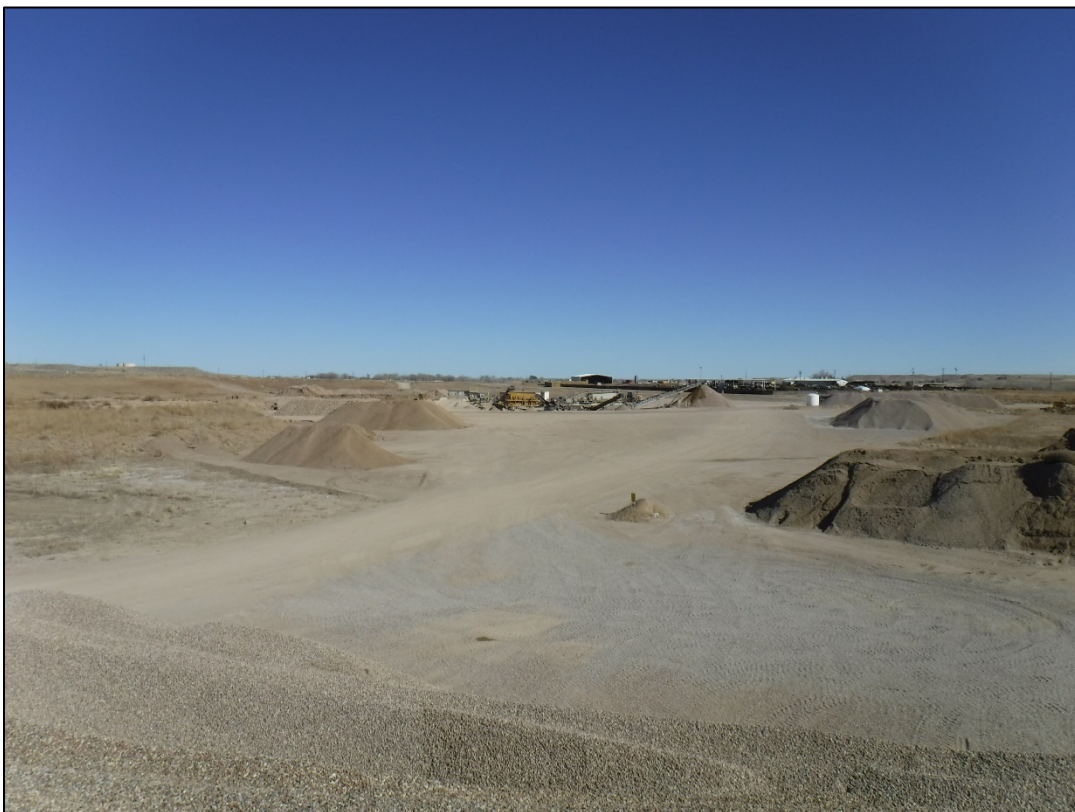
Photo 12: Southern processing area looking north

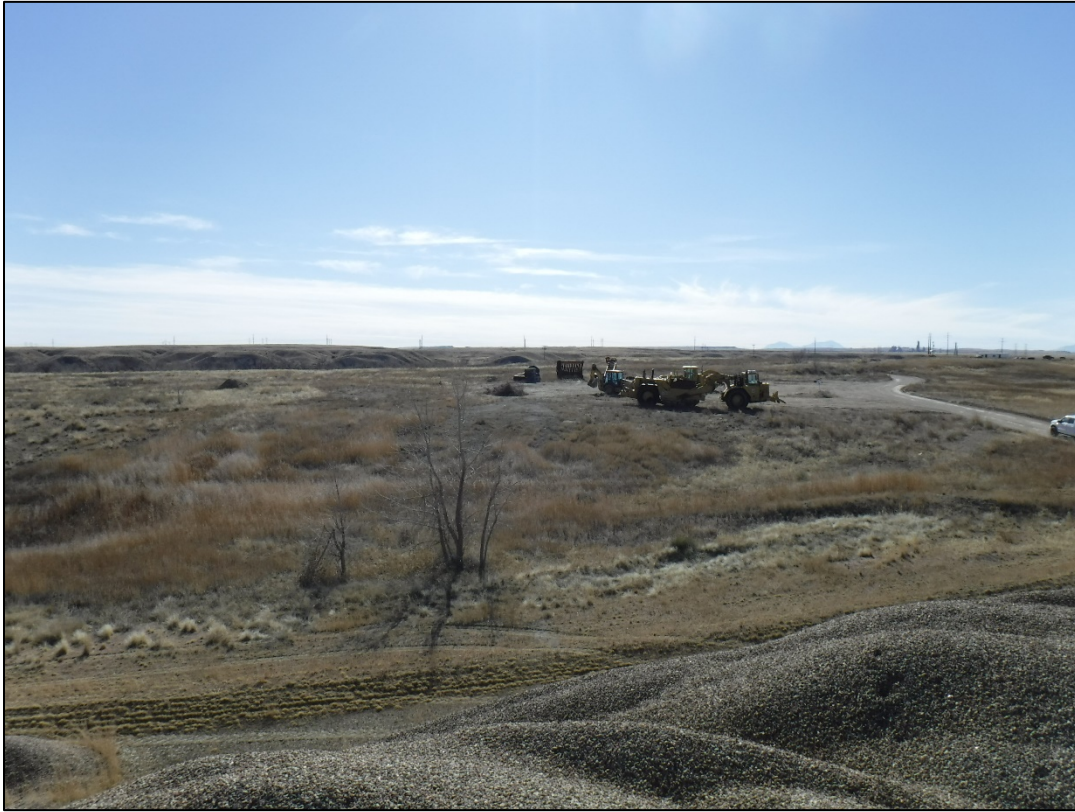
Photo 13: Southern 8 acre reclaimed area showing equipment lay down area which is excluded from area total

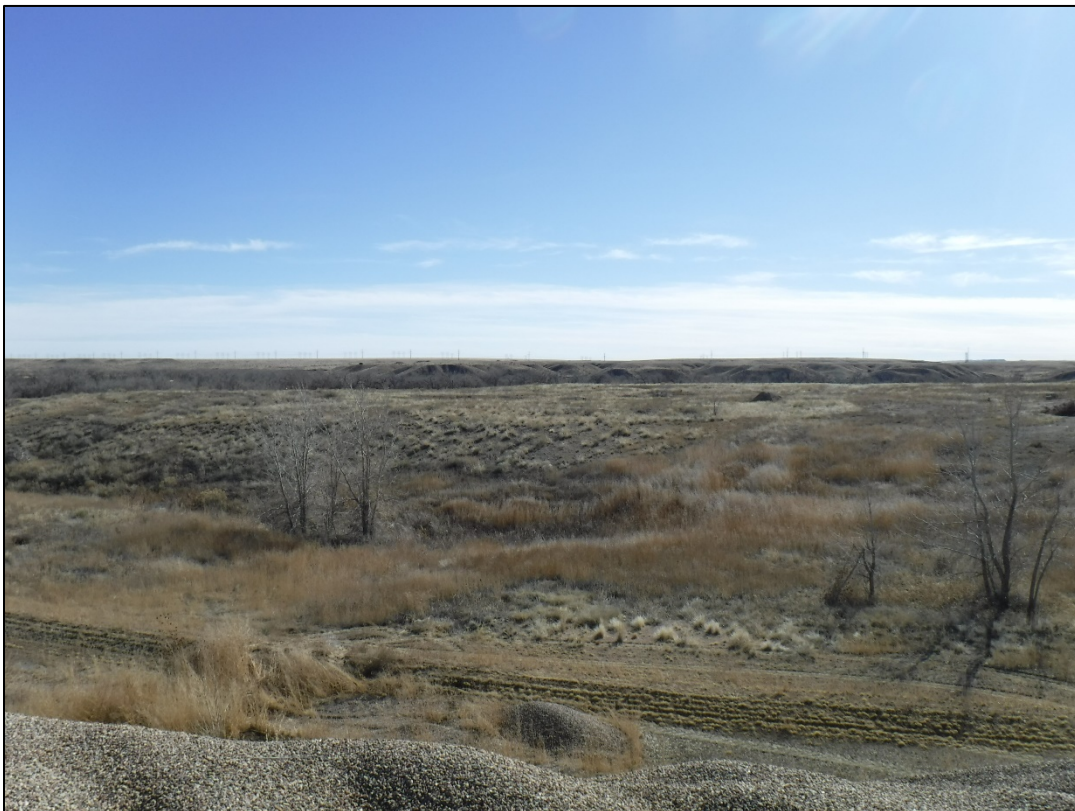
Photo 14: Southern 8 acre reclaimed area
