# MINERALS PROGRAM INSPECTION REPORT PHONE: (303) 866-3567

MINE NAME:	MINE/PROSPECTING ID#:	MINERAL: COUNTY:		
Lehr Gravel Pit	M-1983-213	Sand and gravel Weld		
INSPECTION TYPE:	INSPECTOR(S):	INSP. DATE: INSP. TIME:		
Monitoring	Peter Hays	January 23, 2020 09:30		
OPERATOR:	OPERATOR REPRESENTATIVE	E: TYPE OF OPERATION:		
Weld County Public Works	Clay Kimmi	112c - Construction Regular Operation		
REASON FOR INSPECTION:	BOND CALCULATION TYPE:	BOND AMOUNT:		
Normal I&E Program	None	\$0.00		
DATE OF COMPLAINT:	POST INSP. CONTACTS:	JOINT INSP. AGENCY:		
NA	None	None		
WEATHER:	INSPECTOR'S SIGNATURE:	SIGNATURE DATE:		
Clear	Athy	January 29, 2020

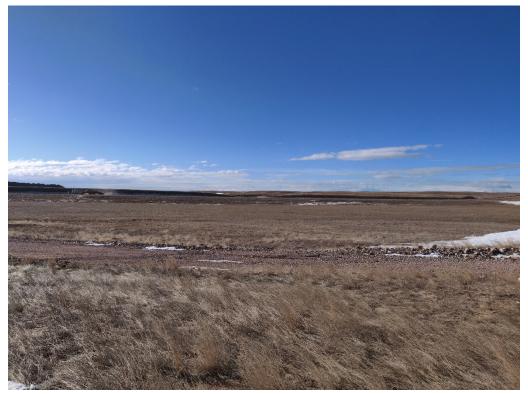
View of the site from the topsoil stockpile looking southwest

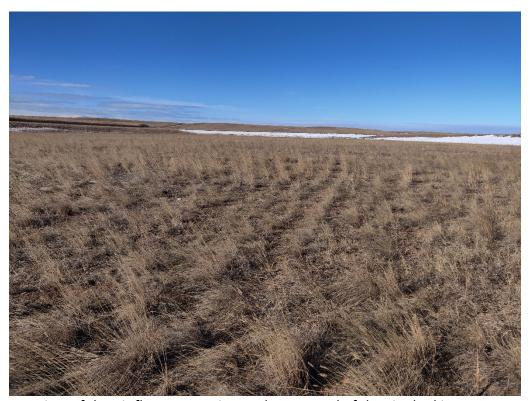
View of the pit floor vegetation at the east end of the site looking west

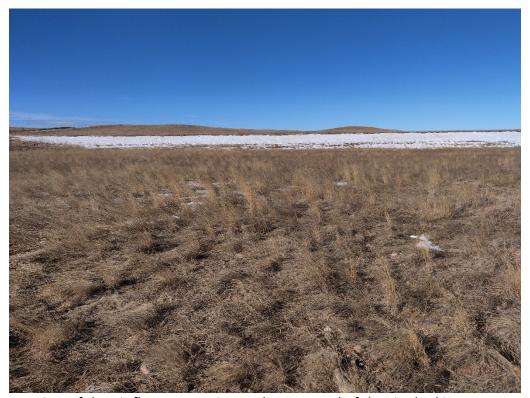
View of the pit floor vegetation at the west end of the site looking west

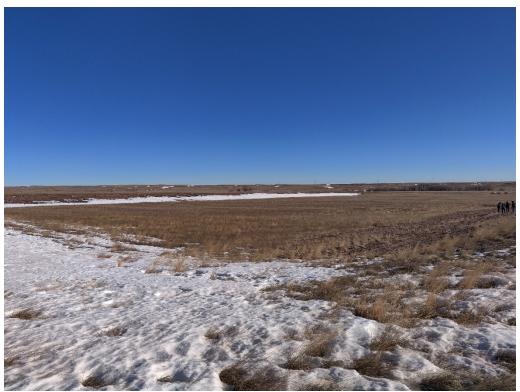
View of the site from the southwest corner looking northeast

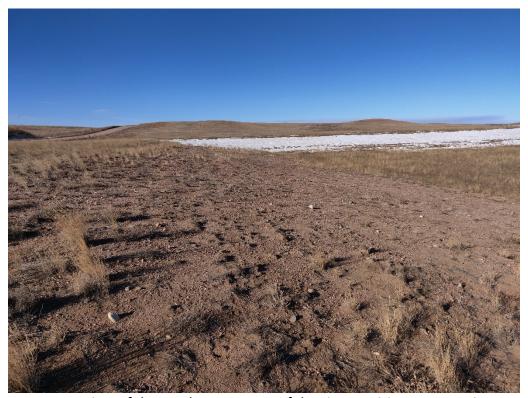
The Division denied a final release request (SL-01) in 2016 due to the presence of noxious weeds on-site. The Operator has been treating the site with Esplanade to control cheat grass and Tordon to control other noxious weeds since 2016. The chemical treatments have resulted in improved vegetative cover and reduced noxious weeds. Only a few cheat grass plants were observed during the inspection. The site vegetation, with the exception of the southwest corner of the site, appeared well-established and consistent with the surrounding rangeland vegetation. The southwest corner slope of the site consisted of mostly bare ground with limited vegetation. The Operator stated the southwest corner would be topsoiled and re-seeded this spring. The Division recommends the Operator submits a final release request in the summer once the revegetation of the southwest corner is established.

View of the southwest corner of the site requiring revegetation

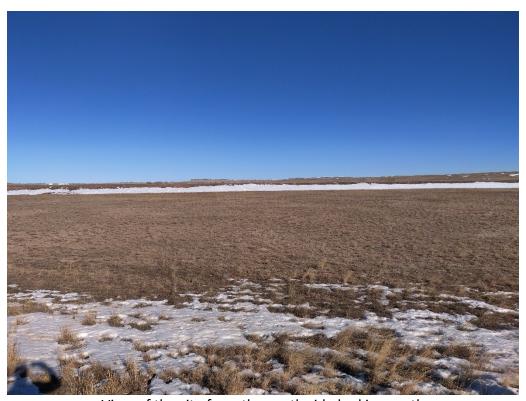
View of the site from the south side looking north
