MINERALS PROGRAM INSPECTION REPORT
PHONE: (303) 866-3567

MINE NAME: Pikeview Quarry	MINE/PROSPECTING ID#: M-1977-211	MINERAL: Limestone (general), granite, granite gneiss and dolomite	COUNTY: El Paso
INSPECTION TYPE: Preoperation Inspection	INSPECTOR(S): Timothy Cazier	INSP. DATE: December 5, 2019	INSP. TIME: 12:00
OPERATOR: Continental Materials Corporation	OPERATOR REPRESENTATIVE: Jerry Schnabel	TYPE OF OPERATION: 112c - Construction Regular Operation	
REASON FOR INSPECTION: Preoperation Inspection	BOND CALCULATION TYPE: None	BOND AMOUNT: \$15,000,000.00	
DATE OF COMPLAINT: NA	POST INSP. CONTACTS: None	JOINT INSP. AGENCY: None	
WEATHER: Cloudy	INSPECTOR'S SIGNATURE:

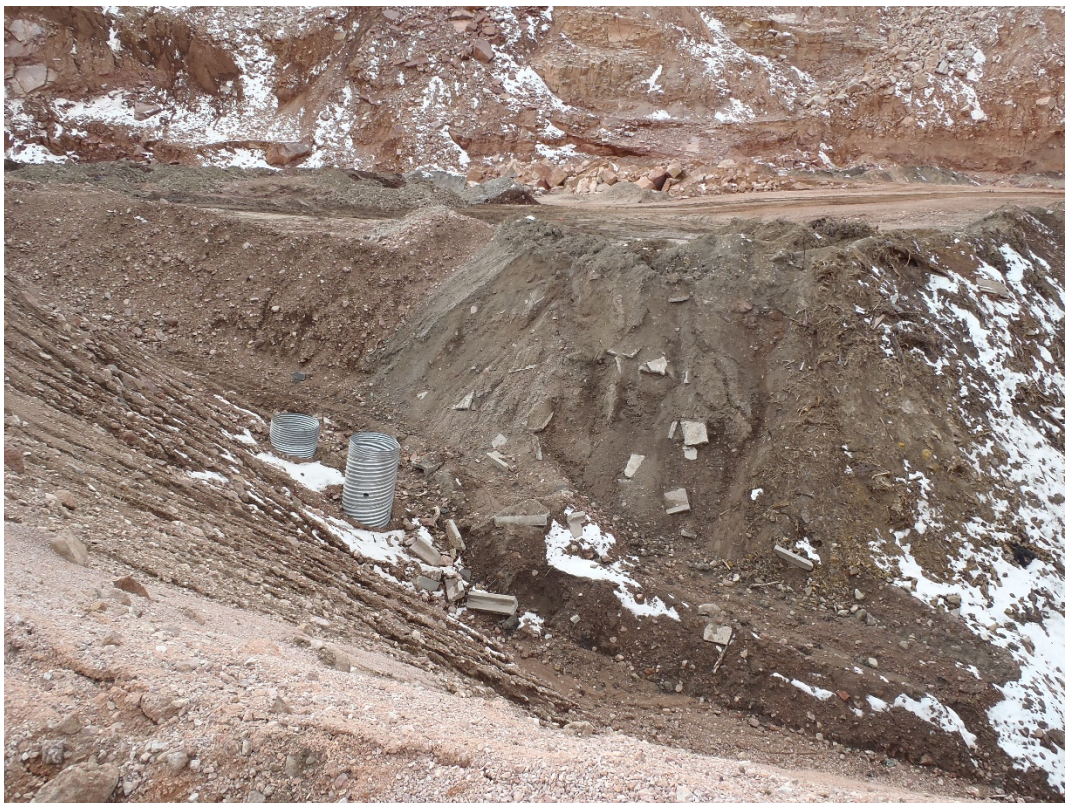
Backfilling and Grading: The primary goal for the site is reclamation and stabilizing the slide area in the process. Pike view imports backfill from primarily four different offsite construction projects. Several haul trucks were observed bringing in backfill material. The area at the toe of the highwall, referred to as Area H has nearly been backfilled to the level of the limestone bench (see **Photo 1**).

Reclamation Success: The majority of the reclamation required involves backfilling for highwall stabilization which was actively being performed during the inspection. A significant portion of Area H had been backfilled since the January 2019 inspection.

Photo 1. Mostly backfilled Area H (looking west).

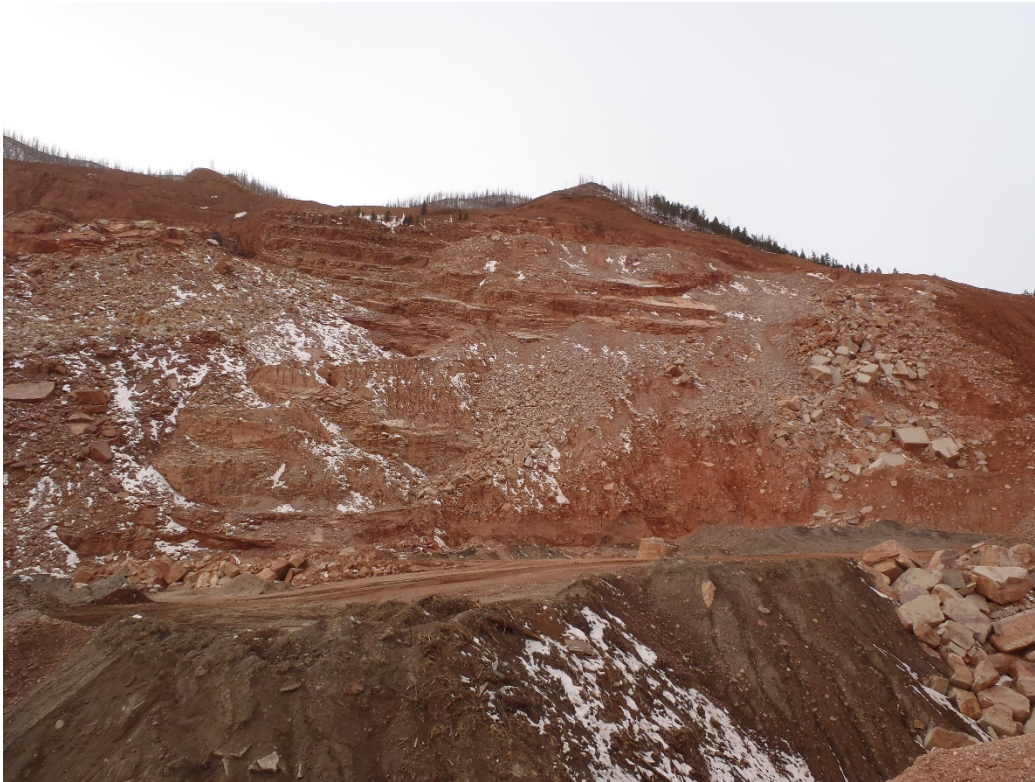
Photo 2. Benched highwalls above Area H (looking NW).

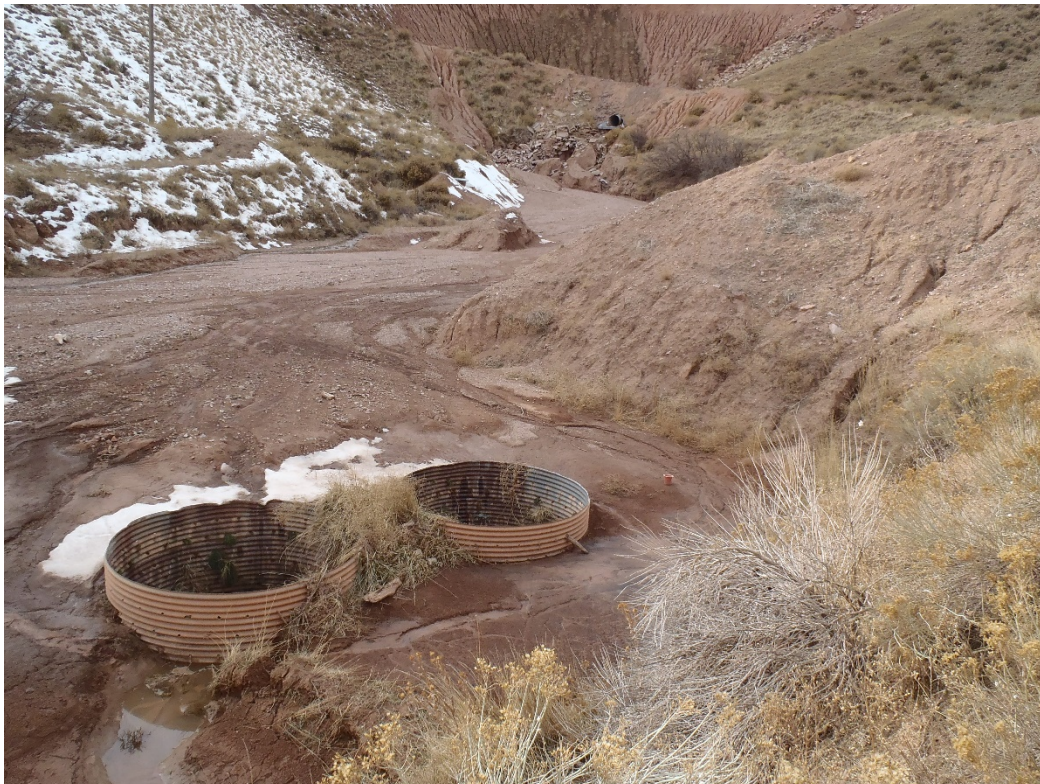
Revegetation: Some areas have been revegetated, such as much of the Horseshoe area in the south and intermittent smaller areas such as below the central haul road the (see **Photo 3**). No noxious weeds were

Photo 3. Revegetated area below central haul road (upper left) & Pond No. 3 (needing maintenance).

observed. Site representatives stated they have implemented a noxious weed control program. [The DRMS will make sure the weed control plan is formalized in AM-04 during the review process.](#)

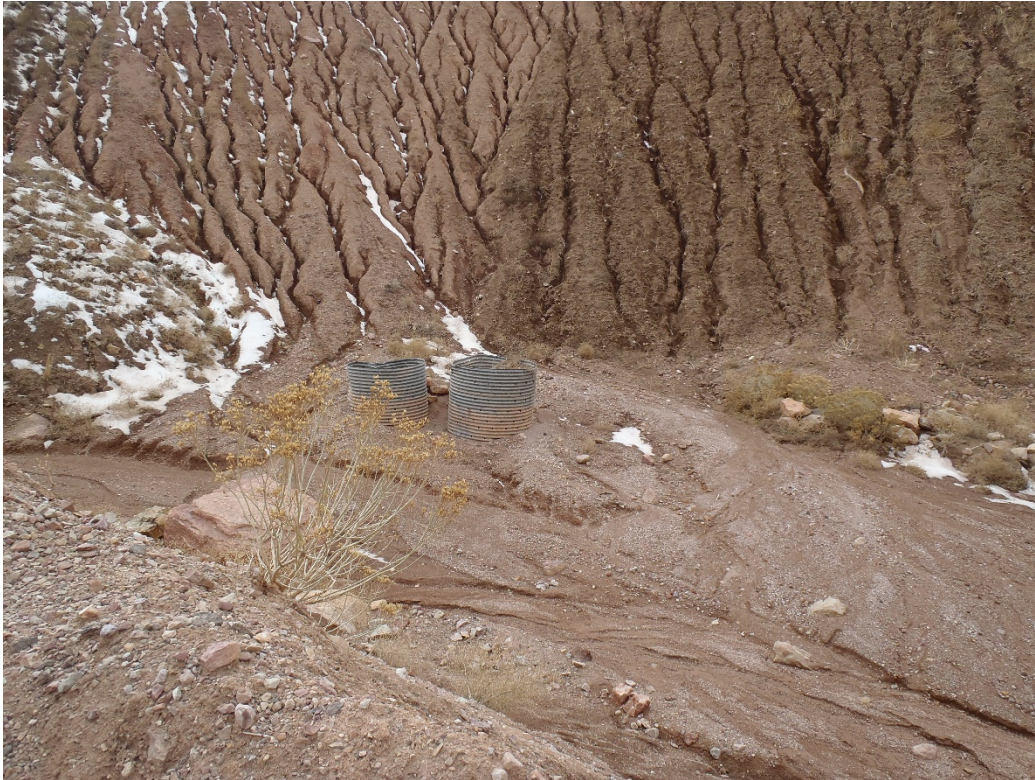
Sediment Control: Significant erosion rilling was observed below the haul road immediately above sediment control Pond No. 2 (see **Photo 4**). No BMPs were needed at the time of the inspection as this area contributes directly to the sediment pond.

Photo 4. Rilling above sediment control Pond No. 2 (looking west).

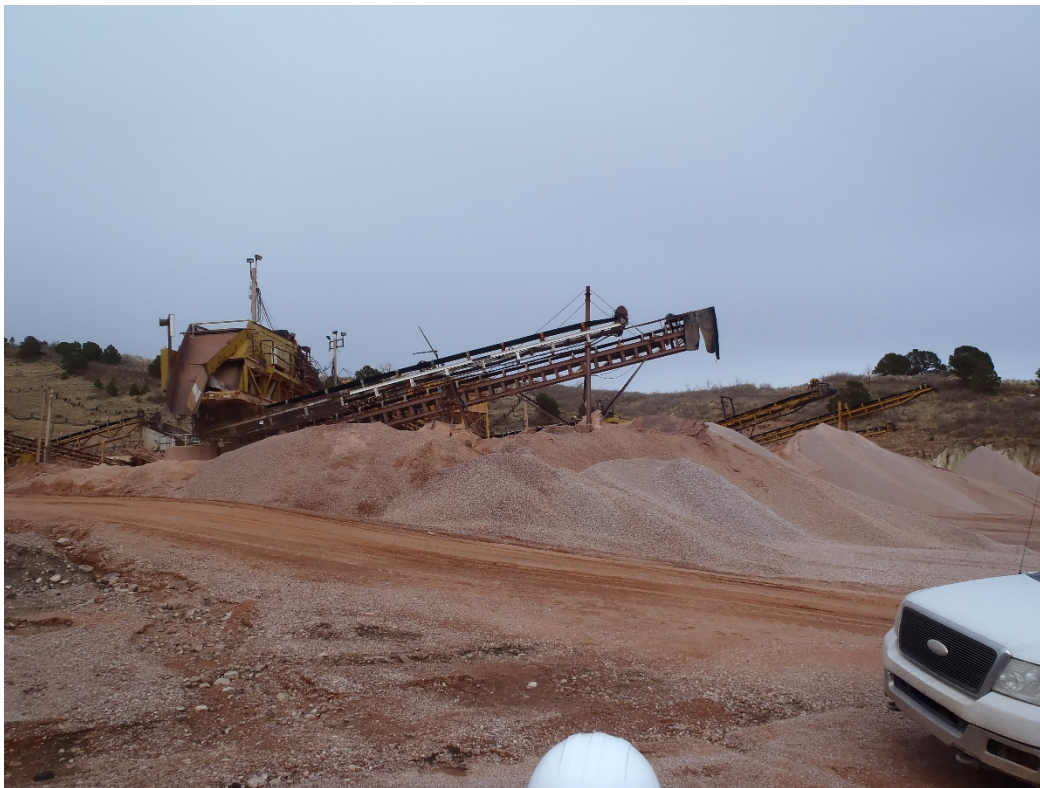
Support Facilities On-site: A crushing and screening plant was observed on site (see **Photo 5**).

Photo 5. Crushing/screening plant and product stockpile (looking NE from Area H).

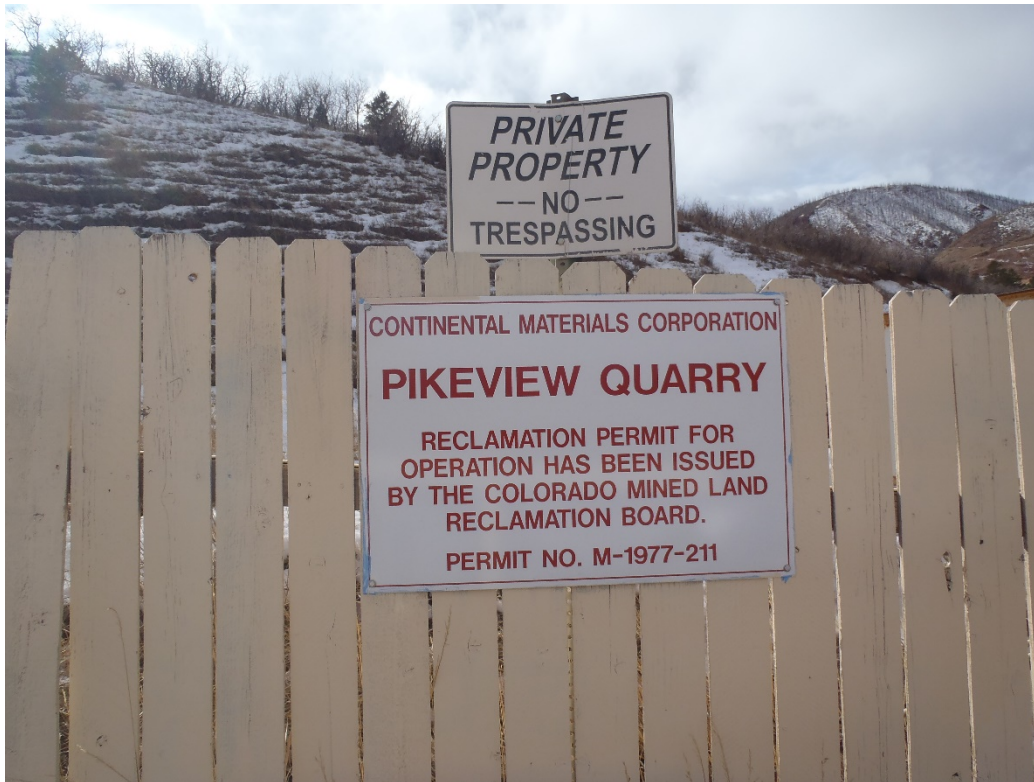
Signs and Markers: The permit sign was properly posted (see **Photo 6**) as was the notice required for the amendment under review (see **Photo 7**).

Photo 6. Permit sign at entrance.

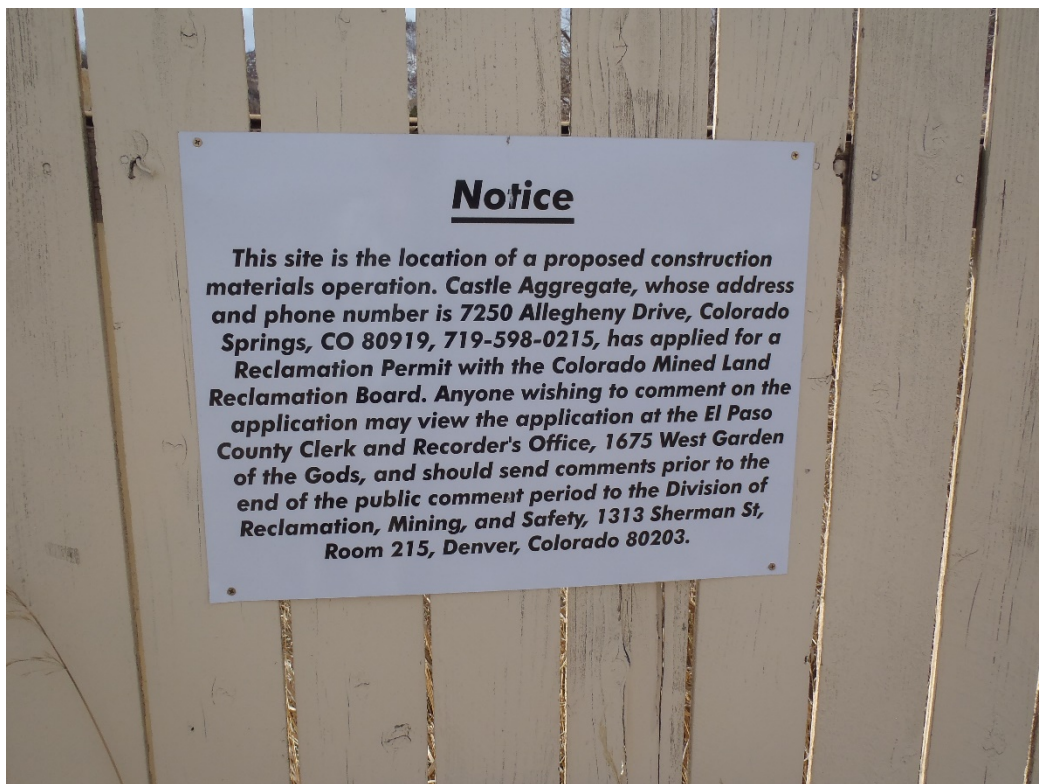
Photo 7. Required amendment notice sign at entrance.

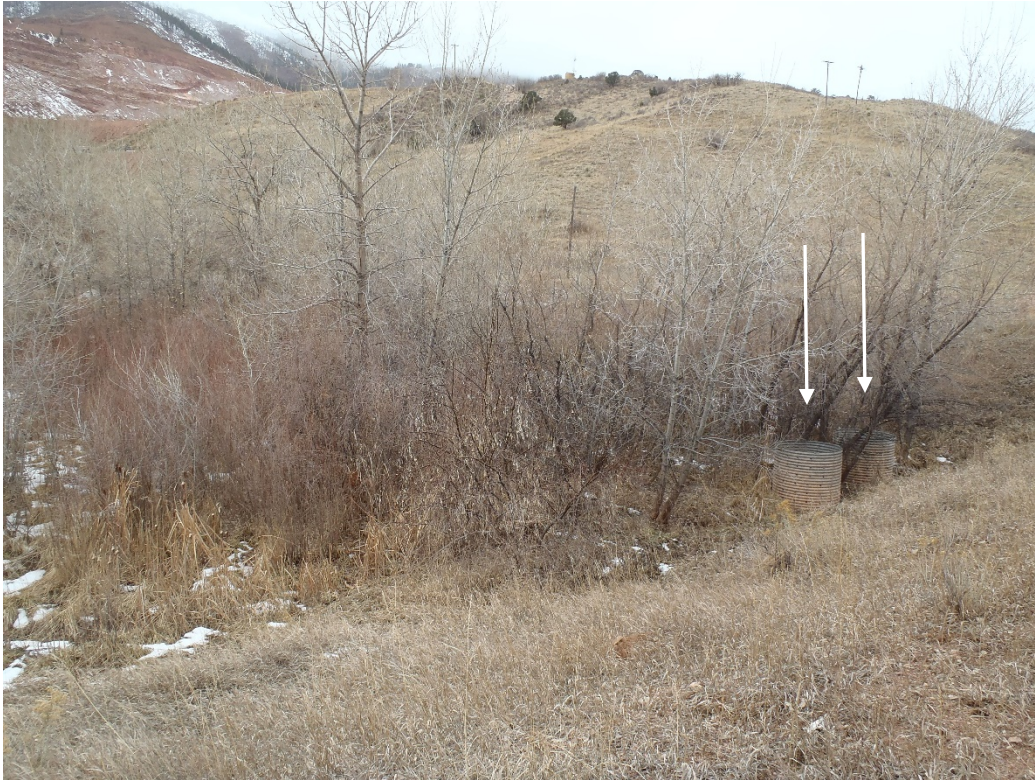
Storm Water MGT Plan: Site representatives stated there are four detention basins on site. Each one was visited. The lowest/eastern-most pond (No. 4) is well vegetated and full of mature trees (see **Photo 8**), but does not appear to have received new sediment in many years, despite having a steady low flow of water running through it to the riser pipes (see **Photo 9**). Pond No. 3 (see **Photo 3**) and No. 2 (see **Photo 4**) could use some maintenance to remove the large amount of sediment observed. Representatives stated an electronic copy of the stormwater management plan is kept in site trailer. No oil or fuel spills observed.

Photo 8. Mature trees and established vegetation in Pond No. 4 (looking north, note riser pipes).

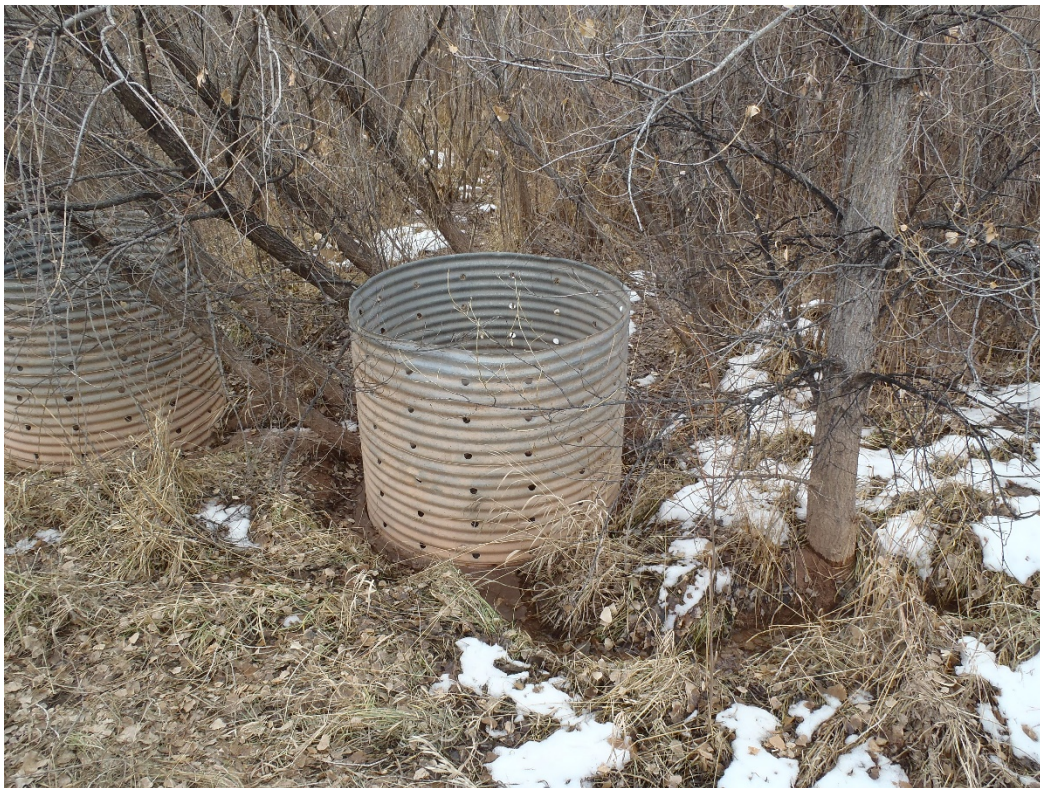
Photo 9. Riser pipes in Pond No. 4 (east side).

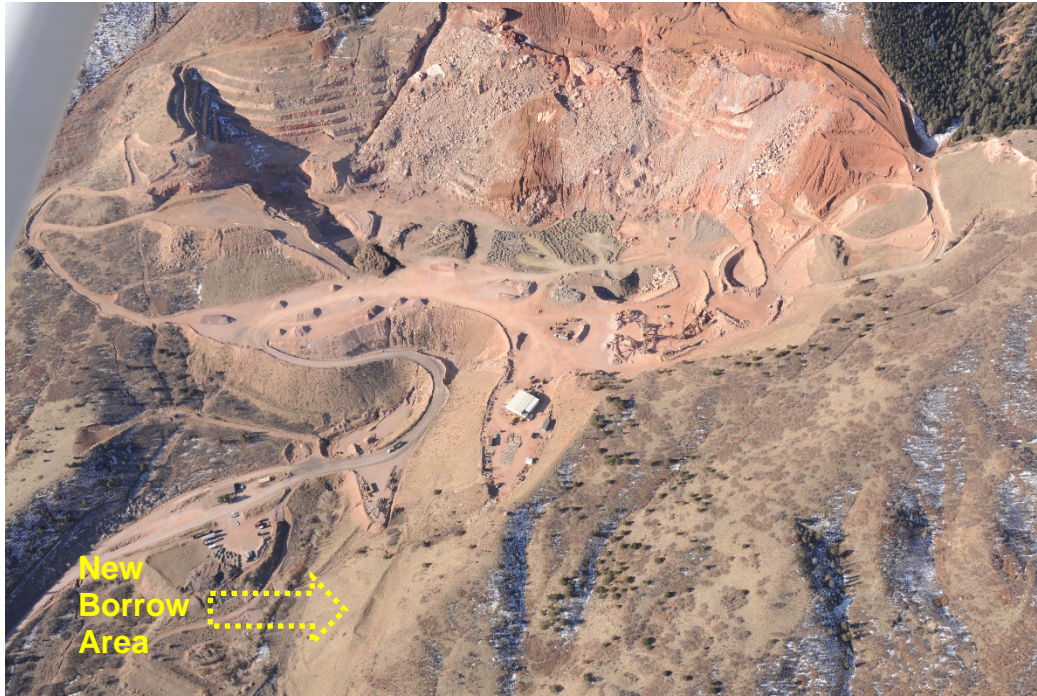
Photo 10. New borrow area (1/24/2020 aerial photo, looking SSW).

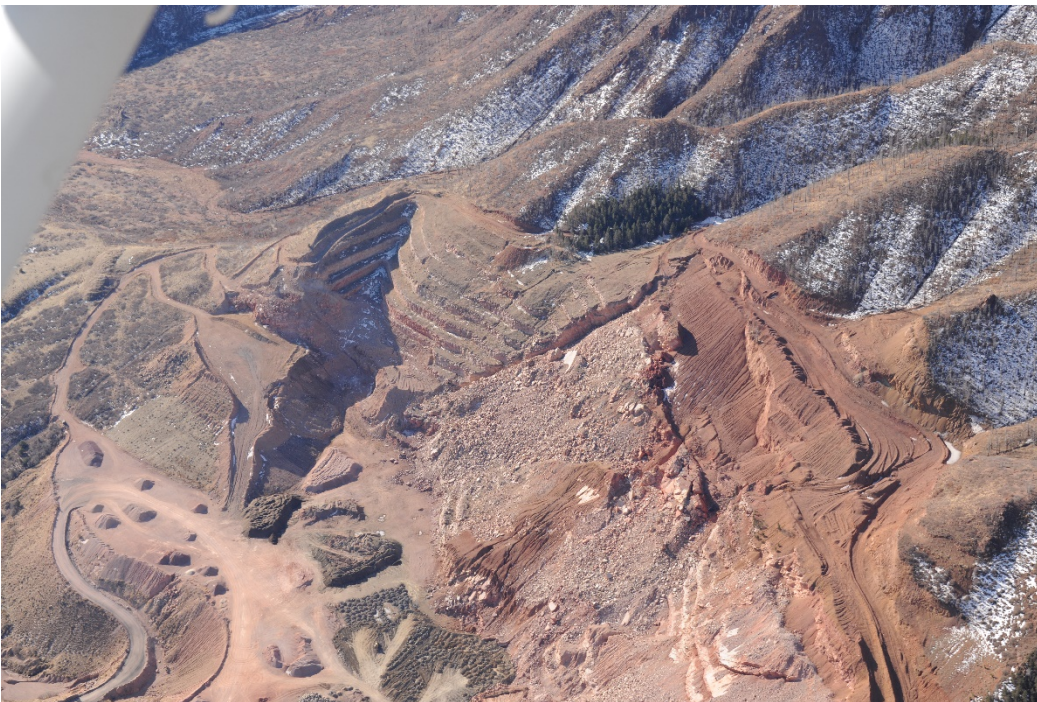
Photo 11. Grading at crest of highwall (1/24/2020 aerial photo, looking south).

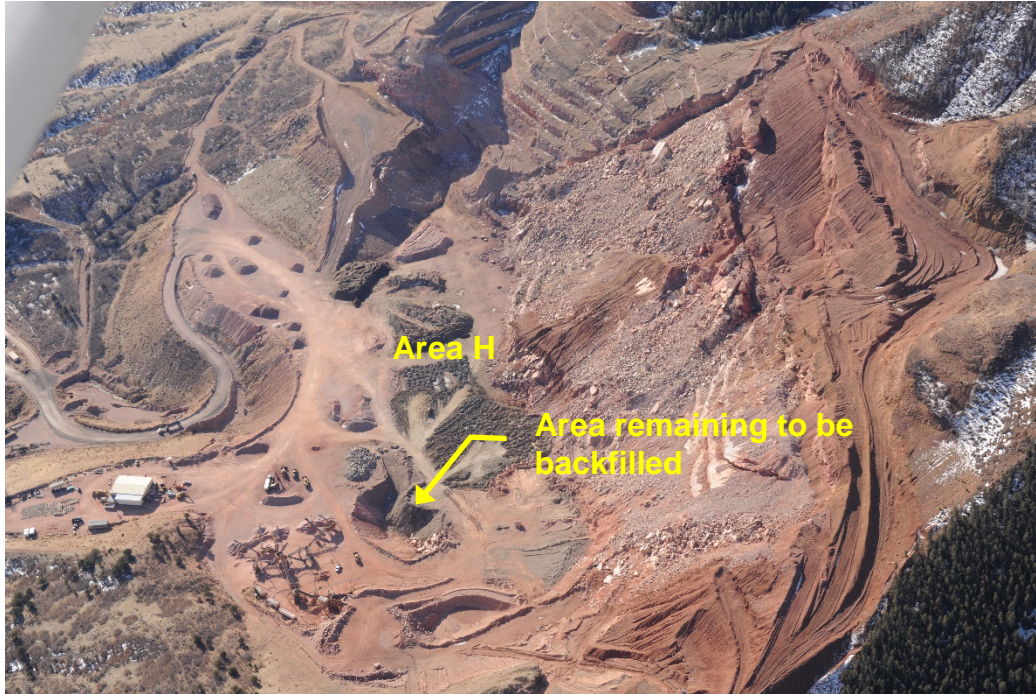
Aerial Inspection: Images taken from the January 24, 2020 flight over the quarry show the new proposed borrow area (see **Photo 10**), current grading work at the crest (see **Photo 11**), and the extent of the nearly completed backfill of Area H (see **Photo 12**).

Photo 12. Extent of Area H backfill (1/24/2020 aerial photo, looking south).
