MINERALS PROGRAM INSPECTION REPORT
PHONE: (303) 866-3567

MINE NAME: North River Pit	MINE/PROSPECTING ID#: M-1999-005	MINERAL: Sand and gravel and material for construc	COUNTY: Otero
INSPECTION TYPE: Monitoring	INSPECTOR(S): Daniel Cunningham	INSP. DATE: January 28, 2020	INSP. TIME: 14:30
OPERATOR: All-Rite Paving & Redi-Mix, Inc.	OPERATOR REPRESENTATIVE: Jodi Schreiber & Herb Pearson	TYPE OF OPERATION: 112c - Construction Regular Operation	
REASON FOR INSPECTION: Normal I&E Program	BOND CALCULATION TYPE: Complete Bond	BOND AMOUNT: \$431,039.00	
DATE OF COMPLAINT: NA	POST INSP. CONTACTS: None	JOINT INSP. AGENCY: None	
WEATHER: Clear	INSPECTOR'S SIGNATURE:

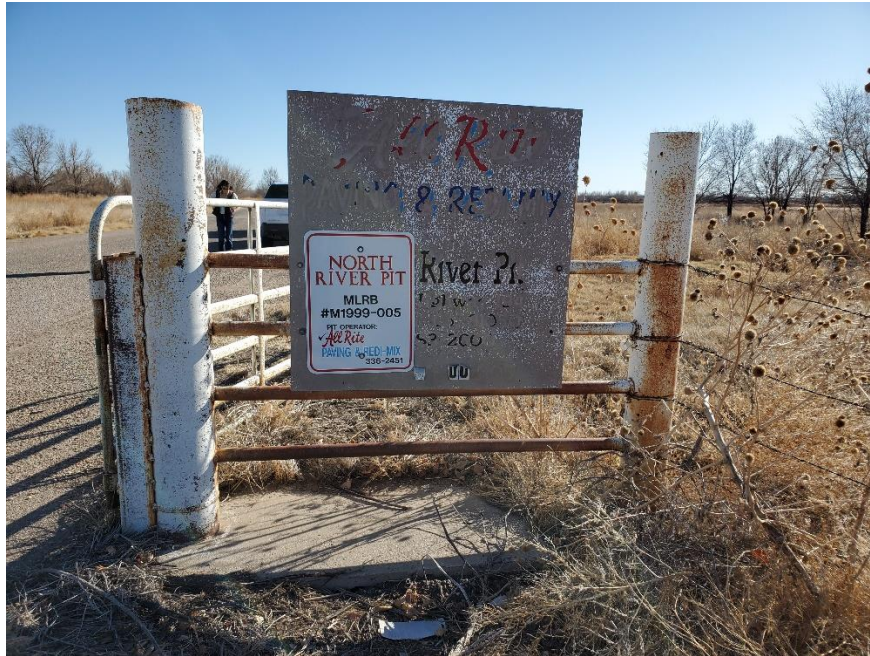
The site identification sign was posted at the mine site entrance and the permit boundary was marked. Slopes were mined at a 3H: 1V or greater slope. Topsoil was being stored on the site in berms around the perimeter of the lake. The topsoil stockpiles were stable with vegetative cover. According to the Operator, material is being brought in from other mine sites and being washed at the North River Pit.

Photo 1: Mine Entrance Sign

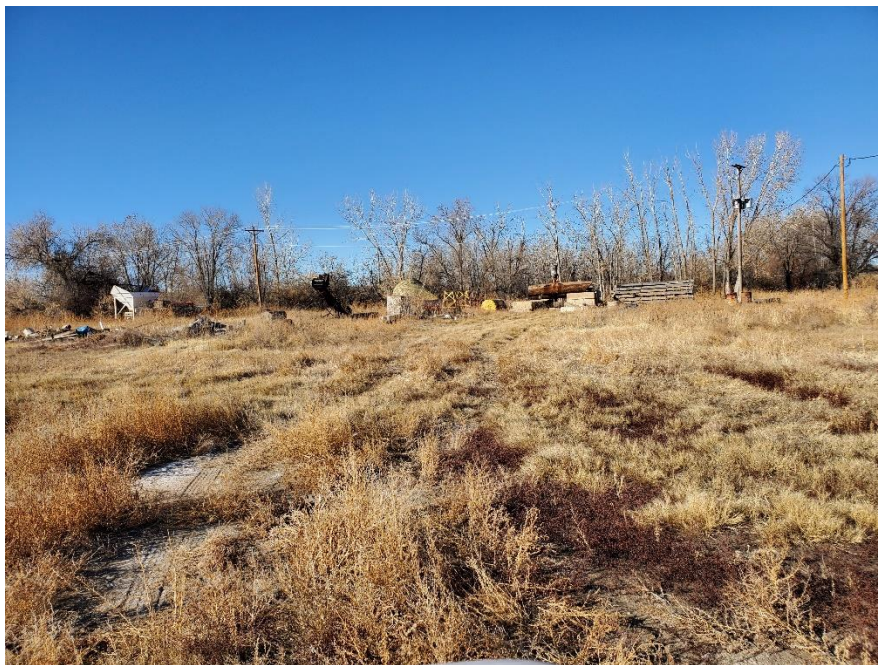
During the inspection, a storage area (Photo:) was noted in the western portion of the permit area. The storage area was noted to be right up to the permit boundary. It is recommended by the division that the Operator monitor this area and ensure that they do not operator outside their permitted area

Photo 2: Storage area

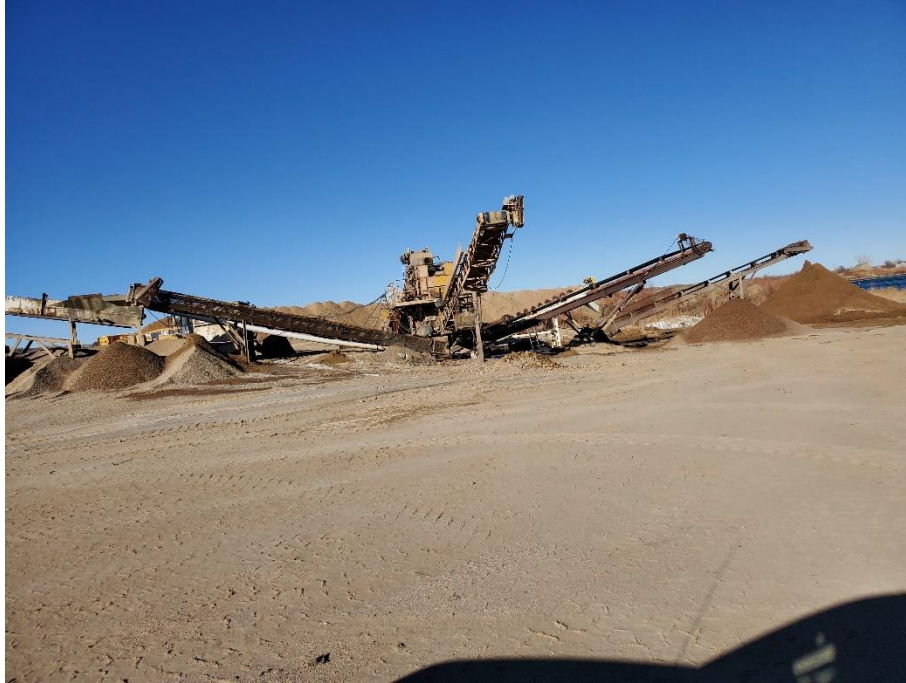
Photo 3: Stockpiles

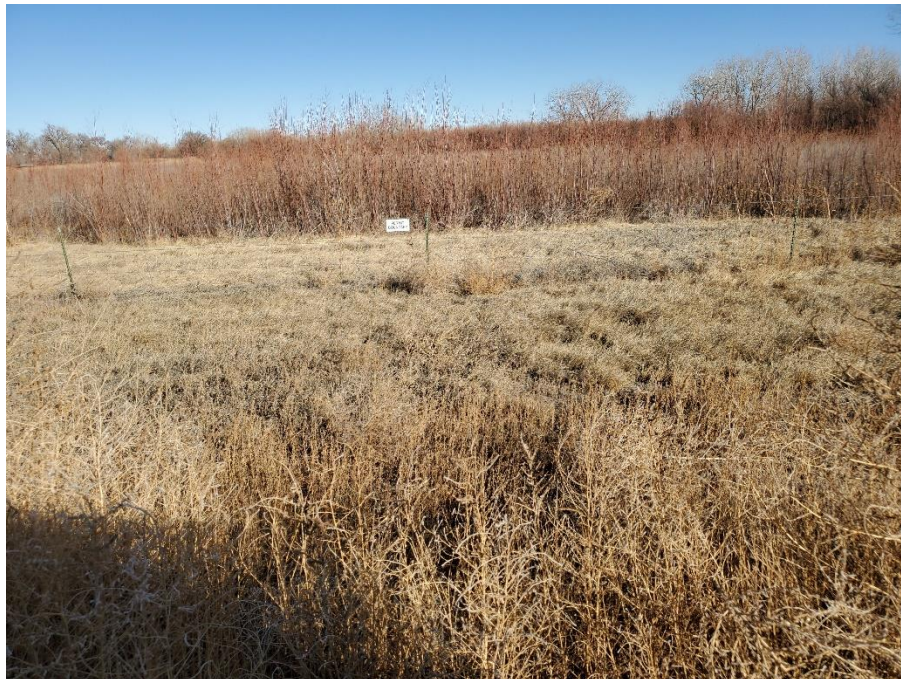
Photo 4: Permit Boundary
