**MINERALS PROGRAM INSPECTION REPORT**  
**PHONE: (303) 866-3567**

<b>MINE NAME:</b> Rocky Ford South Pit	<b>MINE/PROSPECTING ID#:</b> M-1977-222	<b>MINERAL:</b> Sand and gravel	<b>COUNTY:</b> Otero
<b>INSPECTION TYPE:</b> Monitoring	<b>INSPECTOR(S):</b> Daniel Cunningham	<b>INSP. DATE:</b> January 28, 2020	<b>INSP. TIME:</b> 15:30
<b>OPERATOR:</b> All-Rite Paving & Redi-Mix, Inc.	<b>OPERATOR REPRESENTATIVE:</b> Jodi Schreiber & Herb Pearson	<b>TYPE OF OPERATION:</b> 112c - Construction Regular Operation	
<b>REASON FOR INSPECTION:</b> Normal I&E Program	<b>BOND CALCULATION TYPE:</b> Complete Bond	<b>BOND AMOUNT:</b> \$85,500.00	
<b>DATE OF COMPLAINT:</b> NA	<b>POST INSP. CONTACTS:</b> None	<b>JOINT INSP. AGENCY:</b> None	
<b>WEATHER:</b> Clear	<b>INSPECTOR'S SIGNATURE:</b>

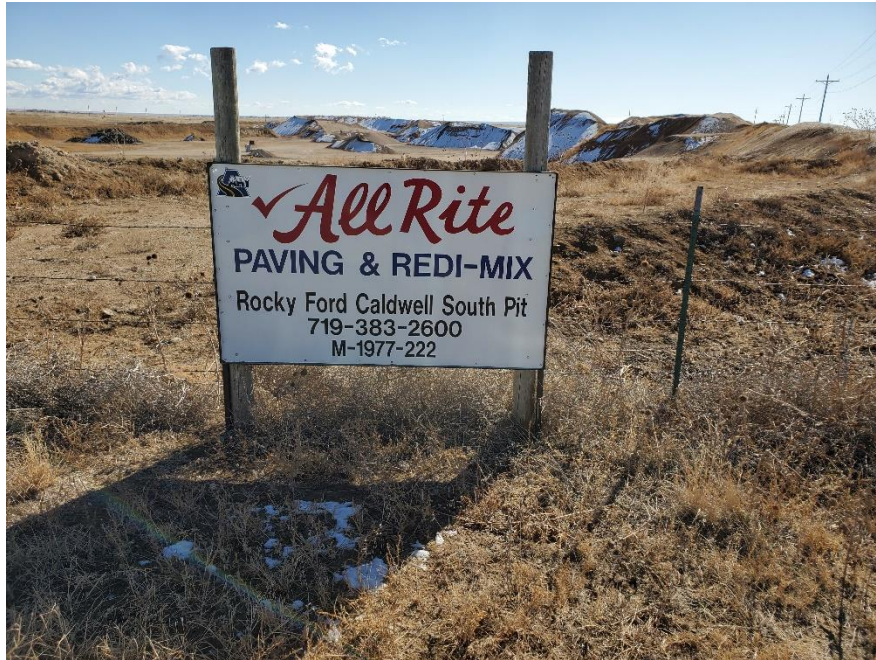
**Photo 1: Mine entrance sign**

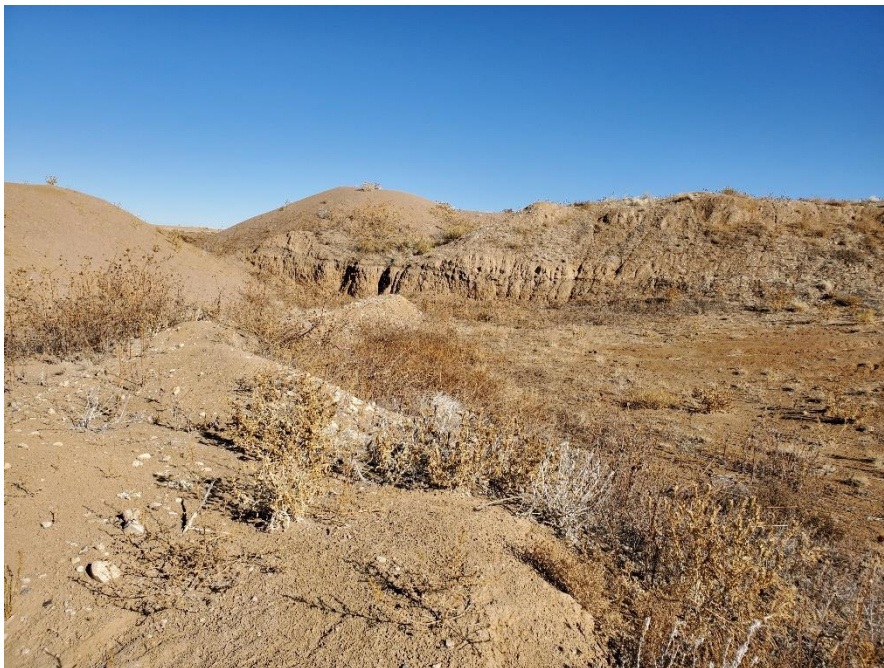
The site identification sign was posted at the mine site entrance and the permit boundary was marked. Most of the area was sloped at a 3H:1V, however some areas had a 0.5H: 1V high wall. Topsoil was being stored in two locations and a small amount was placed as a berm around the perimeter of the pit. The topsoil stockpiles were stable with vegetative cover. Some minor erosional issues were noted throughout the disturbed area. Several large material piles were noted on the pit floor at the time of the inspection. It is the recommendation of the Division that the Operator monitor these minor erosion features and take any necessary erosion control measures to prevent off-site impact.

**Photo 2: Minor erosional issues**

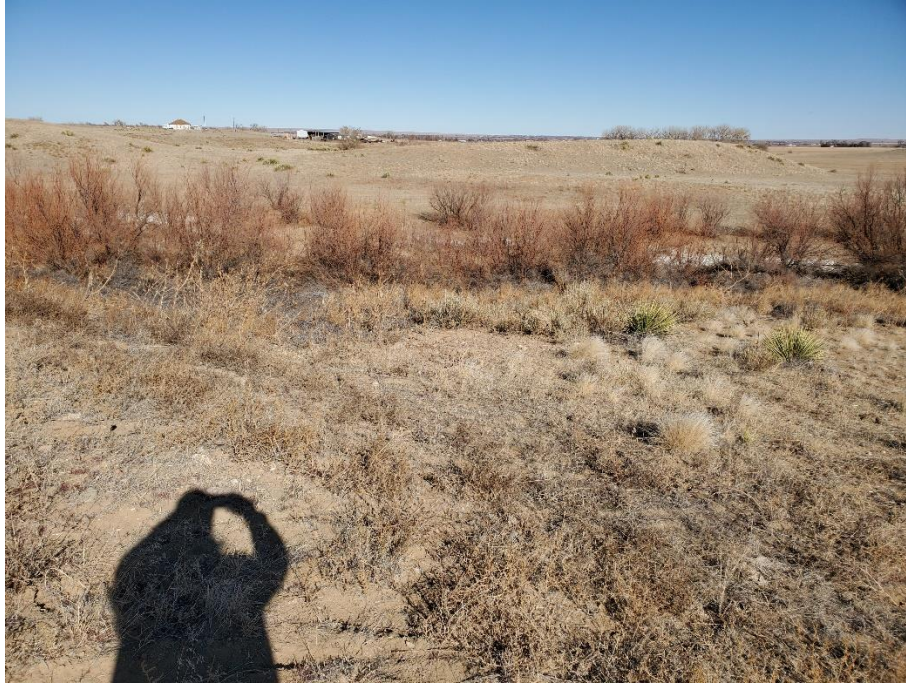
Significant state-listed noxious weed species, tamarisk (salt cedar), were observed in the northeastern portion of the disturbed area. The Division is citing a problem in this report (see page 1) for failure to employ weed control methods for a state-listed noxious weed species within the permitted area, and to reduce the spread of weeds to nearby areas as required by Rule 3.1.10(6). The Operator will need to develop a new weed control and management plan in consultation with the county extension agency or weed control district office, and submit this plan in a Technical Revision.

**Photo 3: Tamarisks in northeastern section of the disturbed area**
