MINERALS PROGRAM INSPECTION REPORT
PHONE: (303) 866-3567

MINE NAME: Harold Eichman Gravel Pit	MINE/PROSPECTING ID#: M-1985-105	MINERAL: Sand and gravel	COUNTY: Lincoln
INSPECTION TYPE: Monitoring	INSPECTOR(S): Daniel Cunningham	INSP. DATE: January 28, 2020	INSP. TIME: 10:30
OPERATOR: Lincoln County	OPERATOR REPRESENTATIVE: Fred Lundy	TYPE OF OPERATION: 110c - Construction Limited Impact

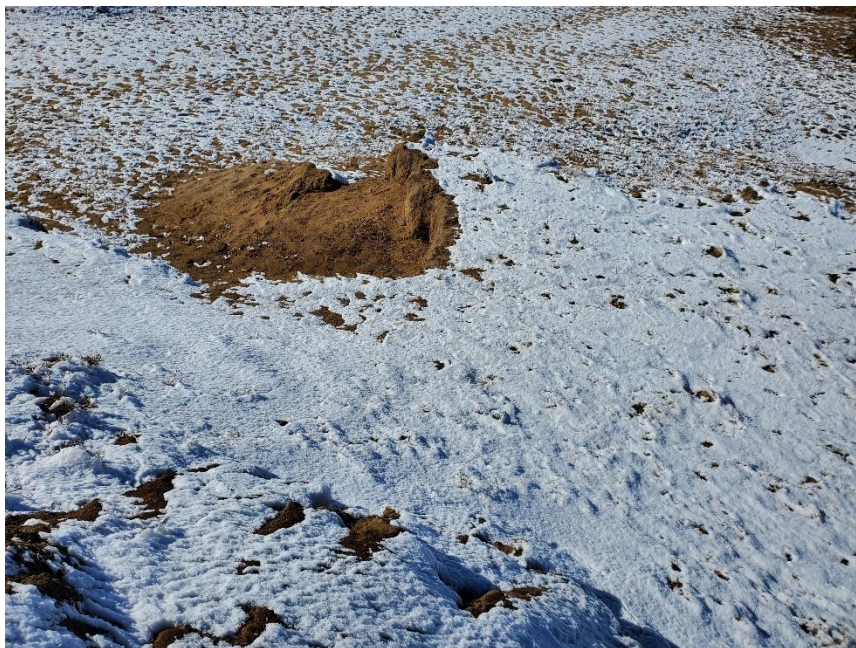
Erosional issues (**Photo: 2**) were noted around the stockpiles at the mining site. However, no damage to offsite area was noted from the erosion. It is the recommendation of the Division that the stockpiles be sloped to a 2:1 and a berm be placed around the stockpile area to help prevent sediment from moving to offsite areas.

Photo 2: Erosional issues at stockpile

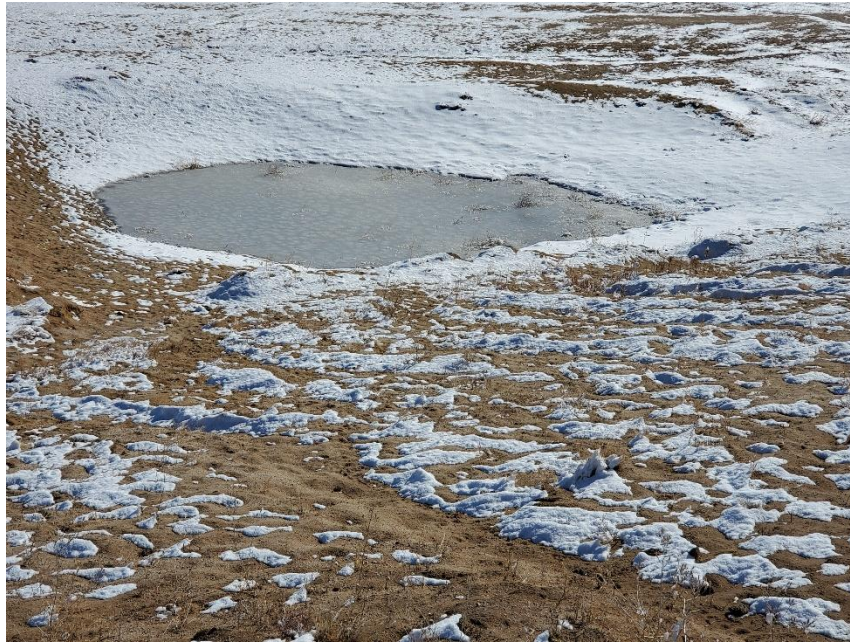
PROBLEM: Standing water was noted in the bottom of the mine pit. This water is likely a mixture of impounded surface water and possibly exposed groundwater. The Division has no evidence that the operator has a valid well permit, substitute water supply plan, or approved water augmentation plan for the exposed groundwater at the site or surface water impounded for greater than 72 hours. This is a problem related to 34-32.5-116(4)(h) of the Colorado Revised Statutes and 3.1.6(1)(a) of the Construction Materials Rules and Regulations governing injury to existing water rights.

Standing water (**Photo: 3**) was noted on the bottom of the pit floor during this inspection. This was previously mentioned in the 2016 inspection report. This water is likely a mixture of surface and groundwater and appears to remain in the pit for longer than 72 hours. The Operator will need to contact the Division of Water Resources (State Engineer's Office) and ensure they are in compliance with their rules and regulations regarding impacts to water rights. The Operator is not approved to expose groundwater at the site or impound surface water for greater than 72 hours. Given this, the operator will either need to backfill the pit excavation to at least two feet above the groundwater table, conduct earthwork so that the affected lands positively drain without causing off-site sedimentation; or submit documentation that they have obtained a valid well permit and substitute water supply plan or permanent plan for augmentation from the Colorado Division of Water Resources. At this time, the Division is citing this as a problem at the beginning of the report.

Photo 3: Standing water in pit floor

CORRECTIVE ACTIONS: The Operator shall demonstrate that the operation is in compliance with the Office of the State Engineer, show evidence that the Operator is taking measures to bring the site into compliance with the SEO, backfill the pits to at least two feet above the groundwater surface or ensure the mine pit positively drains by the corrective action date specified. **CORRECTIVE ACTION DUE DATE: 4/29/20**

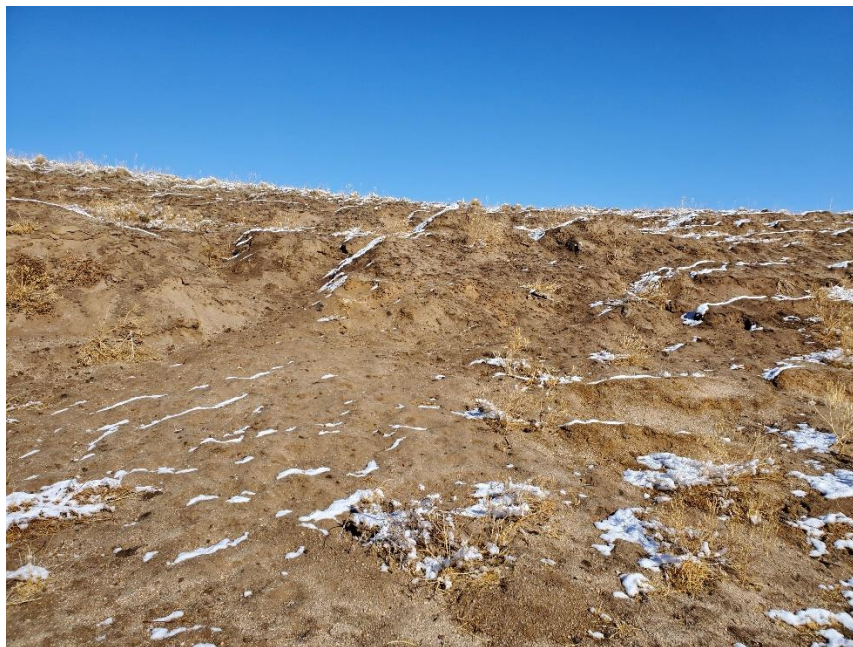
The site identification sign was posted at the mine site entrance and the permit boundary was marked. Slopes were originally mined at a 3H:1V or greater slope. It was noted during the inspection and due to erosion of the area, the slopes have not been maintained at a 3H:1V ratio (**Photo: 4**) and will need to be reshaped or a technical revision will need to be submitted to reflect the difference in the mining plan.

Photo 4: Erosion on the slopes of the mine
