MINERALS PROGRAM INSPECTION REPORT
PHONE: (303) 866-3567

MINE NAME: Cresson Project	MINE/PROSPECTING ID#: M-1980-244	MINERAL: Gold	COUNTY: Teller
INSPECTION TYPE: Monitoring	INSPECTOR(S): Timothy Cazier	INSP. DATE: November 19, 2019	INSP. TIME: 09:30
OPERATOR: Cripple Creek & Victor Gold Mining Company	OPERATOR REPRESENTATIVE: Justin Bills & Katie Blake	TYPE OF OPERATION: 112d-3 - Designated Mining Operation	
REASON FOR INSPECTION: Normal I&E Program	BOND CALCULATION TYPE: None	BOND AMOUNT: \$209,491,188.00	
DATE OF COMPLAINT: NA	POST INSP. CONTACTS: None	JOINT INSP. AGENCY: None	
WEATHER: Clear	INSPECTOR'S SIGNATURE:

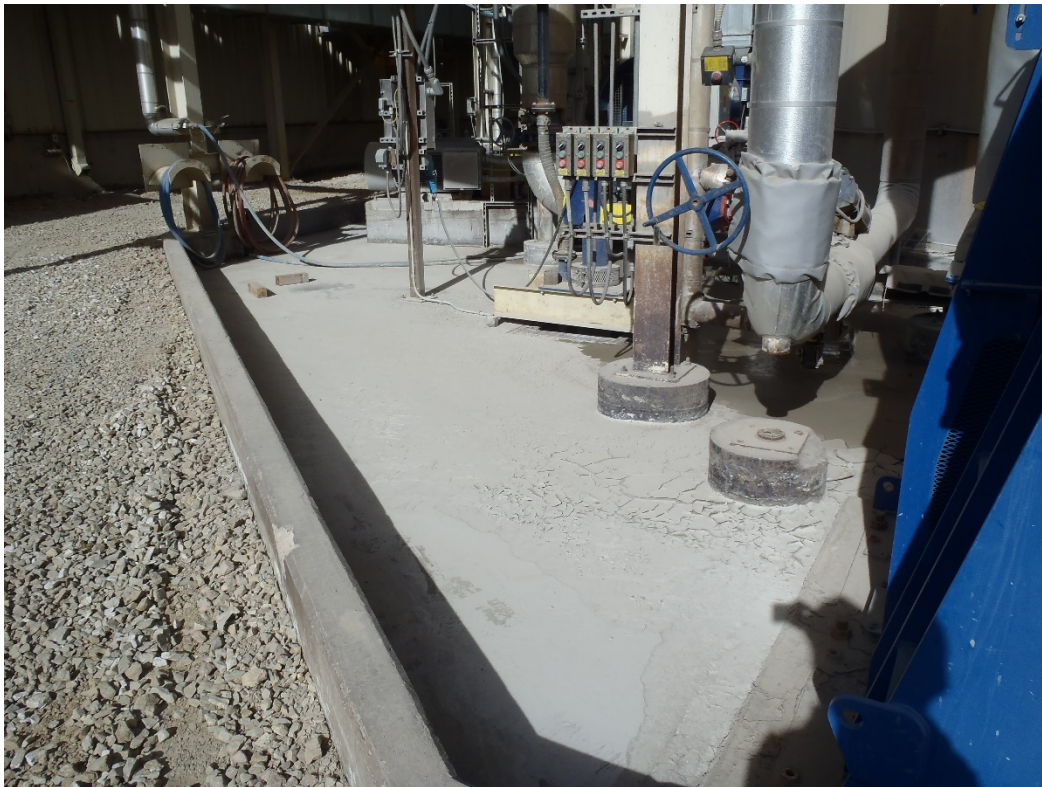
Photo 1. Thin dried sludge layer observed in secondary containment area of Neutral pH Process Water Tank.

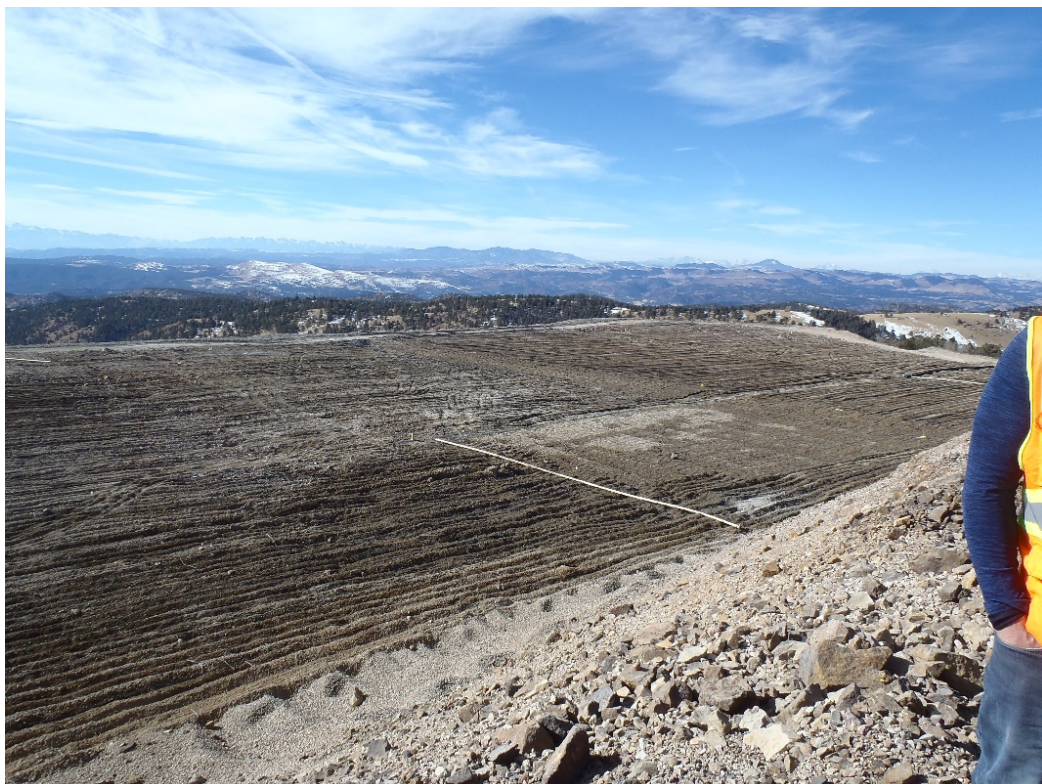
Squaw Gulch Valley Leach Facility (VLF2): Messrs. Bissue and Laurin Colby accompanied the DRMS to VLF 2. The VLF2 9,900 level was observed from the 9,950 level. No ponded process solution was observed (see **Photo 3**). Ore stacking appeared to be in accordance with the approved mine plan.

Photo 3. VLF2 9,900 level observed from the 9,950 level, no ponded process solution was observed.

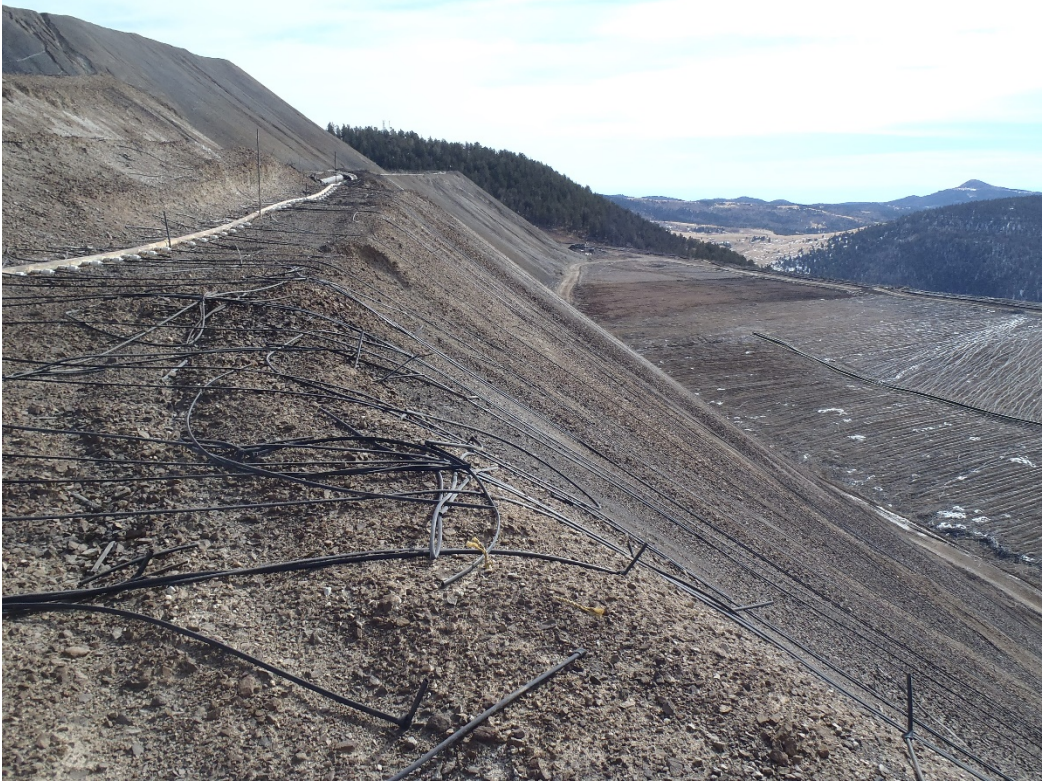
Arequa Gulch Valley Leach Facility (VLF1): Messrs. Colby and Dylan Noble accompanied the DRMS to VLF 1. Both the 10,200 and 10,300 levels on the south side of VLF1 (see **Photo 4**) and the 10,300 level northeast side (above the South Cresson pit, (see **Photo 5**) were inspected. Some ice was observed, but no significant ponding. The 10,400 level (see **Photo 6**) was also inspected and found to be in compliance with the approved wildlife protection plan.

Photo 4. VLF1 10,300 bench (left) and 10,200 level (right) – no ponded process solution observed.

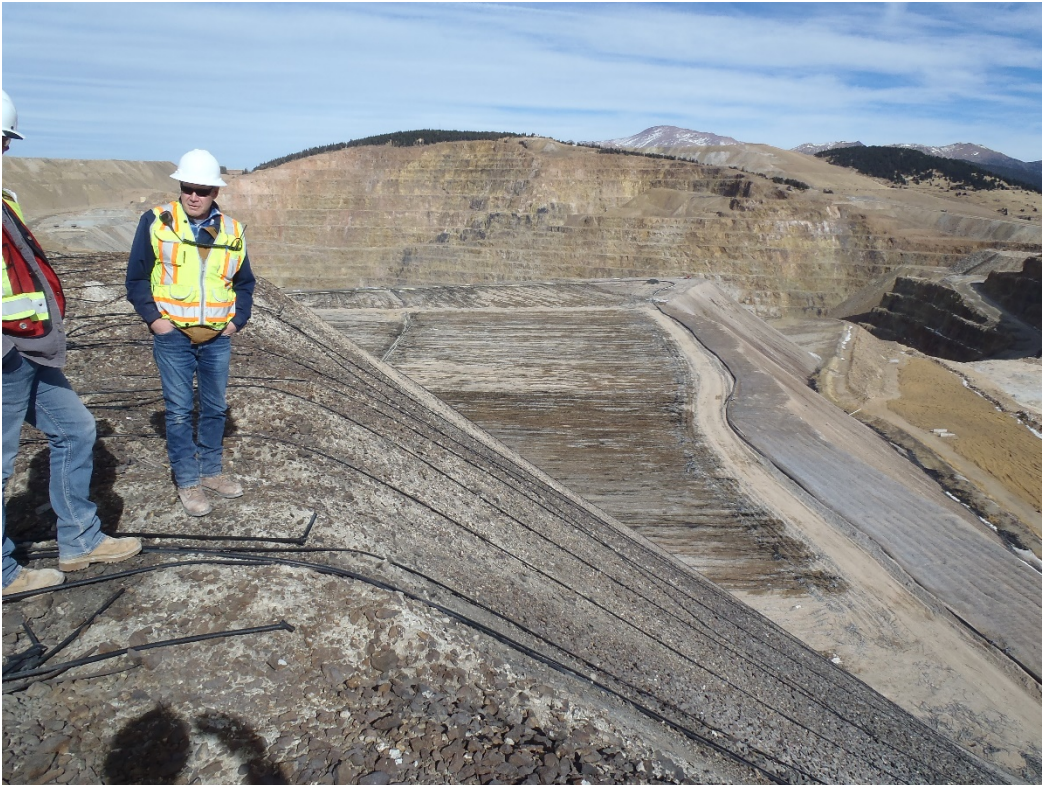
Photo 5. VLF1 10,300 level (east end) – no ponded process solution observed (looking east).

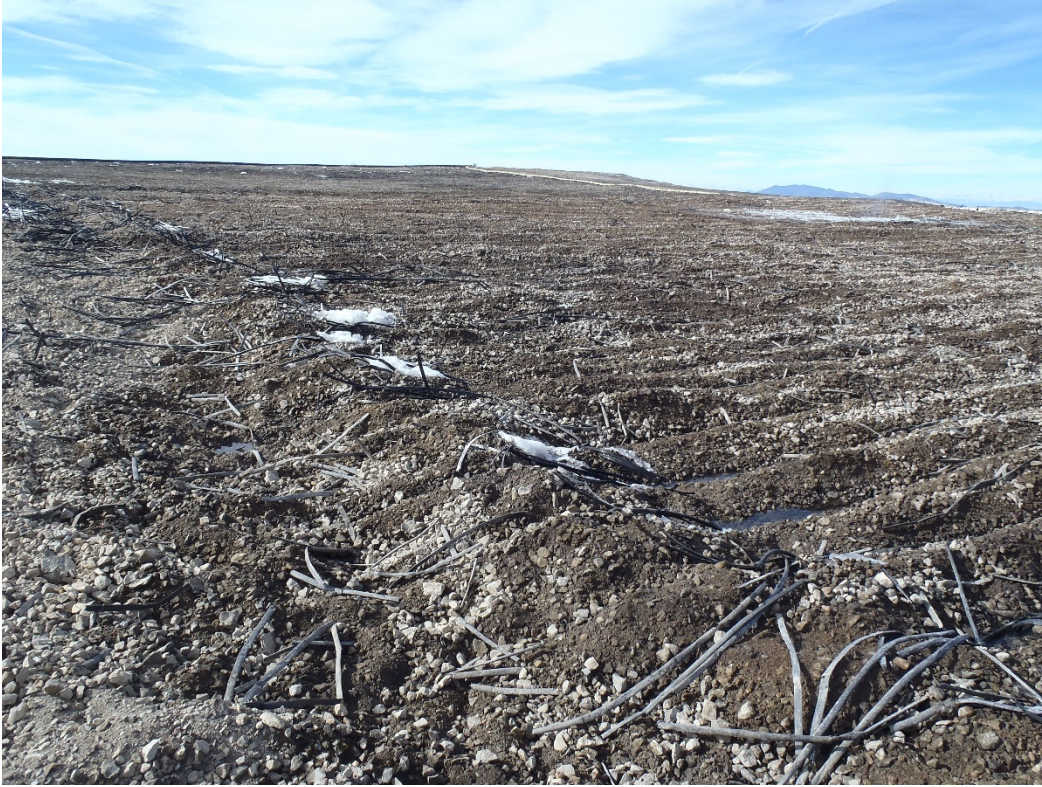
Photo 6. VLF1 – 10,400 level – no significant ponding of process solution observed.

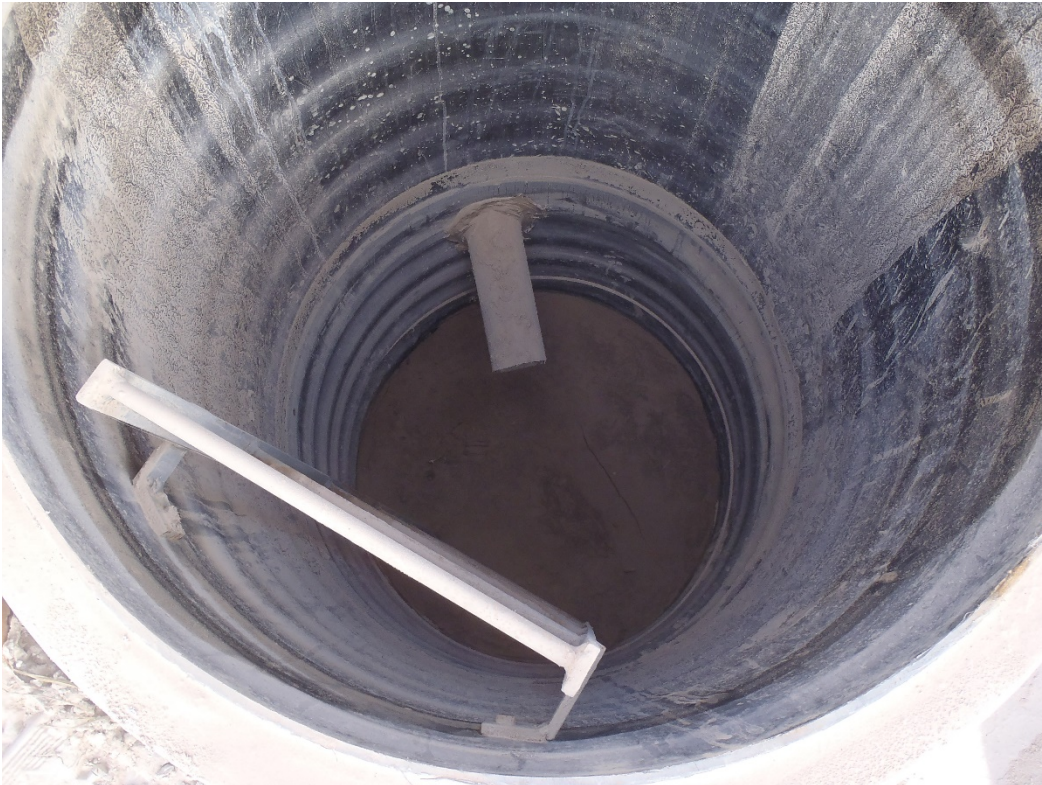
Lime Silo: Messrs. Bissue accompanied the DRMS to the lime silo in the crusher area. No problems were observed. Leak detection system sumps LDS-12 and -13 are nearby below the conveyor segment between the silo and the load out bin (LOB). Both sumps were checked and observed to be dry (see **Photos 7 and 8**).

Photo 7. VLF1 LDS-12 sump observed to be dry.

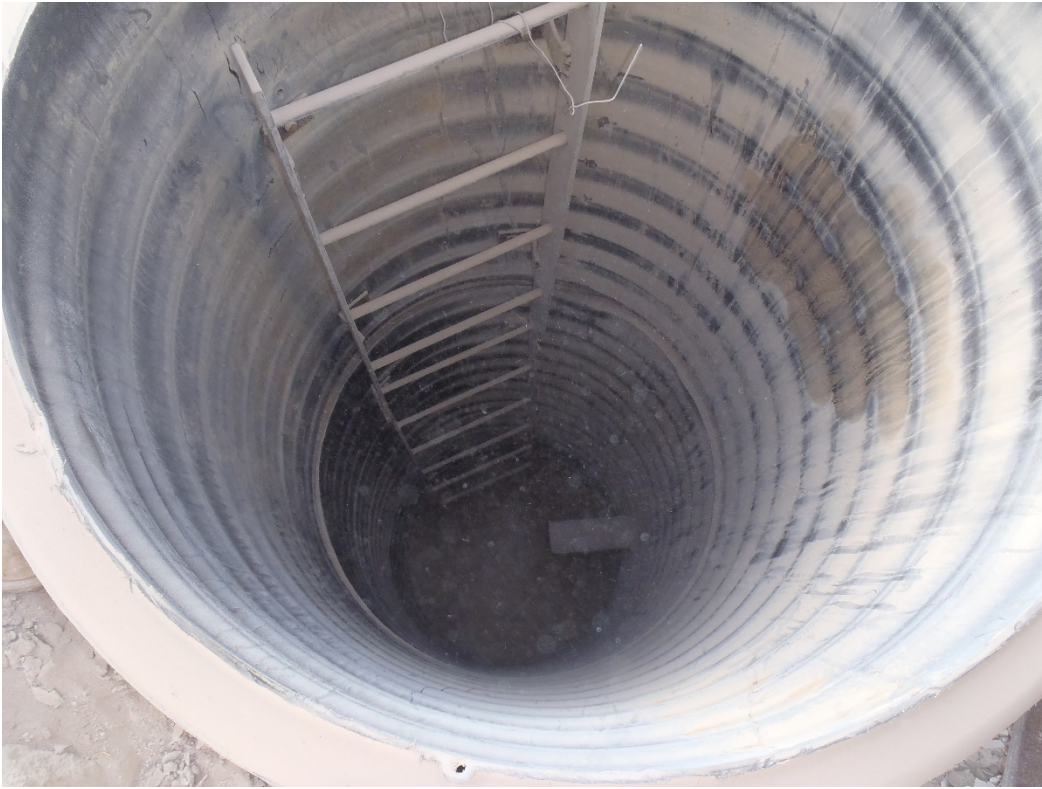
Photo 8. VLF1 LDS-13 sump observed to be dry.

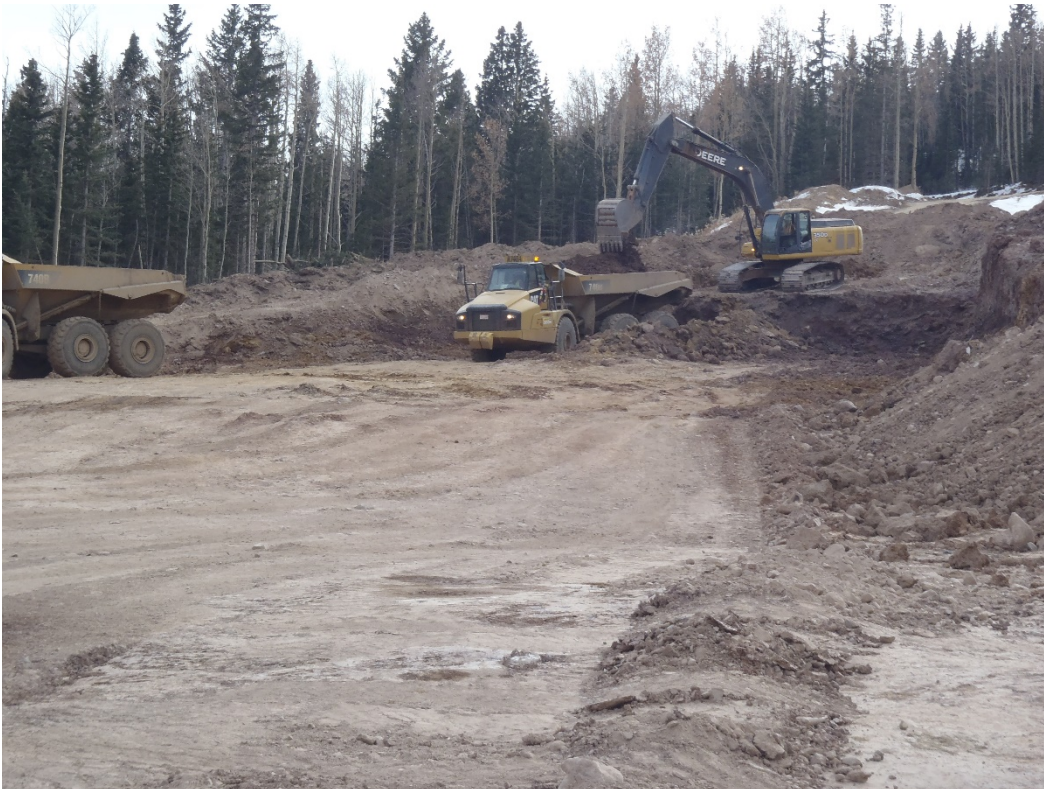
ECOSA Clay Borrow area: Telephone conversations with site personnel informed the DRMS a significant clay source had been located south of the ECOSA seep at the toe of the ECOSA. Furthermore, CC&V stated their intent to utilize the clay in upcoming VLF2 liner construction. The DRMS expressed concerns about undercutting the potentially buttressing function of the borrow area. As such, the DRMS decided to inspect the borrow source. Ms. Jeana Ratcliff and Mr. Jeff Gaul were present at the clay borrow area (see **Photos 9 and 10**). CC&V representatives described measures being implemented to monitor the ECOSA for movement and stability. The monitoring methods consist of twice weekly prism surveys and drone flights used every two weeks to collect topographic data for comparison with previous data in order to assess whether movement has occurred. In

Photo 9. ECOSA clay borrow source (looking SSW).

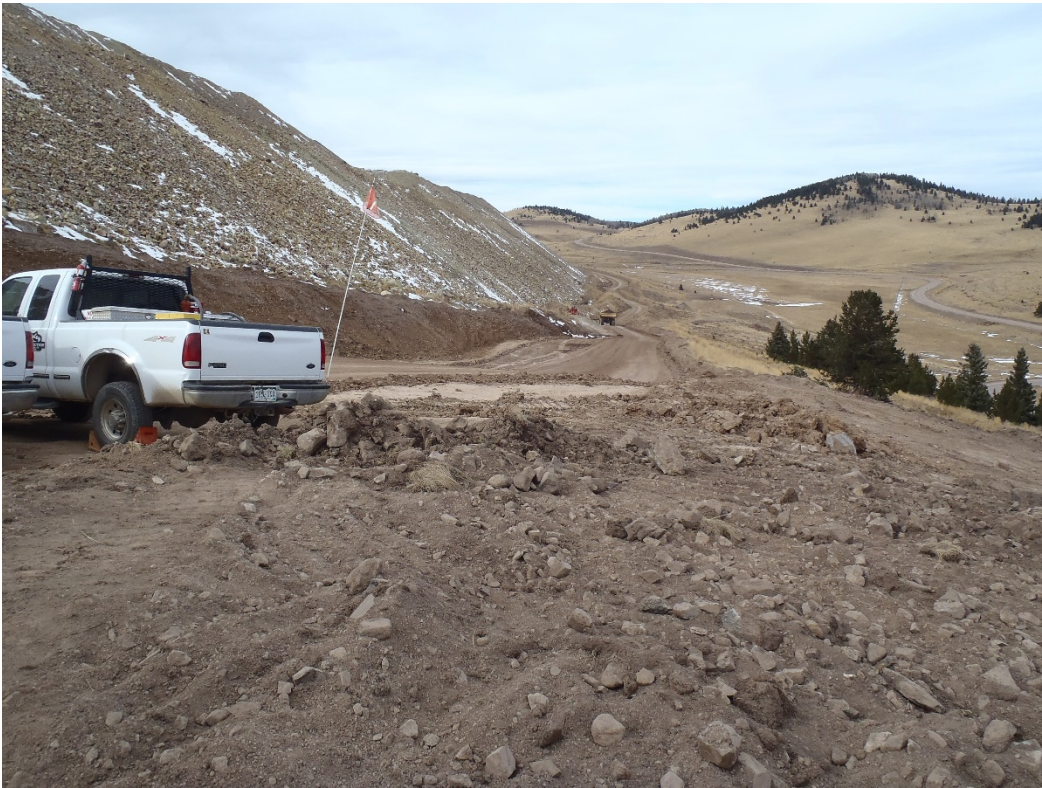
Photo 10. ECOSA clay borrow source (looking NNE).

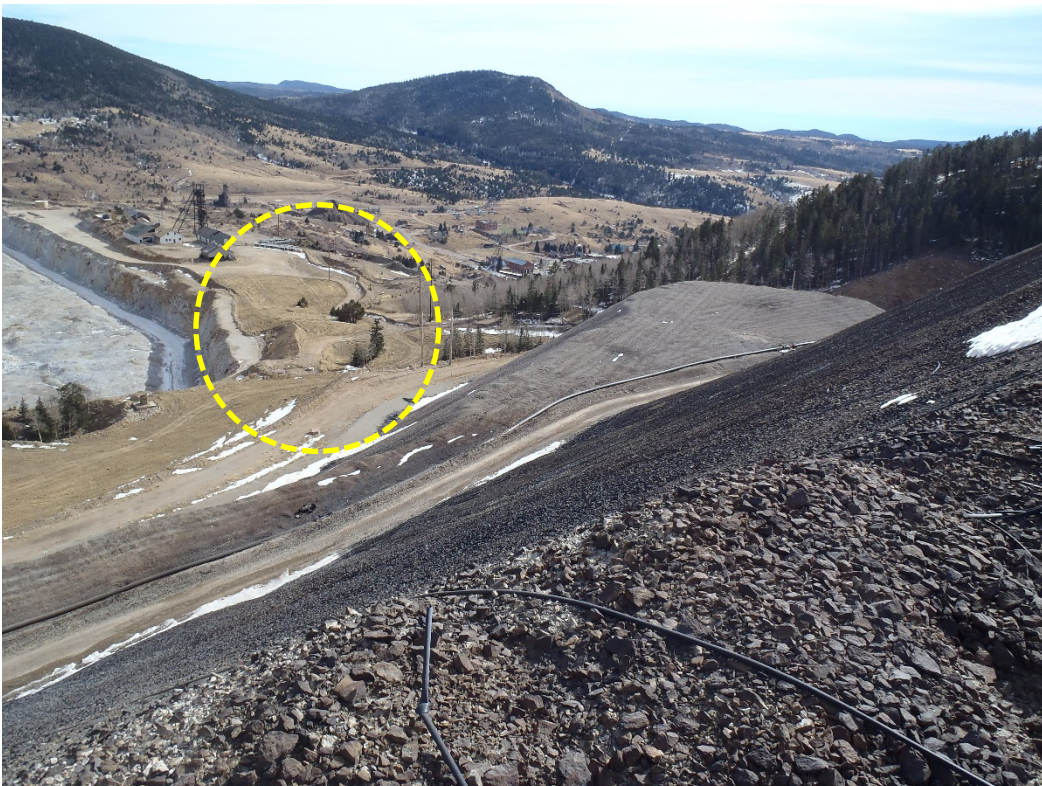
General Site Observations: Site representatives stated blasting was being conducted in all five pits (Main & South Cresson, WHEX, Globe Hill, and Schist Island). Haul road stormwater sumps appeared to be in good operating condition. Dust control measures were being implemented. Site representatives pointed out an area between VLF1 phase V and the South Cresson pit, near the Ajax area had been hydroseeded (**Photo 11**). No fuel or oil spills were observed.

Photo 11. Hydroseeded area between VLF1 & South Cresson pit, near the Ajax.
