**MINERALS PROGRAM INSPECTION REPORT**  
**PHONE: (303) 866-3567**

<b>MINE NAME:</b> Cresson Project	<b>MINE/PROSPECTING ID#:</b> M-1980-244	<b>MINERAL:</b> Gold	<b>COUNTY:</b> Teller
<b>INSPECTION TYPE:</b> Monitoring	<b>INSPECTOR(S):</b> Timothy Cazier	<b>INSP. DATE:</b> January 28, 2020	<b>INSP. TIME:</b> 10:00
<b>OPERATOR:</b> Cripple Creek & Victor Gold Mining Company	<b>OPERATOR REPRESENTATIVE:</b> Justin Bills, Katie Blake	<b>TYPE OF OPERATION:</b> 112d-3 - Designated Mining Operation	
<b>REASON FOR INSPECTION:</b> Normal I&E Program	<b>BOND CALCULATION TYPE:</b> None	<b>BOND AMOUNT:</b> \$209,491,188.00	
<b>DATE OF COMPLAINT:</b> NA	<b>POST INSP. CONTACTS:</b> None	<b>JOINT INSP. AGENCY:</b> None	
<b>WEATHER:</b> Clear	<b>INSPECTOR'S SIGNATURE:</b>

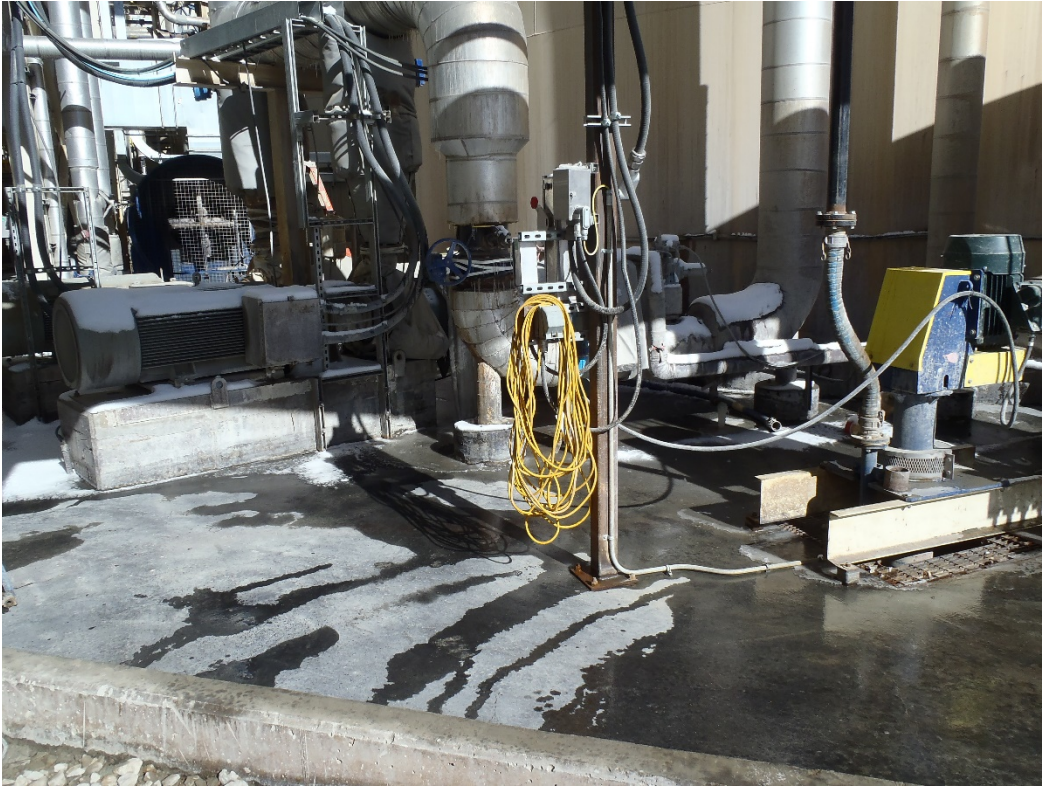
High Grade Mill: Messrs. Charles Bissue and Dylan Noble accompanied the DRMS on the mill exterior walk-around inspection. The purpose was to perform a visual inspection for leaks, spills and secondary containment problems. Both the east and west sides of the mill exterior were inspected, as well as the area around the concentrate storage facility (Con Barn). No problems were observed. Snow in the secondary containment areas ranged from none in the semi-sheltered areas (see **Photo 1**) to a maximum of about two inches in the more open west side vat leach area (see **Photo 2**).

Photo 1. Very little snow in semi-sheltered Neutral pH Process Water Tank secondary containment area.

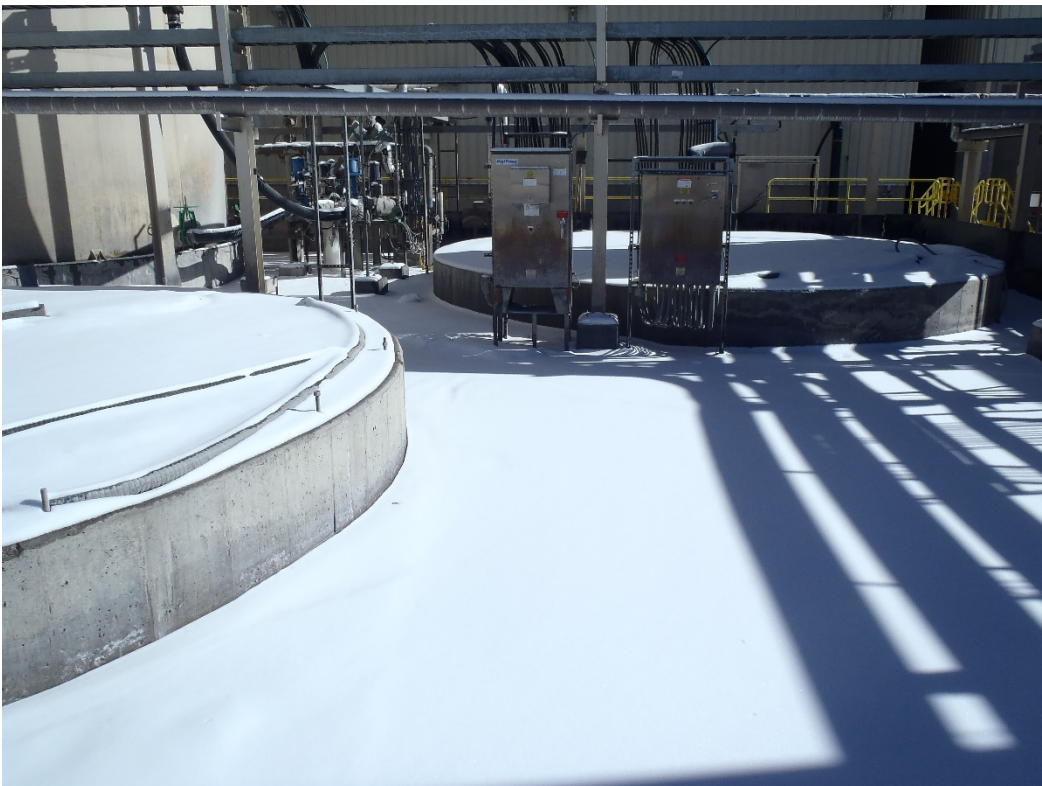
Photo 2. 2" - 3" snow in the vat leach secondary containment area.

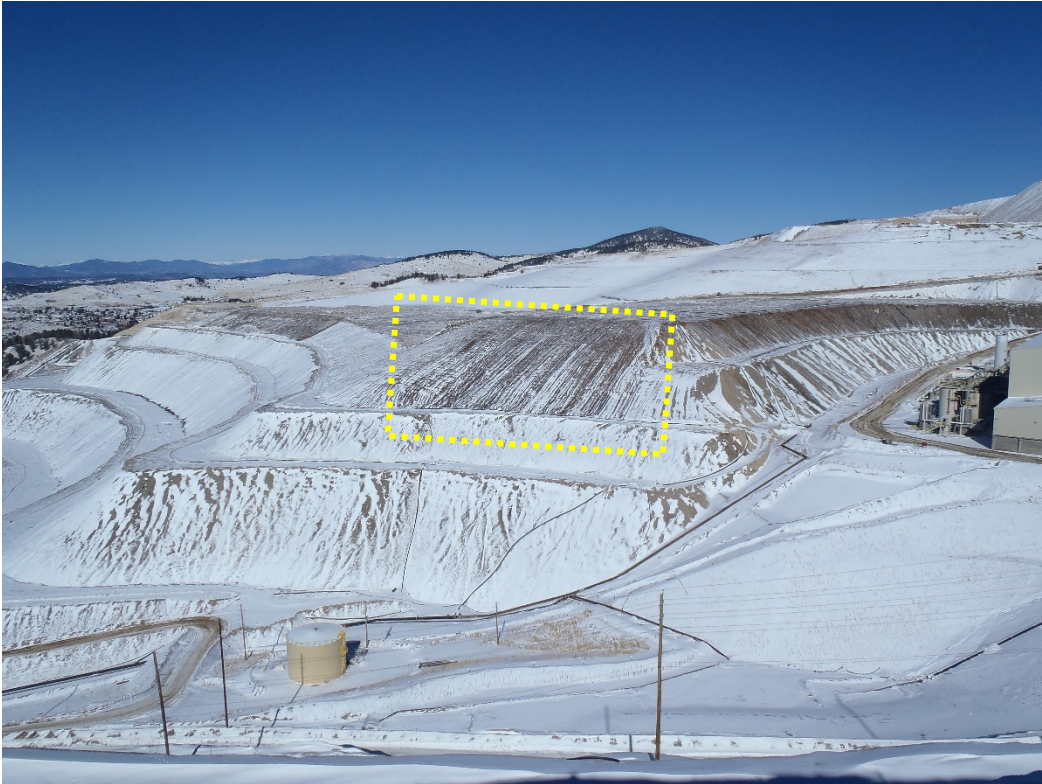
Squaw Gulch Valley Leach Facility (VLF2): Messrs. Bissue, Noble and Laurin Colby accompanied the DRMS to the VLF 2 overlook (from VLF 1). Snow was observed on the outcrops of VLF2, but the top was relatively clear and no ponded process solution was observed (see **Photo 3**).

Photo 3. VLF2 from VLF1 overlook – no ponded process solution observed (note flattened slope).

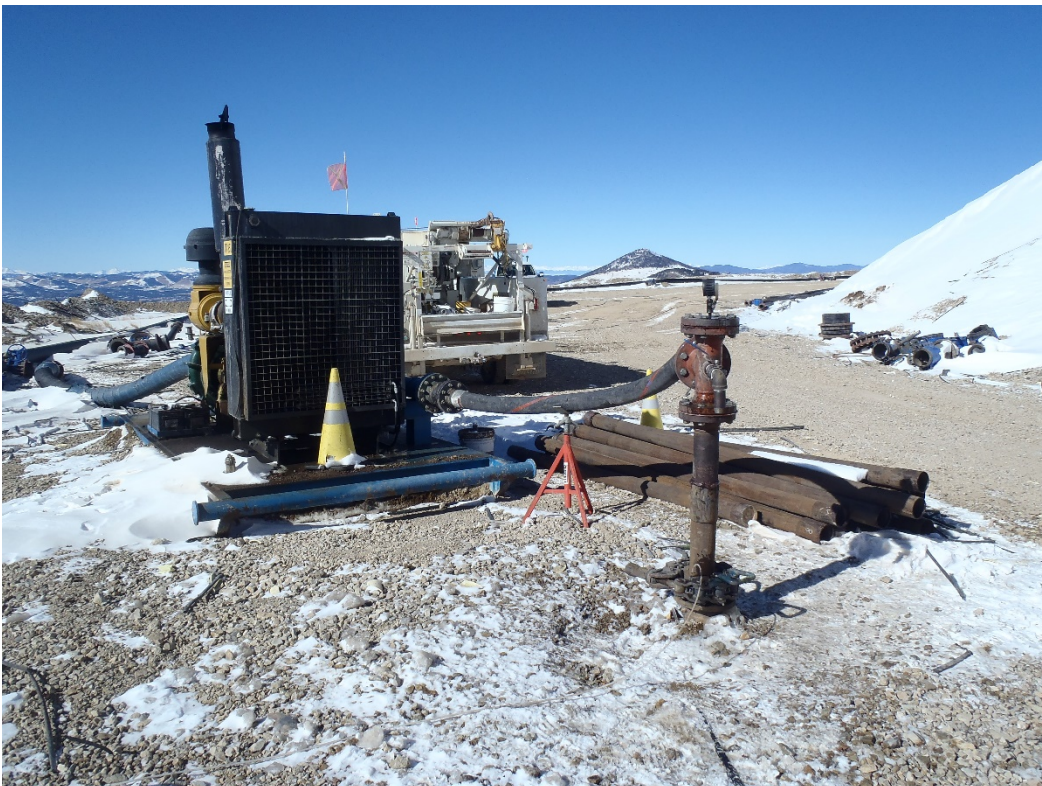
Arequa Gulch Valley Leach Facility (VLF1): Messrs. Bissue, Noble and Colby accompanied the DRMS to VLF 1 where the focus was on the operation of the injection wells approved with TR-57. Nine injection wells were constructed on the 9,925 level bench for the purpose of injecting lime at depth in VLF1. Well HJ-8 (see **Photo 4**) was being operated at the time of the inspection, but for process solution injection, rather than for lime. Site representatives explained only one well in an area contributing to a process solution storage area (PSSA "pond") is used for injection at one time and at no more than 1,600 gpm so as not to overwhelm the pumping capacity of the PSSA pumps. Site representatives explained the injection wells had perforations (approximately 1 inch in diameter) cut into the casing internally after it was set over a hundred or more feet, depending on the well. However, the specific injection interval is set to five feet by setting inflatable packers (pressurized to 300 psi and monitored). Well HJ-8 was being injected at a depth of 115 ft bgs at operated at a pressure of about 112 psi as indicated by the pressure gage (see **Photo 5**). The well operator explained the injection is limited by both pressure and flow rate, so as not to exceed either. Furthermore, the injection pressure at the injection depth is not to exceed the estimated lithostatic overburden pressure determined by HydroGeophysics in 2010 as part of the TR-57 pilot project. According to the HydroGeophysics determination, the estimated overburden pressure at 115 feet bgs is approximately 90 psi. The HydroJex pilot program measured the pressure at both the top of the well head and in the injection zone, within the casing. Due in part to the high flow rate (up to 1600 gpm) in a small pipe (three inch diameter), significant pressure/head loss was measured at the injection depth. As such, the pressure at the top of the well greatly exceeds that in the injection zone. Based on formulae developed from the pilot program data, the maximum top of well pressure (including a factor of safety) for an injection

Photo 4. HJ-8 injection well on 9925 bench of VLF1 (looking NW).

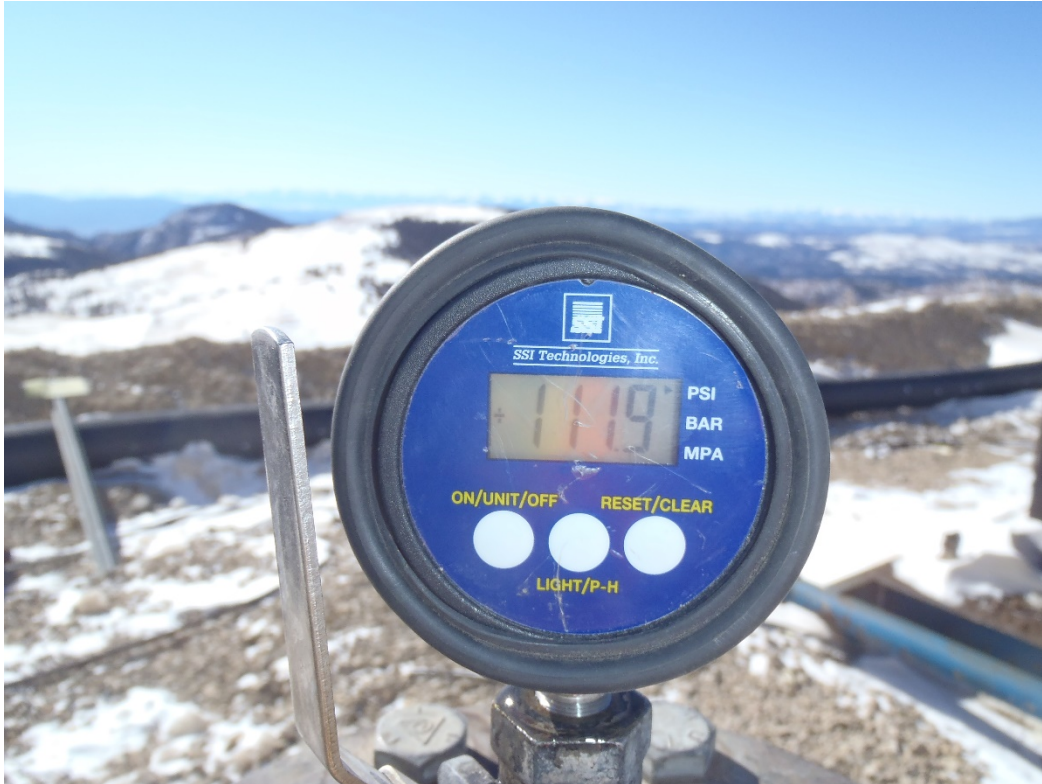
depth of 110 feet is 119 psi. Therefore, the observed operating pressure was below the limit for the injection depth. It should be noted the DRMS is reviewing the February 10, 2020 adequacy response to the DRMS and additional information may be required.

Photo 6. Top of HJ-8 well gage pressure (111.9 psi) at time of inspection.

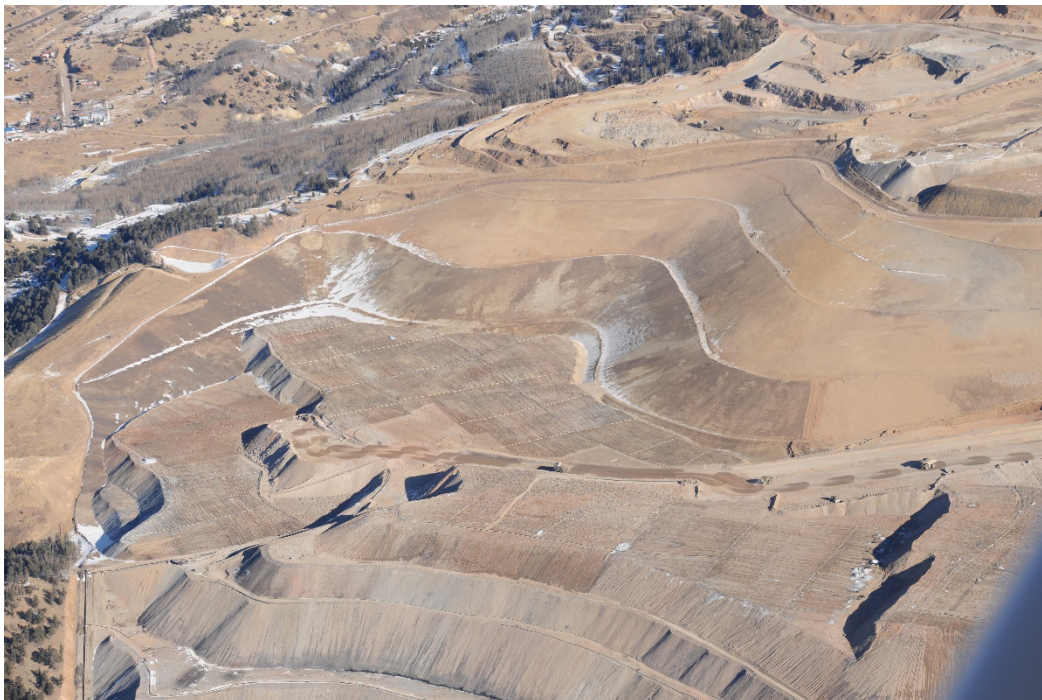
General Site Observations: The DRMS performed an aerial inspection on January 24, 2020 (see separate aerial inspection report). Photos from this aerial inspection were reviewed to determine if appropriate ore stacking practices were being adhered to on VLF2 (see **Photo 6**).

Photo 7. January 24, 2020 aerial view of VLF2 ore stacking.
