Huddleston-Berry
Engineering & Testing, LLC

January 16, 2020
Project#01349-0001

Subject: Summary of Instrumentation Monitoring
4th Quarter 2019
Bowie Coal Waste Disposal Area No. 2
Paonia, Colorado

SUBJECT: Summary Report, 4th Quarter 2019, Inclinometer and Active Vibrating Wire Piezometer Data October – December 2019, Bowie Mine #2 Coal Waste Disposal Area (CWDA) #2

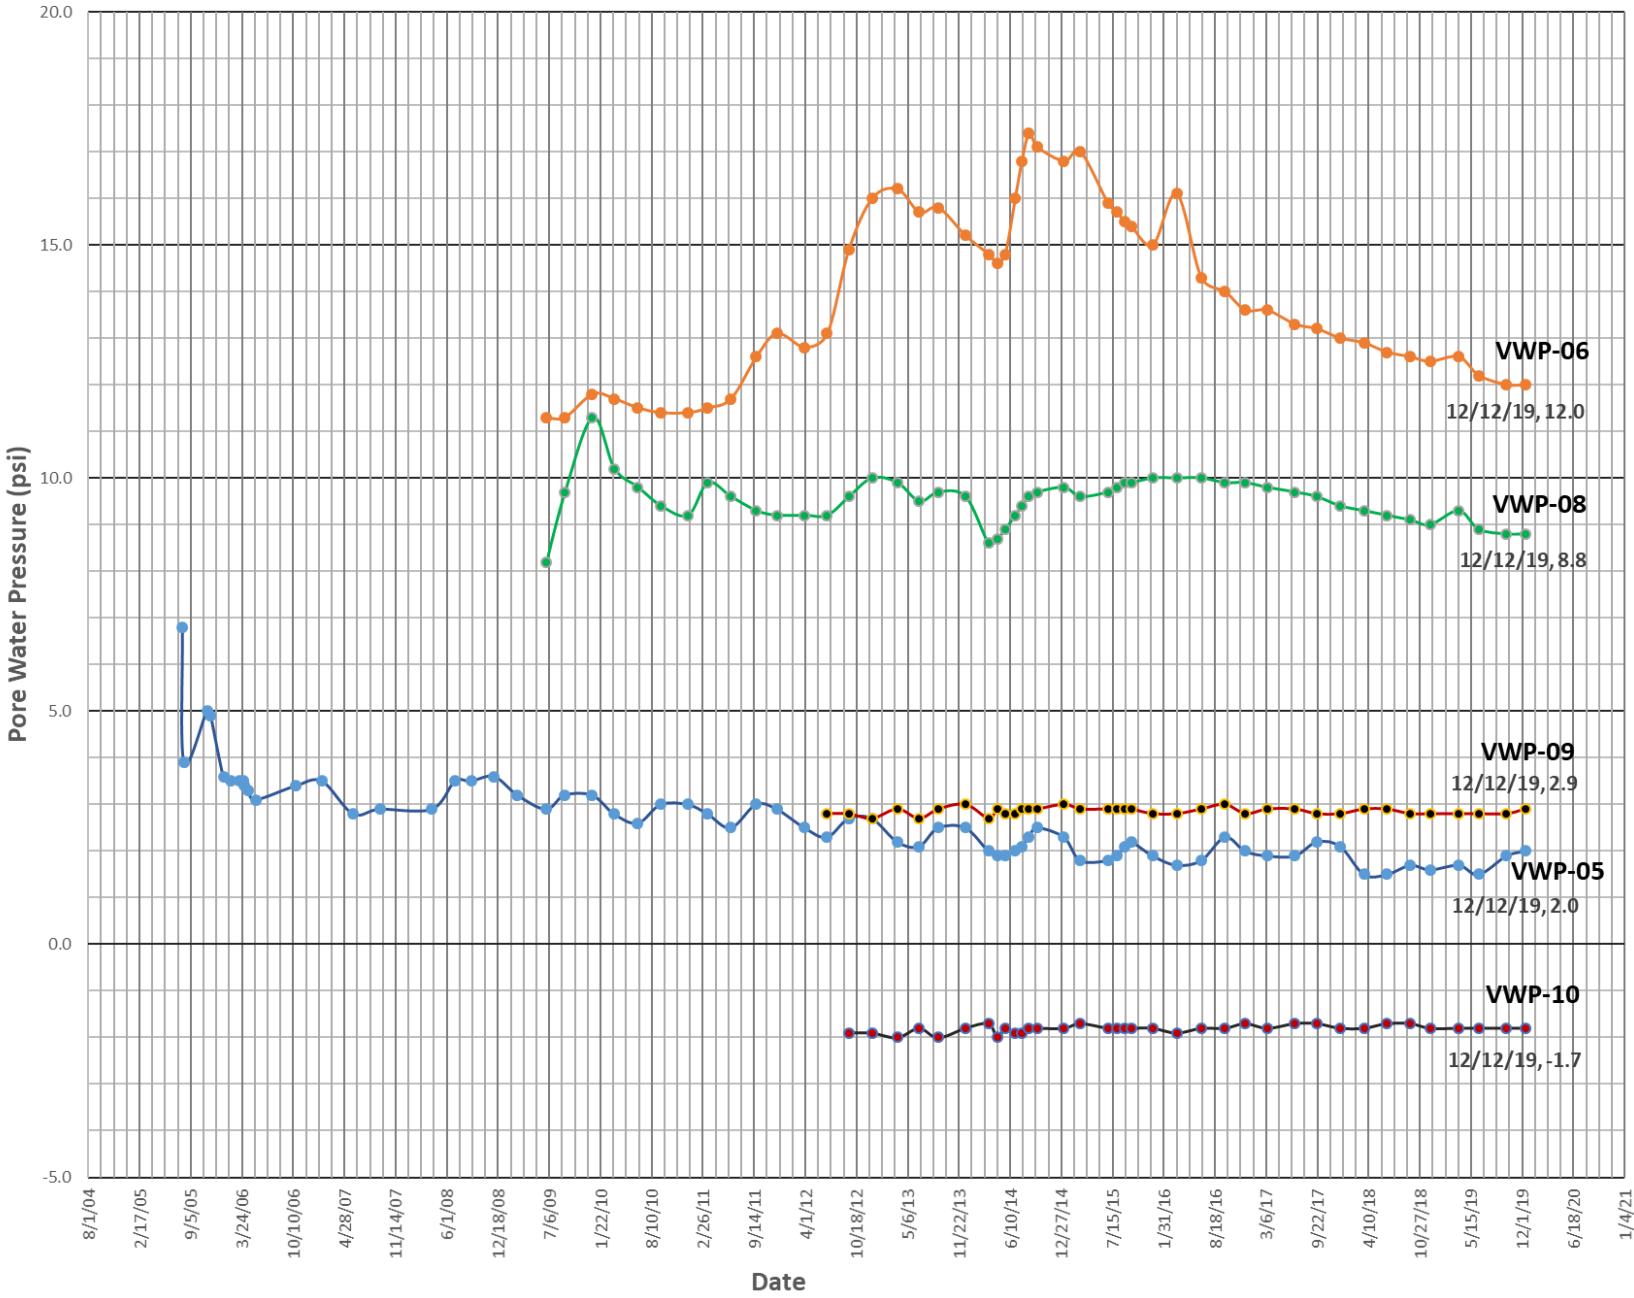
Figure 2 - Bowie Mine #2 - CWDA #2
Active Vibrating Wire Piezometer Data

As seen on Figure 2, the VWP readings are consistent either with previous recent or historic readings. Pore pressure readings went up slightly (0.1 psi) in two piezometers and stayed the same in two piezometers when compared to the Q3 readings.

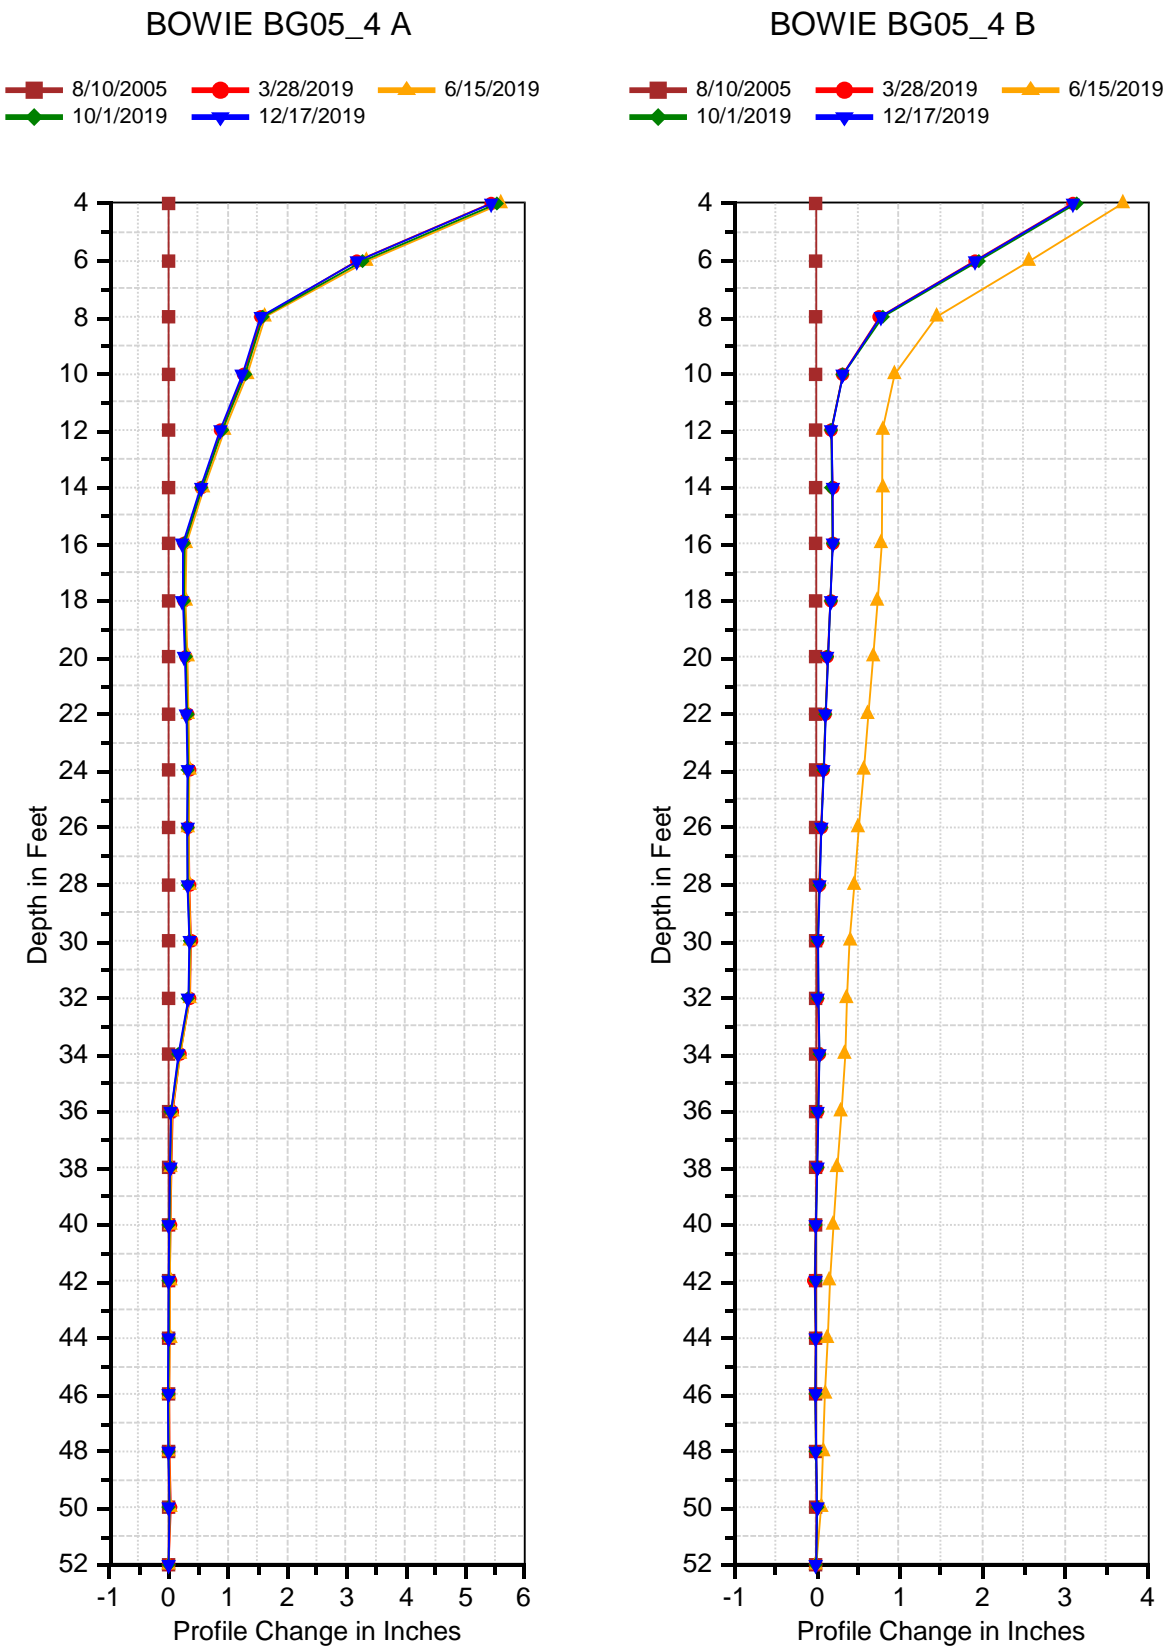
Figure 3 - Inclinator Displacement Curves

As described in previous reports, we believe historic displacements indicated on the plots for the approximate upper ten feet of the inclinometers are likely due to placement of cover soil on the face of the waste pile during normal maintenance and revegetation operations. Based on the inclinometer readings, there hasn't been downslope movement (Axis A) are generally consistent with previous readings. As we mentioned in our October report, there appeared to have been some displacement in the orthogonal direction (Axis B) for inclinometer BG05-5B in the 3rd quarter. However, in December 2019 the displacement graph appeared to be very similar to the March and June readings. It is likely that the displacement calculated in October may have been due to an error near 42 feet. We will evaluate the data again in March to conform whether there is additional movement. It should be noted that water was standing in the BGI 05-05 inclinometer pipe at a depth of about 4 feet below grade, but there was no water in inclinometer BGI 05-07 and water was at around 50 feet in BGI 05-07. There is no downslope displacement of any of the three inclinometers. This discrepancy should be evaluated during the next (2020 Q1) reading.

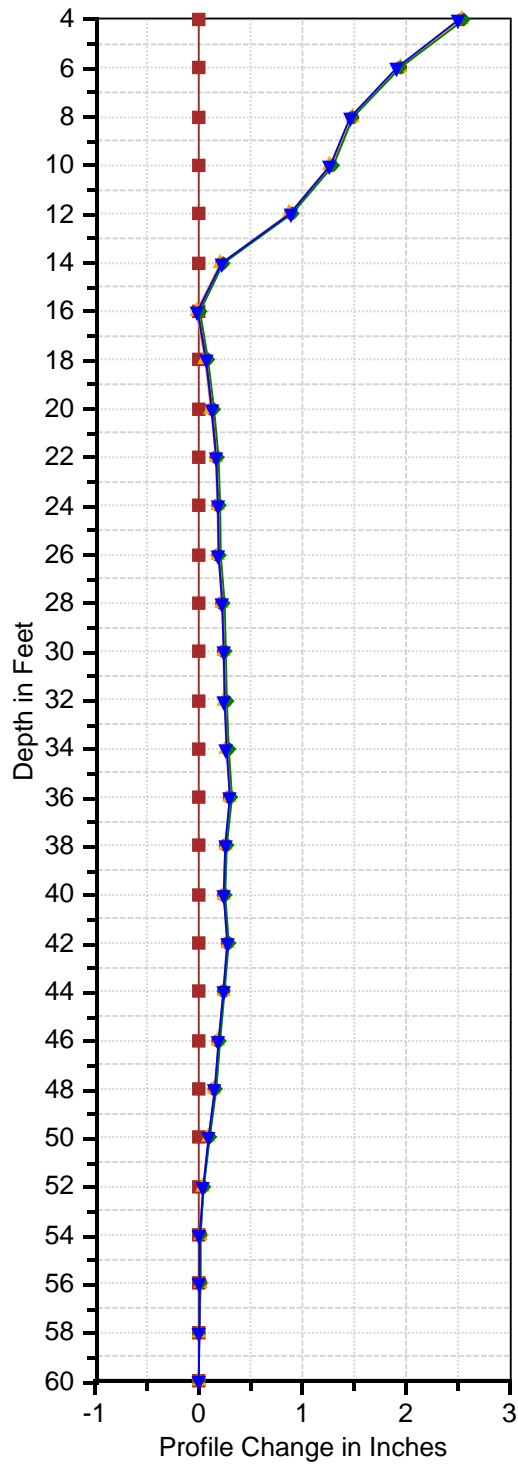
BOWIE BG05_5 A

The 2nd and 3rd Quarter readings showed deflection in BG05-5. However, the deflection was perpendicular to the slope direction. In addition, the 4th Quarter data does not show this deflection. As a result, HBET does not believe that the reported deflection is an indication of instability. However, the next quarterly reading will provide additional information for evaluation. No significant movements were reported for the other inclinometers.
