MINERALS PROGRAM INSPECTION REPORT
PHONE: (303) 866-3567

MINE NAME: Allison Gravel Pit	MINE/PROSPECTING ID#: M-2001-010	MINERAL: Gravel	COUNTY: Elbert
INSPECTION TYPE: Monitoring	INSPECTOR(S): Brock Bowles	INSP. DATE: January 21, 2020	INSP. TIME: 11:00
OPERATOR: Elbert County	OPERATOR REPRESENTATIVE: Ralph Lewis	TYPE OF OPERATION: 112c - Construction Regular Operation	
REASON FOR INSPECTION: Normal I&E Program	BOND CALCULATION TYPE: None	BOND AMOUNT: \$0.00	
DATE OF COMPLAINT: NA	POST INSP. CONTACTS: None	JOINT INSP. AGENCY: None	
WEATHER: Cloudy	INSPECTOR'S SIGNATURE:

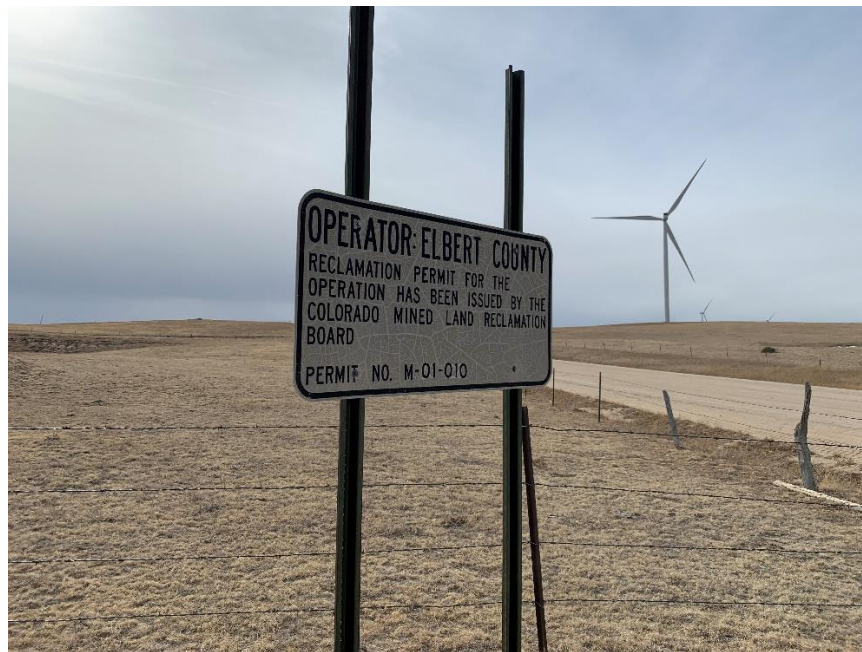
The mine entrance sign was in place with the required information. The permit boundary markers were in place. A front end loader was on site but no mining was taking place during the inspection.

Mine entrance sign from County Road 149

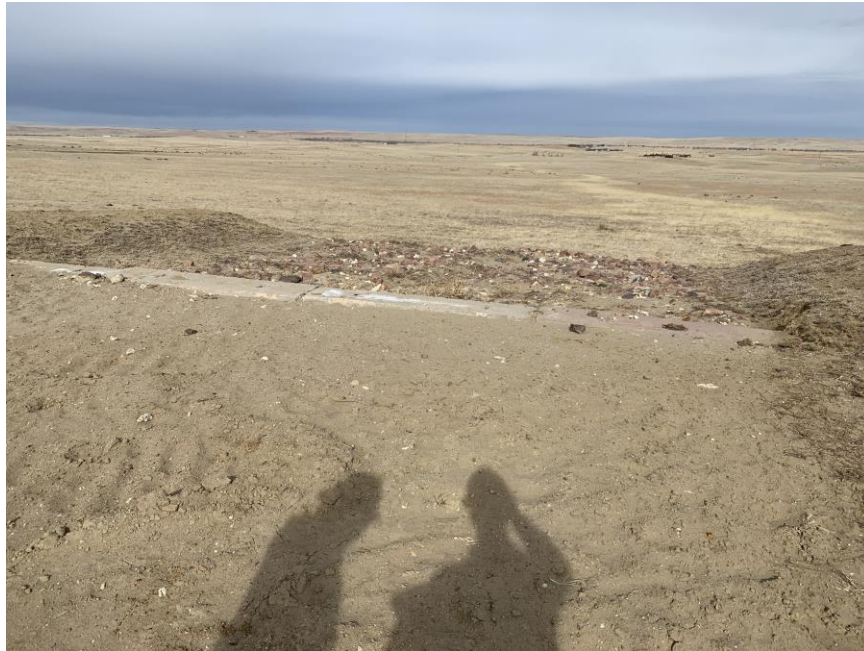
No ground water was seen in the pit area. The drainage structure approved in TR-4 was well maintained and free and clear of obstructions.

Drainage structure approved in TR-4

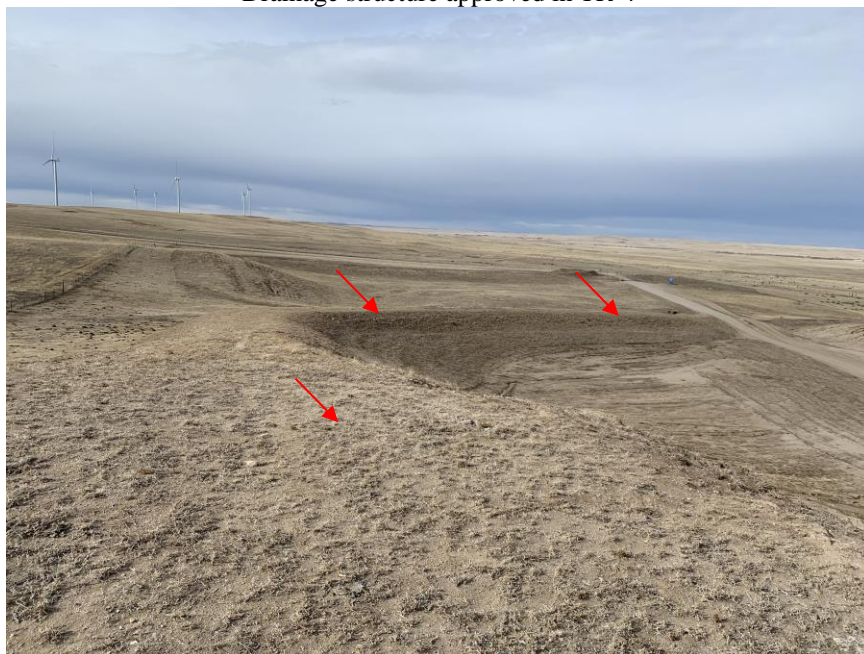
The topsoil stockpile on the south rim of the pit area appeared to be stable and well vegetated. Topsoil was being salvaged from the in front of the pit on the eastern edge of the pit.

Topsoil stockpile on south rim of pit
