MINERALS PROGRAM INSPECTION REPORT
PHONE: (303) 866-3567

| MINE NAME: Schlosser Pit 1 | MINE/PROSPECTING ID#: M-2014-061 | MINERAL: Gravel and sand | COUNTY: Kit Carson |
| INSPECTION TYPE: Monitoring | INSPECTOR(S): Elliott Russell | INSP. DATE: February 10, 2020 | INSP. TIME: 15:30 |
| OPERATOR: Schlosser Incorporated | OPERATOR REPRESENTATIVE: Levi Schlosser | TYPE OF OPERATION: 112c - Construction Regular Operation | |

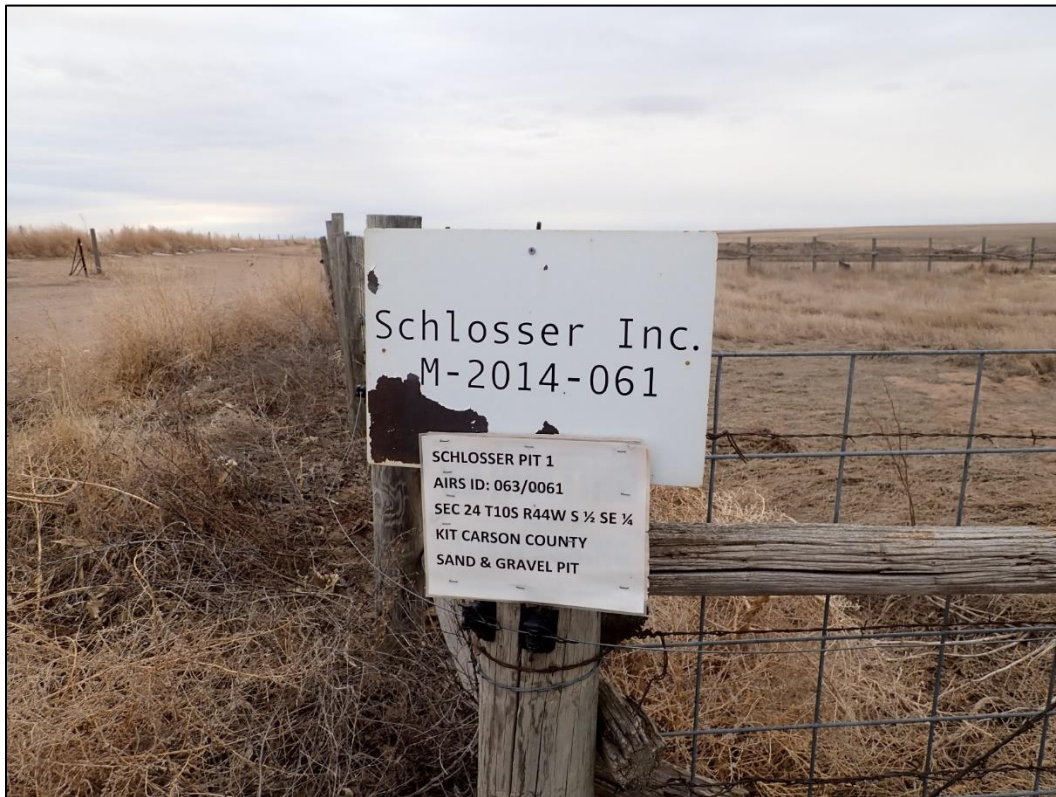
COMPLIANCE PROBLEM #3: The mine identification sign was not posted at the entrance of the mine site or is lacking the required information. This is a problem for failure to post a mine identification sign as required by Rule 3.1.12(1).

Signs and Markers: A permit sign is posted in the southeast corner of the site. As of July 2019, new regulations are now in placed regarding the information required to be listed on permit signs and sets the minimum size of

permit signs. The paint on the posted permit sign is starting to fleck off and will likely need to be refreshed or replaced shortly. Given this, Compliance Problem #3 has been cited requiring the Operator to post a new sign in accordance with Rule 3.1.12(1). The rectangular shaped 80-acre permit boundary was delineated with t-posts and survey monuments at each corner, however, only the southwest and southeast corner of the 50-acre affected lands boundary was marked as these also delineate the permit boundary. Based on the approved Mine Plan and Reclamation Plan Maps, there should be 7 markers delineating each corner-point along the northern affected lands boundary just south of Sandy Creek. This has been cited as Compliance Problem #4 requiring the Operator to conduct a survey and establish the affected lands boundary markers. The access road crossing Sandy Creek discussed above appears to have been constructed outside of the affected lands boundary, however, without the markers in place the Division was unable to determine this at the time of the inspection.

Photo 1. Mine identification sign; looking west.

CORRECTIVE ACTIONS: The Operator shall, at the entrance of the mine site, post a sign which shall be clearly visible from the access road with the following: 1) the name of the Operator; 2) the name of the operation; 3) the permit number; and 4) a statement that a reclamation permit for the operation has been issued by the Colorado Mined Land Reclamation Board. The sign shall be a minimum of 11" tall x 17" wide with appropriate font size. The operator shall submit photo documentation that a proper sign has been posted by the corrective action date.

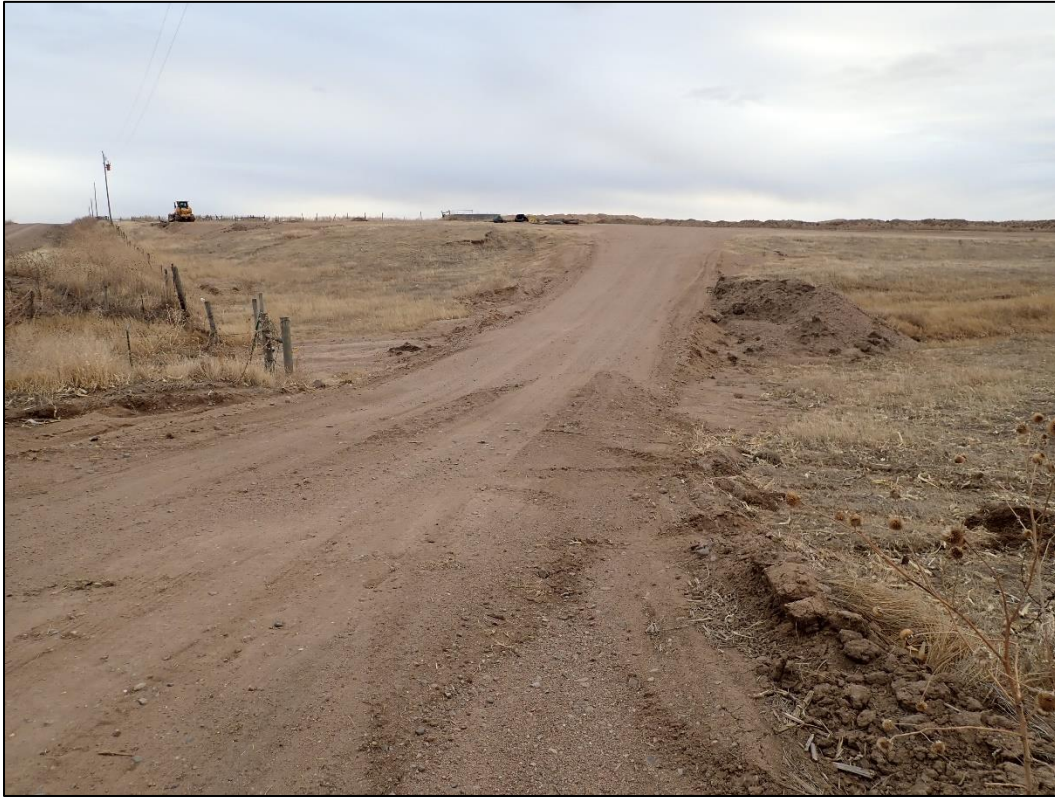
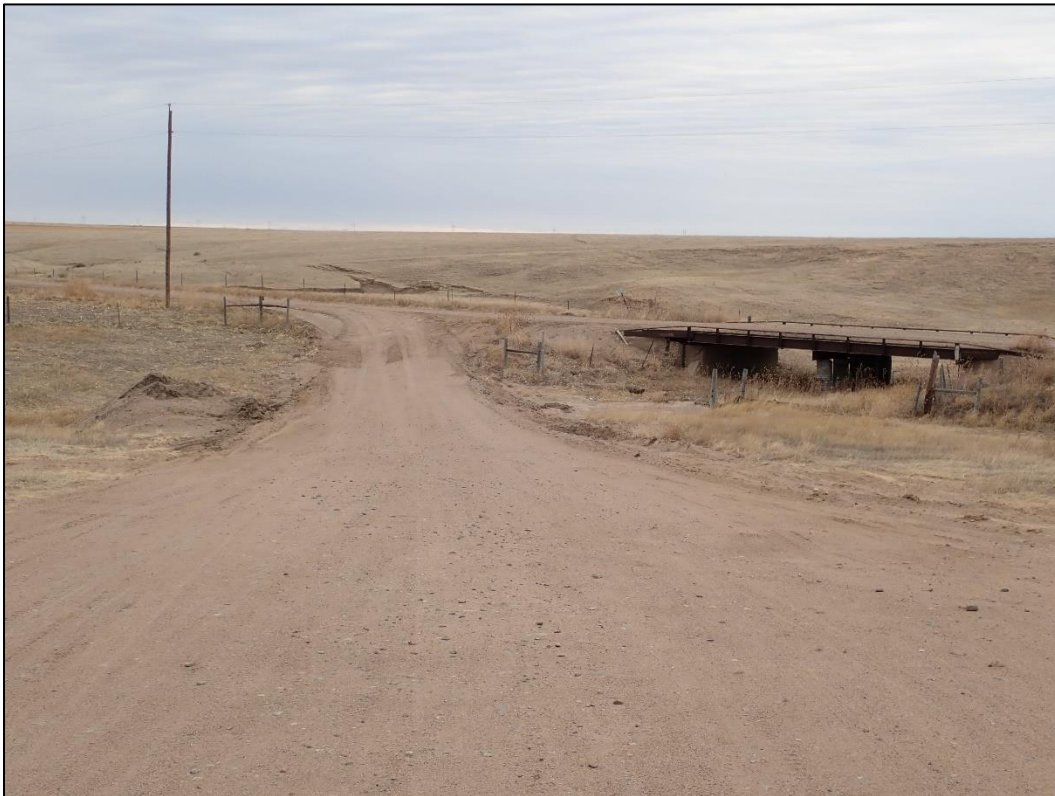
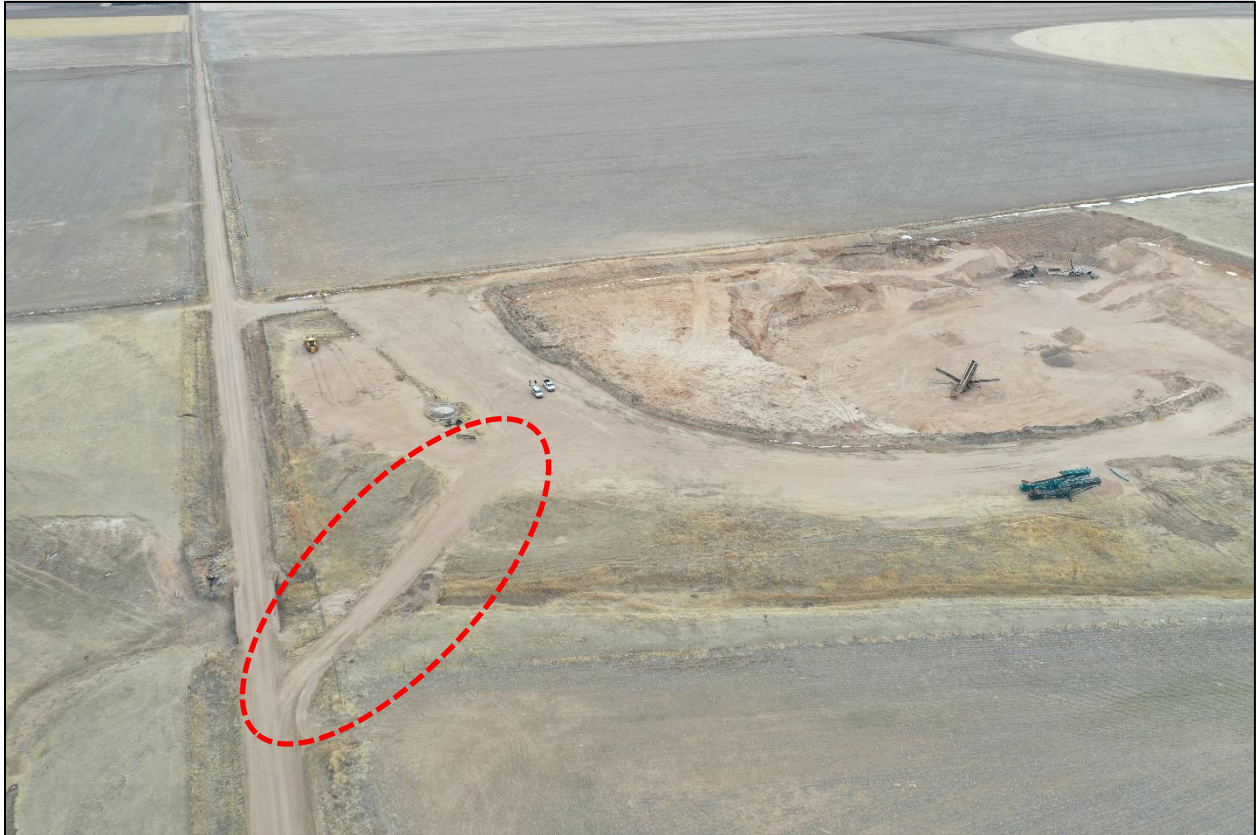
COMPLIANCE PROBLEM #1: The operation is currently blocking the channel of Sandy Creek with a newly constructed access road.

Hydrologic Balance: No impounded storm water nor exposed groundwater was observed at the site, however, the Operator has created an additional access road across Sandy Creek which will impound ephemeral flows. This access road was created to bypass the County Road 49 bridge over Sandy Creek as loaded haul trucks traveling north out of the site's main entrance exceed the bridge's weight limit. The Operator placed approximately 3 feet of road base material across the creek which now blocks the natural flow of the creek. This has been cited as Compliance Problem #1 requiring the Operator to re-establish the natural flow of Sandy Creek. The Operator may remove the road base material down to the normal creek bed elevation or install appropriate size and number of culverts.

Photo 2. New access road across Sandy Creek; looking southwest.

Photo 3. New access road across Sandy Creek; looking northwest.

Photo 4. Aerial overview of mine site, new access road circled; looking southwest.

CORRECTIVE ACTIONS: The Operator shall remove the material blocking the natural flow of Sandy Creek on or before the corrective action deadline.

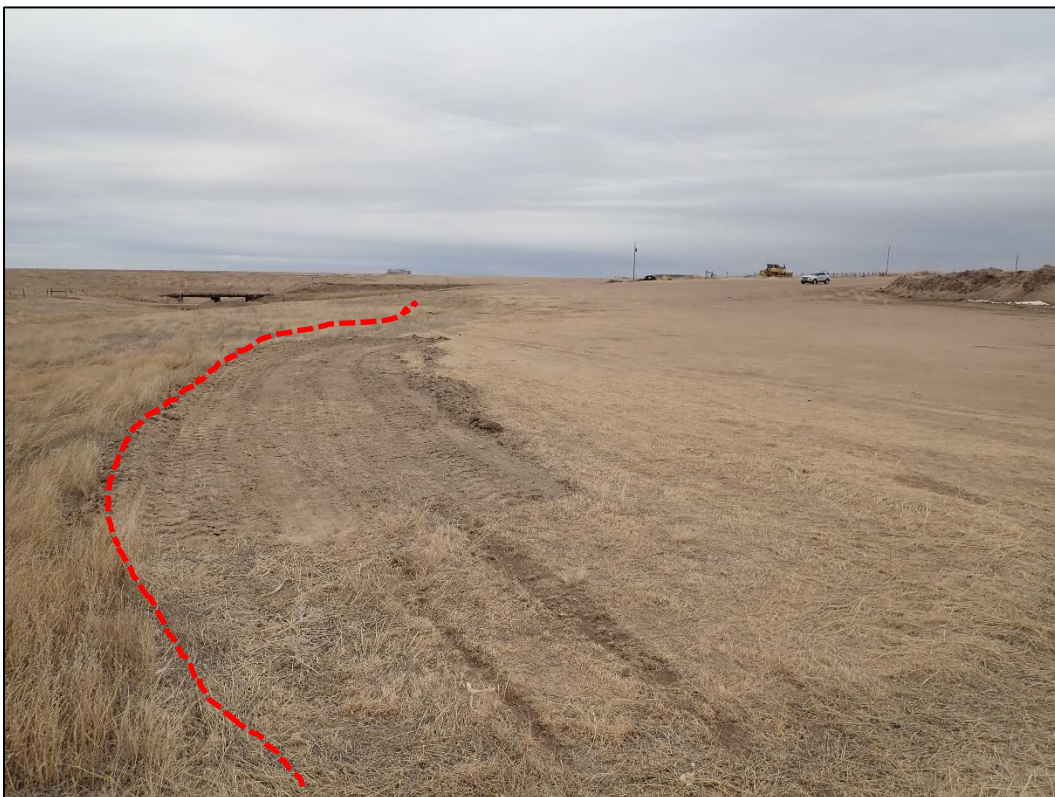
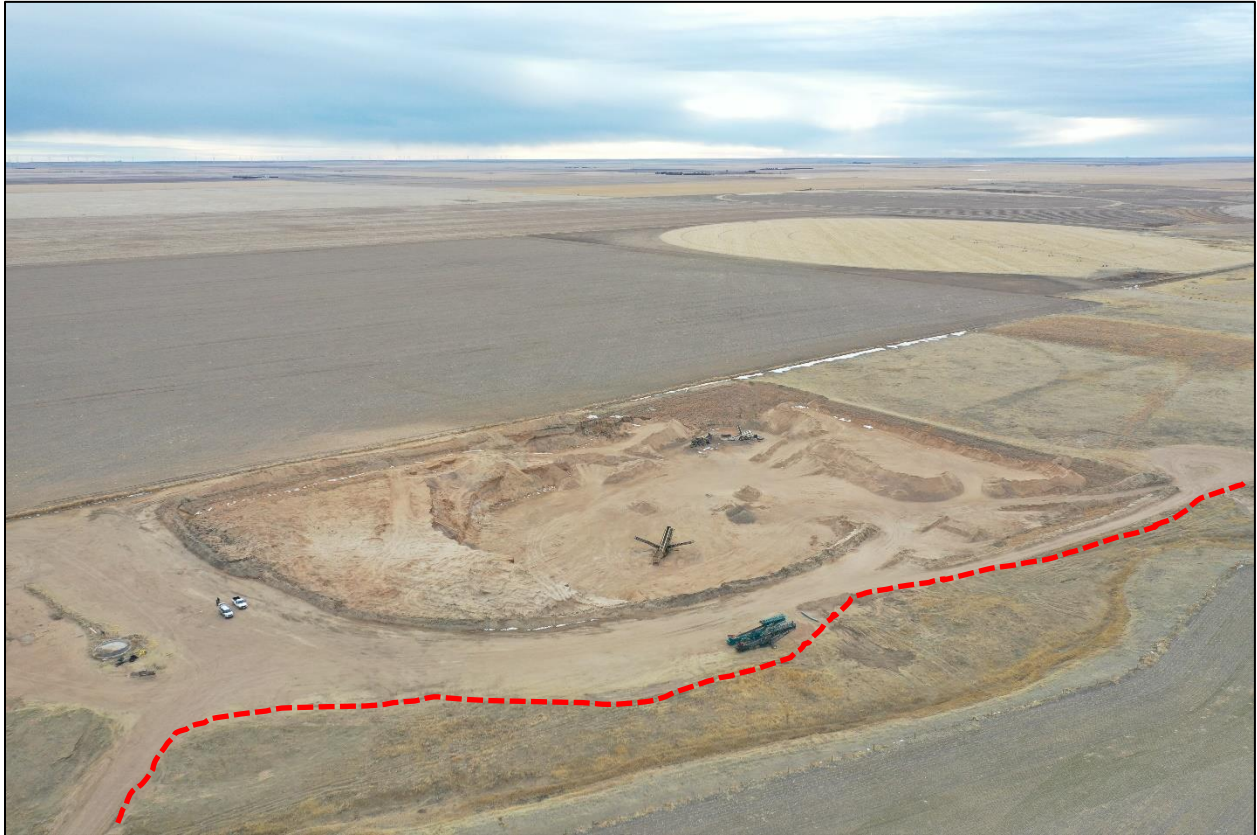
COMPLIANCE PROBLEM #2: No sediment control measures are in place to prevent mine site storm water and sediment from reaching the Sandy Creek. This is a problem pursuant to C.R.S. 34-32-116(7)(i).

Sediment Control: The disturbance is located south of Sandy Creek and slopes north to the channel. Currently there are no sediment control measures in place to prevent storm water and sediment from reaching the channel. This has been cited as Compliance Problem #2 requiring the Operator to establish a storm water berm, silt fencing, or other sediment control measures at the site to protect the creek channel. As the Permit has established a 100-foot buffer from the creek, the Operator may want to establish the sediment control measures at the edge of the buffer to ensure the buffer is maintained during the mining operation.

Photo 5. Northern portion of mine disturbance, suggested alignment of sediment control measure; looking east.

Photo 6. Aerial overview of mine site, suggested alignment of sediment control measure; looking southeast.

CORRECTIVE ACTIONS: The Operator shall implement sediment control measures at the site and provide photo documentation to the Division by the corrective action due date.

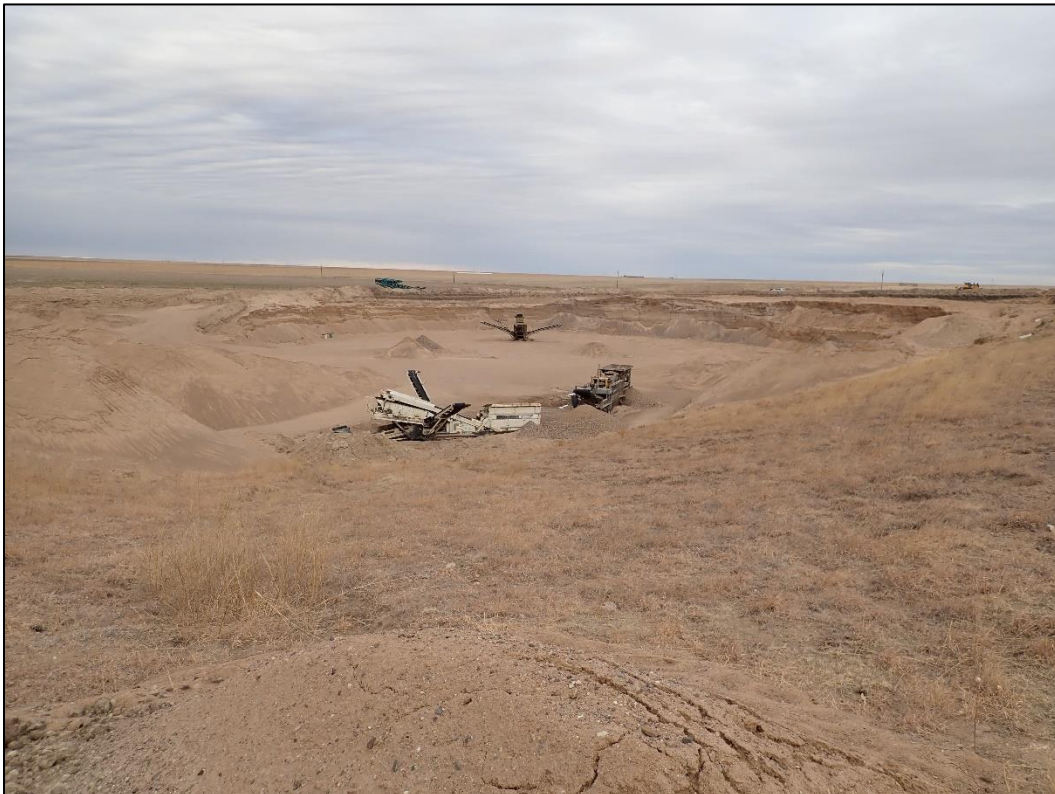
Photo 7. Pit overview from the southwest corner of Phase 1; looking northeast.

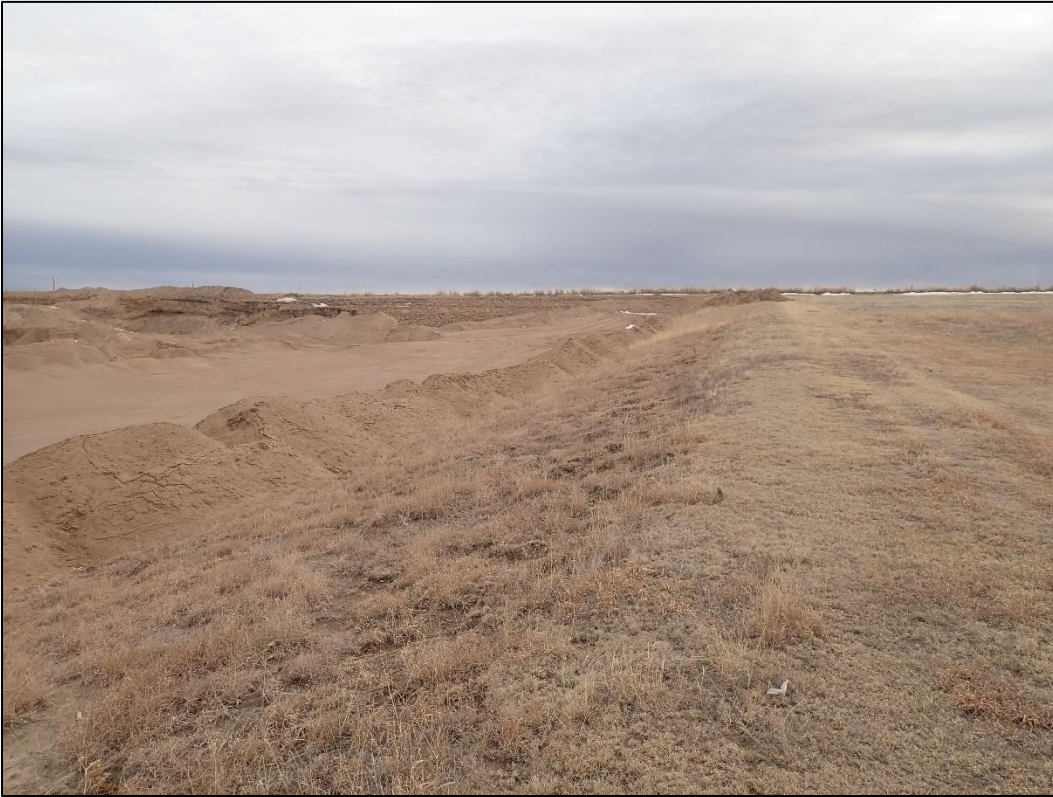
Photo 8. Western edge of pit where older pre-permit disturbance ended too; looking south.

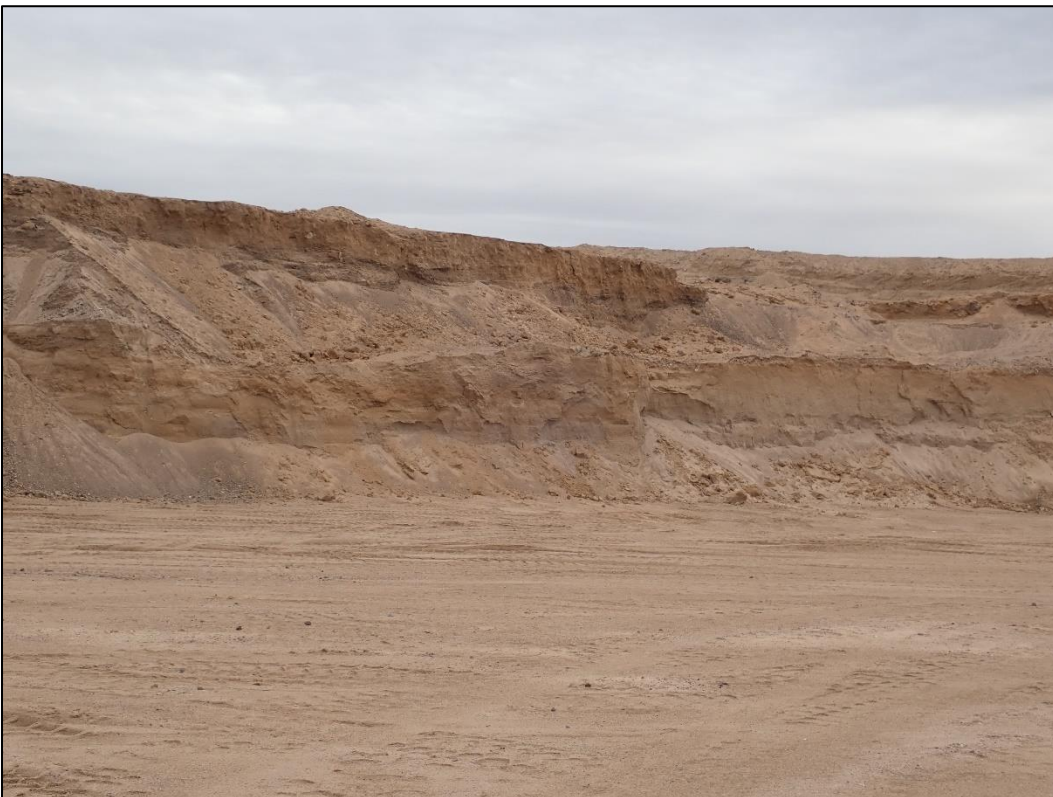
Gen. Compliance With Mine Plan: The operation appeared to be in compliance with the approved mine plan. The Division estimates approximately 16 acres have been disturbed within Phase 1. High walls were estimated to vary between 20 and 30 feet in high on the north end of the pit and 30-40 feet on the south end of the pit.

Photo 9. Southern pit highwall; looking south.

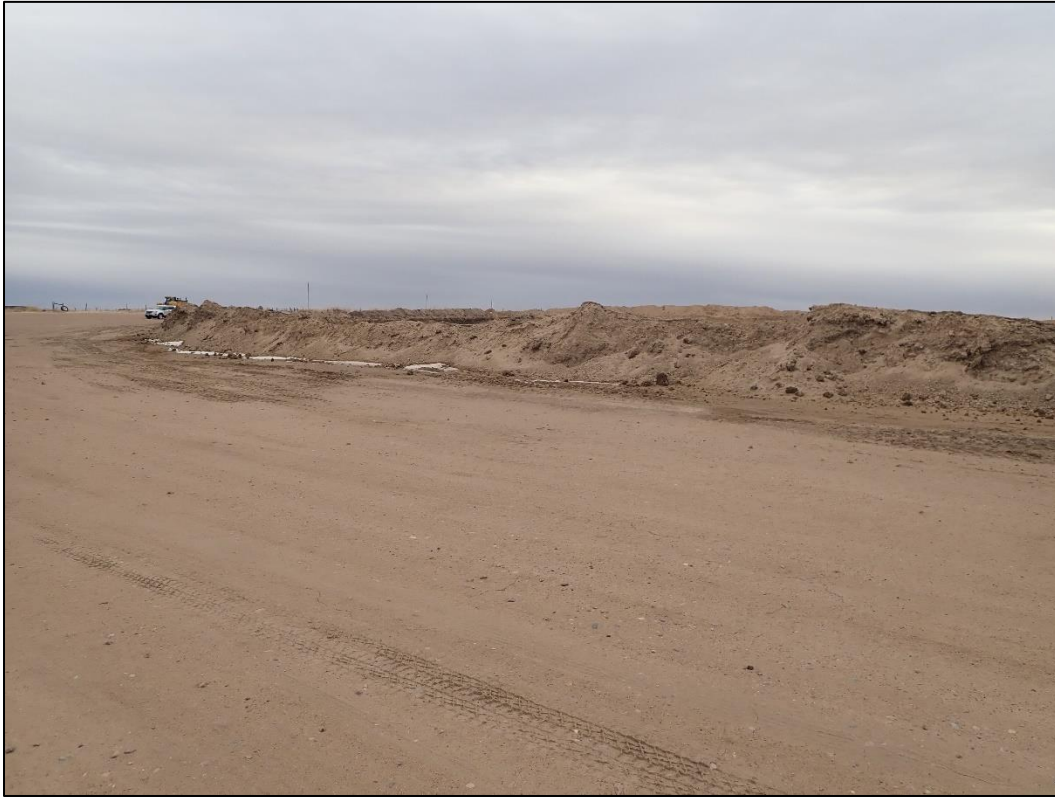
Topsoil: The permit requires 12-18 inches of topsoil to be salvaged during mining and replaced during reclamation. Topsoil has been stripped and stockpiled around the crest of the excavation.

Photo 10. Portion of the topsoil stripped and stockpiled around the crest of the pit; looking southeast.
