MINERALS PROGRAM INSPECTION REPORT**PHONE: (303) 866-3567**

| MINE NAME: McKenzie Pit | MINE/PROSPECTING ID#: M-1980-224 | MINERAL: Sand and gravel | COUNTY: Fremont |
| INSPECTION TYPE: Monitoring | INSPECTOR(S): Timothy A. Cazier | INSP. DATE: August 28, 2019 | INSP. TIME: 13:25 |
| OPERATOR: Fremont Paving & Redi-Mix, Inc. | OPERATOR REPRESENTATIVE: John Young | TYPE OF OPERATION: 112c - Construction Regular Operation | |

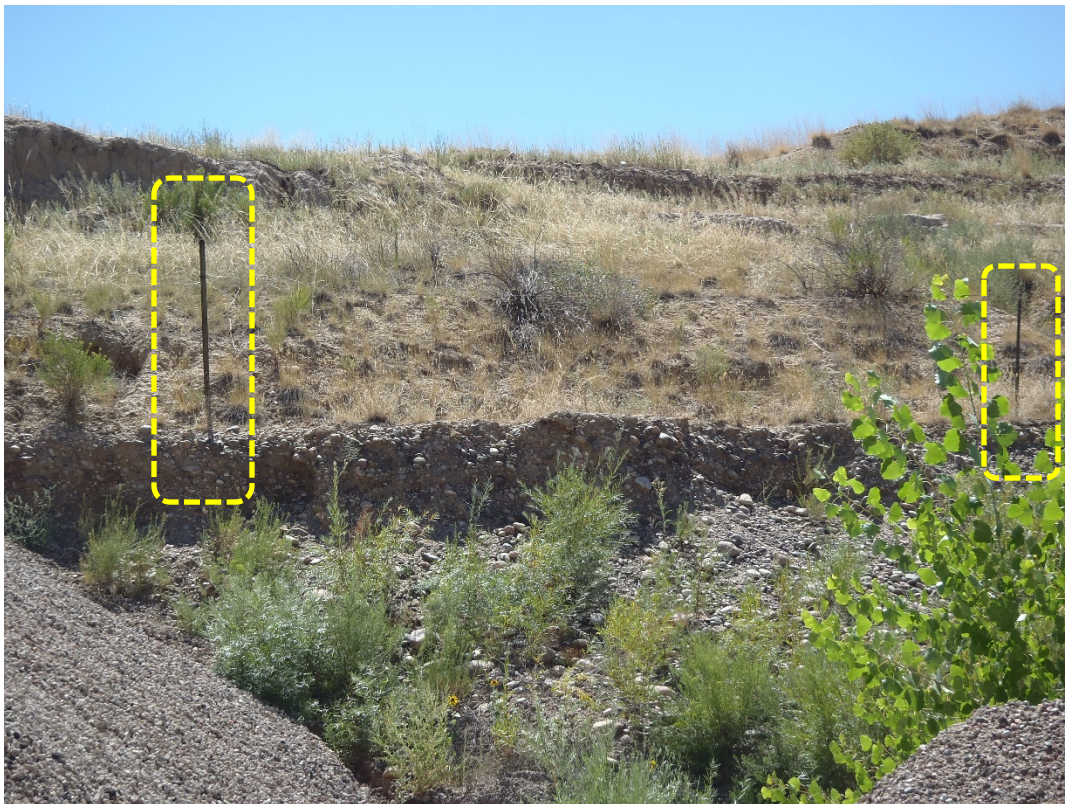
Gen. Compliance with Mine Plan: The operation appeared to be in compliance with the approved mine plan. Google Earth was used to measure the disturbed area, which was estimated to be approximately 6.5 acres, based on 2016 imagery. During a post inspection discussion with Ms. Jodi Schreiber on October 7, 2019, she indicated she would supply a map supporting the 2-acre disturbance claimed on the 2018 annual report. The DRMS has not seen this map to date and consider the disturbed are to be 6.5 acres. Highwalls were benched and estimated to vary between 10 and 15 feet in height, appearing appeared stable (see **Photo 1**).

Photo 1. Benched highwall and boundary markers (looking south).

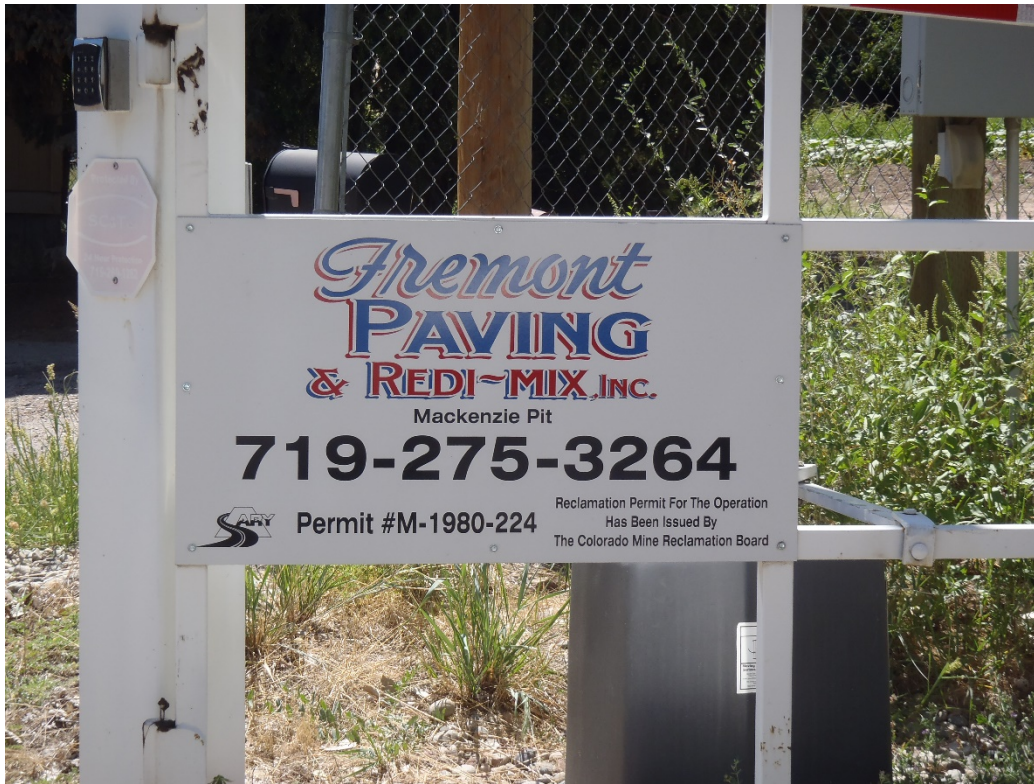
Signs and Markers: Permit signs were properly posted at the east entrance (see **Photo 2**) and the south entrance (see **Photo 3**) and boundary markers (PVC pipes and fences) were observed to delineate the permit boundary (see **Photo 4**).

Photo 2. Permit sign – east entrance.

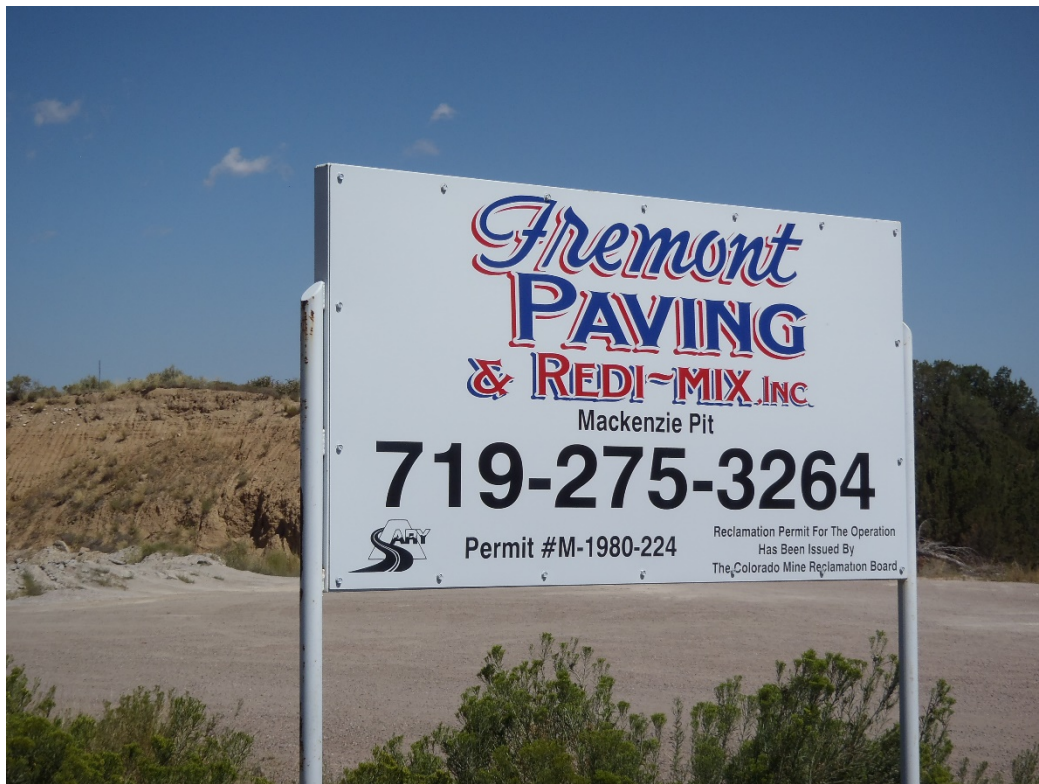
Photo 3. Permit sign – south entrance.

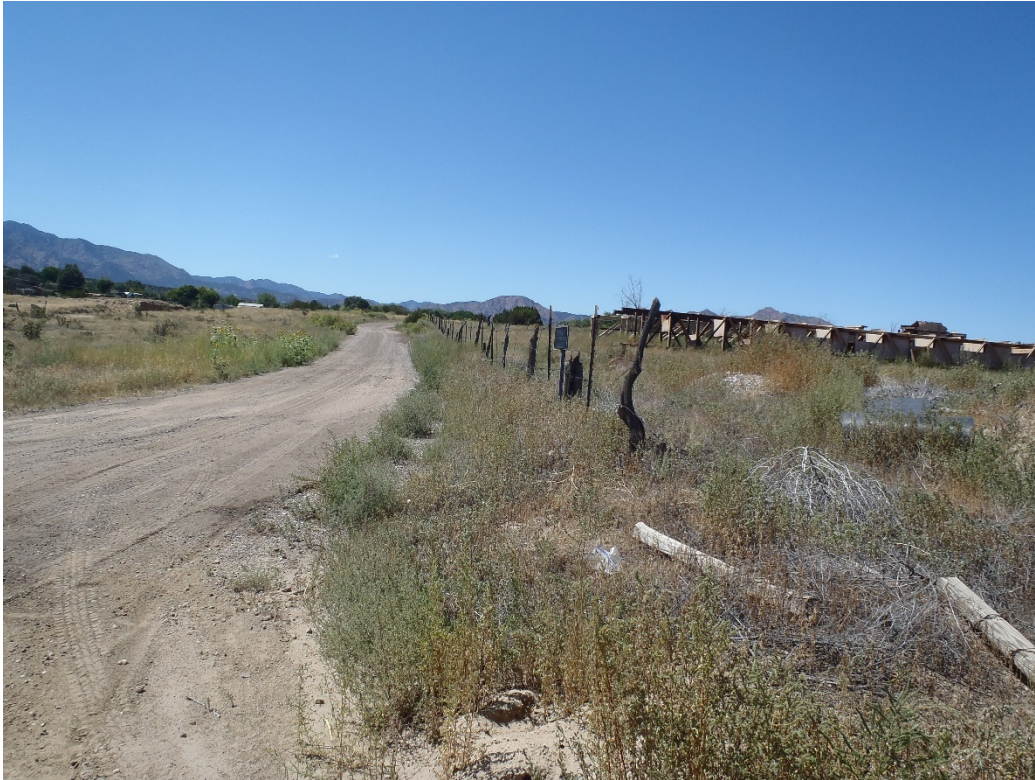
Photo 4. South permit boundary markers.
