MINERALS PROGRAM INSPECTION REPORT
PHONE: (303) 866-3567

MINE NAME: Carnation Mine	MINE/PROSPECTING ID#: M-1977-416	MINERAL: Uranium and vanadium	COUNTY: San Miguel
INSPECTION TYPE: Monitoring	INSPECTOR(S): Lucas West	INSP. DATE: February 11, 2020	INSP. TIME: 11:05
OPERATOR: Pinon Ridge Mining LLC	OPERATOR REPRESENTATIVE: Michael Rutter	TYPE OF OPERATION: 110d - Designated Limited Impact	
REASON FOR INSPECTION: Normal I&E Program	BOND CALCULATION TYPE: None	BOND AMOUNT: \$40,245.00	
DATE OF COMPLAINT: NA	POST INSP. CONTACTS: None	JOINT INSP. AGENCY: None	
WEATHER: Clear	INSPECTOR'S SIGNATURE:

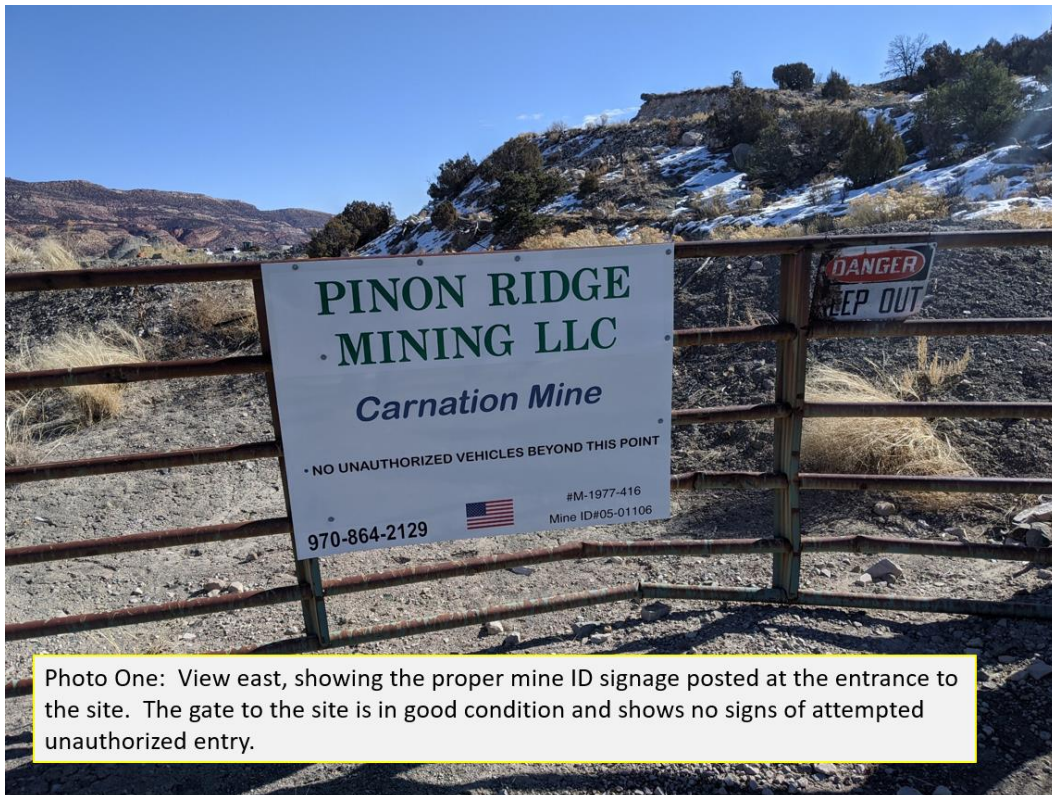
As seen in Photo One, the permit ID sign was observed at the entrance to the site. The permit boundary markers were also observed and all disturbances were confined within the permitted area. Evidence that the diversion ditches and storm water control devices are functioning as designed and no significant erosion was observed throughout the site. The lower permit area was also in good condition with no signs of significant erosion.

Photo One: View east, showing the proper mine ID signage posted at the entrance to the site. The gate to the site is in good condition and shows no signs of attempted unauthorized entry.

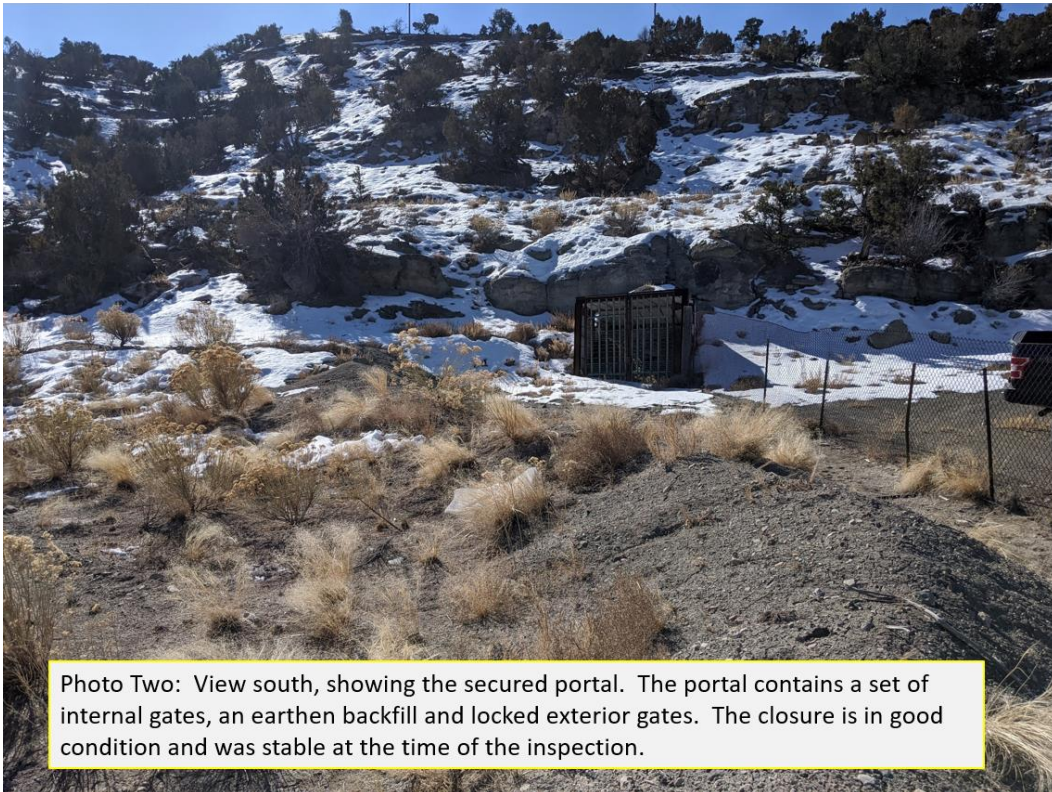
The portal located on site was also secured, it has been backfilled, closed off with steel grates as well as encompassed by a small berm. The portal and it's closure can be seen in Photo Two. No fuel storage containers are located on site. The main pad and work area was in good condition as seen in Photos Three and Four, evidence of weed management during the growing season was observed. The whole site exhibits positive drainage and no erosional issues were observed at this time. A concrete slab foundation is located on the portal pad measuring approximately 20 x 30 ft. with an adjacent utility pole and line. The foundation, utility pole and wire are slated to be removed during final reclamation. The lower area and the portal pad area has begun to revegetate itself with volunteer species.

Photo Two: View south, showing the secured portal. The portal contains a set of internal gates, an earthen backfill and locked exterior gates. The closure is in good condition and was stable at the time of the inspection.

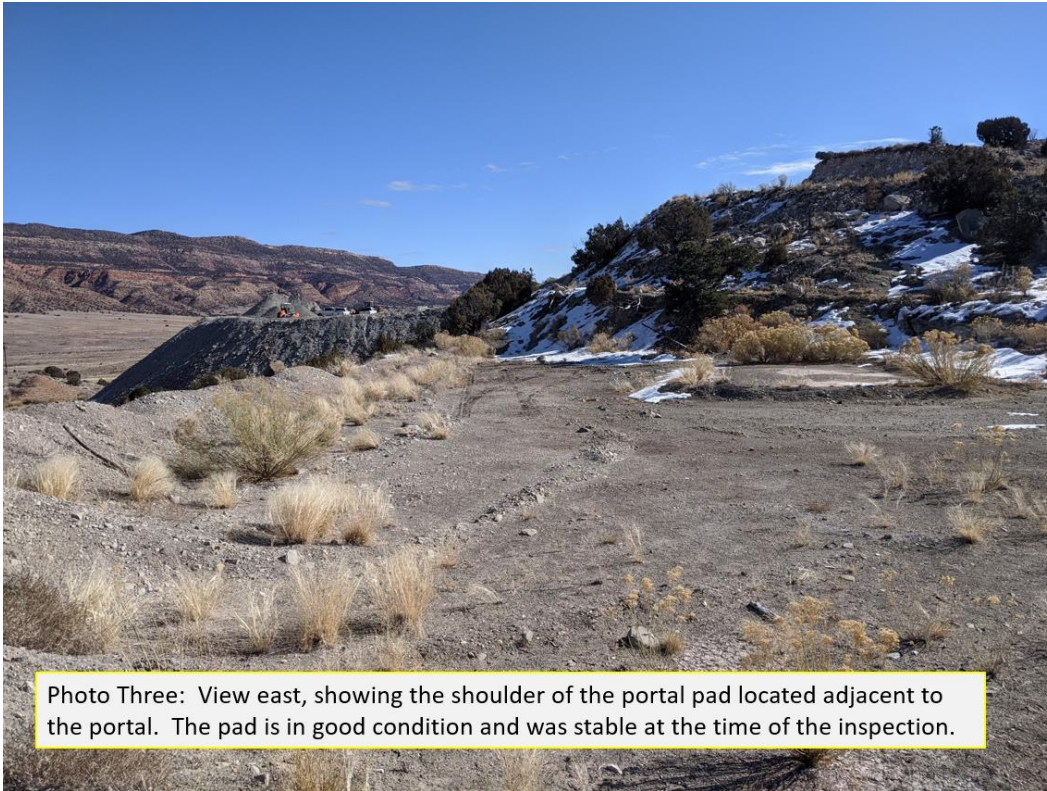
Photo Three: View east, showing the shoulder of the portal pad located adjacent to the portal. The pad is in good condition and was stable at the time of the inspection.

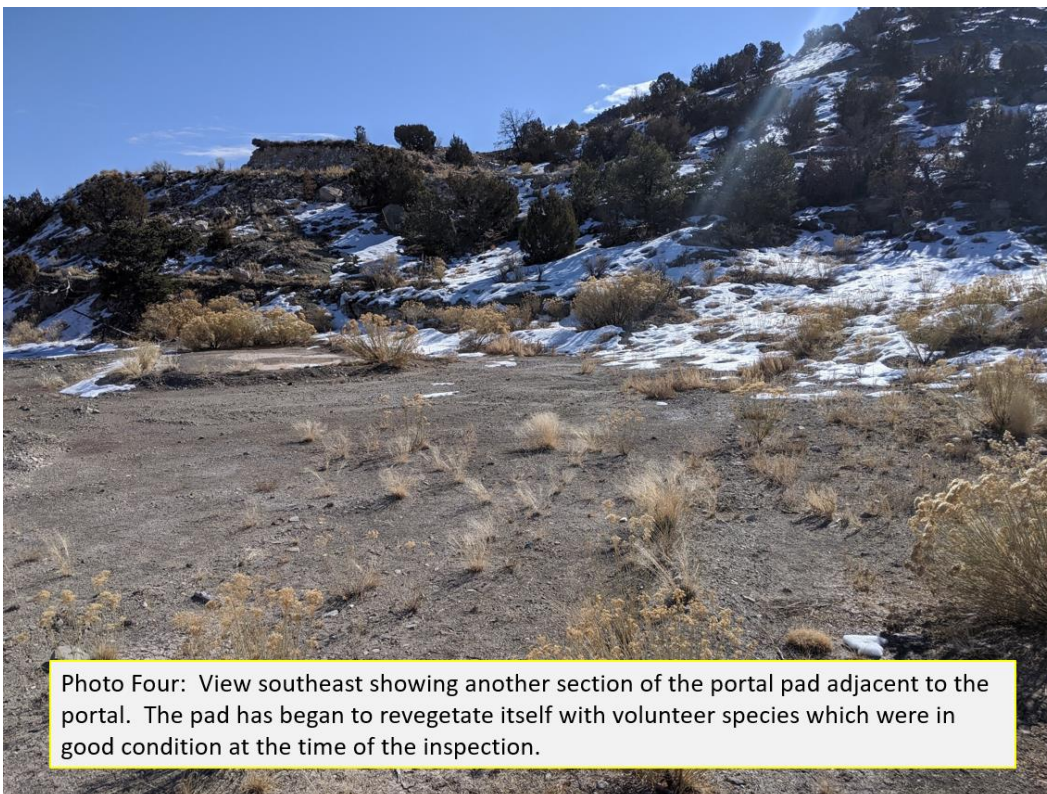
Photo Four: View southeast showing another section of the portal pad adjacent to the portal. The pad has begun to revegetate itself with volunteer species which were in good condition at the time of the inspection.
