COLORADO
Division of Reclamation,
Mining and Safety
Department of Natural Resources

Permit Number: C-1981-008 Mine Name: New Horizon Mine Operator: Elk Ridge Mining and Reclamation, LLC Operator Address: Mr Tony Tennyson 5731 State Highway 13 Meeker, CO 81641	County: Montrose Operation Type: Surface Permit Status: Active Ownership: Private
	Operator Representative Present: NA
Operator Representative Signature: (Field Issuance Only)

Inspection Start Date: January 24, 2020 Inspection Start Time: 03:38 Inspection End Date: January 24, 2020 Inspection End Time: 03:40		Inspection Type: Aerial Inspection Inspection Reason: Normal I&E Program Weather: Clear	
Joint Inspection Agency: None		Joint Inspection Contacts:	
Post Inspection Agency: None		Post Inspection Contacts:	
Inspector(s): Janet Binns Harry Ranney	Inspector's Signature:

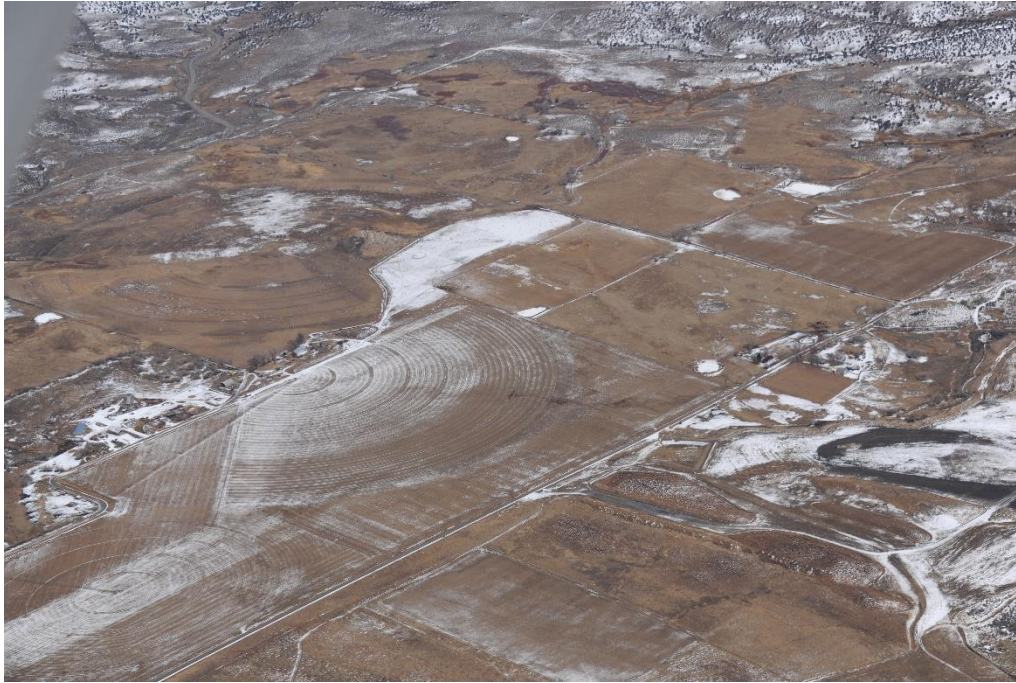
The vegetation on the irrigated cropland parcel (Morgan property) is dormant. The thin snow cover helps highlight the drainage swale that the landowner has expressed concern about. This drainage area drains to the northwest towards the location of the reclaimed pond. The winter aerial photo may help the operator and landowner locate where to place a grassed waterway or other method of managing the irrigation runoff.

Photo 1: Irrigated cropland parcel. N is at lower right corner. Irrigation runoff path is visible as a dark feature running diagonally across the field.

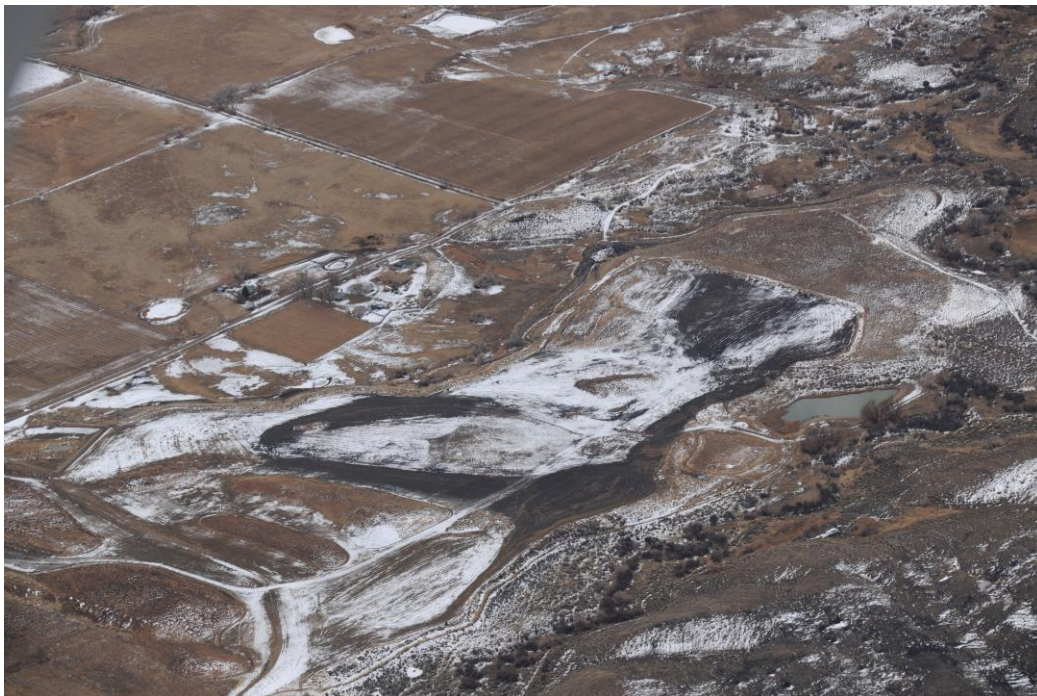
The majority of the permit area has been backfilled and graded. Much of the backfilled and graded parcels have received Phase I bond release. An area at the northwest portion of the mine, at the last area of mining has been backfilled and generally graded, but not yet at final contours. The operator has not completed grading this area as they resolve spoil spring management.

A small puddle of water is visible in Pond 16. Pond 18 contains a thin frozen puddle, and the inslope of the embankment is snow covered. Pond 13 held a full pool of water that did not appear to be frozen. Pond 15 appear dry with a patchy covering of snow.

Photo 2: final pit area. Pond 13 is at right of photo. Pond 15 is towards center of photo

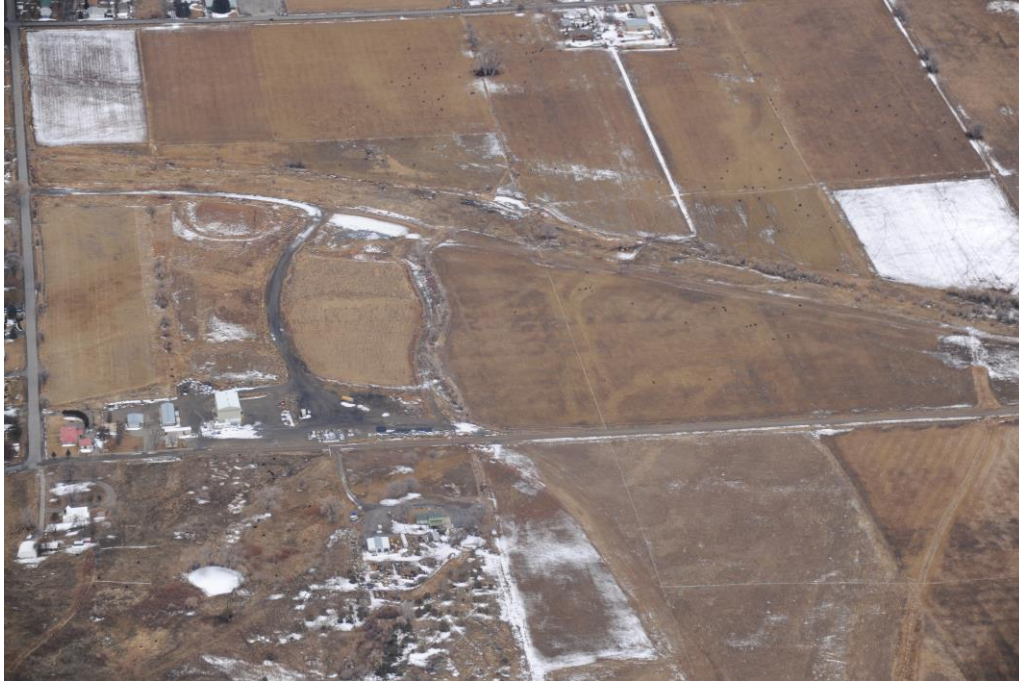
Photo 3: ERMR office, warehouse, facilities area, and pond 18 at center left of photo.

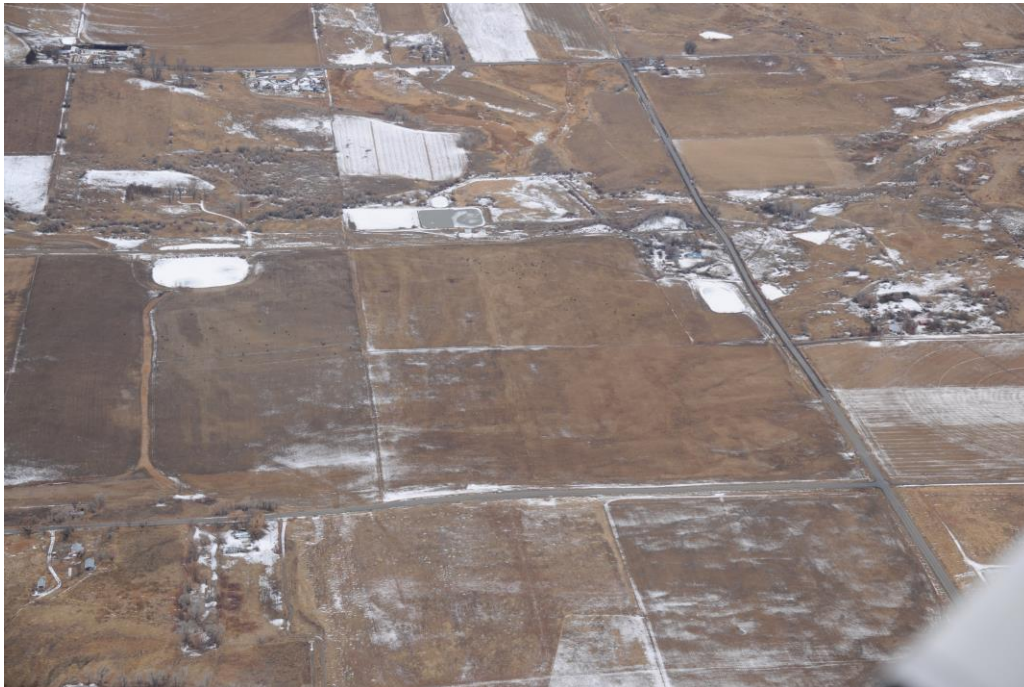
Photo 4: North is at bottom of photo: Parcel DP-1, IP1, IP-2, and IP3 are in foreground.
