MINERALS PROGRAM INSPECTION REPORT
PHONE: (303) 866-3567

MINE NAME: Topaz Mine	MINE/PROSPECTING ID#: M-1980-055-HR	MINERAL: Uranium and vanadium	COUNTY: San Miguel
INSPECTION TYPE: Monitoring	INSPECTOR(S): Lucas West	INSP. DATE: February 11, 2020	INSP. TIME: 12:30
OPERATOR: Pinon Ridge Mining LLC	OPERATOR REPRESENTATIVE: Michael Rutter	TYPE OF OPERATION: 112d-3 - Designated Mining Operation	
REASON FOR INSPECTION: Normal I&E Program	BOND CALCULATION TYPE: None	BOND AMOUNT: \$99,893.00	
DATE OF COMPLAINT: NA	POST INSP. CONTACTS: None	JOINT INSP. AGENCY: None	
WEATHER: Clear	INSPECTOR'S SIGNATURE:

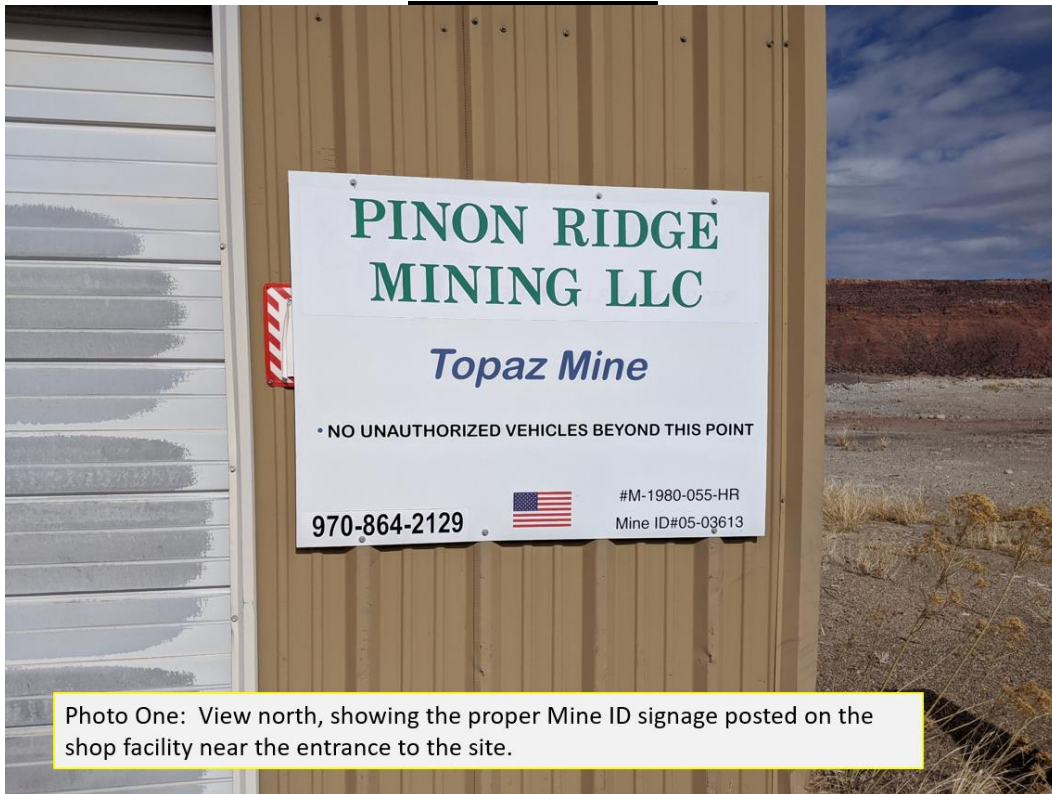
As seen in Photo One, the permit ID sign was observed near the entrance to the site. The permit boundary markers were also observed. Evidence that the diversion ditches and storm water control devices are functioning as designed was noted and no significant erosion was observed throughout the site. Maintenance of the storm water control structures has been completed and all structures were in good condition at the time of the inspection.

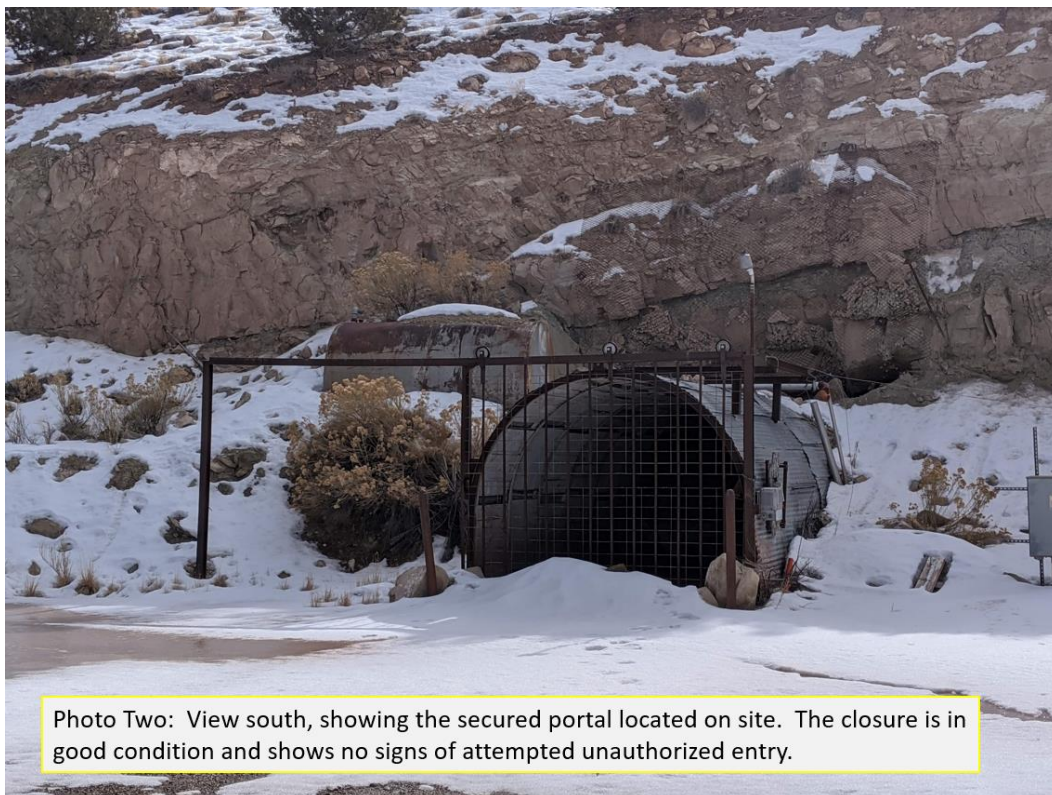
The shop facility located on site has been repaired, has had power restored and is in good working order. No damage or signs of vandalism was noted during the inspection. The portal located on site was also secured, it has been closed off with steel grates as well as encompassed by a small berm as seen in Photo Two. Some mining related equipment including vent tubing and steel scaffolding is being stored on site. The items that are stored are in a neat and orderly fashion and not considered a problem at this time. No fuel storage containers were observed on site. Various other debris was observed on site however it was stored in an orderly fashion and was not a concern at this time.

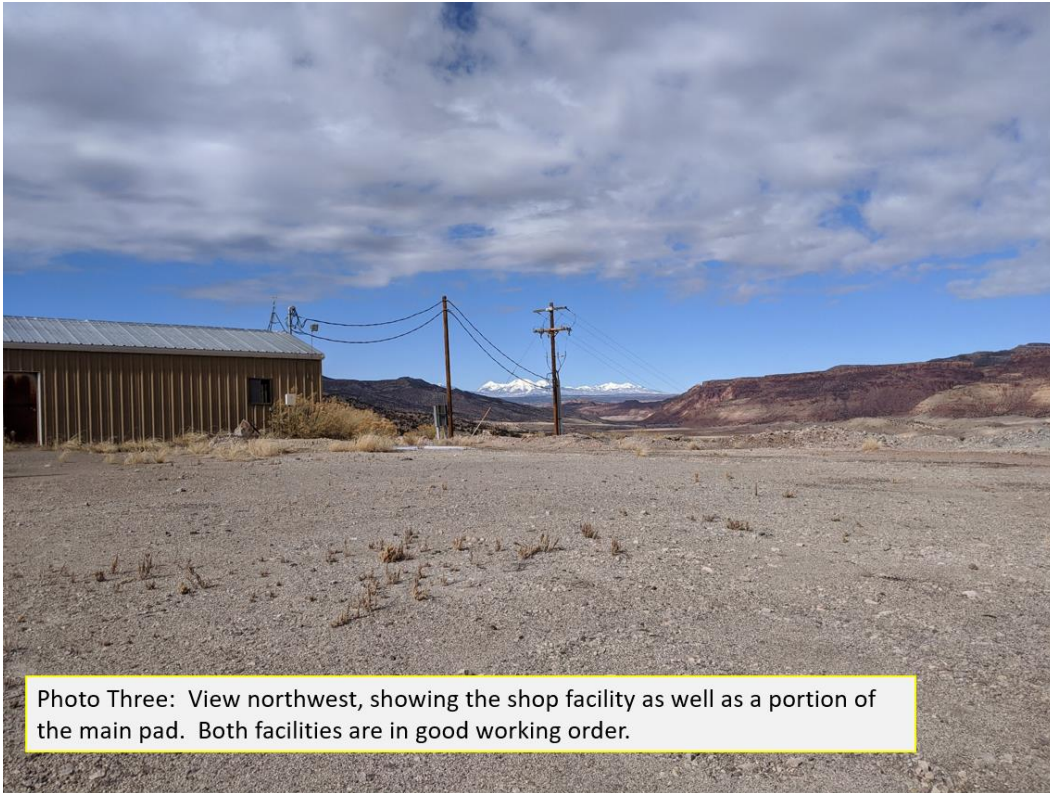
The main pad and work area was in good condition as seen in Photos Three and Four, evidence of weed management during the growing season was observed. Some areas around the perimeter of the pad area have begun to revegetate themselves with volunteer species. The whole site exhibits positive drainage and no erosional issues were observed at this time.

Photo Three: View northwest, showing the shop facility as well as a portion of the main pad. Both facilities are in good working order.

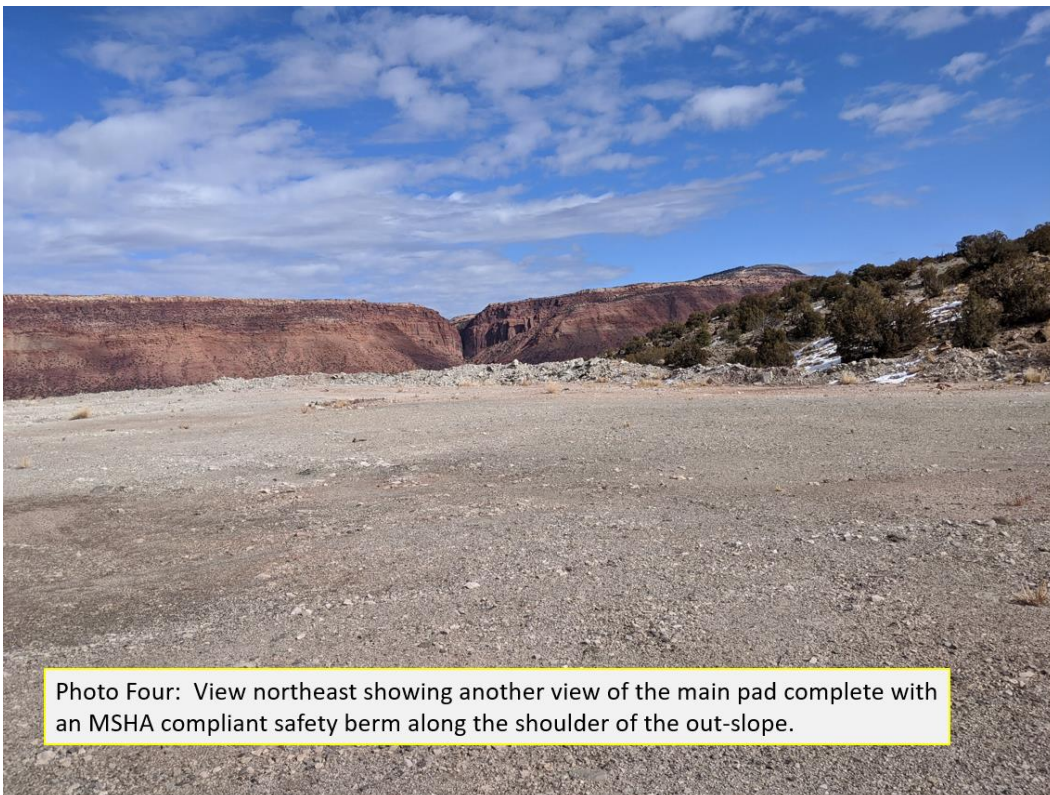
Photo Four: View northeast showing another view of the main pad complete with an MSHA compliant safety berm along the shoulder of the out-slope.
