**MINERALS PROGRAM INSPECTION REPORT**  
**PHONE: (303) 866-3567**

<b>MINE NAME:</b> Sunday Mine	<b>MINE/PROSPECTING ID#:</b> M-1977-285	<b>MINERAL:</b> Uranium and vanadium	<b>COUNTY:</b> San Miguel
<b>INSPECTION TYPE:</b> Monitoring	<b>INSPECTOR(S):</b> Lucas West	<b>INSP. DATE:</b> February 11, 2020	<b>INSP. TIME:</b> 09:52
<b>OPERATOR:</b> Pinon Ridge Mining LLC	<b>OPERATOR REPRESENTATIVE:</b> Michael Rutter	<b>TYPE OF OPERATION:</b> 112d-2 - Designated Mining Operation	
<b>REASON FOR INSPECTION:</b> Normal I&E Program	<b>BOND CALCULATION TYPE:</b> Complete Bond	<b>BOND AMOUNT:</b> \$330,242.00	
<b>DATE OF COMPLAINT:</b> NA	<b>POST INSP. CONTACTS:</b> None	<b>JOINT INSP. AGENCY:</b> None	
<b>WEATHER:</b> Clear	<b>INSPECTOR'S SIGNATURE:</b>

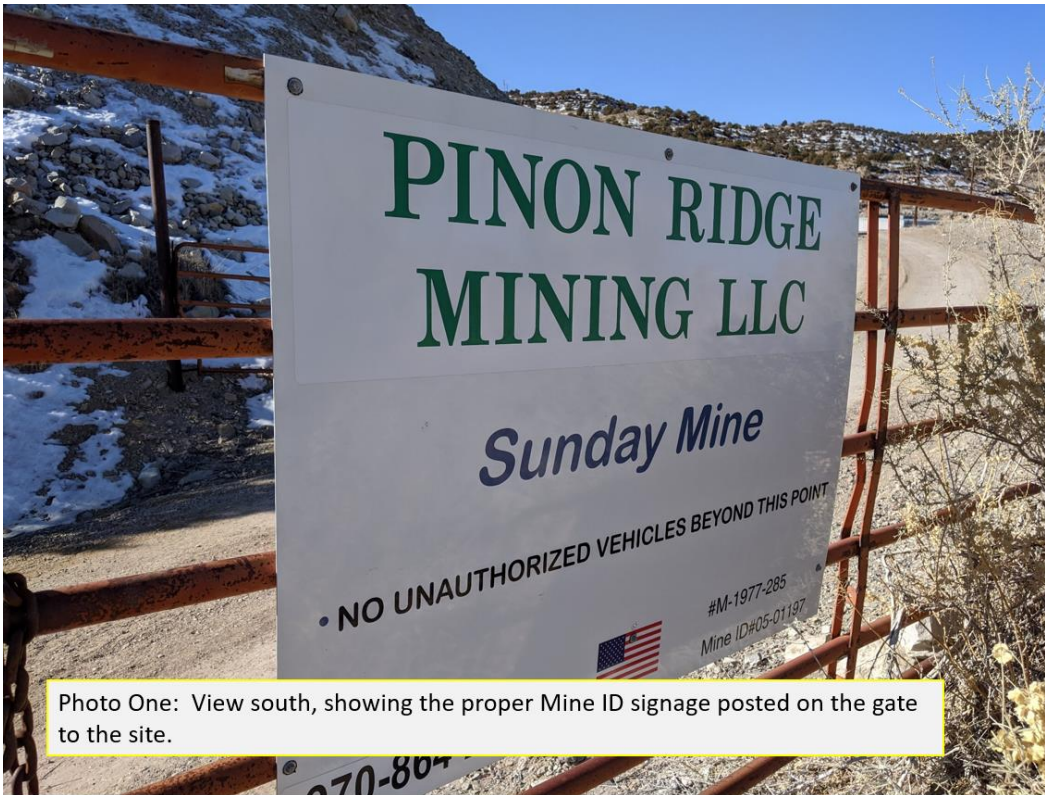
As seen in Photo One, the permit ID sign was observed at the entrance to the site. The permit boundary markers were also observed. Photos Two and Three shows an example of the sediment catchment basins that are located on site as part of the storm water management plan. All storm water control devices were in good condition and appear to be functioning as designed. All diversion ditches appear to be functioning as designed and no significant erosion was observed throughout of the site. Significant work had been performed recently which included cleaning out sediment ponds and ditches. The waste rock dumps and out slopes of all constructed faces were observed and appear to be stable. The portal on site remains secure and shows no signs of attempted unauthorized entry. The earthen backfill and locked steel gate are in good condition. The portal and its enclosure can be seen in Photo Four. All work facilities were secure and seemed to be in good condition during the time of the inspection. Repair work to the shop facilities and buildings has been completed. Examples of the work facilities can be seen in Photos Five and Six. Vent shaft S-2, located to the Northwest of the shop facilities is covered with a steel grate and has been secured. All loadouts, roads and pad areas that exist on site were observed and in good condition.

Photo One: View south, showing the proper Mine ID signage posted on the gate to the site.

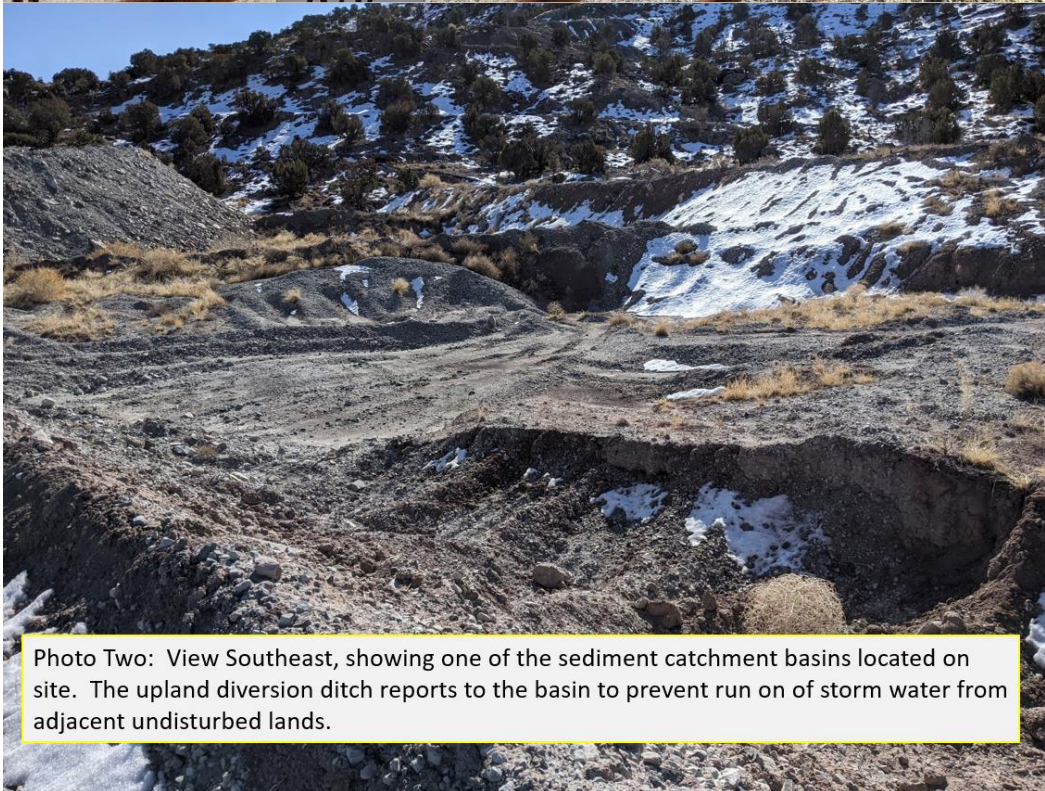
Photo Two: View Southeast, showing one of the sediment catchment basins located on site. The upland diversion ditch reports to the basin to prevent run on of storm water from adjacent undisturbed lands.

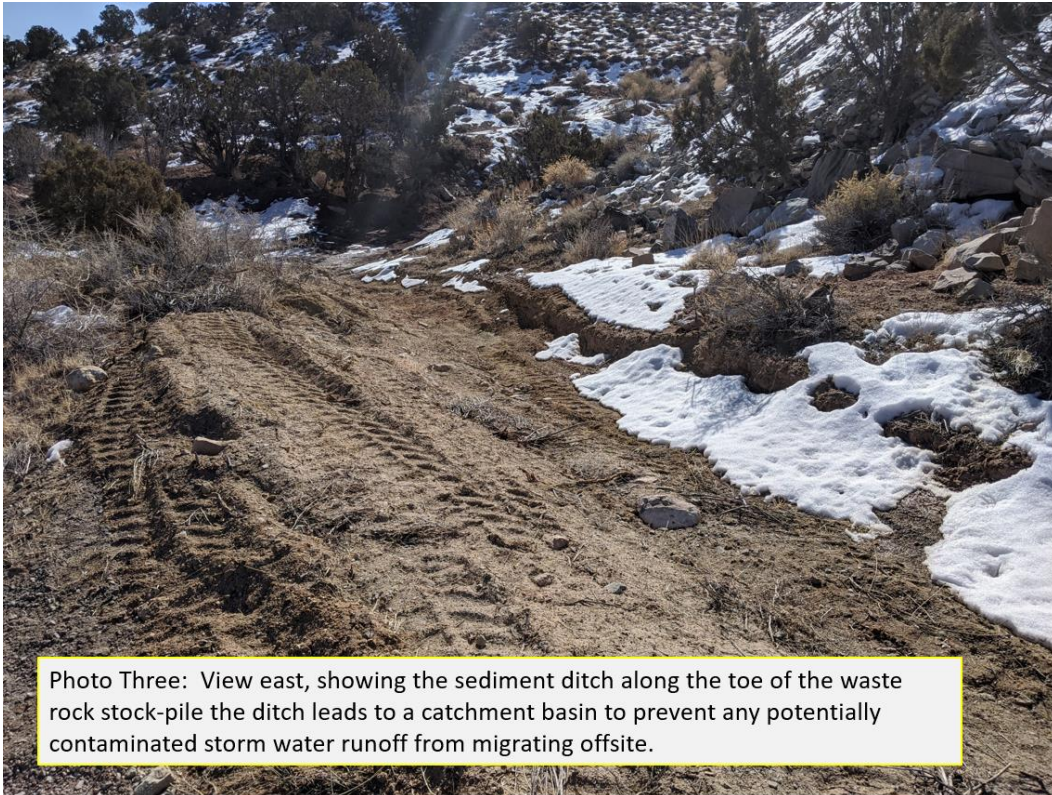
Photo Three: View east, showing the sediment ditch along the toe of the waste rock stock-pile the ditch leads to a catchment basin to prevent any potentially contaminated storm water runoff from migrating offsite.

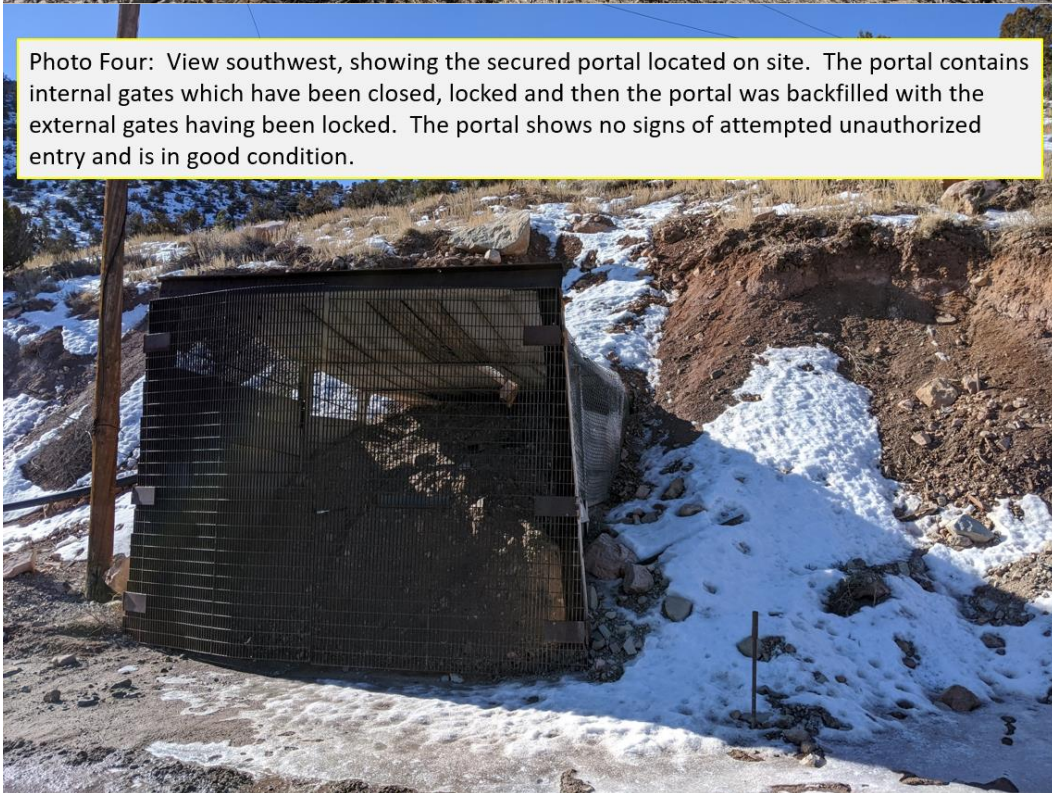
Photo Four: View southwest, showing the secured portal located on site. The portal contains internal gates which have been closed, locked and then the portal was backfilled with the external gates having been locked. The portal shows no signs of attempted unauthorized entry and is in good condition.

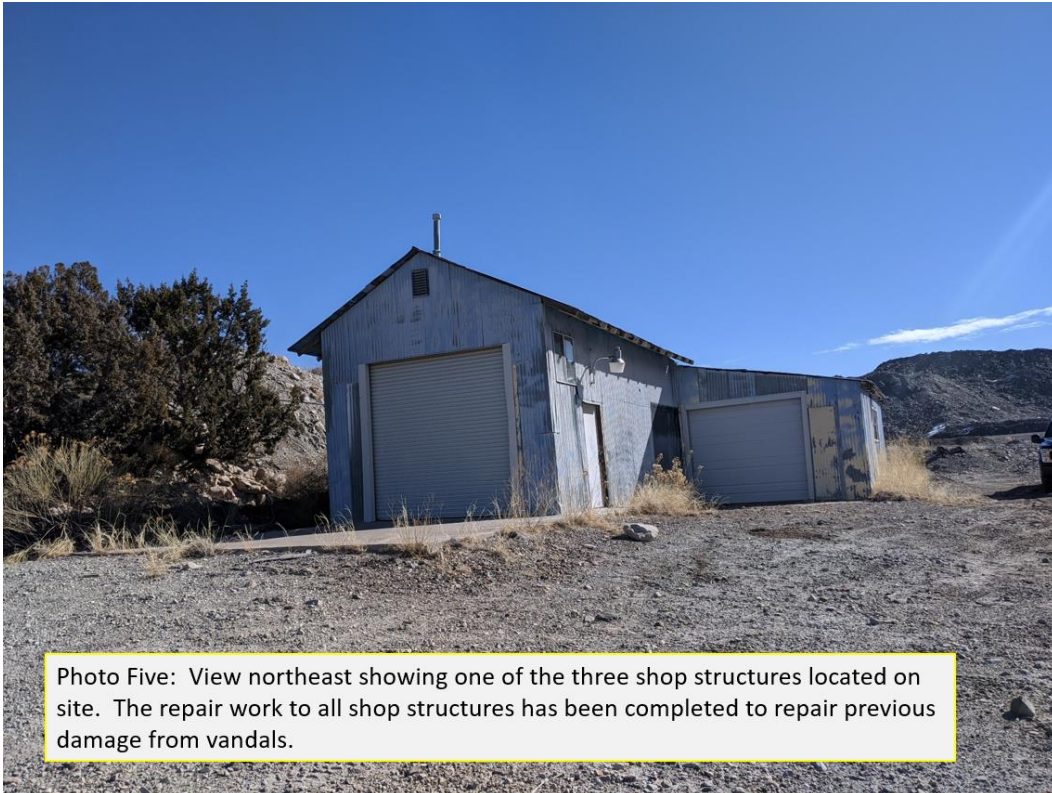
Photo Five: View northeast showing one of the three shop structures located on site. The repair work to all shop structures has been completed to repair previous damage from vandals.

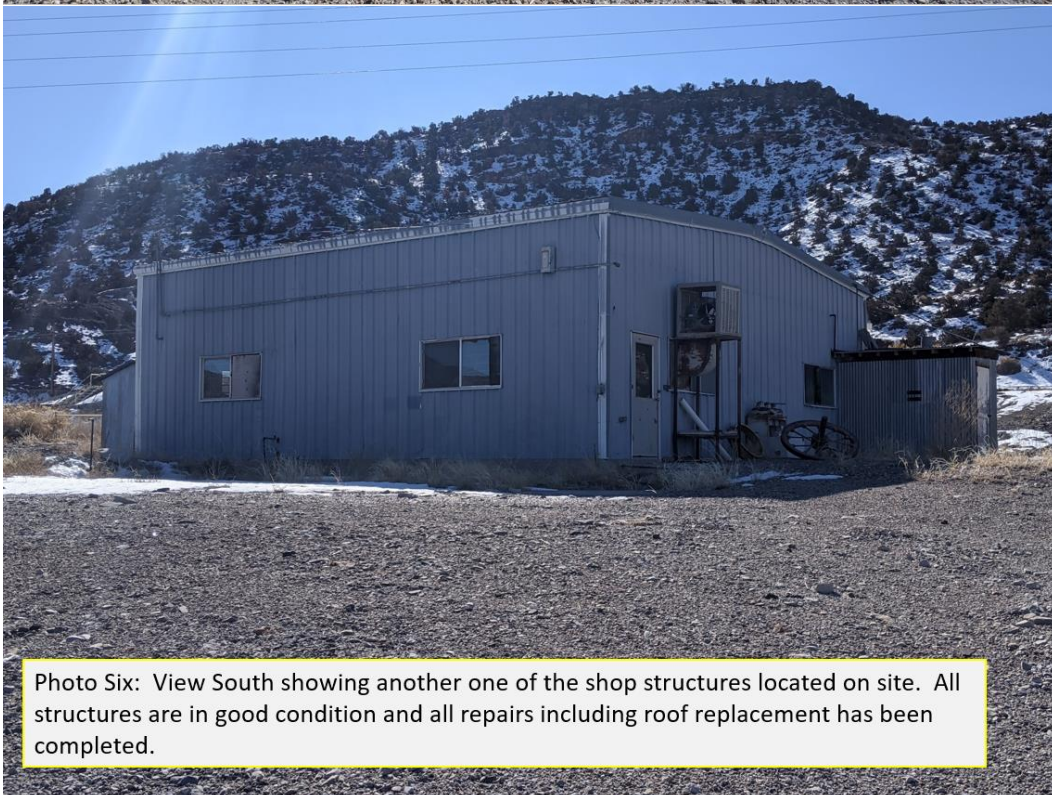
Photo Six: View South showing another one of the shop structures located on site. All structures are in good condition and all repairs including roof replacement has been completed.

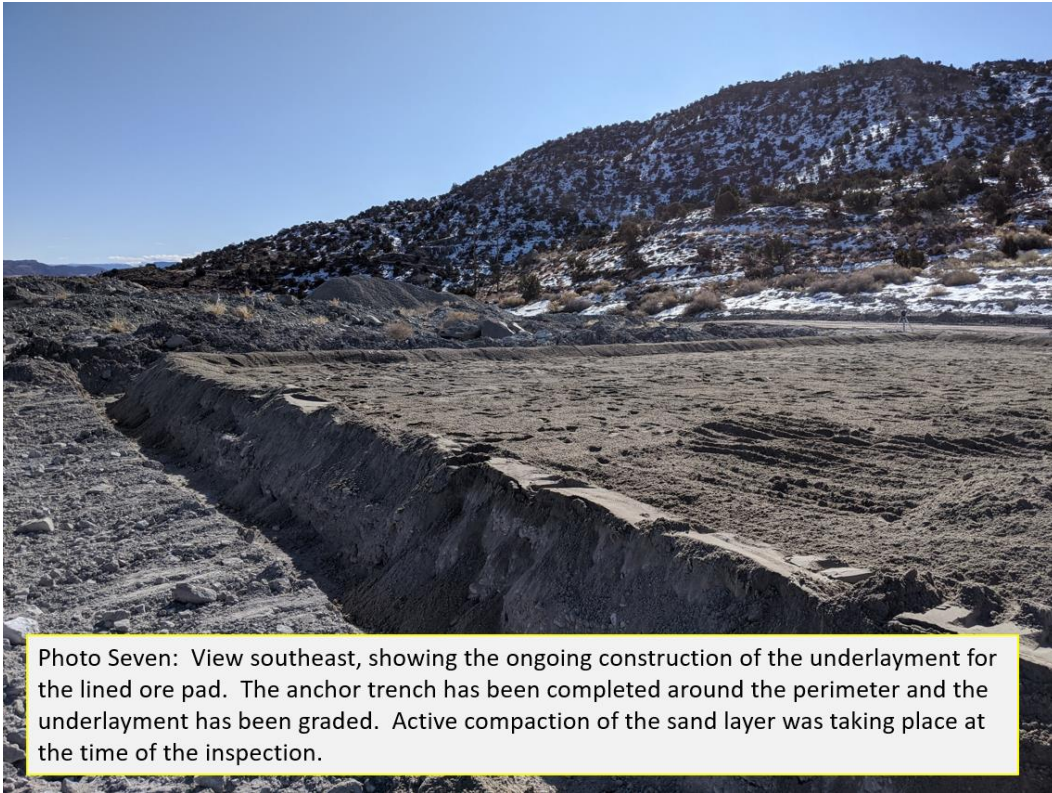
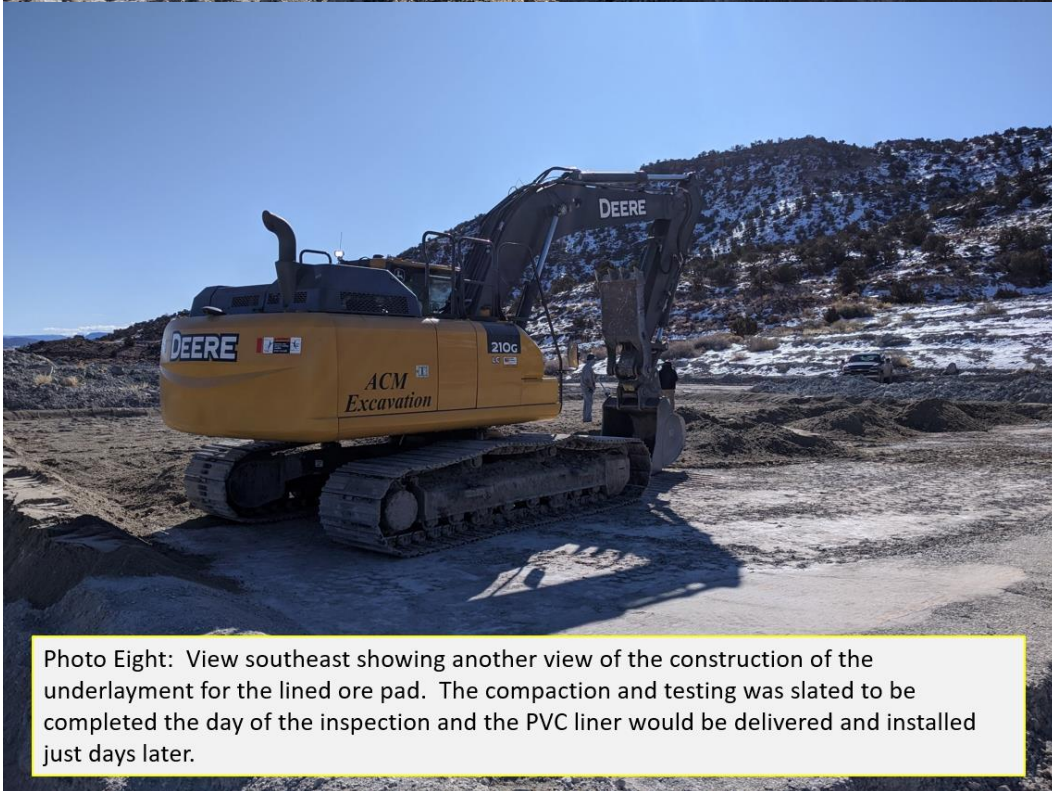
Construction of the lined ore pad was being conducted on site at the time of the inspection. The progress of the pad can be seen in Photos Seven and Eight. The pad design depicts an 80' X 80' pad, lined with 30 Mil PVC and an "operational soils" layer between the liner and the stockpiled ore. The design also specifies the thickness of each layer, compaction of the underlayment and the installation of a "witness layer" within the Operational Soils layer to prevent possible damage to the liner. At the time of the inspection the underlayment of the pad design was being constructed in preparation for the delivery and installation of the PVC Liner. The main pad area has been graded and was actively being compacted in accordance with the specifications designated in the EPP. The anchor trench around the entire perimeter of the pad has been constructed. All elements of the pad including the location, dimensions and compaction specifications are in compliance with the design contained within the EPP. All material for the construction of the underlayment were obtained on site from the waste rock piles, screened for size and stockpiled on site. The field QA/QC checks and certified as built report will need to be submitted to the Division for review and approval upon

completion of construction.
