MINERALS PROGRAM INSPECTION REPORT
PHONE: (303) 866-3567

MINE NAME: St Jude Mine	MINE/PROSPECTING ID#: M-1978-039-HR	MINERAL: Uranium and vanadium	COUNTY: San Miguel
INSPECTION TYPE: Monitoring	INSPECTOR(S): Lucas West	INSP. DATE: February 11, 2020	INSP. TIME: 11:20
OPERATOR: Pinon Ridge Mining LLC	OPERATOR REPRESENTATIVE: Michael Rutter	TYPE OF OPERATION: 110d - Designated Limited Impact	
REASON FOR INSPECTION: Normal I&E Program	BOND CALCULATION TYPE: Complete Bond	BOND AMOUNT: \$61,021.00	
DATE OF COMPLAINT: NA	POST INSP. CONTACTS: None	JOINT INSP. AGENCY: None	
WEATHER: Clear	INSPECTOR'S SIGNATURE:

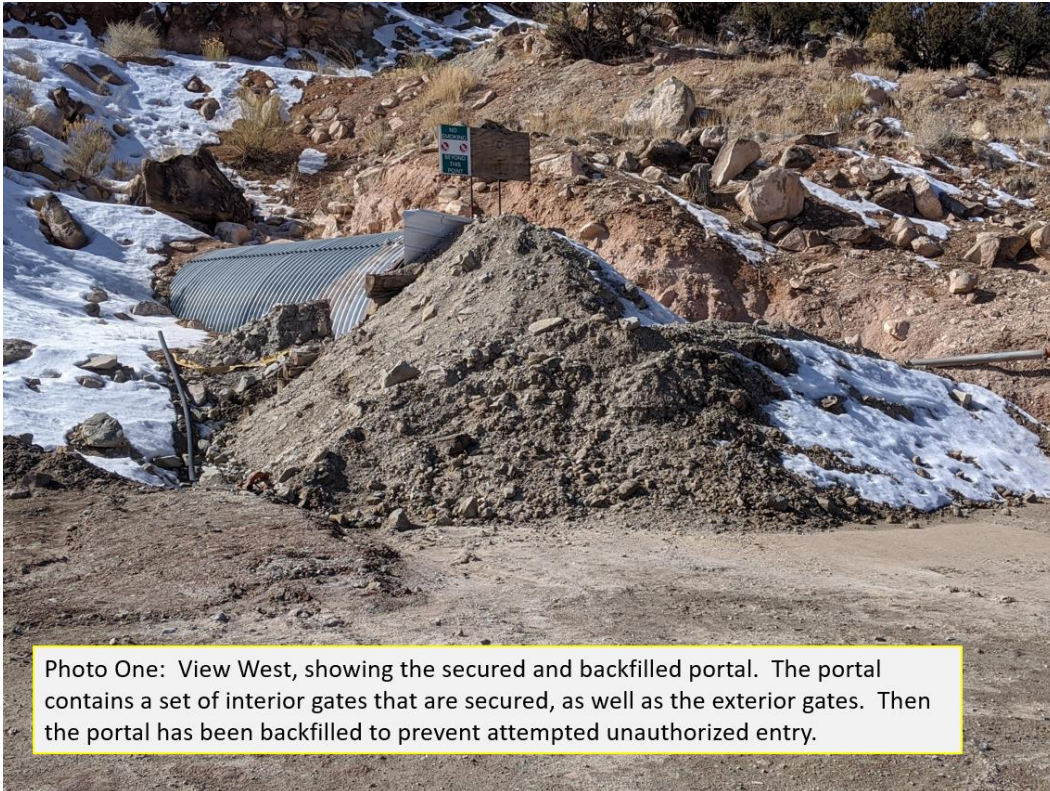
Photo One: View West, showing the secured and backfilled portal. The portal contains a set of interior gates that are secured, as well as the exterior gates. Then the portal has been backfilled to prevent attempted unauthorized entry.

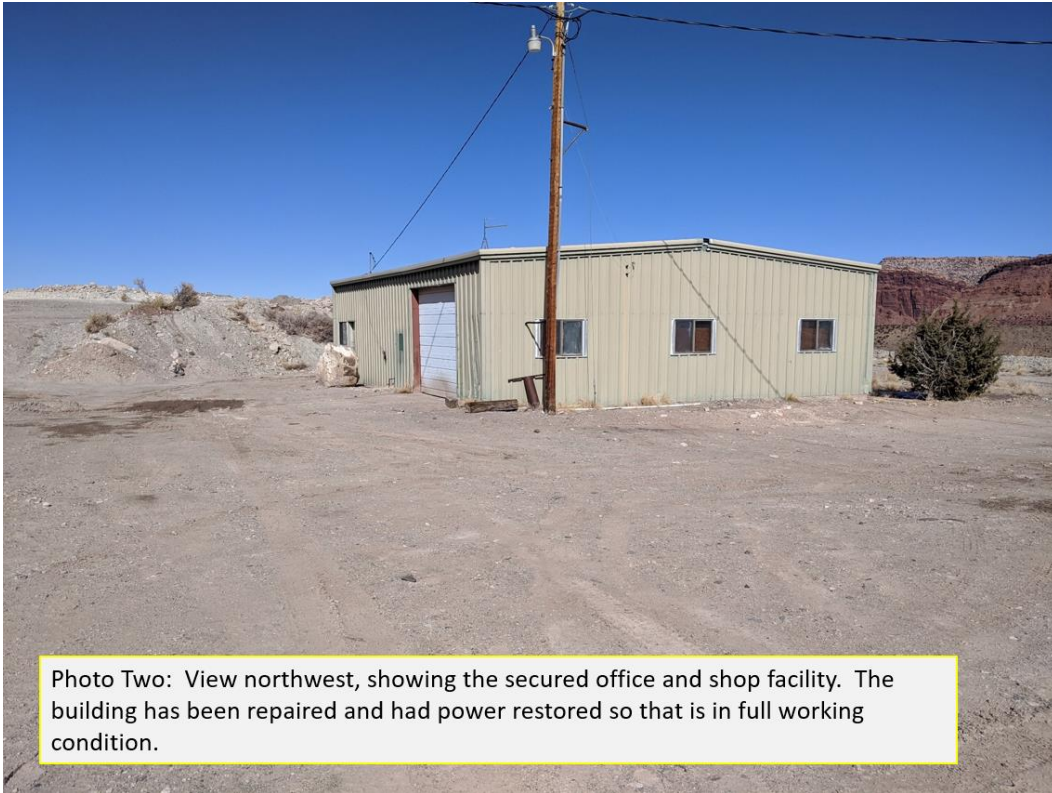
Photo Two: View northwest, showing the secured office and shop facility. The building has been repaired and had power restored so that is in full working condition.

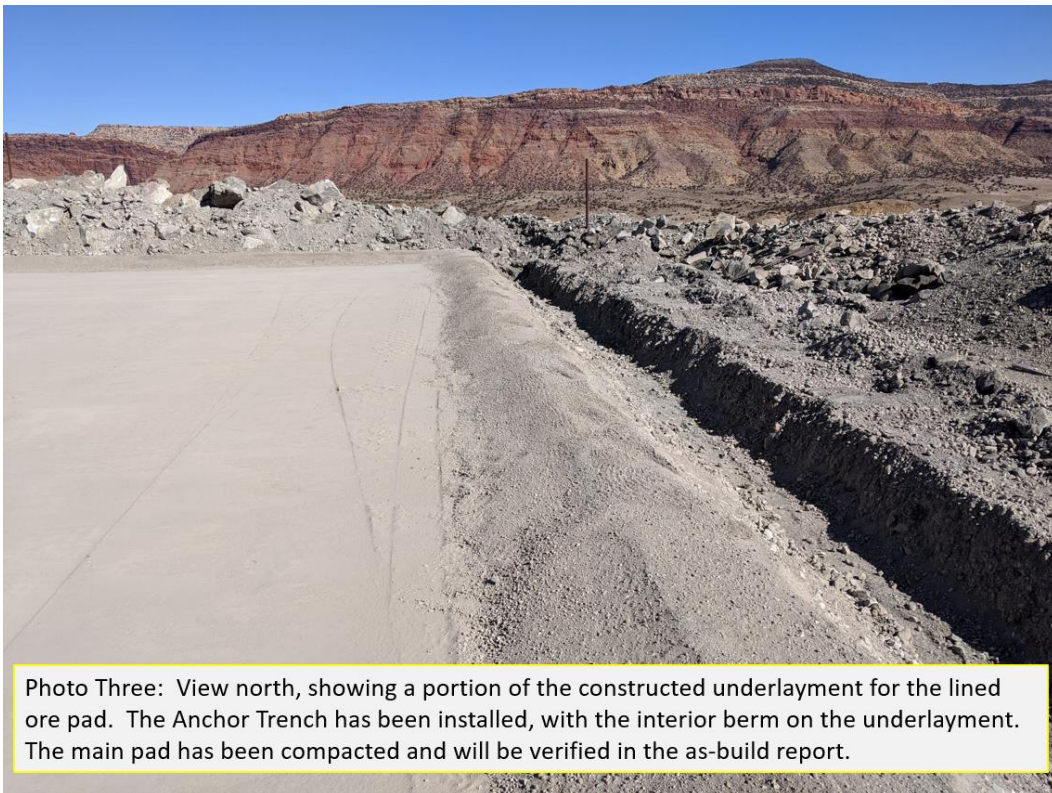
Construction of the underlayment for the Lined Ore Pad has been completed at this site. The pad with the compacted underlayment and anchor trench for the liner can be seen in Photos Three and Four. The pad design depicts a 60' X 60' pad, lined with 30 Mil PVC and an "operational soils" layer between the liner and the stockpiled ore. The design also specifies the thickness of each later, compaction of the underlayment and the installation of a "witness layer" within the Operational Soils layer to prevent possible damage to the liner. The main pad area has been graded and was actively being compacted in accordance with the specifications designated in the EPP. The anchor trench around the entire perimeter of the pad has been constructed. All elements of the pad including the location, dimensions and compaction specifications are in compliance with the design contained within the EPP. All material for the construction of the underlayment were obtained on site from the waste rock piles, screened for size and stockpiled on site. The field QA/QC checks and certified as built report will need to be submitted to the Division for review and approval upon completion of construction.

Photo Three: View north, showing a portion of the constructed underlayment for the lined ore pad. The Anchor Trench has been installed, with the interior berm on the underlayment. The main pad has been compacted and will be verified in the as-build report.
