**MINERALS PROGRAM INSPECTION REPORT**  
**PHONE: (303) 866-3567**

<b>MINE NAME:</b> West Sunday	<b>MINE/PROSPECTING ID#:</b> M-1981-021	<b>MINERAL:</b> Uranium and vanadium	<b>COUNTY:</b> San Miguel
<b>INSPECTION TYPE:</b> Monitoring	<b>INSPECTOR(S):</b> Lucas West	<b>INSP. DATE:</b> February 11, 2020	<b>INSP. TIME:</b> 11:59
<b>OPERATOR:</b> Pinon Ridge Mining LLC	<b>OPERATOR REPRESENTATIVE:</b> Michael Rutter	<b>TYPE OF OPERATION:</b> 112d-3 - Designated Mining Operation	
<b>REASON FOR INSPECTION:</b> Normal I&E Program	<b>BOND CALCULATION TYPE:</b> Complete Bond	<b>BOND AMOUNT:</b> \$85,036.00	
<b>DATE OF COMPLAINT:</b> NA	<b>POST INSP. CONTACTS:</b> None	<b>JOINT INSP. AGENCY:</b> None	
<b>WEATHER:</b> Clear	<b>INSPECTOR'S SIGNATURE:</b>

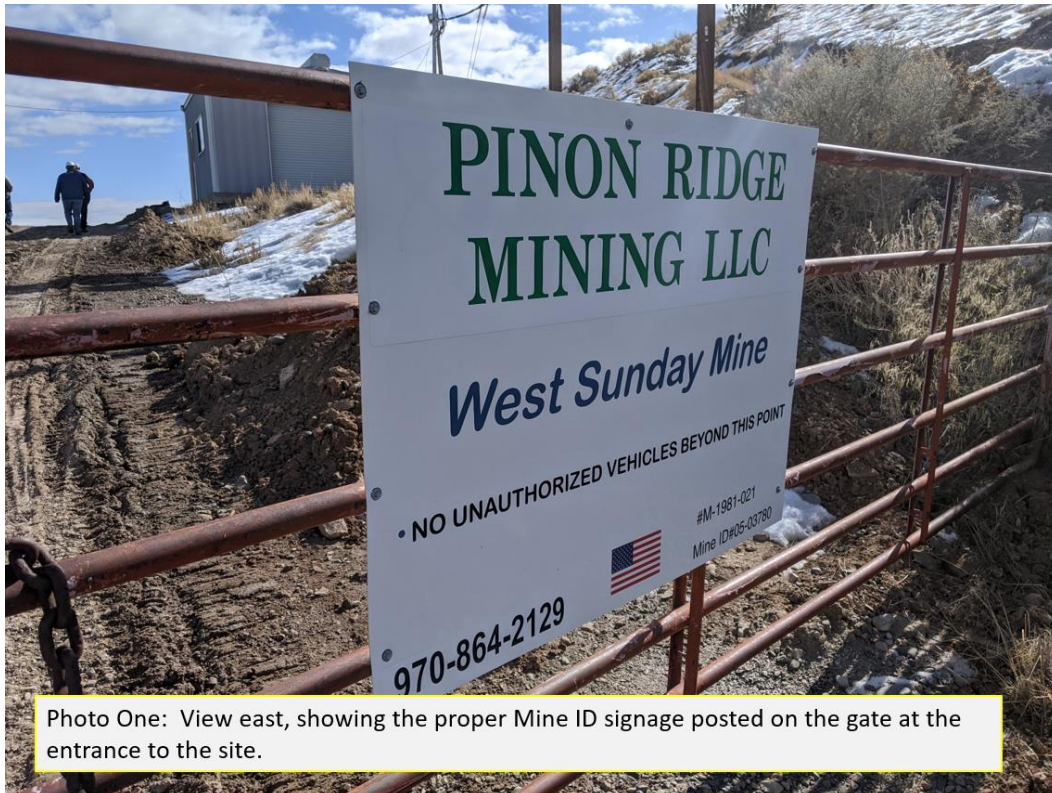
As seen in Photo One, the permit ID sign was observed at the entrance to the site. The permit boundary markers were also observed. The remote vent shaft sites were not inspected at this time. Evidence that the diversion ditches and storm water control devices are functioning as designed was observed and no significant erosion was observed throughout the site. Maintenance of all storm water control structures on site has been performed and all structures are in good condition. The shop and storage facilities located on site were observed. Repair work to the facilities has been conducted and no evidence of vandalism or damage was noted. The facilities can be seen in Photos Two and Three. The portal located on site was also secured, it has been backfilled, closed off with steel grates as well as encompassed by a small berm as seen in Photo Four. One fuel storage container was observed on site but were empty and appear to have not been utilized in some time. Various other debris was observed on site however it was stored in an orderly fashion and was not a concern at this time. The main pad and work area was in good condition, evidence of weed management during the growing season was observed. The whole site exhibits positive drainage and no erosional issues were observed at this time. Some areas around the perimeter of the pad area have begun to revegetate themselves with volunteer species.

Photo One: View east, showing the proper Mine ID signage posted on the gate at the entrance to the site.

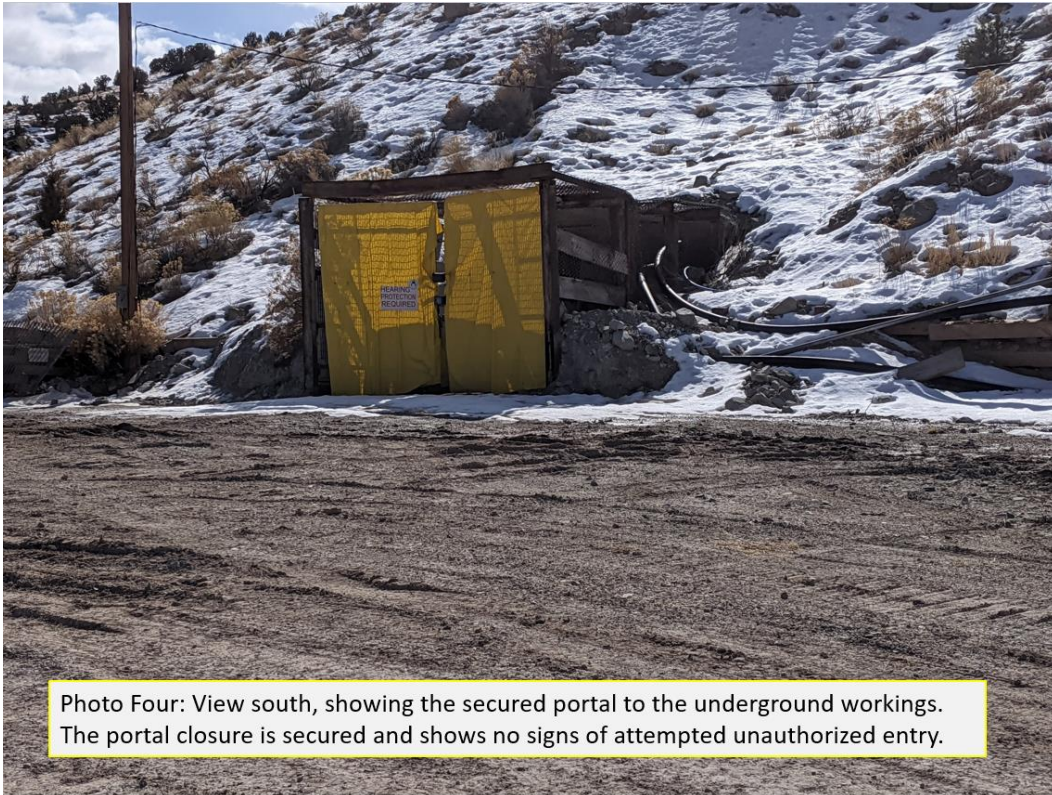
Photo Four: View south, showing the secured portal to the underground workings. The portal closure is secured and shows no signs of attempted unauthorized entry.

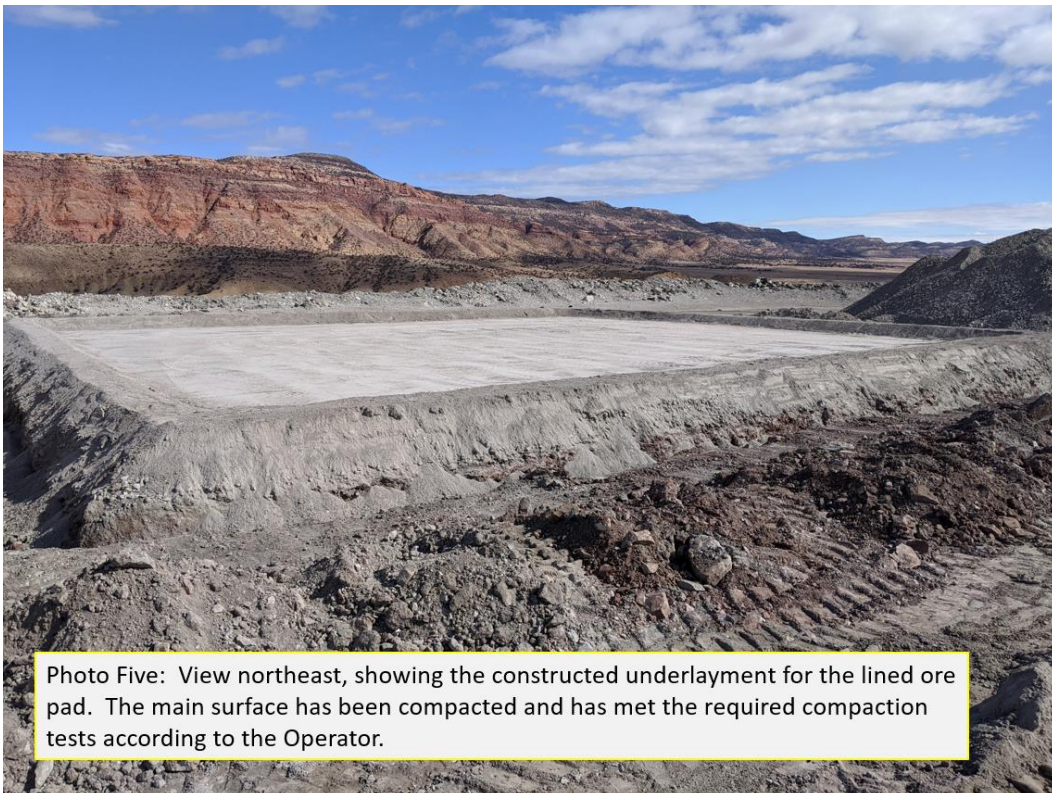
Construction of the underlayment for the Lined Ore Pad has been completed at this site. The pad with the compacted underlayment and anchor trench for the liner can be seen in Photos Five and Six. The pad design depicts a 60' X 60' pad, lined with 30 Mil PVC and an "operational soils" layer between the liner and the stockpiled ore. The design also specifies the thickness of each later, compaction of the underlayment and the installation of a "witness layer" within the Operational Soils layer to prevent possible damage to the liner. The main pad area has been graded and was actively being compacted in accordance with the specifications designated in the EPP. The anchor trench around the entire perimeter of the pad has been constructed. All elements of the pad including the location, dimensions and compaction specifications are in compliance with the design contained within the EPP. All material for the construction of the underlayment were obtained on site from the waste rock piles, screened for size and stockpiled on site. The field QA/QC checks and certified as built report will need to be submitted to the Division for review and approval upon completion of construction

Photo Five: View northeast, showing the constructed underlayment for the lined ore pad. The main surface has been compacted and has met the required compaction tests according to the Operator.
