MINERALS PROGRAM INSPECTION REPORT
PHONE: (303) 866-3567

MINE NAME: South 40 Quarry	MINE/PROSPECTING ID#: M-1990-016	MINERAL: Stone	COUNTY: Fremont
INSPECTION TYPE: Monitoring	INSPECTOR(S): Timothy Cazier	INSP. DATE: October 15, 2019	INSP. TIME: 09:20
OPERATOR: High Plains Stone Company	OPERATOR REPRESENTATIVE: Debbie Wagner	TYPE OF OPERATION: 110c - Construction Limited Impact

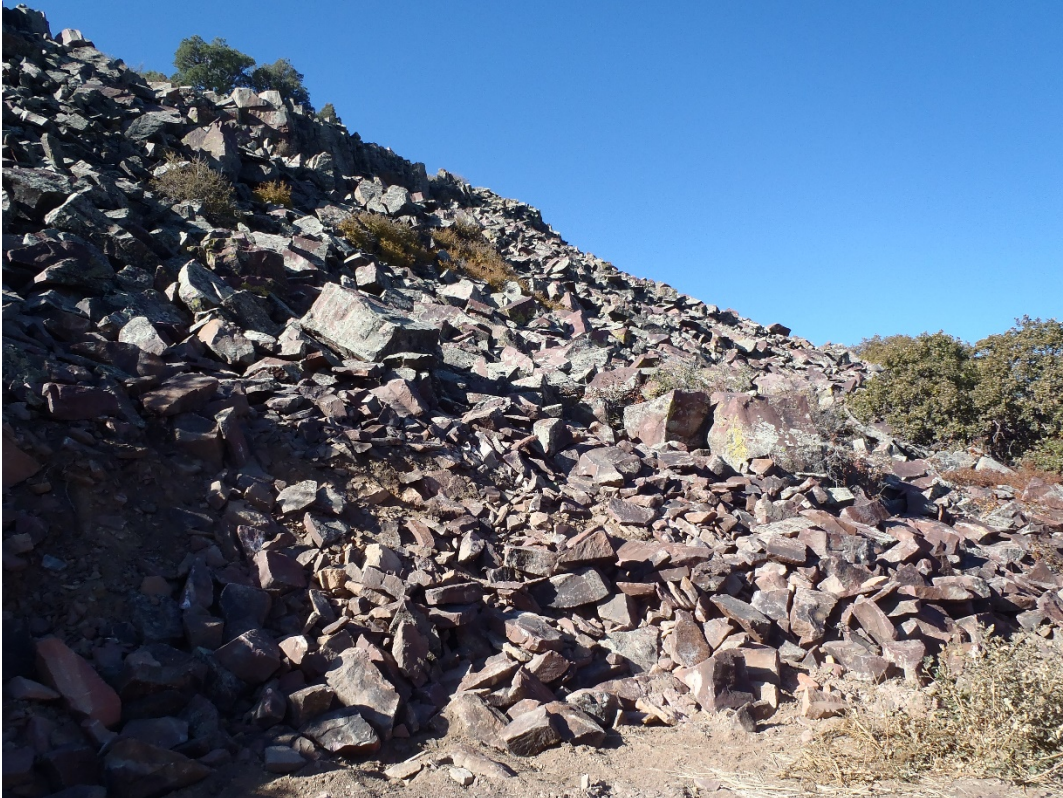
Gen. Compliance with Mine Plan: The upper, or south area (see **Photos 1 and 2**) that appears to be covered by the aforementioned 1994 Declaratory Order. As no reclamation permit required was required by the MLRB, there is no mine plan to follow. The Declaratory Order was granted with the understanding all work would be performed under human power with hand tools with the exception of the use of a forklift to lift palletized rock onto haul trucks. Based on a review of Google Earth history, an access road (see **Photo 3**) has advanced approximately 1,450 feet since 1999 (see attached **Post Inspection Map**).

Photo 1. Active area in Declaratory Order area.

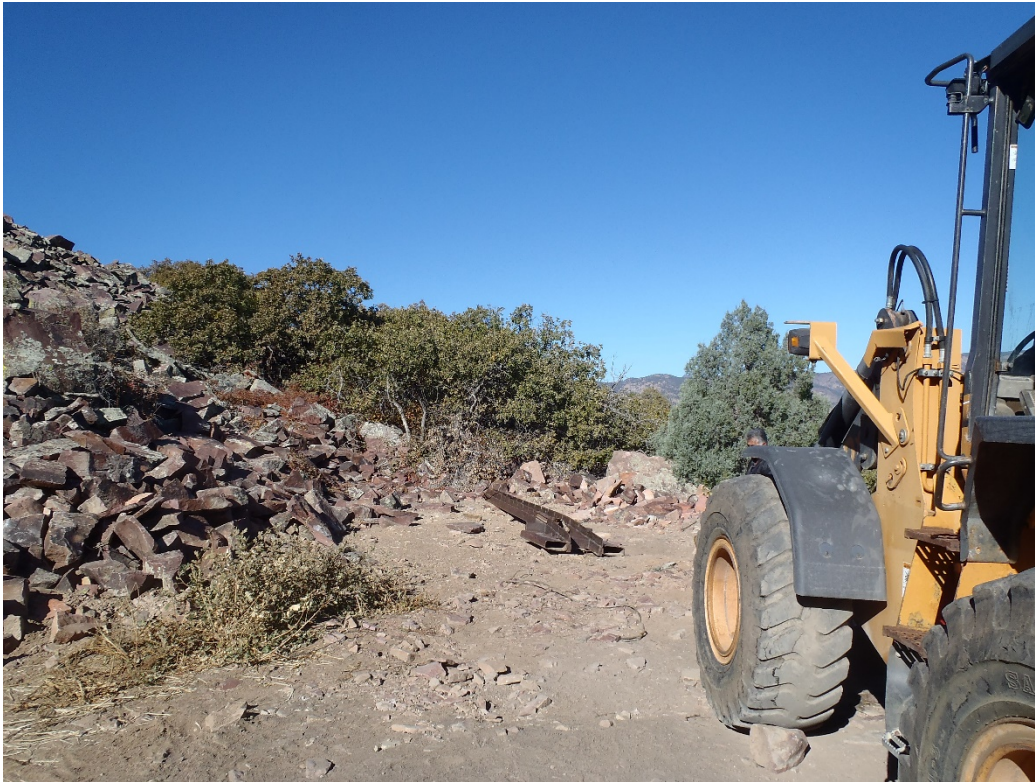
Support Facilities On-site: No equipment or facilities were observed in the permitted area. A loader and mobile crane were also observed (see **Photos 2 and 3**) in the Declaratory Order area.

Photo 2. West end of access road in active area in Declaratory Order area.

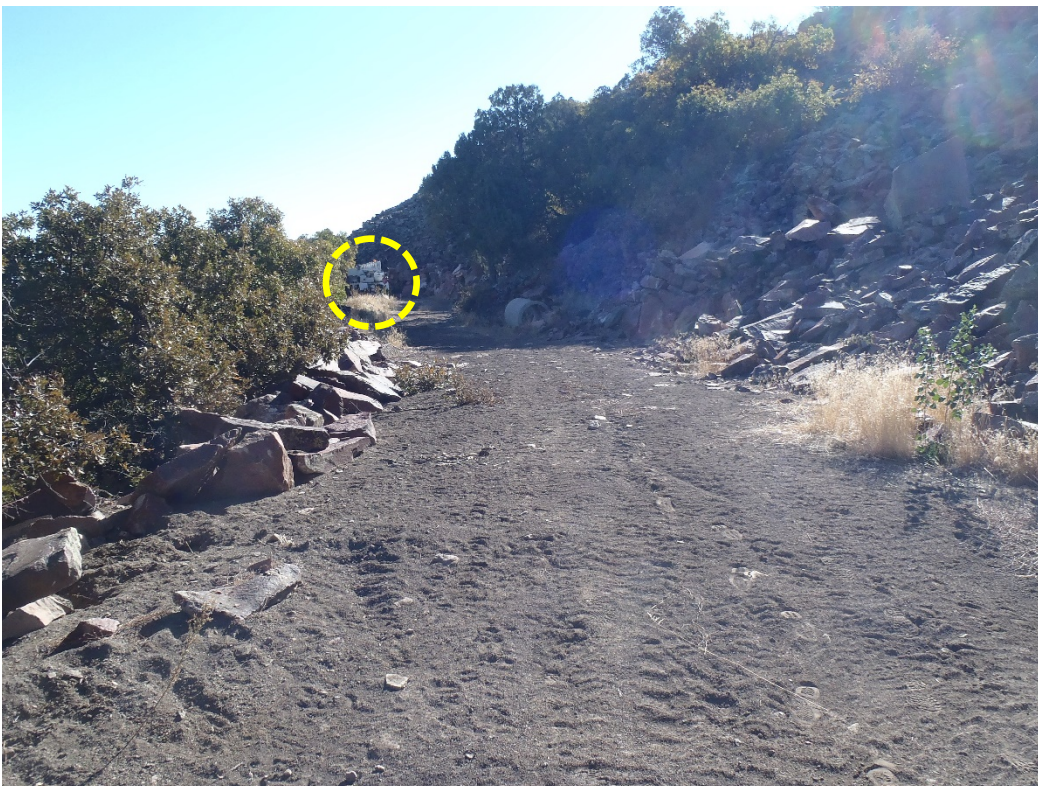
PROBLEM/POSSIBLE VIOLATION: Problem: The active mining area is limited to an area granted a Declaratory Order to mine without a permit using hand tools, human power and a forklift. This area has been using a mobile crane and has advanced an access road approximately 1,450 feet.

Photo 3. Access road in Declaratory Order area (looking east, note mobile crane, circled).

CORRECTIVE ACTIONS: Complete one of the following by the **CORRECTIVE ACTION DUE DATE:** A) File a mine reclamation permit application for the active area; B) File an amendment or conversion to add the active area to the existing M-1990-016 permit; or C) Petition the Mined Land Reclamation Board to modify the Declaratory Order to allow the mobile crane and access road construction.

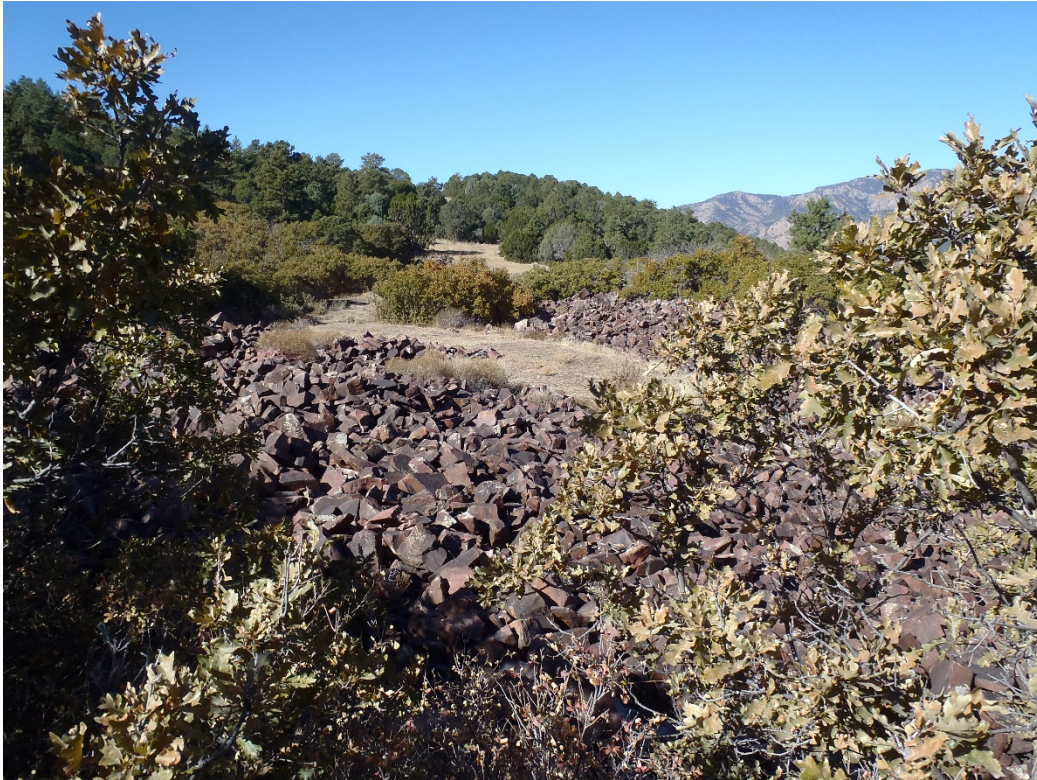
According to Ignacio, the lower, or north area which is regulated by the issued M-1990-016 mine reclamation permit has not been mined in many years. Under his direction, the lower area was visited, specifically Parcels #1 and #2 (see **Photos 4 and 5**). A mobile crane is allowed under the issued permit. No equipment was observed in the permitted area, but concrete (see **Photos 6 and 7**) and a wood pallet (see **Photo 8**) were observed. This debris will need to be removed prior to the release of reclamation liability.

Reclamation Success: Parcels #1 and #2 appear to have been self-reclaimed. However, the concrete and wood pallet seen in **Photos 6, 7 and 8** will need to be removed.

Photo 4. Parcel #1 from parking area to the east (looking west).

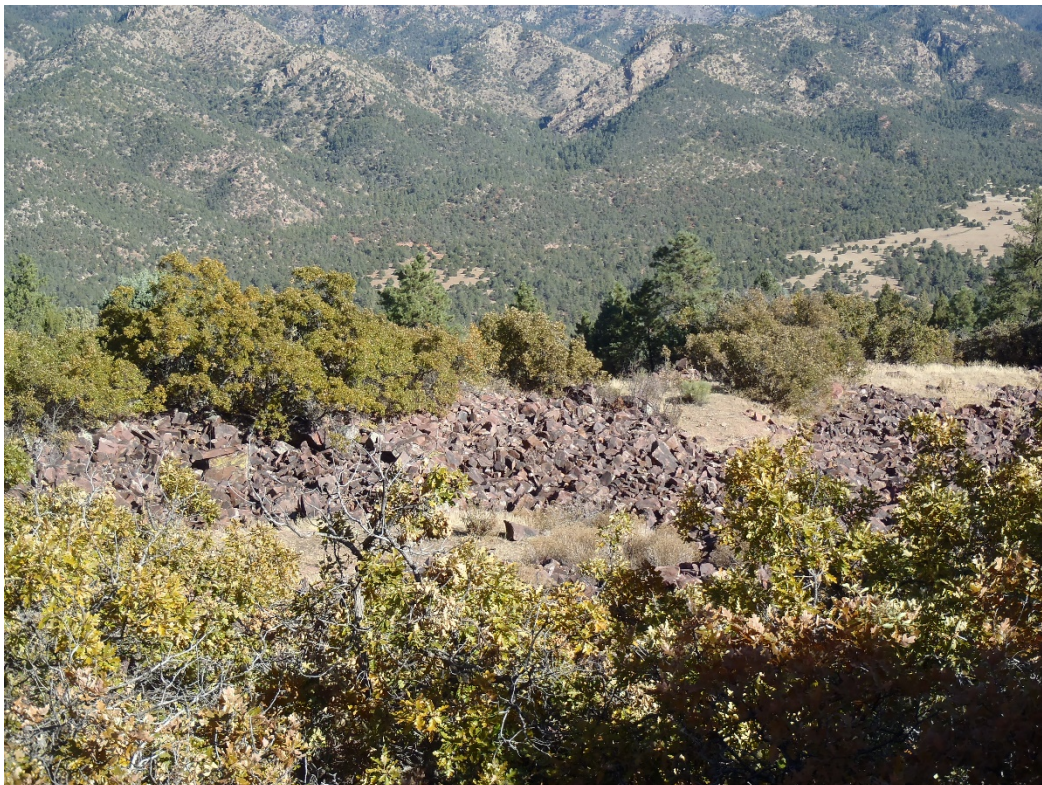
Photo 5. Parcel #2 from BLM access road (looking NNE).

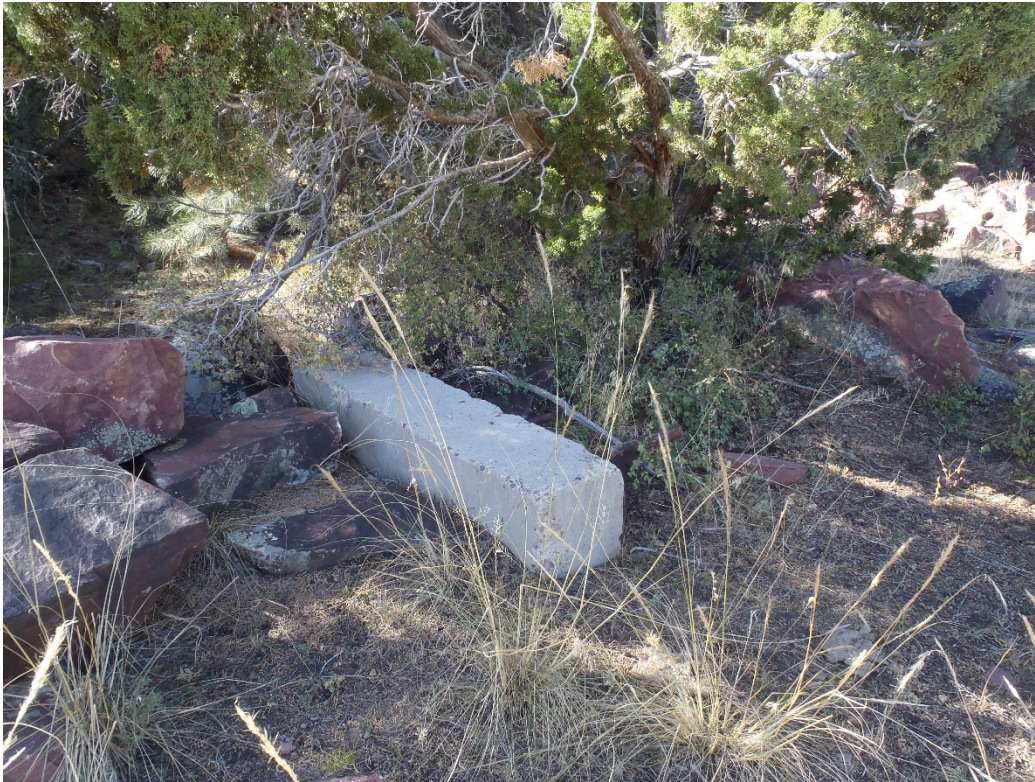
Photo 6. Concrete debris on south side of Parcel #1 access road.

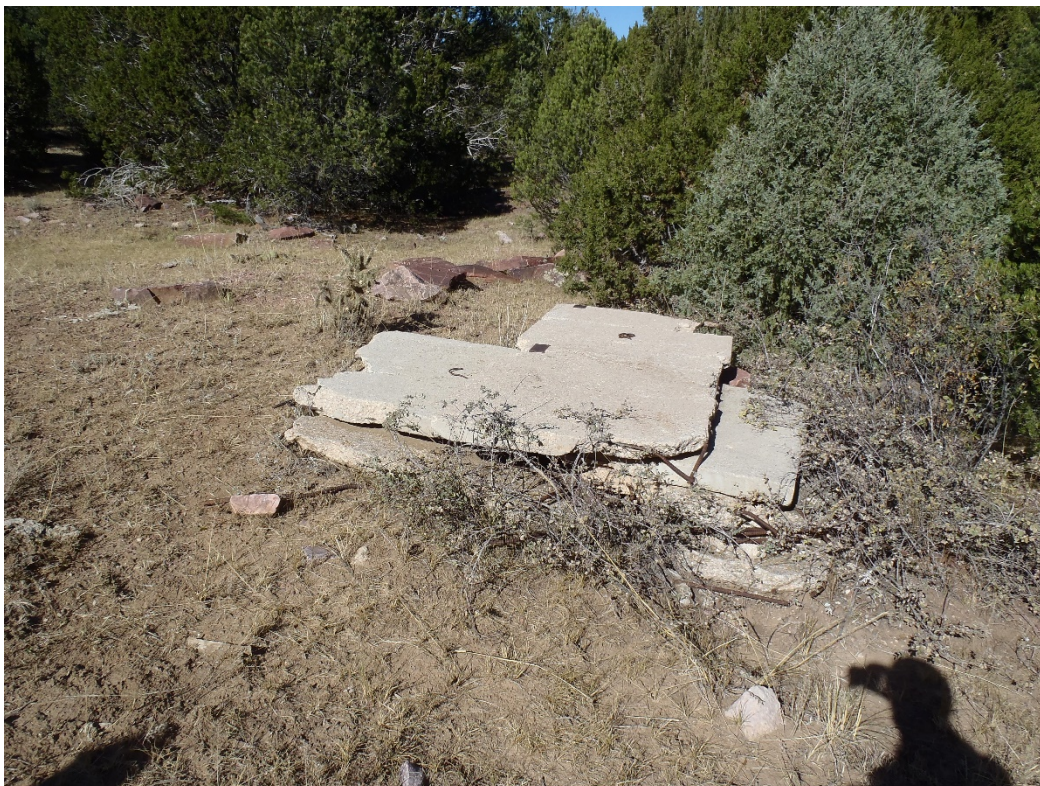
Photo 7. Concrete slabs on north side of Parcel #1 access road.

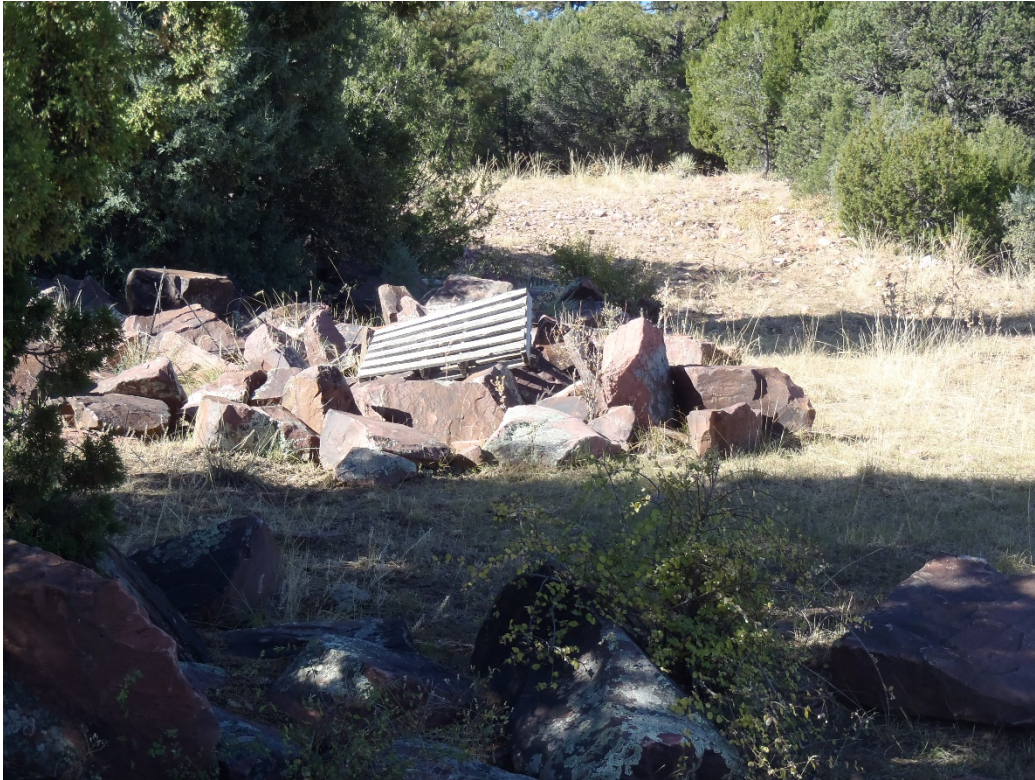
Photo 8. Wood pallet on south side of Parcel #1 access road.

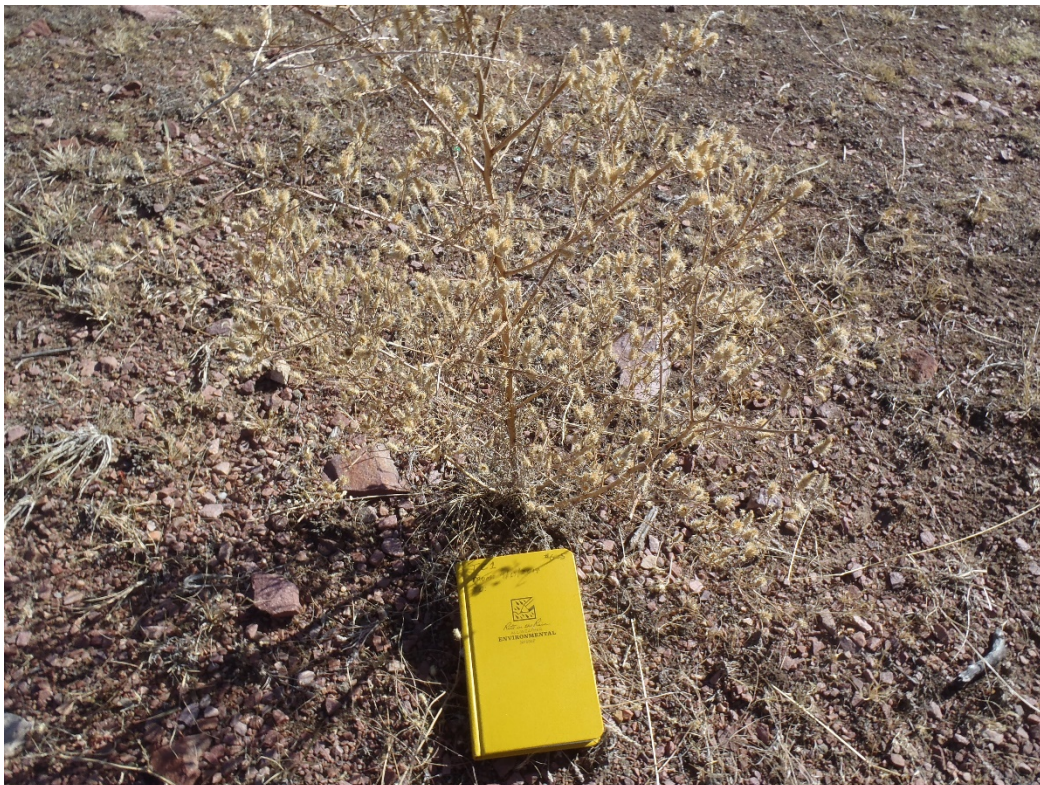
Revegetation: Some knapweed was observed. Most of this was on the lower access road to the BLM Section 15 to the west, not considered part of the permit area. However, a few knapweed plants were observed in the Parcel #1 access road (see **Photo 9**). As it appears the BLM access road is the source and not the Parcel #1 access road, this was not cited as a problem. However, the Permittee should implement a weed control program to reduce the knapweed in the permit area.

Photo 9. Example of knapweed on Parcel #1 access road.

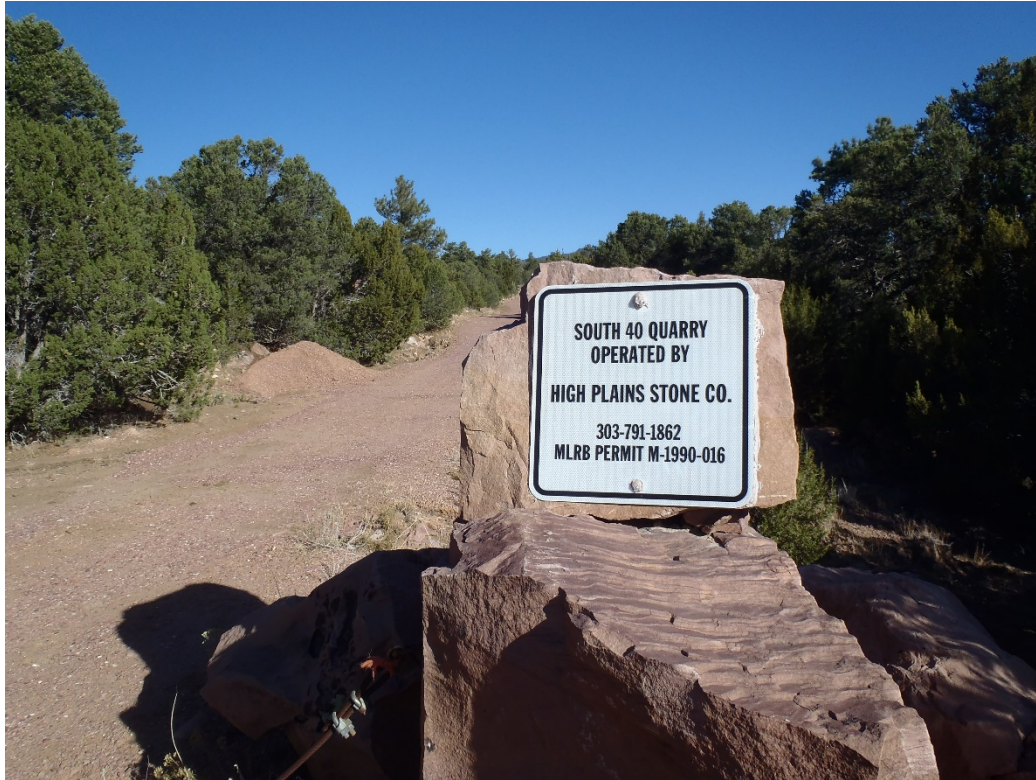
Signs and Markers: The permit sign was properly posted (see **Photo 10**). Boundary markers could not be found for the permitted area where mining operations have not occurred for many years.

Photo 10. Permit sign at State Land Board boundary.
