**MINERALS PROGRAM INSPECTION REPORT**  
**PHONE: (303) 866-3567**

<b>MINE NAME:</b> Boettcher Limestone Quarry	<b>MINE/PROSPECTING ID#:</b> M-1977-348	<b>MINERAL:</b> Limestone (general)	<b>COUNTY:</b> Larimer
<b>INSPECTION TYPE:</b> Monitoring	<b>INSPECTOR(S):</b> Amy Eschberger, Patrick Lennberg, Michael Cunningham, and Russ Means	<b>INSP. DATE:</b> January 30, 2020	<b>INSP. TIME:</b> 10:30
<b>OPERATOR:</b> Holcim (US) Inc.	<b>OPERATOR REPRESENTATIVE:</b> Travis Bennett and Mike Toelle	<b>TYPE OF OPERATION:</b> 112c - Construction Regular Operation	
<b>REASON FOR INSPECTION:</b> Normal I&E Program	<b>BOND CALCULATION TYPE:</b> None	<b>BOND AMOUNT:</b> \$2,518,261.30	
<b>DATE OF COMPLAINT:</b> NA	<b>POST INSP. CONTACTS:</b> None	<b>JOINT INSP. AGENCY:</b> None	
<b>WEATHER:</b> Clear	<b>INSPECTOR'S SIGNATURE:</b>

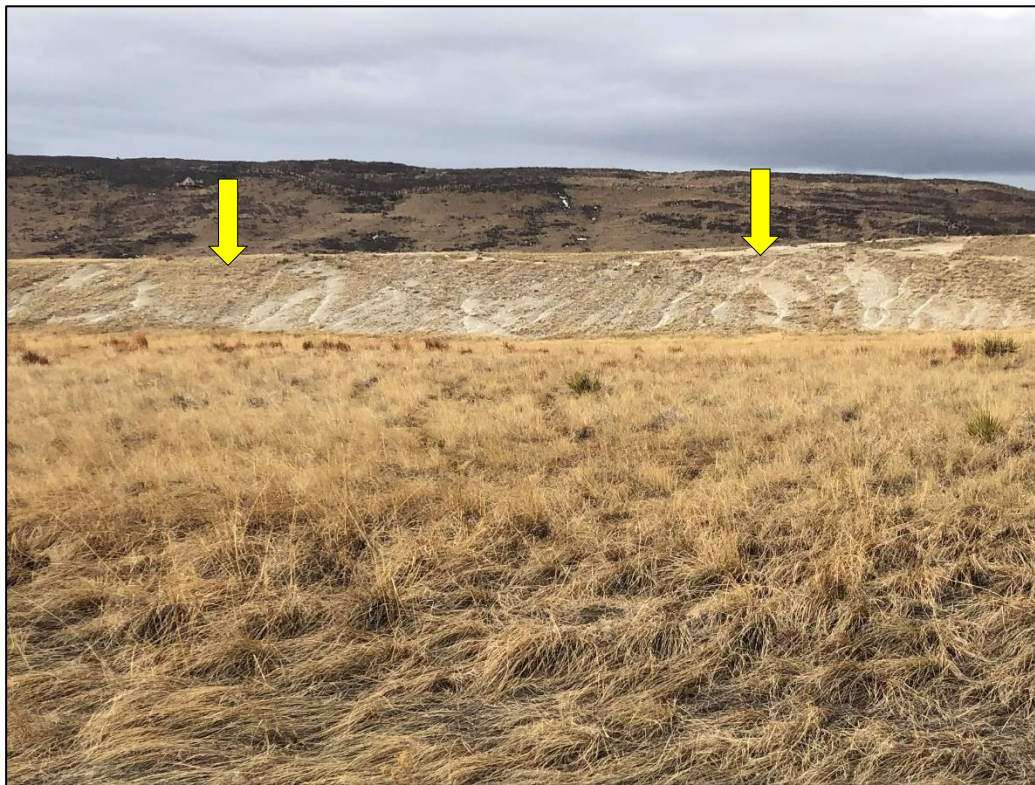
**Photo 4.** View looking west across reclaimed northern portion of permit area, showing pre-law western slope (indicated) which was not re-disturbed by the operation and therefore does not require reclamation.

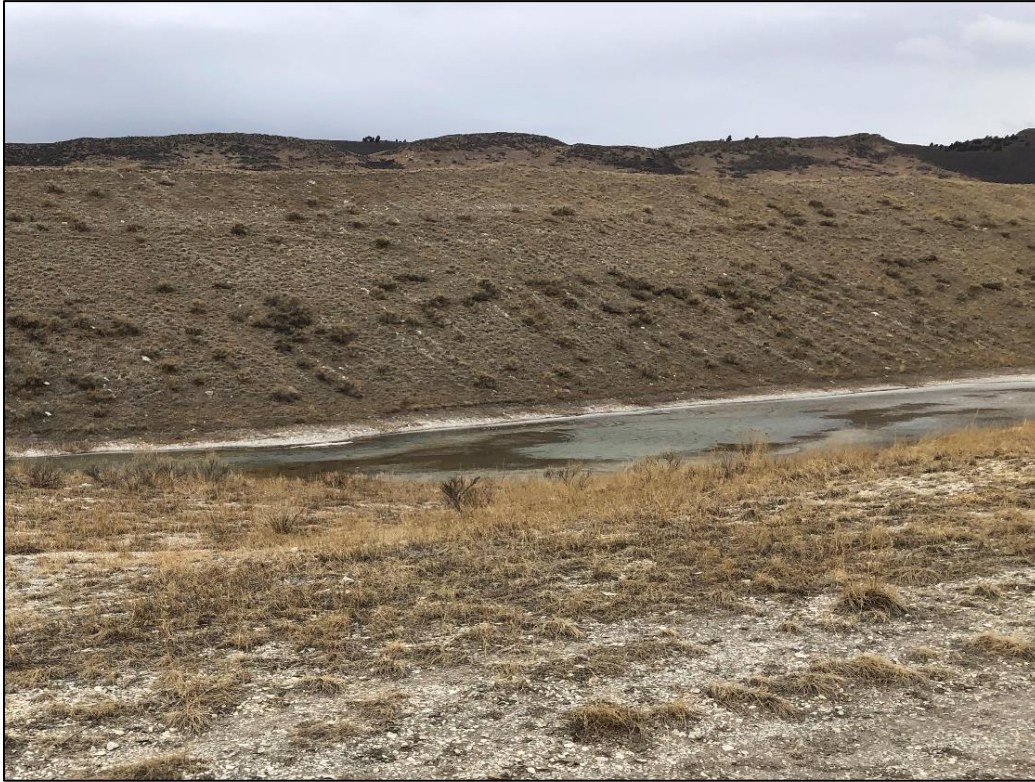
The Division observed water ponded in three of the pits located along the western edge of the permit area (Ponds A, B3, and B) and in two of the pits located along the eastern edge of the permit area (Ponds 2 and C). The operator estimates the ponded water in the pits to be approximately 15 feet deep. Pond B2 located in the western portion of the permit area was dry during the inspection. The Division of Water Resources (DWR) requires operators to ensure water is not retained on site for more than 72 hours, unless an augmentation plan approved by water court is obtained. An augmentation plan must also be obtained for any exposed groundwater, unless an exemption has been approved by DWR.

**Photo 7.** View looking west across Pond A located in western portion of permit area, west of main access road. Note this pit was holding water during the inspection.

A problem is cited in this report (see page 1) for the ponded water on site pursuant to C.R.S. 34-32.5-116(4)(h) and Rule 3.1.6(1)(a) which require the operator to comply with applicable Colorado water laws and regulations governing injury to existing water rights. The operator will need to demonstrate the operation is in compliance with the Office of the State Engineer (SEO), show evidence the operator is taking measures to bring the site into compliance with the SEO, or backfill the pits to at least two feet above the water surface. If, by the corrective action date, the operator has not submitted the required corrective action, the reclamation bond for the site will need to be re-evaluated to include costs for backfilling the ponded water.

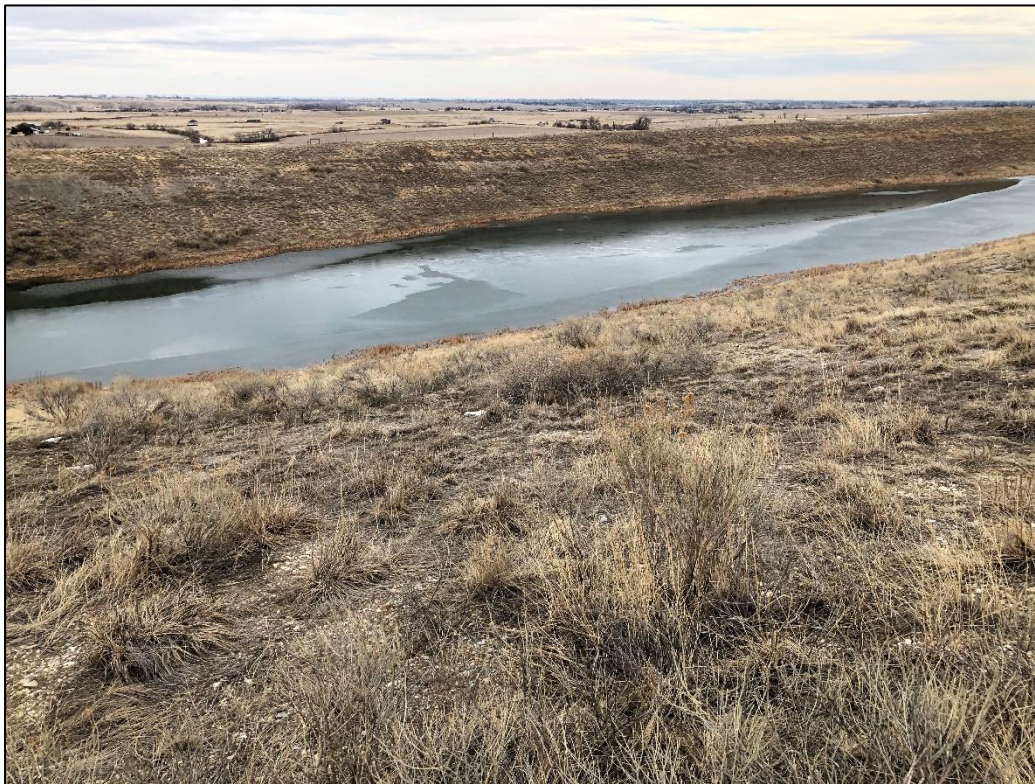
**Photo 8.** View looking southeast across Pond 2 located in eastern portion of permit area, east of main access road. Note this pit was holding water during the inspection.

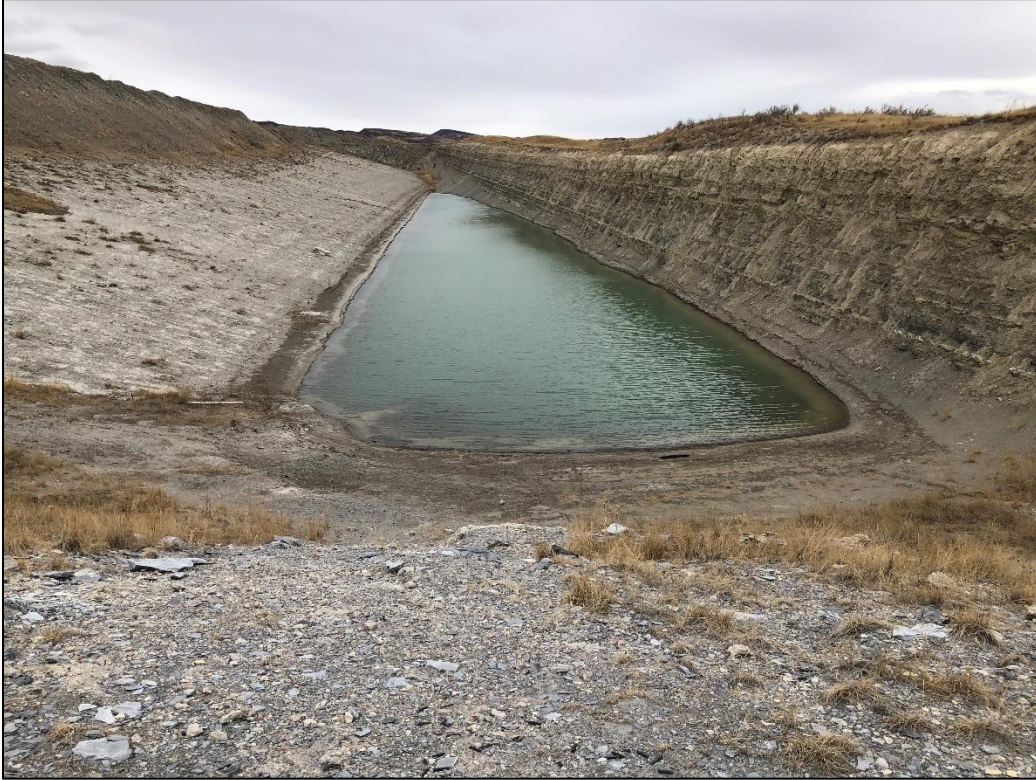
**Photo 9.** View looking north across Pond B3 located in western portion of permit area, west of main access road. Note this pit was holding water during the inspection.

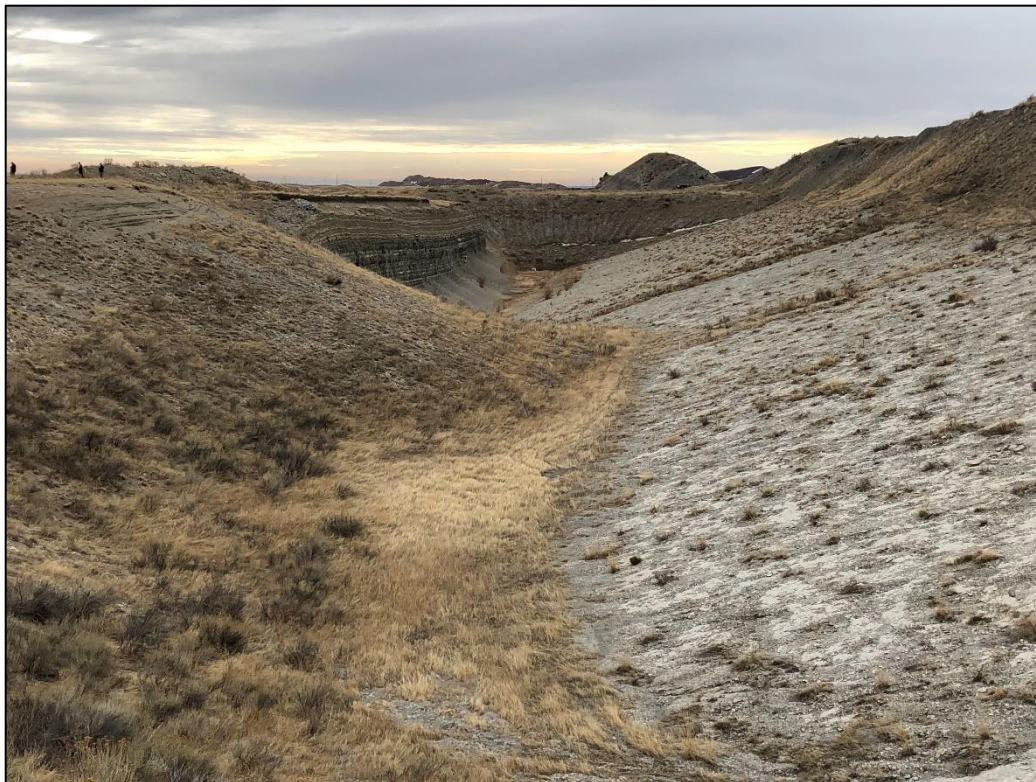
**Photo 10.** View looking south across Pond B2 located in western portion of permit area, west of main access road. Note this pit was dry during the inspection.

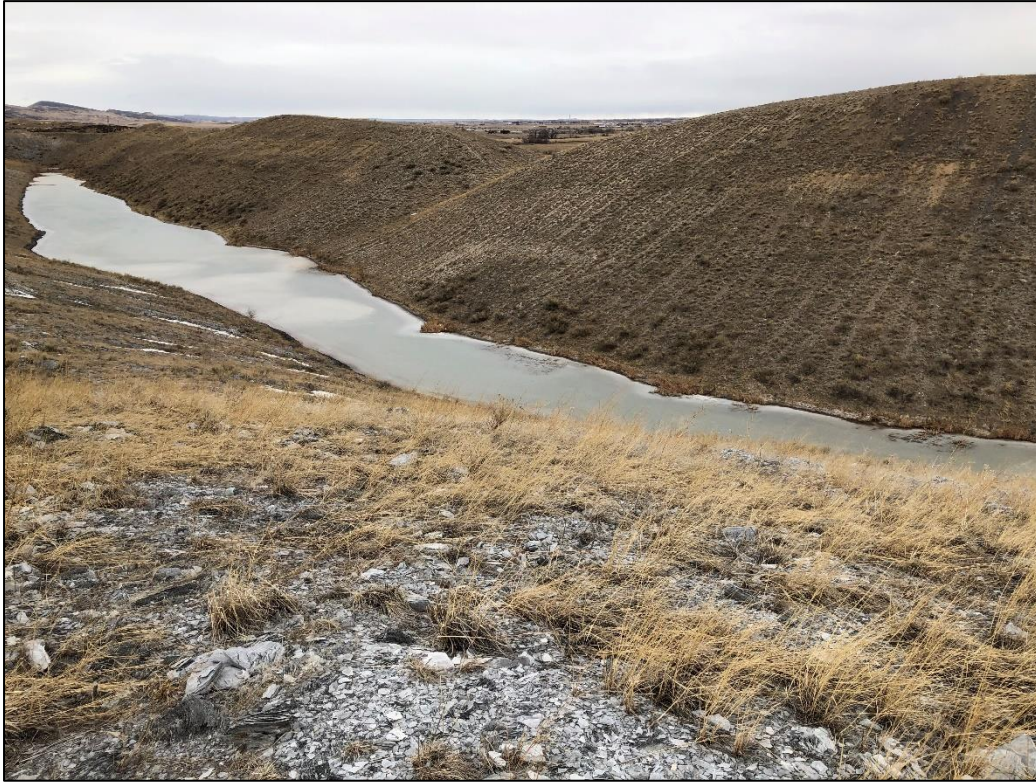
**Photo 11.** View looking northeast across Pond C located in eastern portion of permit area, east of main access road. Note this pit was holding water during the inspection.

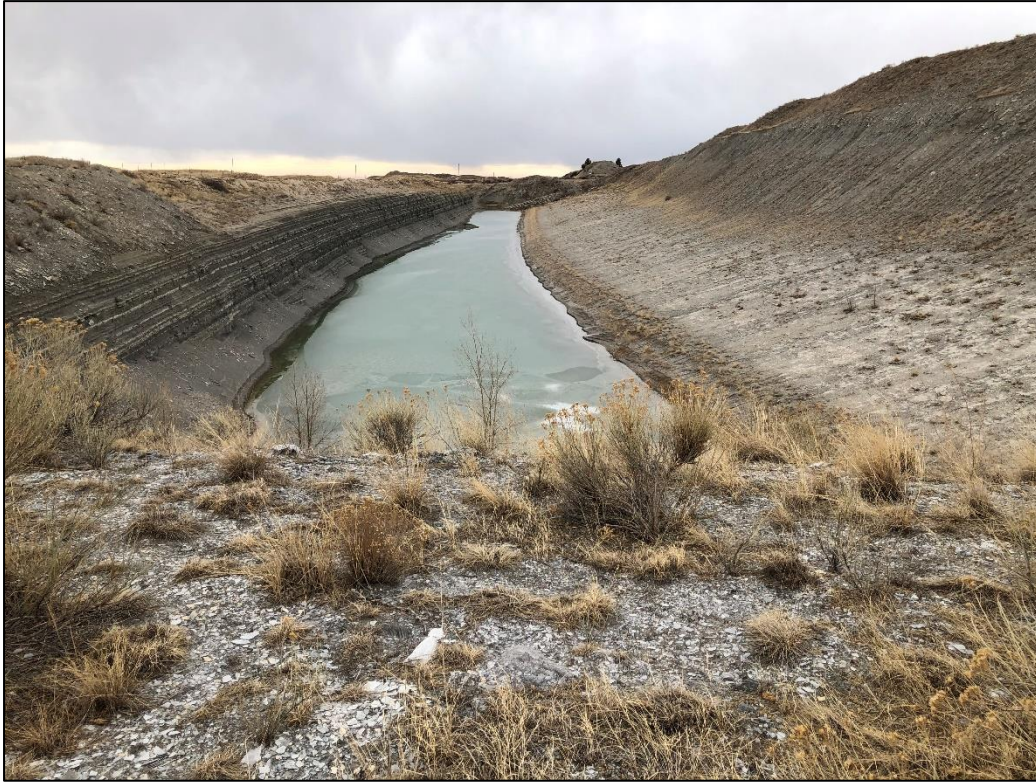
**Photo 13.** View looking south across Pond B located in western portion of permit area, west of main access road. Note this pit was holding water during the inspection.

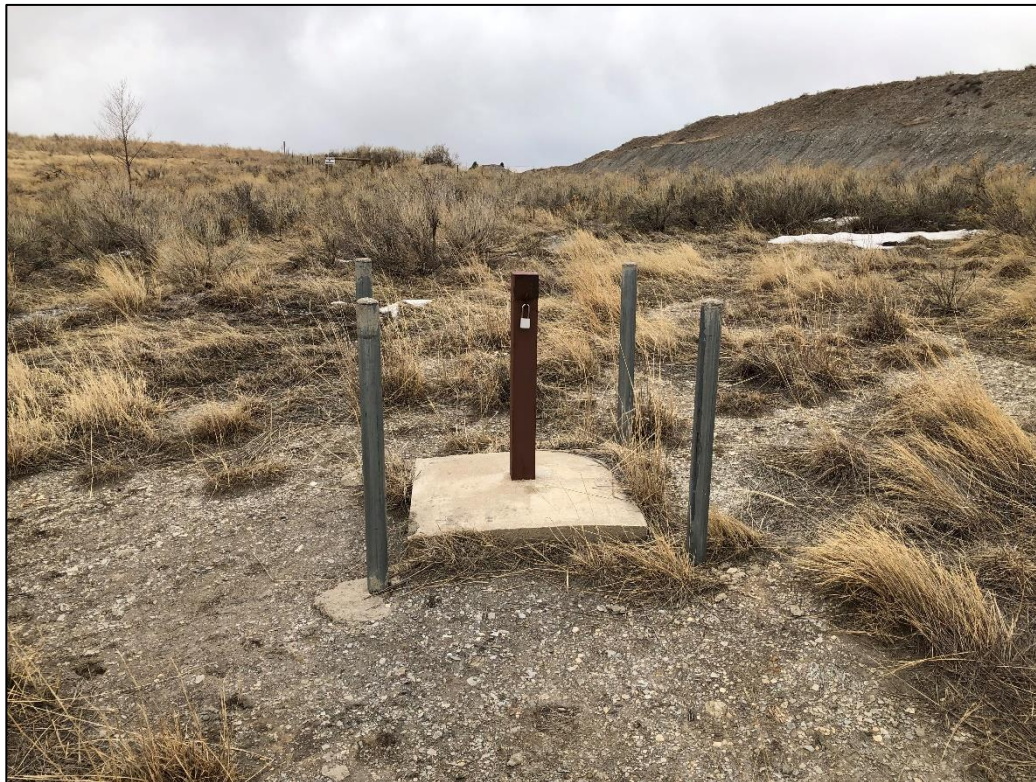
**Photo 14.** View looking south, showing monitoring well MW-5 located outside of CKD disposal areas, just north of Pond B. The well cap was secured with a padlock.

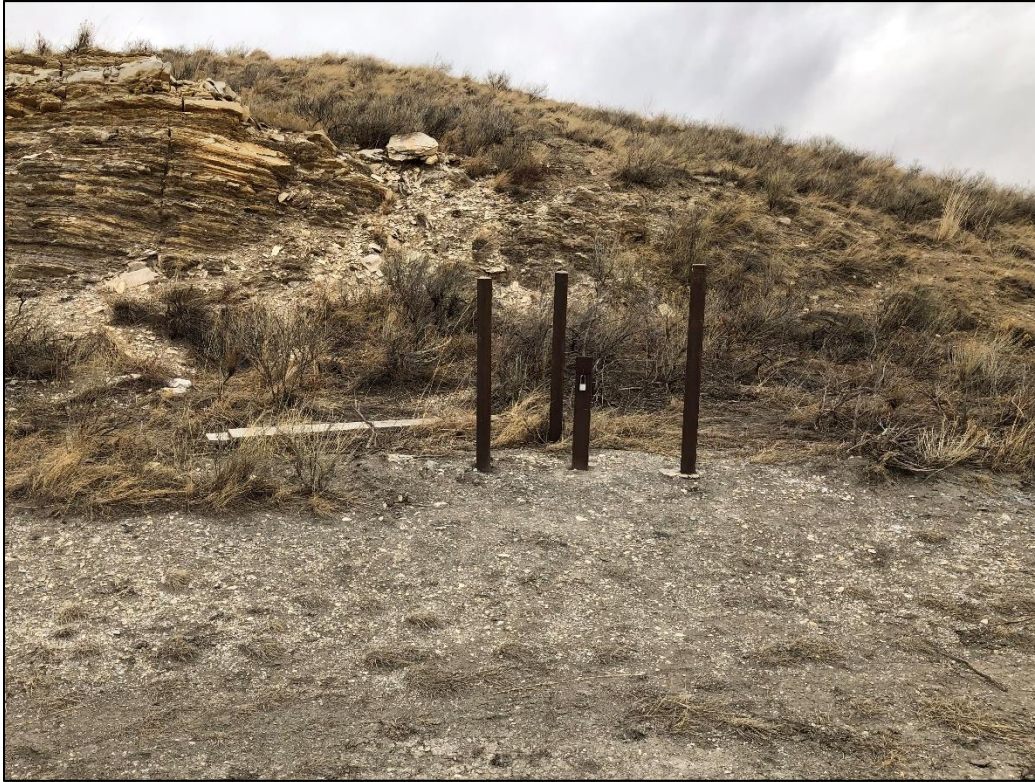
**Photo 15.** View looking east, showing monitoring well MW-2 located at northeastern edge of A2 CKD disposal area. The well cap was secured with a padlock.

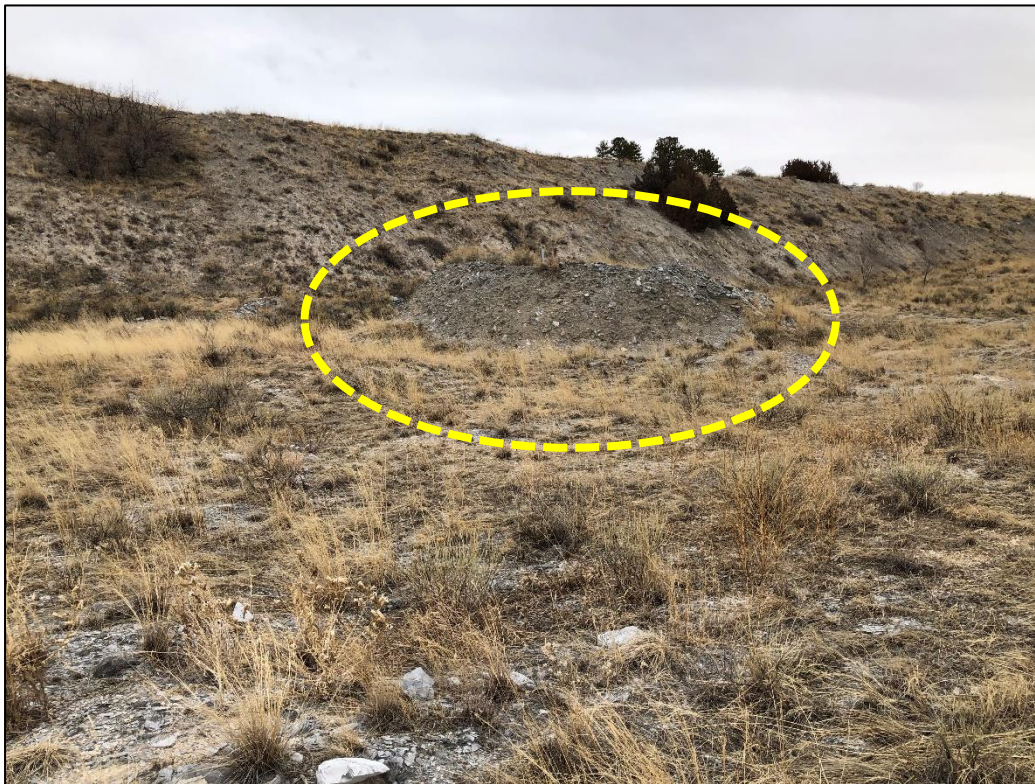
**Photo 16.** View looking northwest, showing monitoring well MW-1 located within A2-CKD disposal area, on top of small overburden mound (circled).

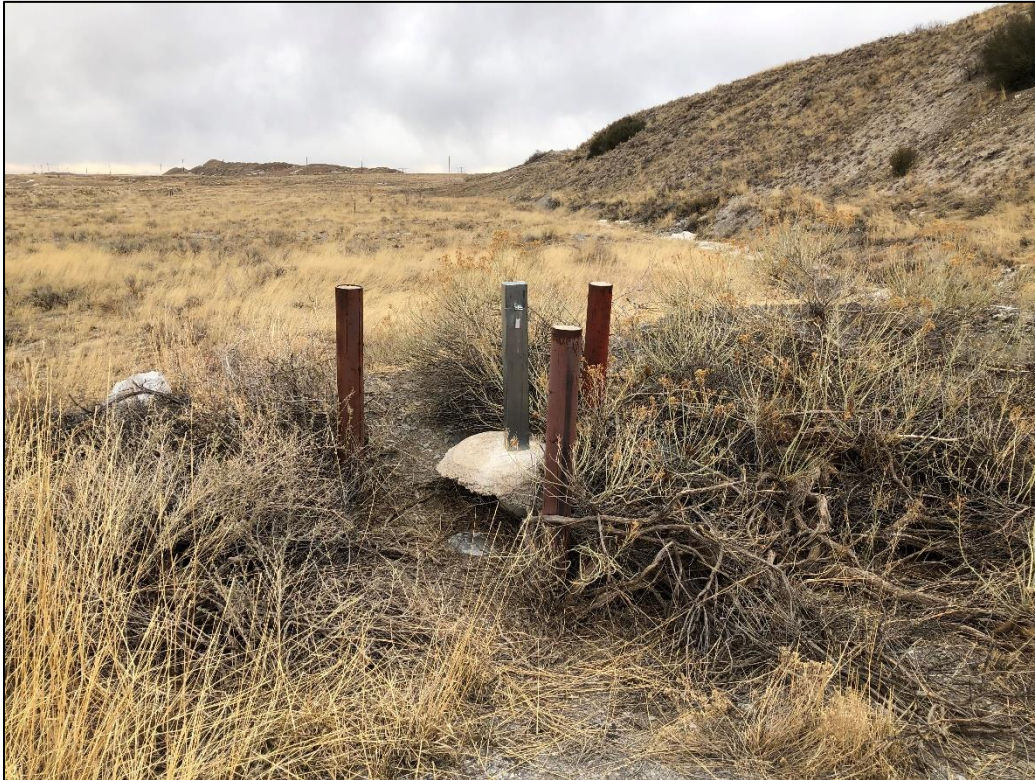
The operation monitors groundwater at the site from a total of seven monitoring wells (MW-1 – MW-7), with all but one (MW-5) located near or downgradient of the CKD disposal areas in the southern portion of the permit area. MW-5 was installed in overburden outside (and north) of the CKD disposal areas. The Division collected GPS data for all well locations during the inspection (see enclosed Google Earth images of site). All wells were properly secured with padlocks. It should be noted, the concrete apron around well MW-1 is elevated above the ground by approximately 8 inches. Depending on the competence of the surface seal of the well, having the apron raised above the ground surface could allow water to migrate down the casing and into the well. Therefore, the Division recommends the operator install a proper concrete apron around well MW-1.

**Photo 17.** View looking south, showing monitoring well MW-1 located within A2-A CKD disposal area on top of small overburden mound. The well cap was secured with a padlock. However, the concrete apron around the well was elevated ~ 8 inches off the ground which could allow water to migrate down the casing and into the well. This needs to be repaired.

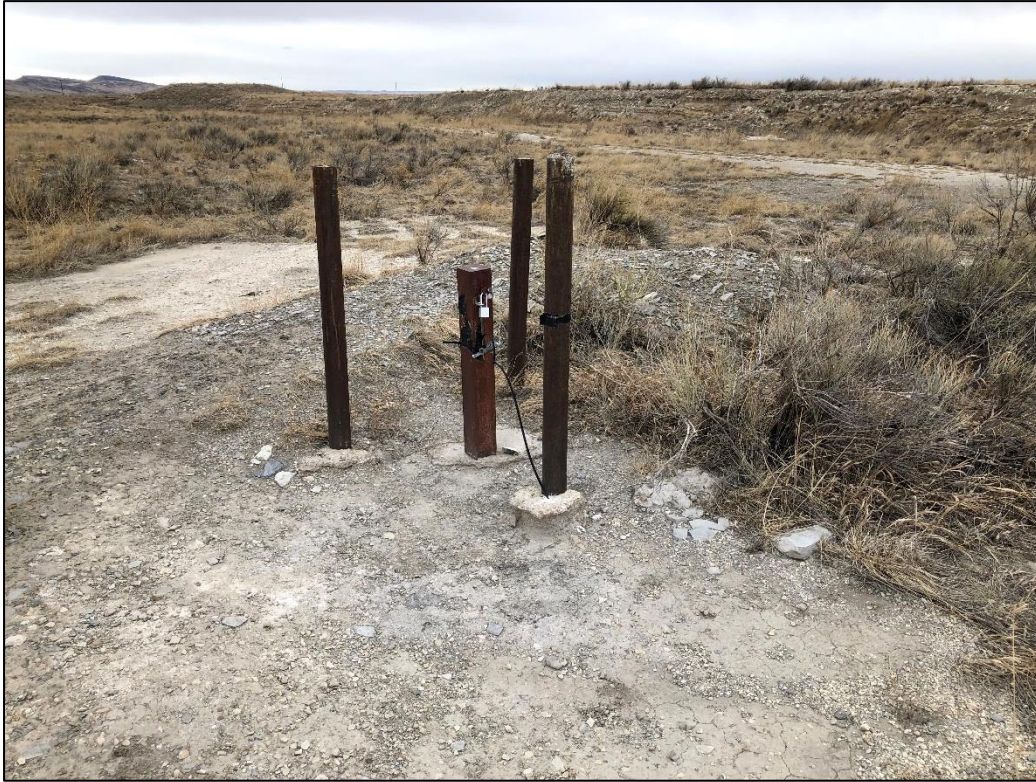
**Photo 19.** View looking northeast, showing monitoring well MW-3 located at eastern edge of A2-A CKD disposal area. The well cap was secured with a padlock.

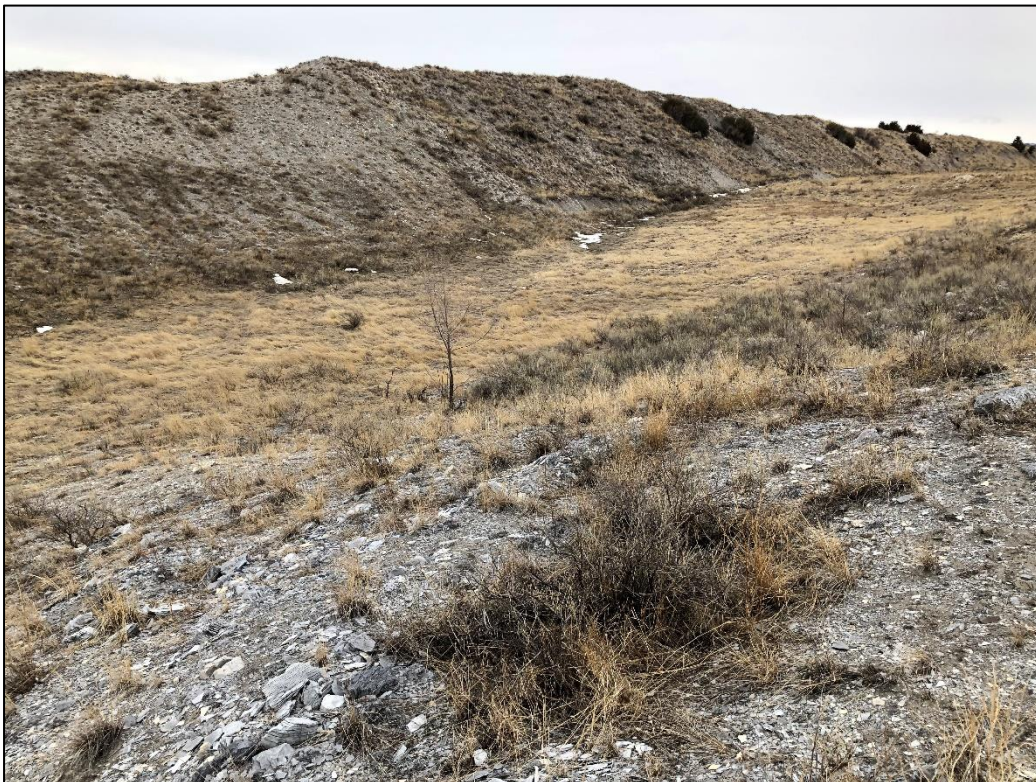
**Photo 20.** View looking northwest across southern portion of reclaimed A2-A CKD disposal area. Note pre-law overburden stockpile along western edge of pit (at left).

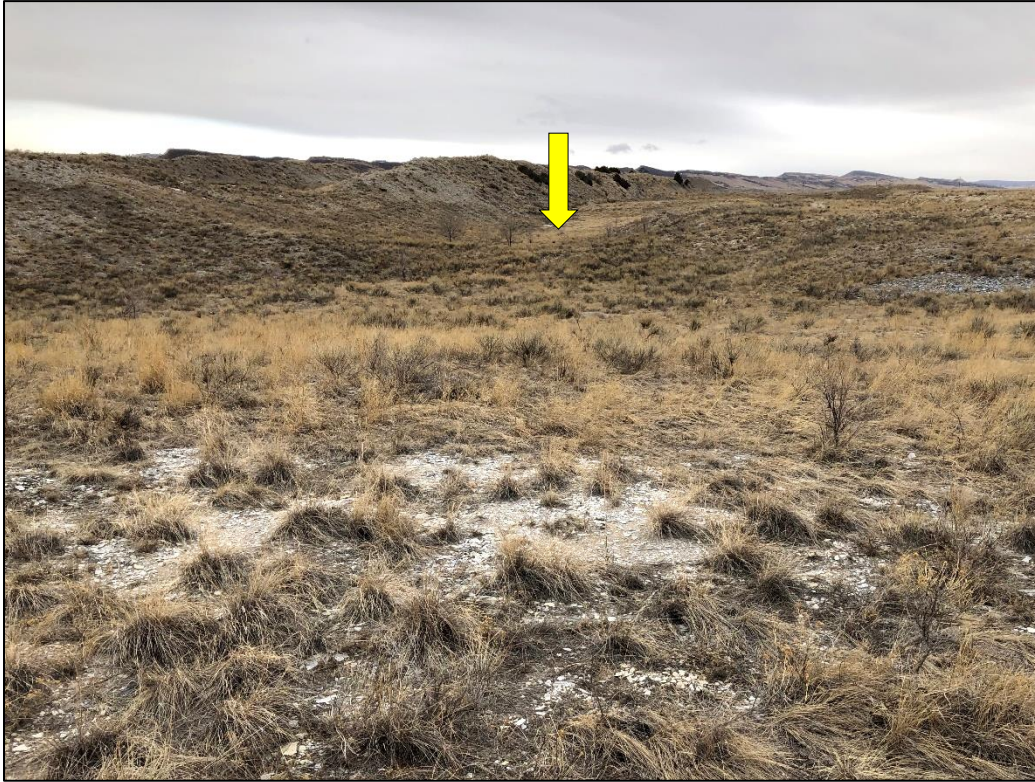
**Photo 21.** View looking northwest across northern portion of reclaimed Dry Fill CKD disposal area. Note surface of Dry Fill CKD disposal area ~30-40 feet higher than surface of A2-A CKD disposal area (indicated in background).

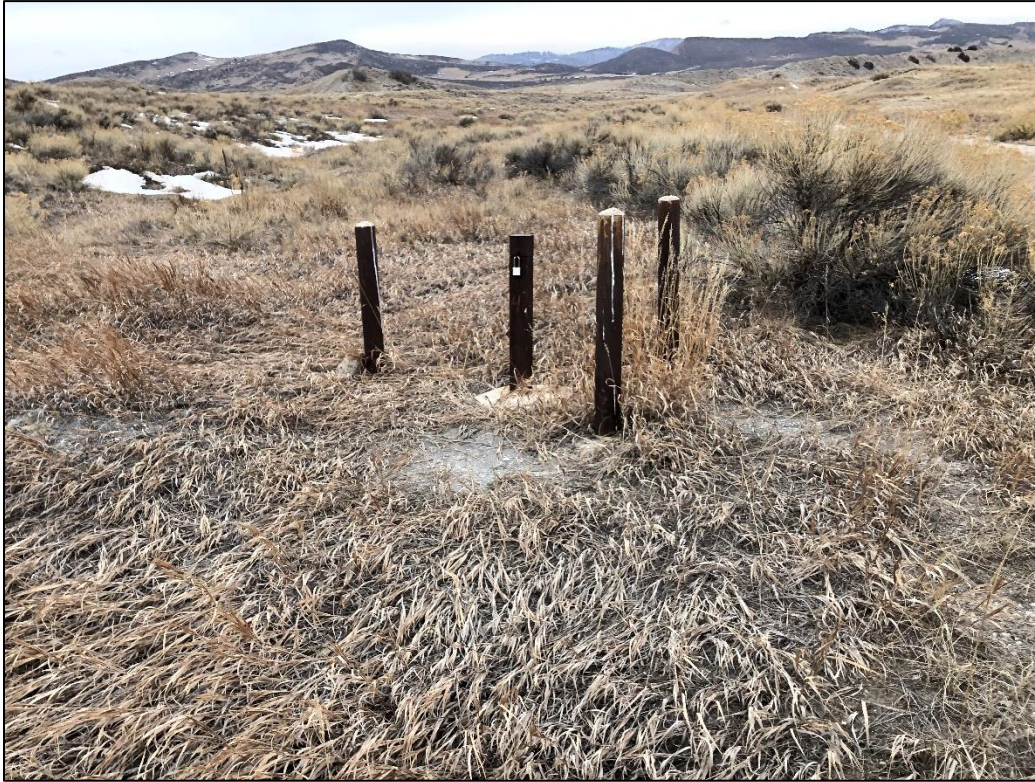
**Photo 23.** View looking north, showing monitoring well MW-4 located southeast of Dry Fill CKD disposal area. The well cap was secured with a padlock.

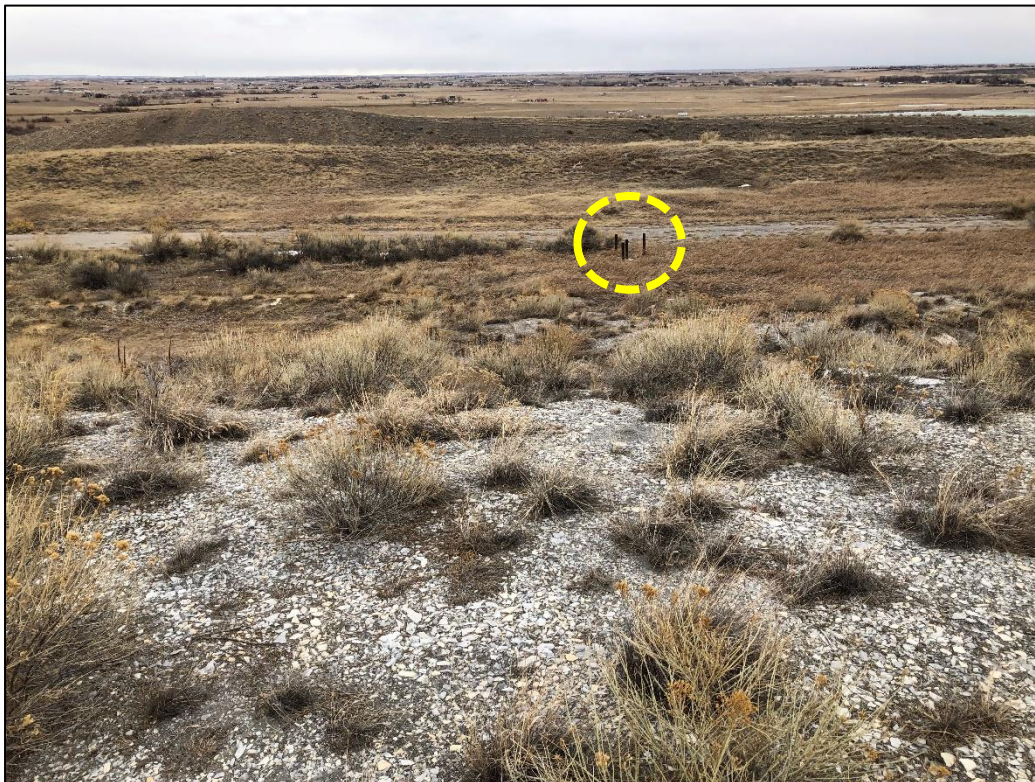
**Photo 24.** View looking southeast from top of Dry Fill CKD disposal area, showing monitoring well MW-4 (circled) located downgradient from this disposal area.

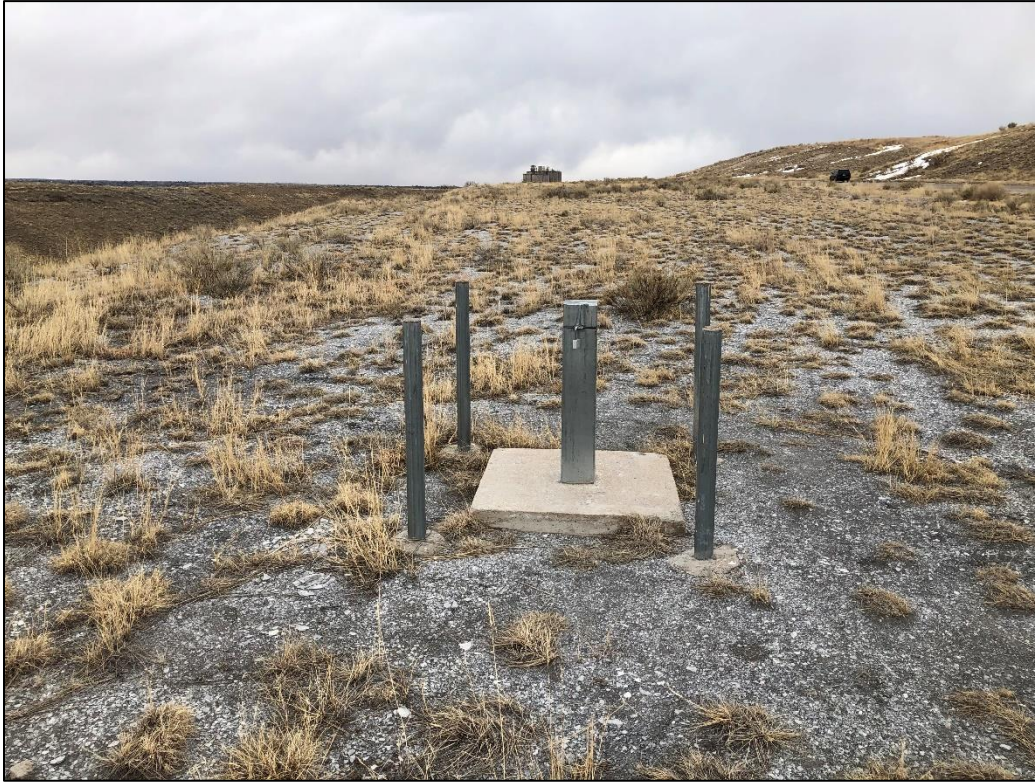
**Photo 25.** View looking south, showing monitoring well MW-7 located east of Dry Fill CKD disposal area, near main access road. The well cap was secured with a padlock.

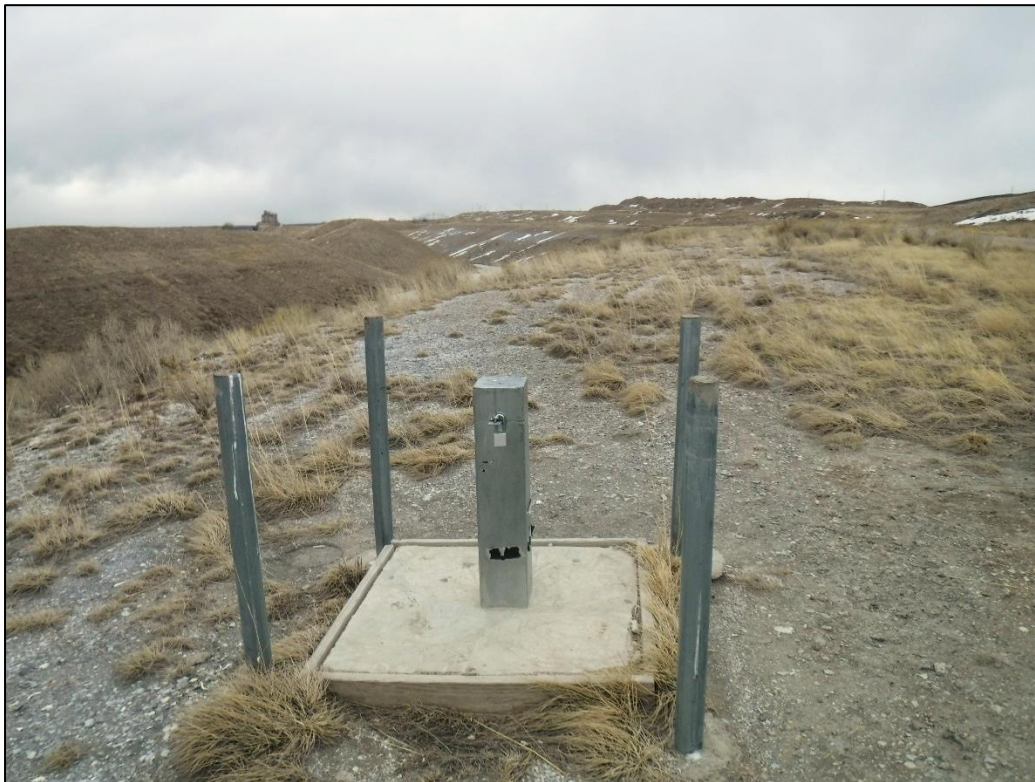
**Photo 26.** View looking south, showing monitoring well MW-6 located east of A2-A CKD disposal area, near main access road. The well cap was secured with a padlock.
