MINERALS PROGRAM INSPECTION REPORT

MINE NAME: Florence Sand & Gravel Pit	MINE/PROSPECTING ID#: M-1992-051	MINERAL: Sand and gravel	COUNTY: Fremont
INSPECTION TYPE: Monitoring	INSPECTOR(S): Timothy A. Cazier	INSP. DATE: August 28, 2019	INSP. TIME: 11:00
OPERATOR: Langston Concrete, Inc.	OPERATOR REPRESENTATIVE: Zac Langston	TYPE OF OPERATION: 112c - Construction Regular Operation	
REASON FOR INSPECTION: Normal I&E Program	BOND CALCULATION TYPE: IT.Bondcalculationtype.CD.Desc	BOND AMOUNT: \$38,100.00	
DATE OF COMPLAINT: NA	POST INSP. CONTACTS: None	JOINT INSP. AGENCY: None	
WEATHER: Clear	INSPECTOR'S SIGNATURE:

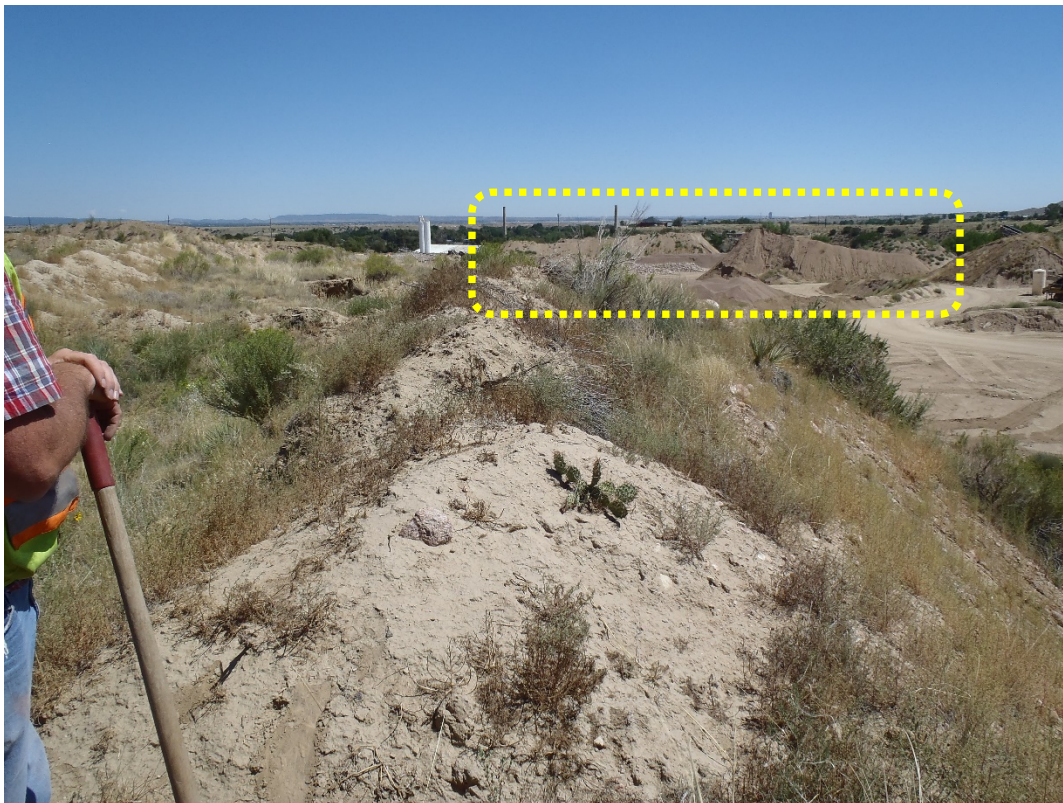
Backfilling and Grading: Sufficient material (fines, considered excess spoil at this site) were observed to be available for backfill on the east end of the site (see **Photo 1**). Mr. Langston pointed out the progress they have made in backfilling the northeast corner (see **Photo 2**), indicating their effort was about 75 percent complete.

Photo 1. Stockpiled fines, east end (looking east).

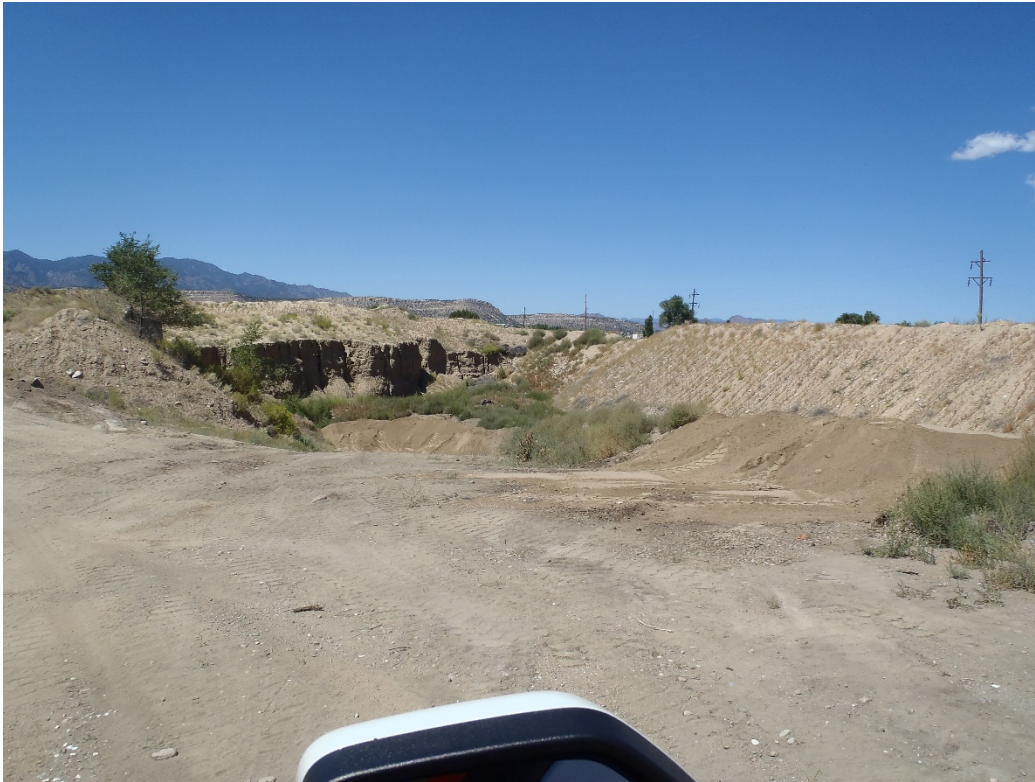
Photo 2. Backfill progress in northeast portion (looking west).

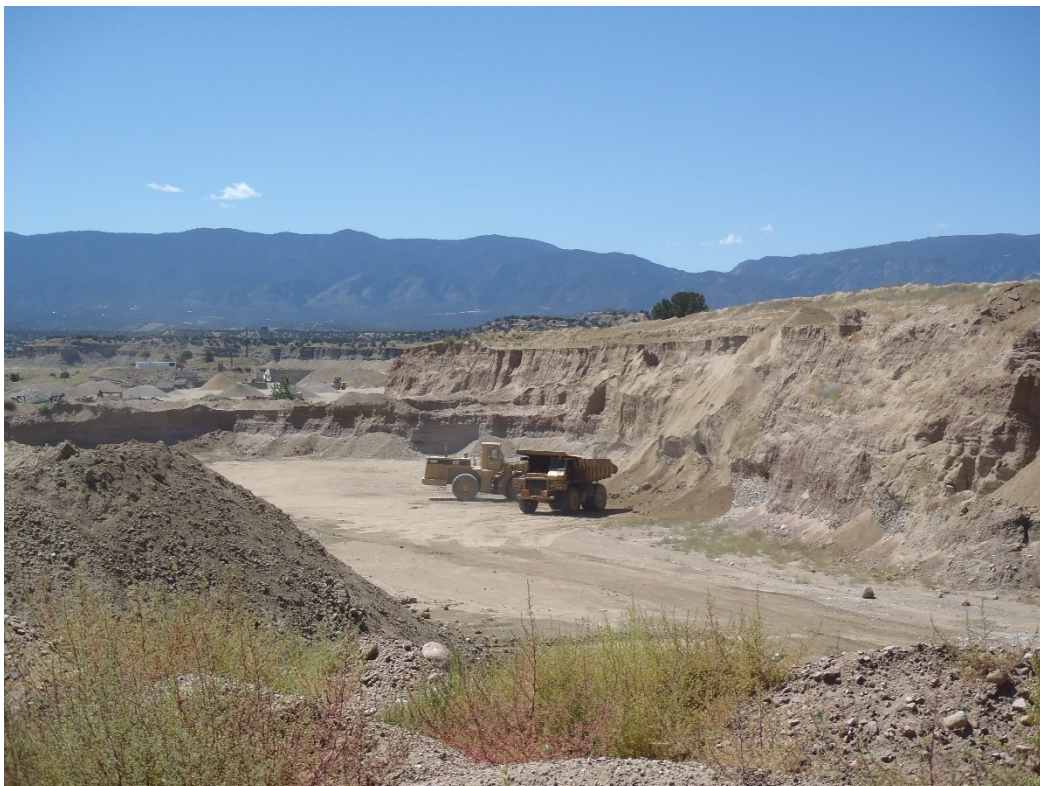
Gen. Compliance with Mine Plan: The operation appeared to be in compliance with the approved mine plan. Google Earth was used to measure the disturbed area, which was estimated to be approximately 45 acres, based on 2018 imagery. Highwalls were estimated to vary between 30 and 40 feet in height and appeared stable (see **Photo 3**).

Photo 3. Active highwall (looking SW).

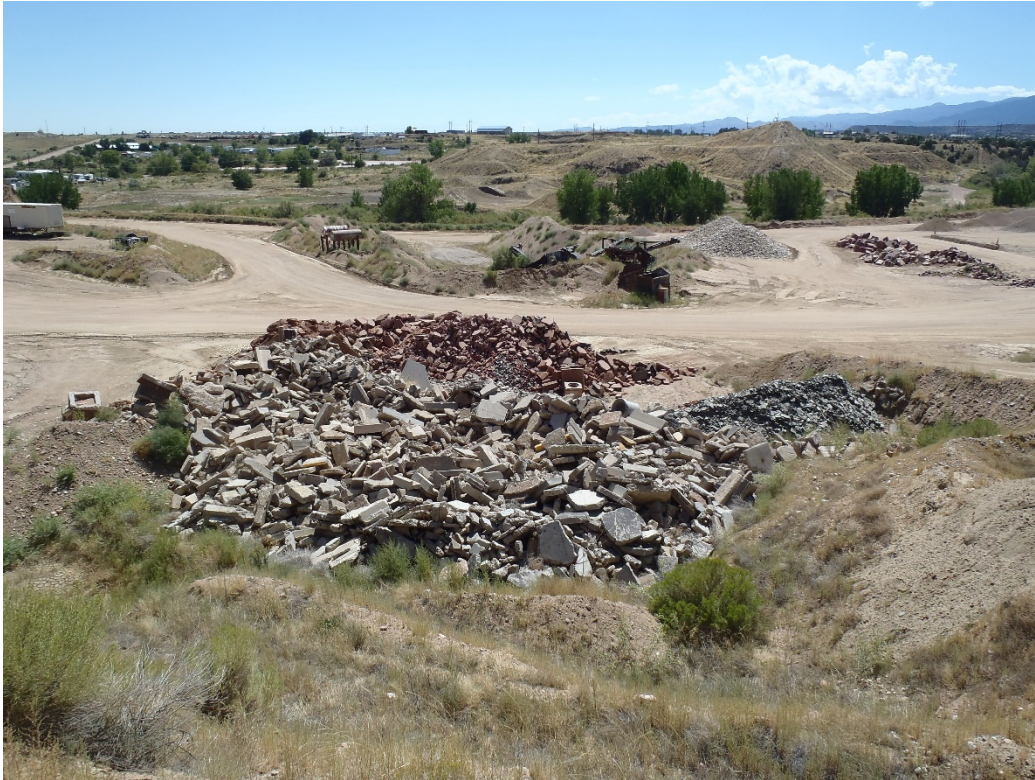
Processing Waste: Observed processing waste was limited to the aforementioned fines stockpiles to be used primarily for backfill. Some stockpiled broken concrete was observed (see **Photo 4**).

Photo 4. Stockpiled broken concrete (east end of processing area, looking south).

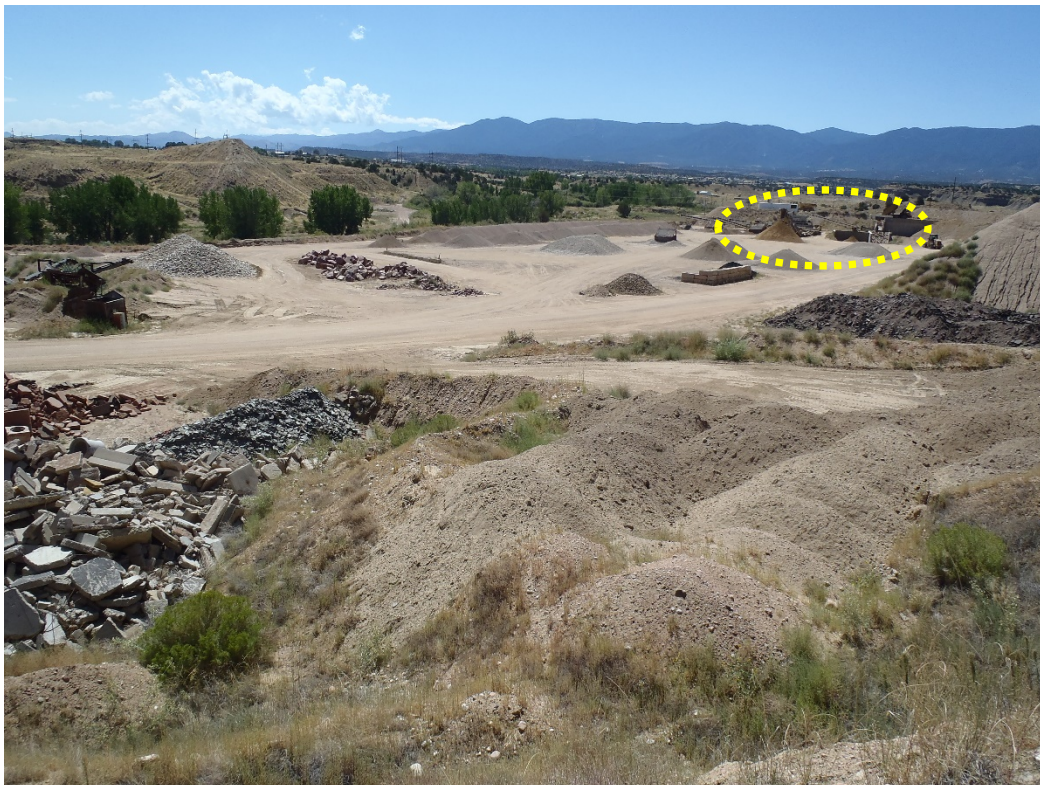
Support Facilities On-site: A screen plant was observed on site (see **Photo 5**). Mr. Langston indicated they also crush from time to time.

Photo 5. Processing area (screen plant circled, looking SW).

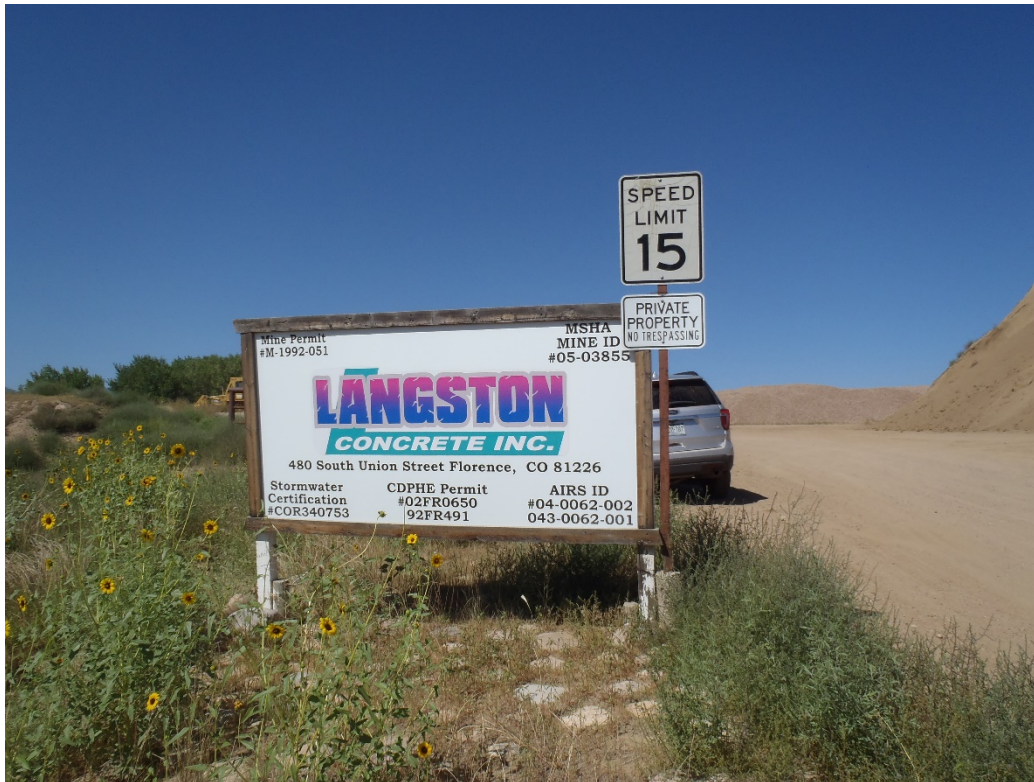
Signs and Markers: The permit sign was properly posted (see **Photo 6**) and observed boundary marker locations, delineating the permit boundary (see **Photo 7**) were collected using a handheld Trimble Juno 3B GPS unit (see **attached Post Inspection map**). Based on post-inspection map work, it appears the boundary markers observed

Photo 6. Permit sign.

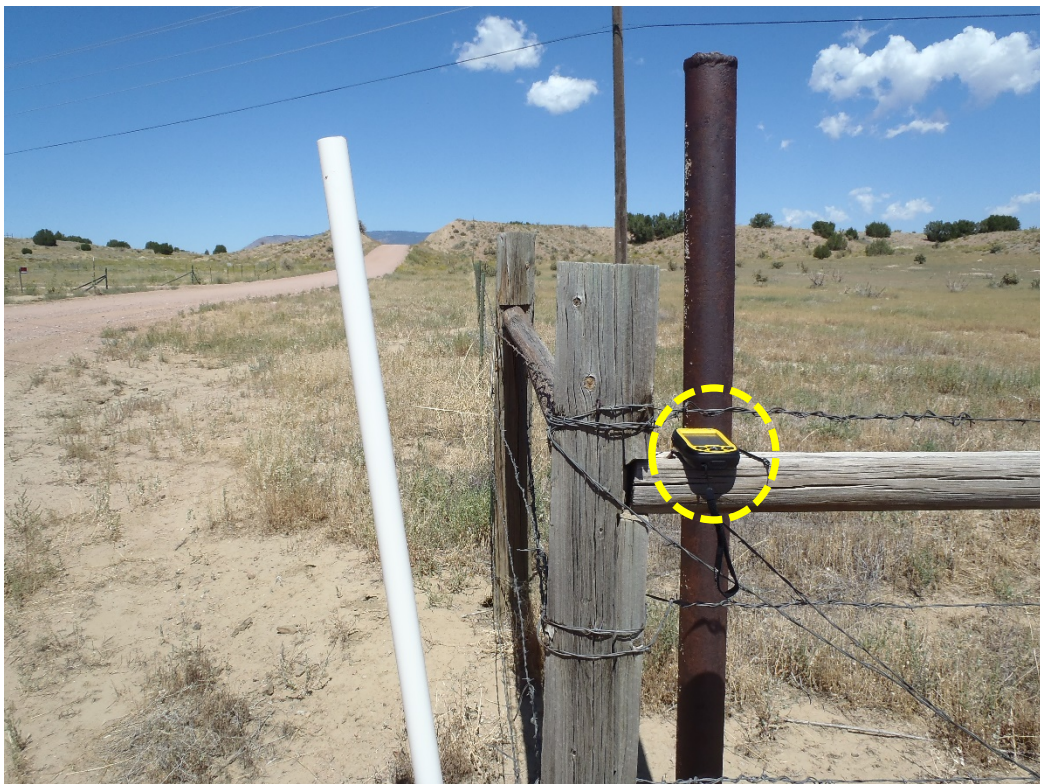
Photo 7. Typical permit boundary marker – north corner, far west boundary (looking east, note GPS unit).

in the field delineate the property boundary and not the permit boundary. Langston Concrete should double check this with their surveyor (Crown Point Land Services on the TR-01 approved map) and if this is the case, install permit boundary markers as soon as possible. It is the affected area (in this case the permit area is the affected area) that is required to be marked pursuant to Rule 3.1.12(2).
