Response to Castle Adequacy Review Response #3

Memo

Re: Continental Materials Corporation/Castle Aggregate, Pikeview Quarry, Permit M-1977-211, Amendment 04, Review of February 7, 2020 Operator Adequacy Answer to DRMS Third Adequacy Review and DRMS Fourth Adequacy Review.

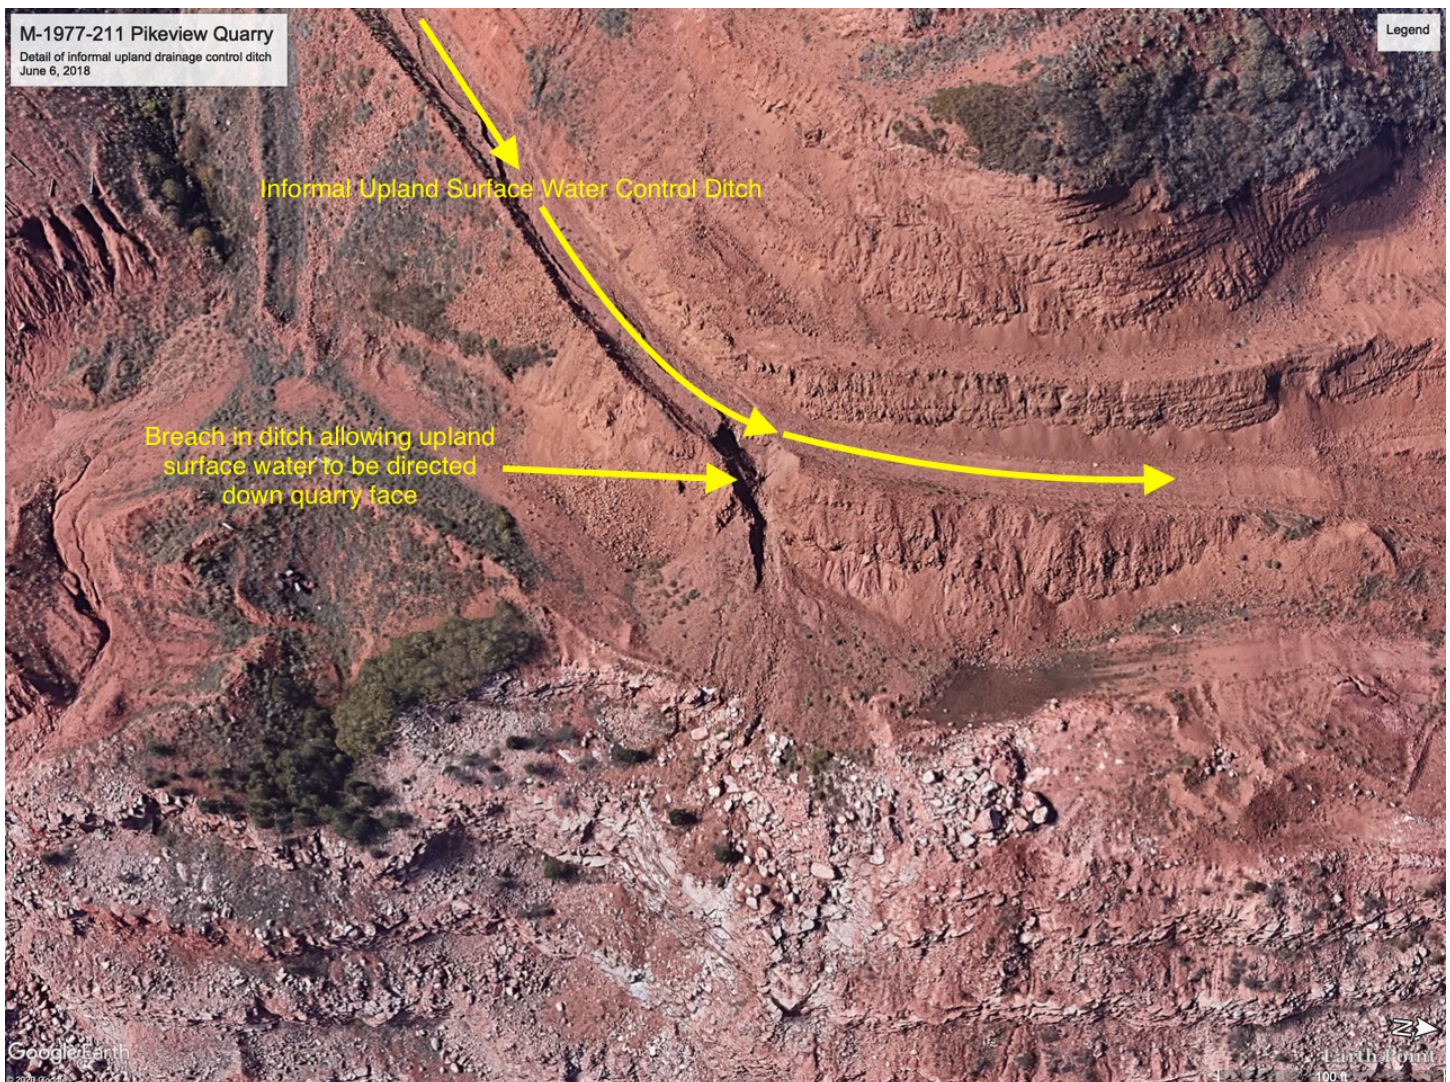
CMC Response to question 33g relating to stormwater diversion during reclamation is the same CMC proposed solution that has not worked before. CMC is counting on “existing diversions” that have failed in the past. The DRMS Fourth Adequacy Review letter says that this response is adequate.

The failure of the northern diversion is what caused water to cascade down the quarry wall in 2015. This ditch looks like it is still not repaired as of 2018 (see Figure 1). It is now obvious that this approach leads to consistent failure of the upland diversion ditches. Why is DRMS not requiring designs for this structure at this point and requirements that the structure be built to those designs?

Figure 1. From Google Earth aerial photo of June 6, 2018 showing informal upland drainage ditch breached in approximately 2015 and still not repaired as of 2018. Above west quarry highwall, north side.

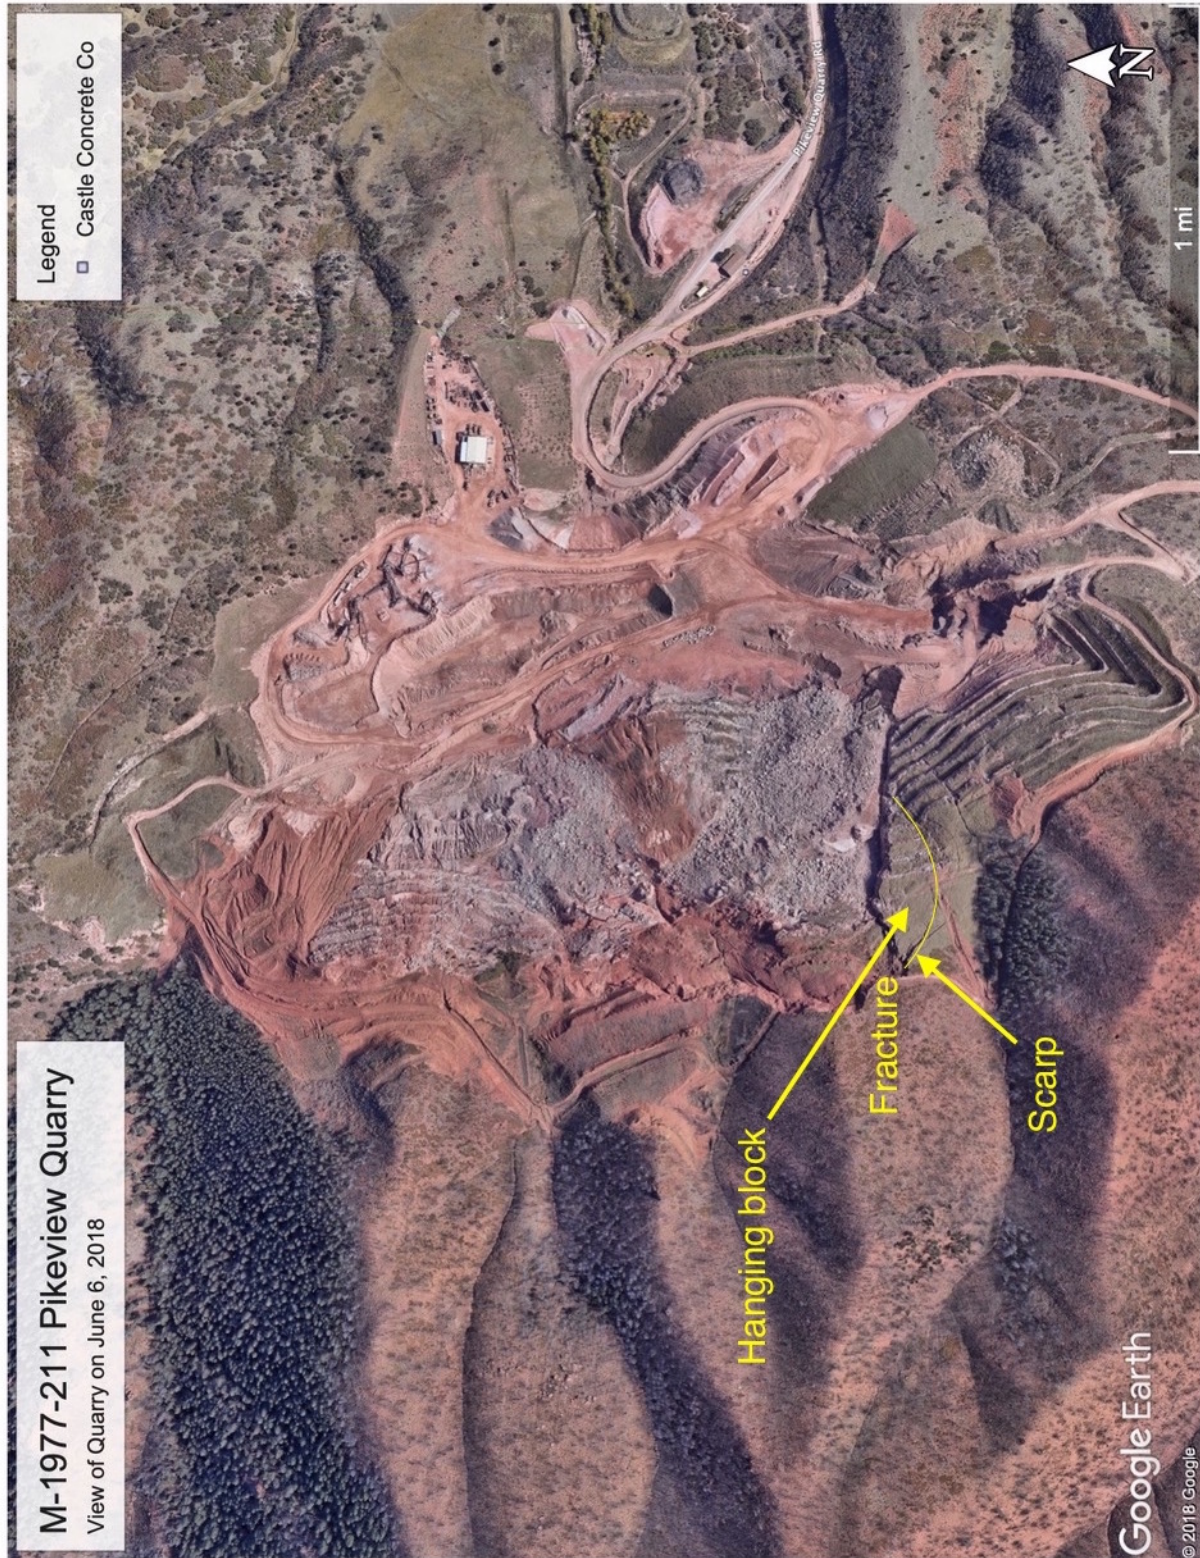
Aerial photos of 2017 (Figure 2) and 2018 (Figure 3 - whole quarry; Figures 4 and 5 - detail) indicate a scarp above the southernmost hanging block at the top of the highwall. The Sawatch clay layer underlies the hanging block located on the south side of the western highwall. Exponent deemed the clay layer the primary failure cause for the December 2, 2008 and related slides. In other words, we are not talking about safety factors of unconsolidated materials such as exist in the body of already failed material but a special condition of a clay layer in the upper part of the Sawatch Formation that could lead to sudden and unexpected sliding of now hanging material above that layer now that the buttressing blocks of material below this have already failed and slid downslope. An additional complicating and destabilizing factor is that the scarp and the separation of materials at the top of the block will probably allow additional surface water to flow directly to the clay layer and further lubricate and destabilize this block.

Figure 3 – Pikeview Quarry conditions on June 6, 2018.

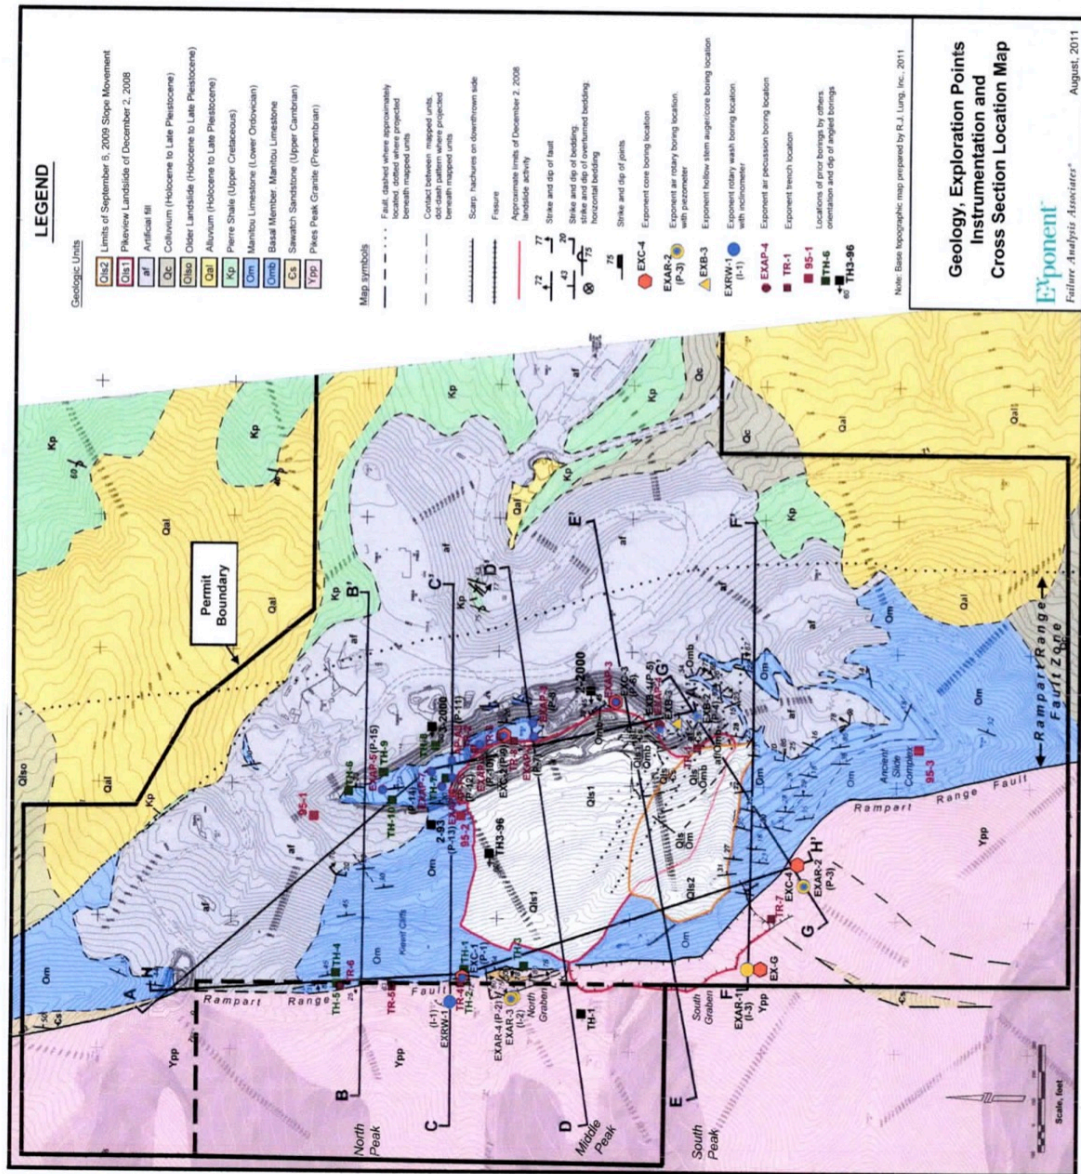
The Exponent Report of 2011 includes a cross-section in Appendix 39 (G-G') that is indeed drawn along the slope gradient and probably intersects part of the present hanging block of limestone in the southern part of the west highwall of the quarry (Figures 6 and 7). After reading this part of the Exponent Report, the concern of instability of this rather large block of material only grows larger because it clearly shows that this is a hanging block and the block could slide in the near future if not properly buttressed, avoided, or handled in some other appropriate way. CMC and DRMS need to recognize this to protect worker safety and address this concern.

Figure 6 – From Exponent Report (2011), Appendix 39. Map of Pikeview Quarry showing Cross Section Locations including G-G'.
